Soil tests

(1) In-situ test

(2) Triaxial compression tests and ring shear tests*

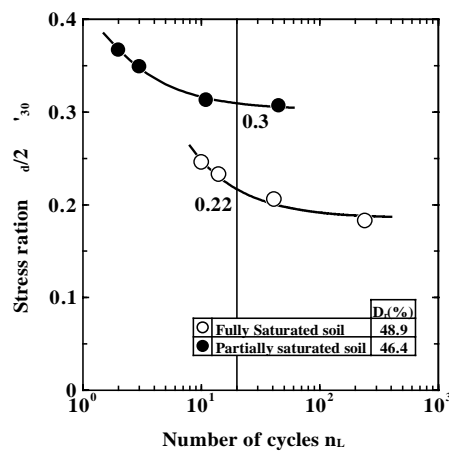
Figures 2.35(a) and 2.35(b) show typical examples of time-varying strain and cyclic deviator stress ratio obtained from the dynamic triaxial tests for partly and fully saturated soil samples, respectively. Excessive pore pressure ratio is also shown in Figure 2.35(b). Figure 2.36 shows the relationship between different stress ratios and corresponding numbers of cycles required for the specimen to liquefy. A specimen was assumed to have liquefied when 5 % axial strain was reached in it.

Figure 2.36 Liquefaction strength

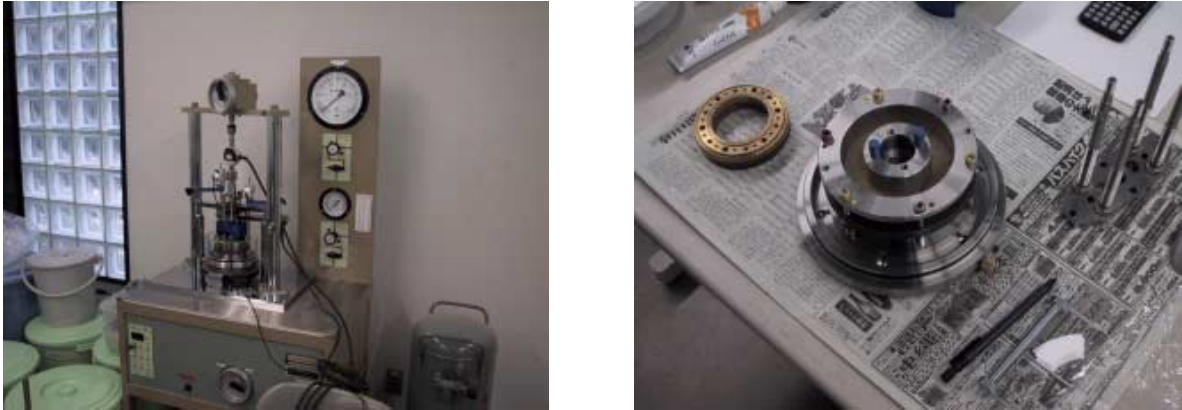
Ring shear tests were carried out on the same pumice sand of the natural water content. The maximum grain size included in the samples was 0.85 mm. The details of the ring shear testing apparatus (**Figure 2.37**) are available in a literature by Suzuki et al. (1997). The stress paths and the rupture envelope plotted in **Figure 2.38** show that the residual strength parameters ϕ_r and c_r are 36.1° and 0 kPa, respectively. Measured strength parameters are summarized in **Table 2.4**.

Figure 2.37. Ring shear testing apparatus

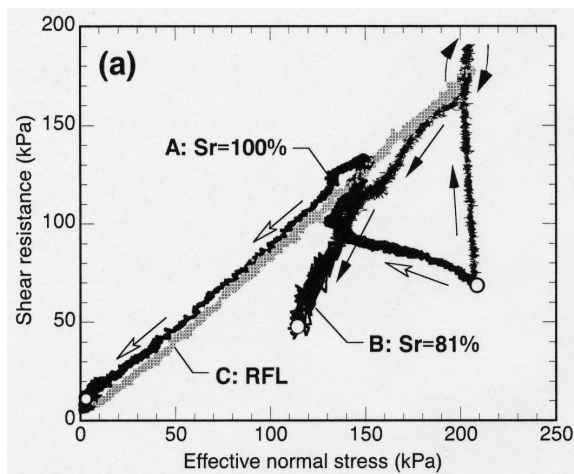
Figure 2.44(a) shows the effective stress paths for the performed two tests (A and B). As soon as the shearing of the sample started in **TEST A (S_r=100%)**, there appeared an excessive pore pressure buildup, which was then followed by dilation of the pumice. When the residual failure line (RFL) was reached, a sudden decrease of apparent friction angle along the RFL was observed. The drop of the shear resistance is also plotted in **Figure 2.44(b)** with respect to the increasing shear displacement. When the twisted pumice sample had slipped 20m distance, the apparent friction angle of about 3.2 degrees was reached, the fact suggesting that a sliding-surface liquefaction occurred in the saturated soil sample (Sassa, 1996 and Sassa et al 1996). The average apparent friction angle mobilized in place, however, was seemingly about 13 degrees, much higher than 3.2 degrees reached in TEST A.

For this reason, **TEST B** was carried out for smaller value of S_r (**S_r=81%**). In this test, the stress path went almost straight up until the RFL was reached (**Figure 2.44(a)**), and then the apparent friction angle dropped down to 12.7 degrees, which is closer to the angle roughly evaluated over the entire travel distance. The path deviated from the RFL presumably because the sensor did not keep a good track of pore pressure of the unsaturated pumice sample.

(a) Effective stress path

Figure 2.44. Ring shear test results

The RFL in **Figure 2.44(a)** was obtained after TEST A by the following procedure:

- (a) The drainage valve on the top of the shear box was opened, and the pore pressure built up in the specimen was released.
- (b) Normal stress was then gradually decreased at a constant rate of 0.2 kPa/sec to zero keeping the constant shearing speed of 0.2 mm/sec.

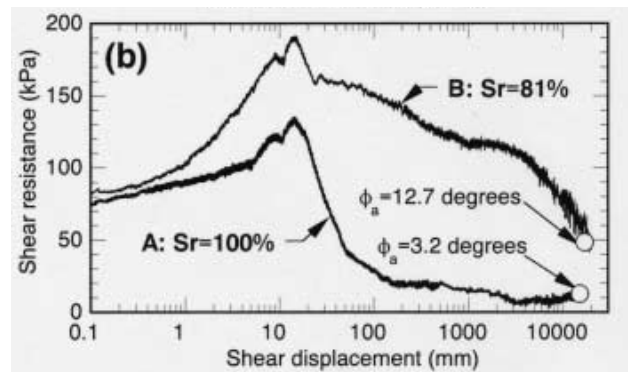
(b) Shear strength vs. shear displacement

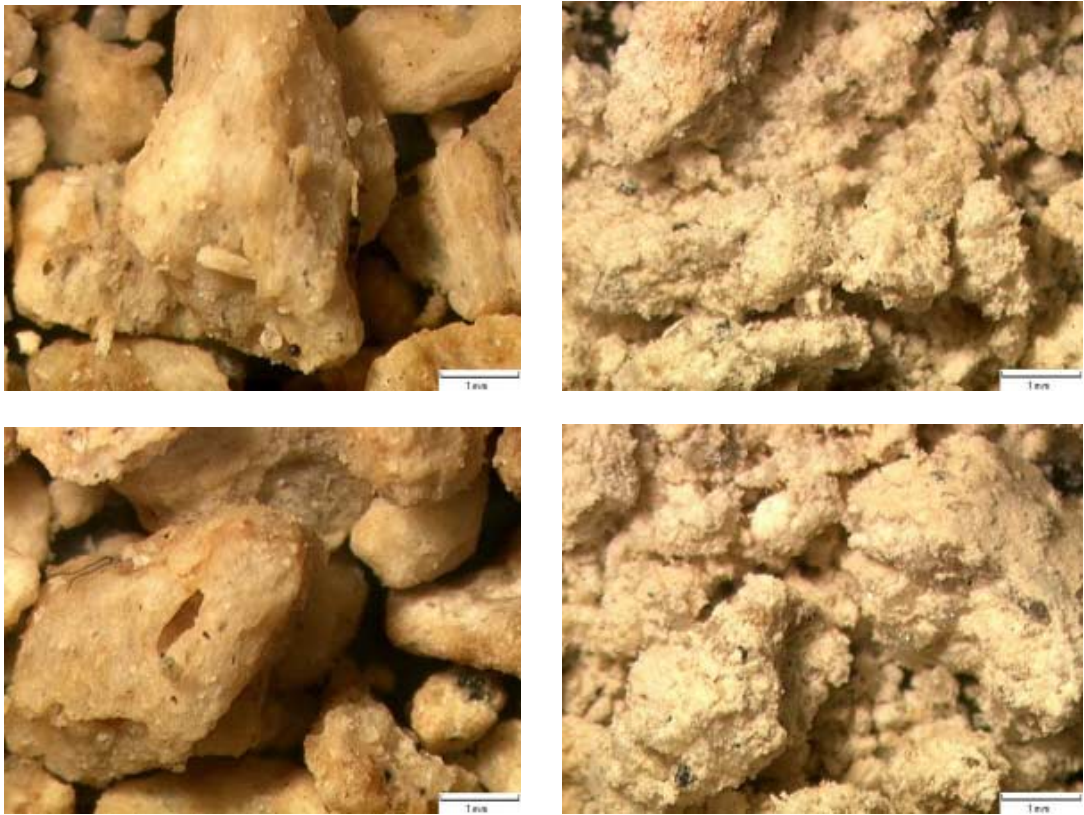
Pairs of micrographs in **Figures 2.45** (optical) and **2.46** (SEM) compare microstructures of the pumice before and after the ring shear test. The scale is shown in each photo. Grain crushing due to shearing is obvious in each pair.

Figure 2.45. microstructure of the pumice by optical microscope (Left: before the test, Right: after the test)

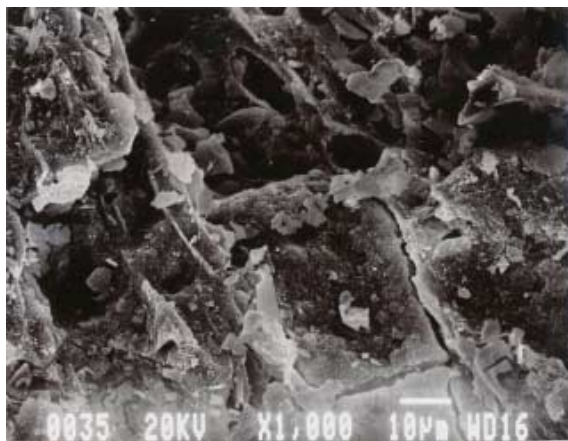
Figure 2.46. microstructure of the pumice by SEM
(Left: before the test, Right: after the test)
