Chapter 5

Tsunami and Its Effects

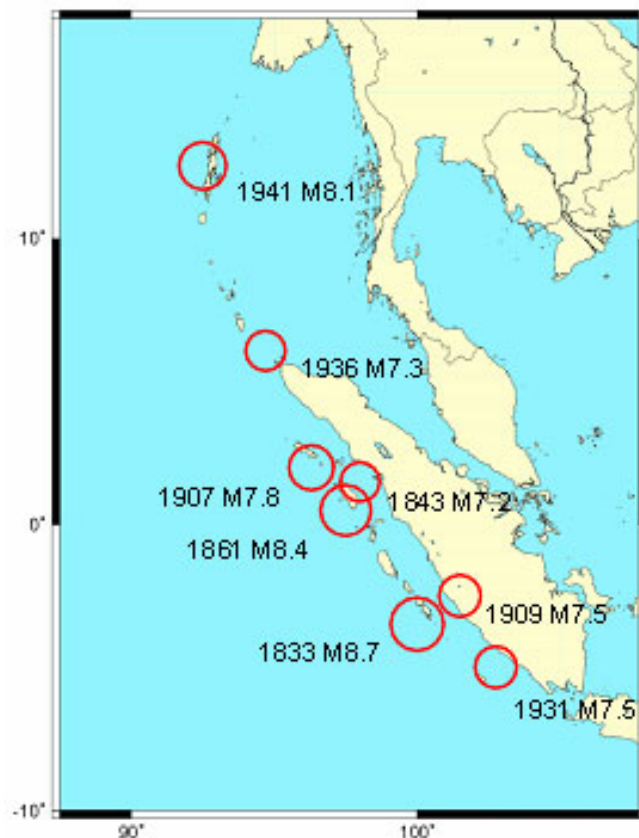
Figure 5.1 Some tsunamigenic earthquakes off the west coast of Sumatra Island (The original figure from BRI)

The 26 December 2004 earthquake was not the first tsunamigenic earthquake, which occurred off the west coast of Sumatra Island. Some earthquakes generated tsunamis in past are shown in Figure 5.1. Only 7 people out of 70,000 people of Simeulue Island nearby the epicenter of the earthquake were killed, thanks to the saying of their ancestors "if there is an earthquake run for your life". The experience of the 1907 tsunami disaster was put to good account.

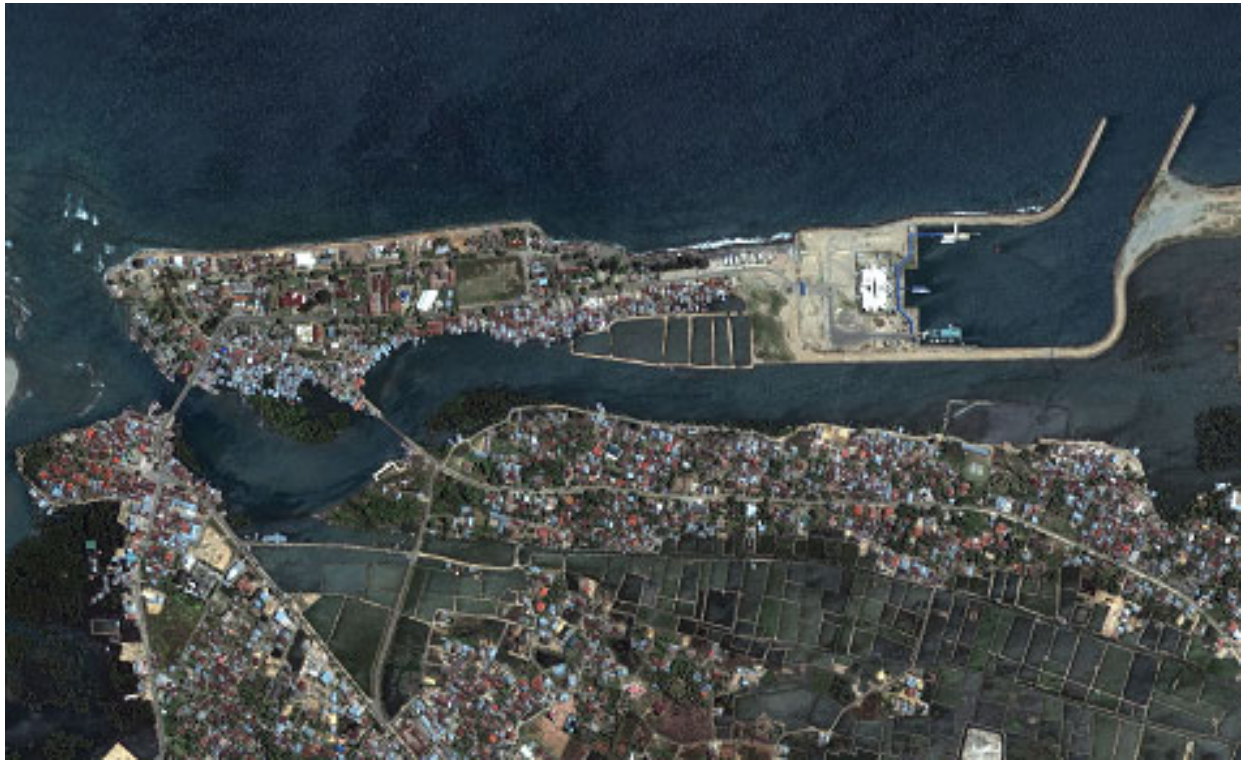
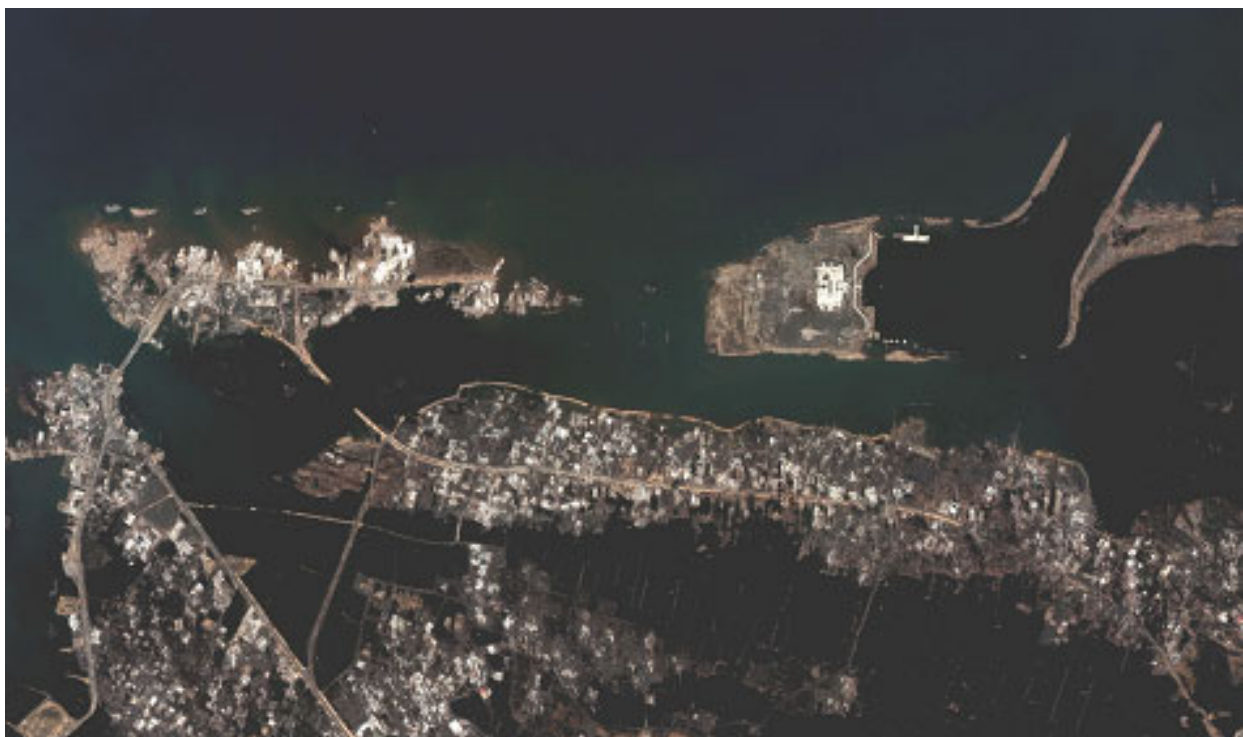
Photo 5.2 Two satellite views of tsunami-affected areas in Aceh province (From DigitalGlobe)

(a) Before the tsunami (on June 23, 2004)

(b) After the tsunami (on December 28, 2004)

The tsunami eroded severely the north coast of Banda Aceh (Photo 5.2). Although there were protection measures by stones in this area before the tsunami, the protection works were completely destroyed and the reclaimed areas behind the protection works were eroded more than 1.5m in height (Photo 5.6), and then the topography was changed. The topographic change is also seen in the Thailand where a sandbar was eroded by the tsunami.

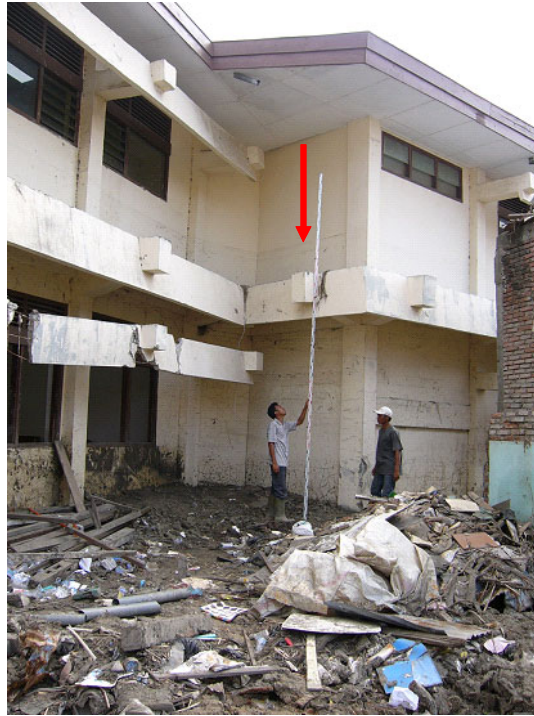
Photo 5.3 Watermark on the first high school in Banda Aceh

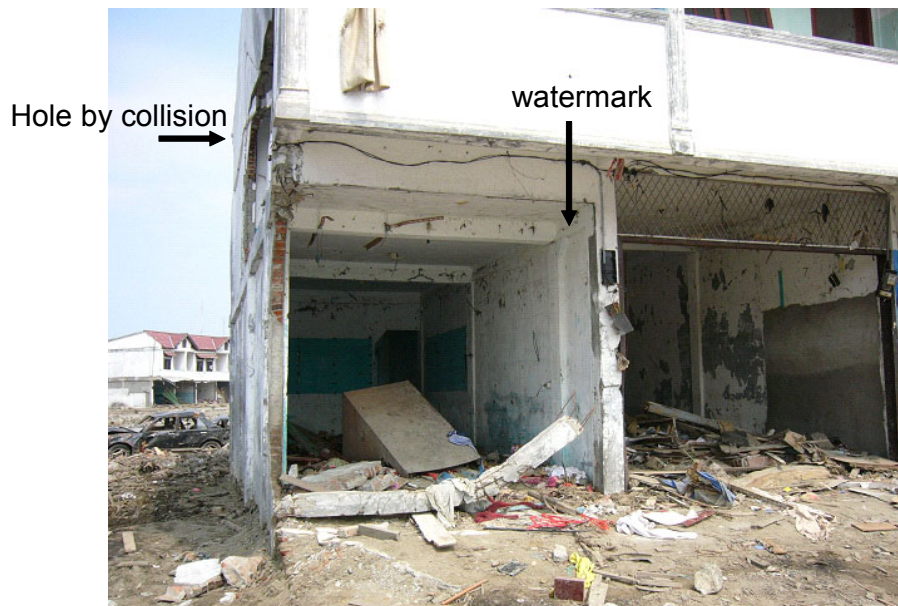
Photo 5.4 A hole by collision of an obstacle and watermark

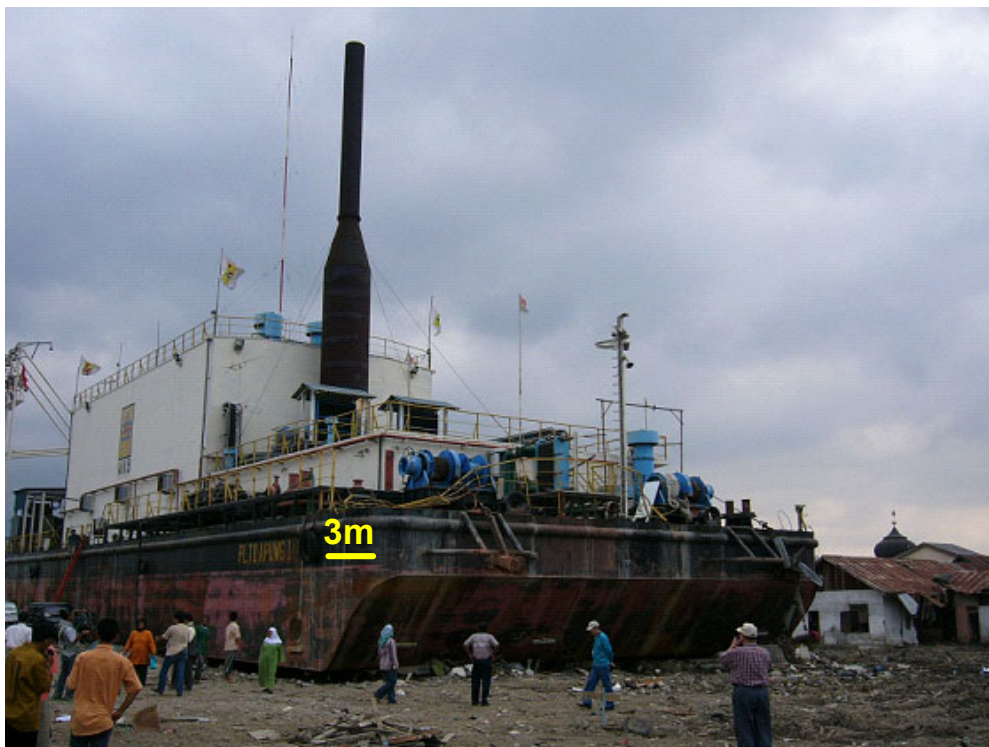
The tsunami swept away large bodies like a power plant barge and oil tanks. The power plant which generated 7,500 KW (Photo 5.5) was moored in a new ferry port of Banda Aceh, and was washed away by the tsunami action. Finally it reached the inland town 3km away from its original site. The watermark left in the inland town was 3m above the ground. The barge can easily drift if the water depth is greater than 3m.

Photo 5.5 Power plant barge (1,700 weight ton) removed in to inland area

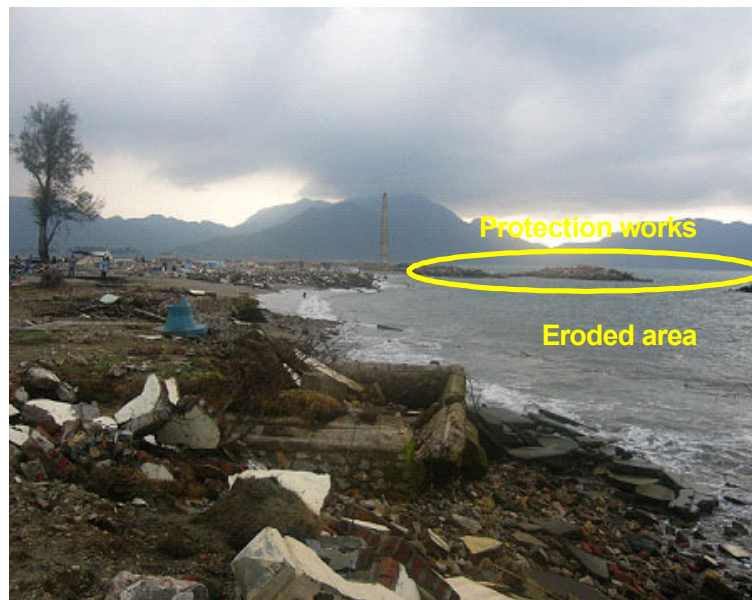
Photo 5.6 Eroded sandbar in the north coast of Banda Aceh
