## Fracture of Reinforcing Steels in Concrete Structures Damaged by ASR

**T.Miyagawa** (Kyoto University)  
**K.Seto** (Ministry of Land, Infrastructure and Transport)  
**K.Sasaki** (Hanshin Expressway Company Limited)  
**Y.Mikata** (Japan Bridge Engineering Center)  
**K.Kuzume** (Kokusai Structural Engineering Corp.)  
**T.Minami** (Shinko Wire Company)

**Keywords:** Alkali-Silica Reaction, Fracture of Reinforcing Steels, Nondestructive Testing Methods, Assessment, Strengthening Methods

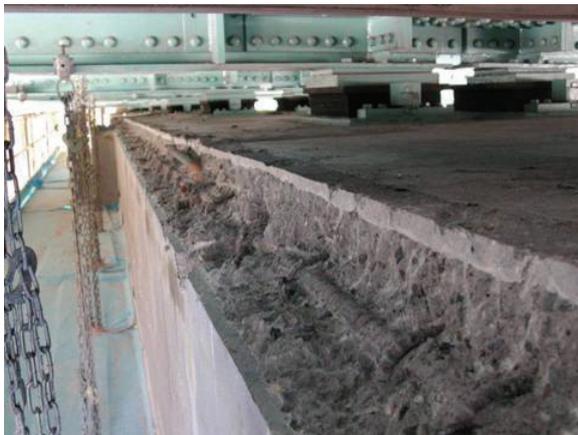
**Photo 2.1 - Pier Beam Chipping Inspection**

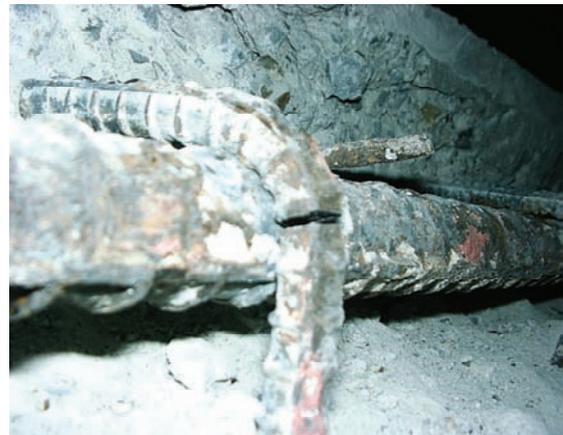
**Photo 2.2 - Failed Steel Bar**
