JSCE SPECIFICATION FOR SEISMIC PERFORMANCE VERIFICATION AND DAMAGE OF CONCRETE STRUCTURES DUE TO RECENT EARTHQUAKES

Hikaru NAKAMURA¹

SUMMARY

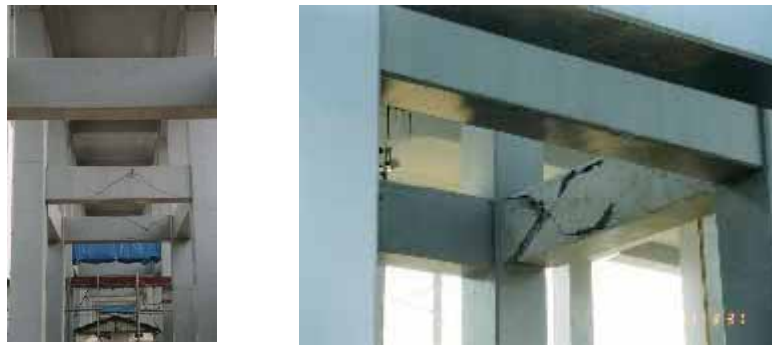
Photo.1 A damaged two story RC rigid frame elevated bridge of Sanyo Shinkansen

The Geiyo Earthquake on March 24, 2001, occurred at Aki-nada in the Seto Inland Sea and the magnitude was 6.7. It was intraslab type earthquake caused by subduction of The Philippine plate. The epicenter was relatively deep and it was about 50 km. The recorded maximum acceleration was more than 800cm/s². 146 piers in RC elevated bridges of Sanyo Shinkansen were damaged. The shear failure with the spalling of cover concrete was observed by 12 piers among these. Photo.1 shows a damaged two story RC rigid frame elevated bridge. In the middle layer beam, severe diagonal shear crack was observed.

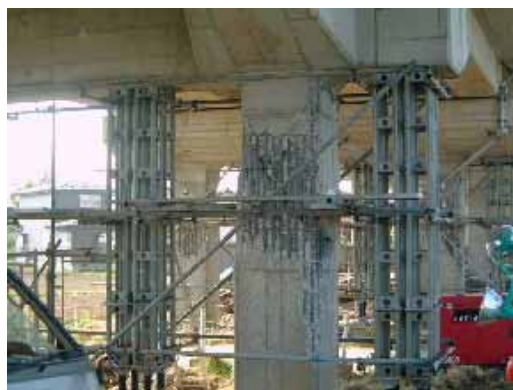
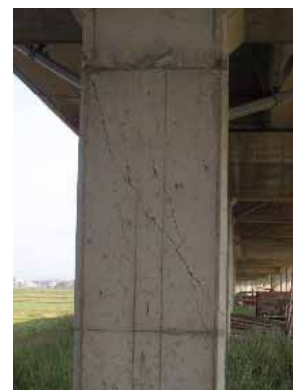
Photo.2 A damaged one story RC rigid frame elevated bridge of Tohoku Shinkansen

(a) damage of end column (view from a) (b) damage of intermediate column (view from b)

Photo.2 shows damaged Dai-san Otagi Bridge R2 of Tohoku Shinkansen which was constructed in 1977 to 1978. This is four bay one story RC frame elevated bridge. The end columns has severe condition for shear failure, since they are shorter than intermediate columns. Two of the end columns failed in shear with the spalling of cover concrete, while others were observed diagonal cracks. The damage due to flexure, however, hardly observed.

analyzed by finite element in two dimension. The column in the frame failed in shear with the spalling of cover concrete as shown in Photo.2. Fig.11 shows the details of the end frame. The structure is modeled with the foundation and the neighboring ground according to the JSCE specification as explained above. Fig.12 shows the finite element model analyzed. The stress-strain relationships of concrete and reinforcement are used by those described in the specification. Osaki model (Osaki, 1980) is used as the shear stress-strain curve of the soil.

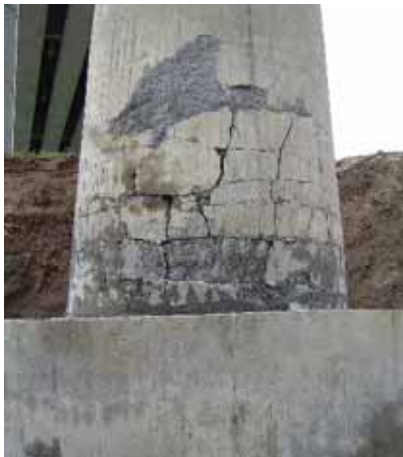
Photo.3 Damage of a pier

Toshibetsu-gawa railway bridge of Nemuro Line was constructed in 1966 to 1969. This is 13 span girder PC bridge of 416m bridge length with circular RC piers. This bridge was damaged around the supports at Off Kushiro earthquake in 1993. Photo.3 shows damaged pier in which the spalling of concrete cover and the buckling of longitudinal bars occurred. Photo.4 shows the damage of the floor slab at the end of girder which occurred due to the collision between girders.

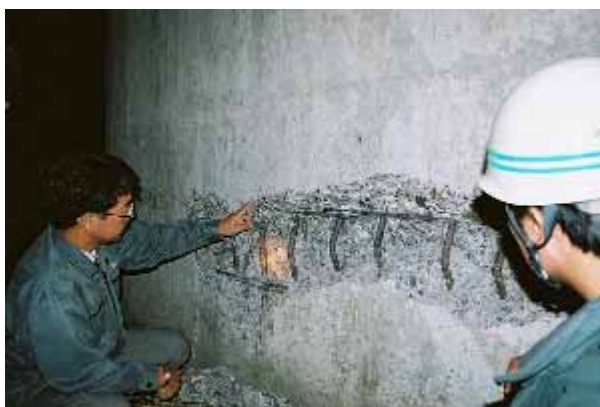
Photo.5 Damage of a pier

Photo.5 shows the damaged Chiyoda highway bridge which consists of middle bridge of 5 span warren truss constructed in 1954 and side bridge of 5 span PC girder constructed in 1966. The flexural failure in the piers of PC girder bridge as shown in Photo.5 and the punching shear failure at support of warren truss bridge due to horizontal force from anchor as shown in Photo.6 occurred. The feature of the damage of the piers is the flexural cracks, the spalling of concrete cover and the buckling of longitudinal bars. Similar failure at support was already observed in Hanshin-Awaji Earthquake.

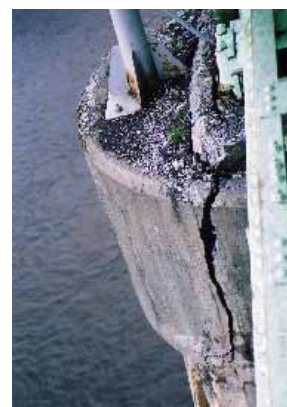
Photo.6 Damage at a support

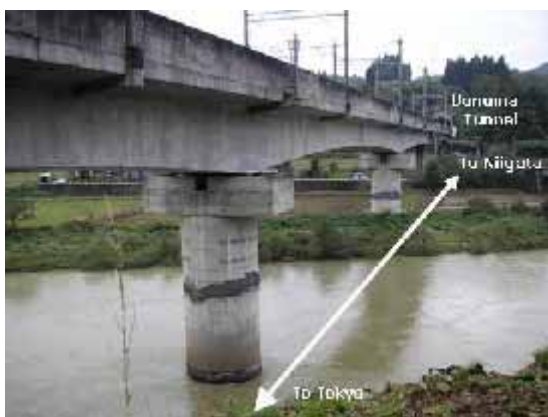
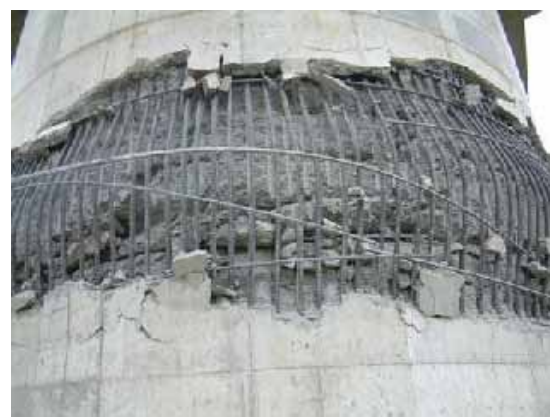
Photo.7 Damaged Uono-gawa Bridge of Joetsu Shinkansen

(a) Panorama of Uono-gawa bridge

(b) Failure at mid height in pier

Photo.7 shows the damage of Uono-gawa Bridge of Joetsu Shinkansen, which is three span box girder PC bridge. In 2P and 3P with circular RC piers with diameter of 6.5 m, the spalling of concrete cover and buckling of longitudinal bars occurred at the mid height. Lateral ties at that location were found to detach. Failure took place at the location of termination point of the longitudinal bars. Three steel arcs with central angle little more than 120 degree were used to make circular ties. No hooks were provided in the lateral ties.

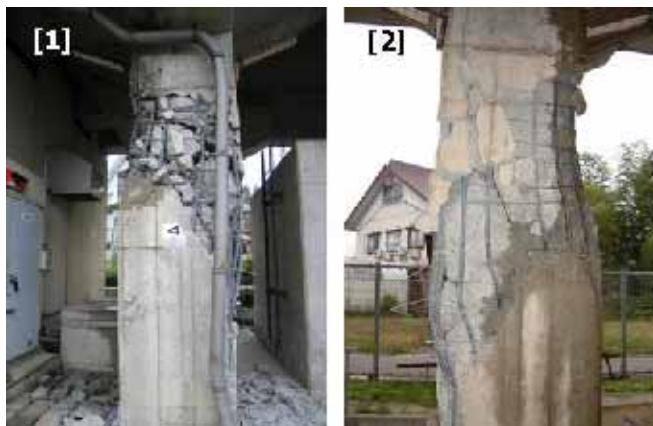
Photo.8 Damage of end column
(both sides of a column)

Photo.8 shows the damage of Dai-san Wanazu Bridge R1 of Joetsu Shinkansen, which is three bay one story RC frame elevated bridge. One of the end columns failed in shear as shown in Photo.8, while another one showed diagonal cracks. The end columns has severe condition for shear failure, since they are shorter than intermediate columns. This failure is the same as the one observed in the South of Sanriku-Oki Earthquake. These were designed by the same specifications for Shinkansen published in 1970 and 1972. It is noted that some columns of elevated bridge of Joetsu Shinkansen were strengthened by the steel jacketing before

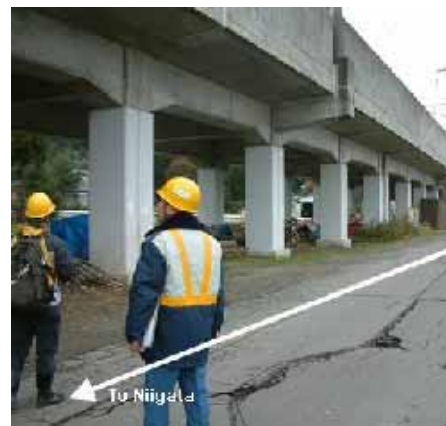
Photo.9 Strengthened column
by the steel jacketing

earthquake as shown in Photo.9. As for them, no damage was observed and the effect of strengthening was confirmed
