GENERAL INFORMATION ON DETERIORATION OF EXISTING CONCRETE STRUCTURES AND RECENT RESEARCH TOPICS ON THE MAINTENANCE TECHNIQUES IN PWRI

Hiroshi WATANABE¹ and Hirohisa KOGA¹

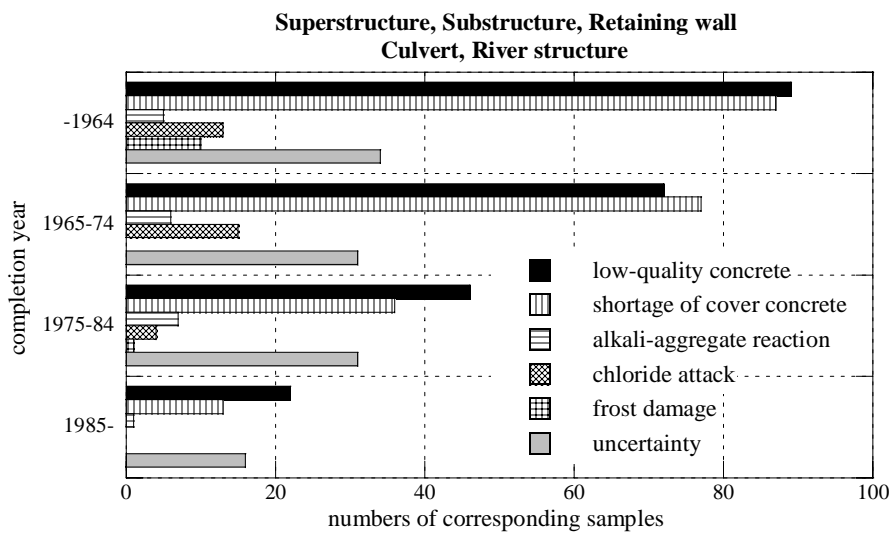
Fig. 2 Estimated causes of deterioration

Causes of deterioration are shown in Fig. 2. "Low-quality concrete" and "shortage of cover concrete" were common. "Low-quality concrete" can be divided into two groups: one (honeycomb, cold joint, etc.) is mainly due to inadequate concreting; the other (efflorescence, etc.) can not be separated into the effects of construction, materials and circumstances, though the former was relatively common. The survey showed that the major cause of deterioration was construction, and hence it is especially important to ensure adequate construction

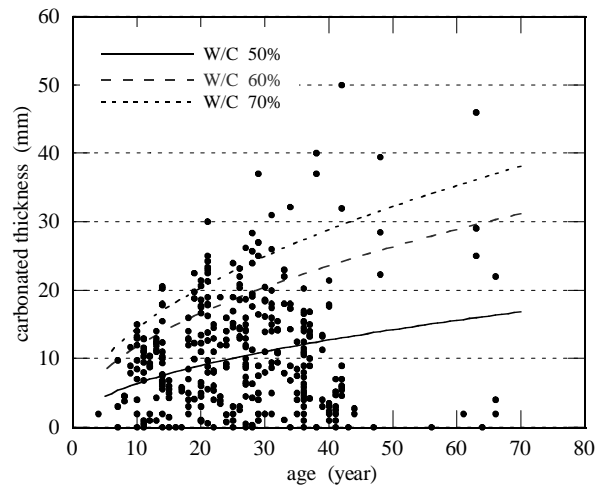
Fig.3 Carbonated thickness and age of structure

Carbonated thickness was measured at three coring sites for each structure. The relationship of carbonated thickness and age of each sample is shown in Fig. 3. The curves in this figure indicate the thickness calculated by Kishitani’s experimental formula (Equation 1). In 84% of samples, the experimental carbonated thickness was less than the calculated one for W/C=60% concrete. Usually, reinforcement is covered by concrete 30 mm deep or more; so few structures should deteriorate owing to carbonation unless the arrangement of reinforcement is poor.

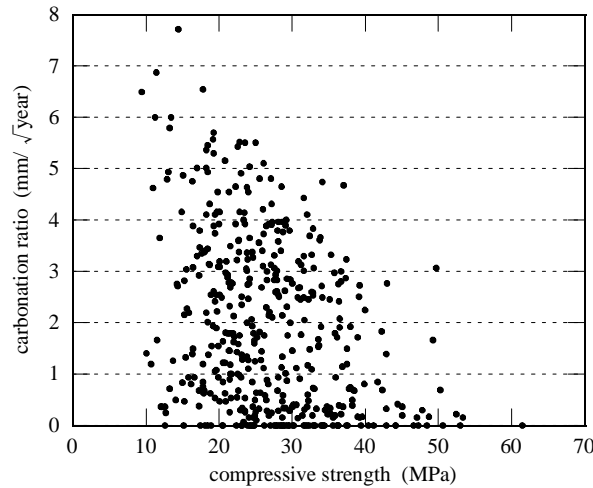
Fig. 4 Relationship of carbonation ratio and compressive strength

Generally, it is assumed that carbonation progresses in proportion to the square root of time. In this paper, the term “carbonation rate” as defined by Equation 2 is used to refer to the speed of carbonation. Fig. 4 shows the relationship of carbonation rate and compressive strength, indicating that the compressive strength of concrete is related to the maximum speed of carbonation.

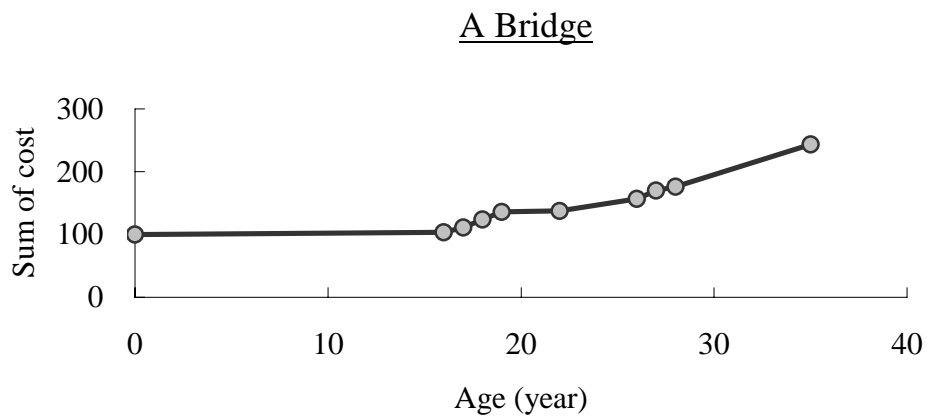
Fig.5 Maintenance cost for a deteriorated concrete bridge

Fig.5 shows cost spent for maintenance action of the pre-stressed concrete bridge deteriorated by salt attack. The vertical axis of Fig.5 means the cost normalized to 100 as initial construction cost. The bridge was demolished and rebuilt after 35 years of the service life. The bridge located in the north part of "Honshu" island denoted as "area A" in Fig.6. Fig.6 shows observed the amount of air-borne salt brought by sea wind which blows from north direction. The horizontal axis of Fig.6 means the distance from coast to the point of observation of air-borne salt. The amount of air-borne salt is rather large in "area A".

The expense during first 16 years after completion was none. After 16 years passed, maintenance cost of the bridge started to increase. The intended use of the expense is detailed inspection, surface coating of concrete, concrete repair, and strengthening by installation of external cable and tentative pier bents. Although these rehabilitations were employed, it was impossible to prevent further progress of deterioration.

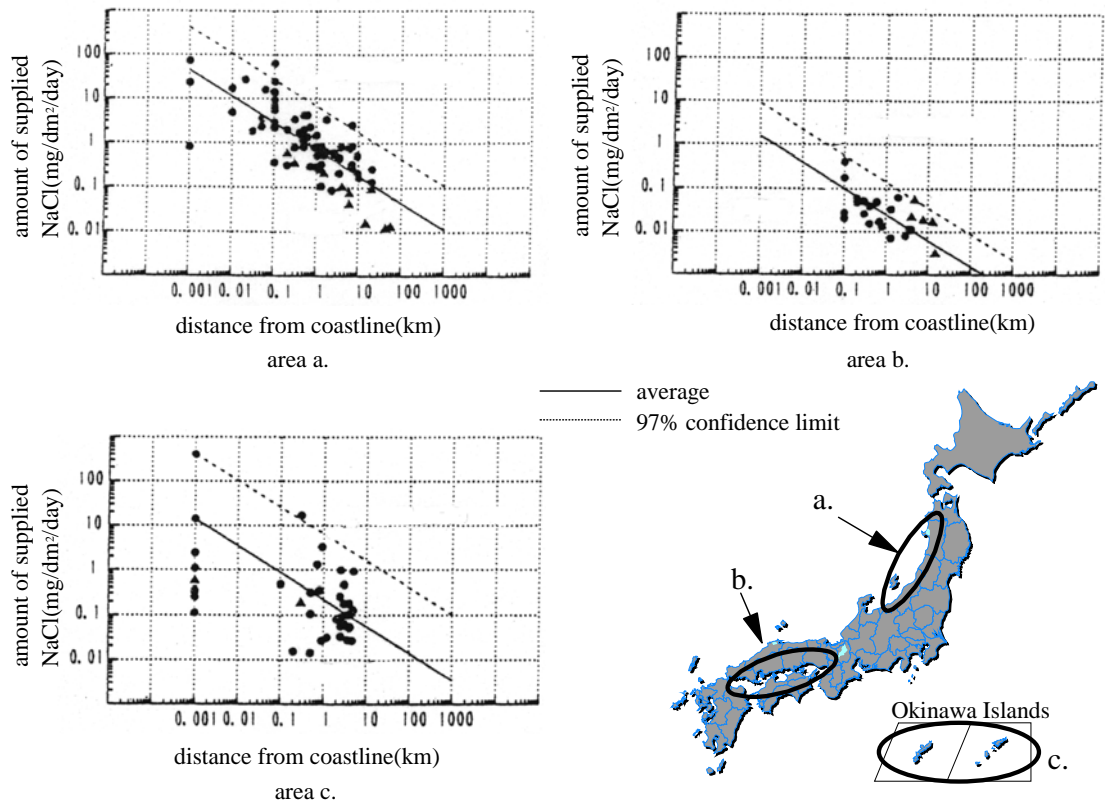
Fig.6 Observed amount of air-borne salt in Japan

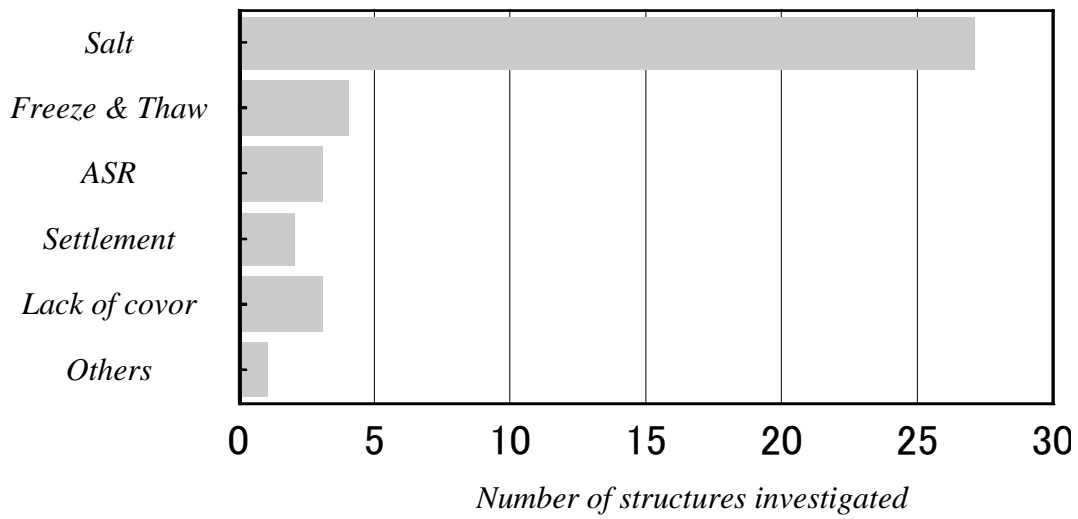
Fig.7 Causes of deterioration of existing concrete in the questionnaire survey

The questionnaire is sent to the local branch offices of MLIT. The number of sample of the structures answered by the local office was 40. Fig.7 shows the distribution of cause of deterioration of the structures. Structures deteriorated by salt attack were most frequently answered in this survey.

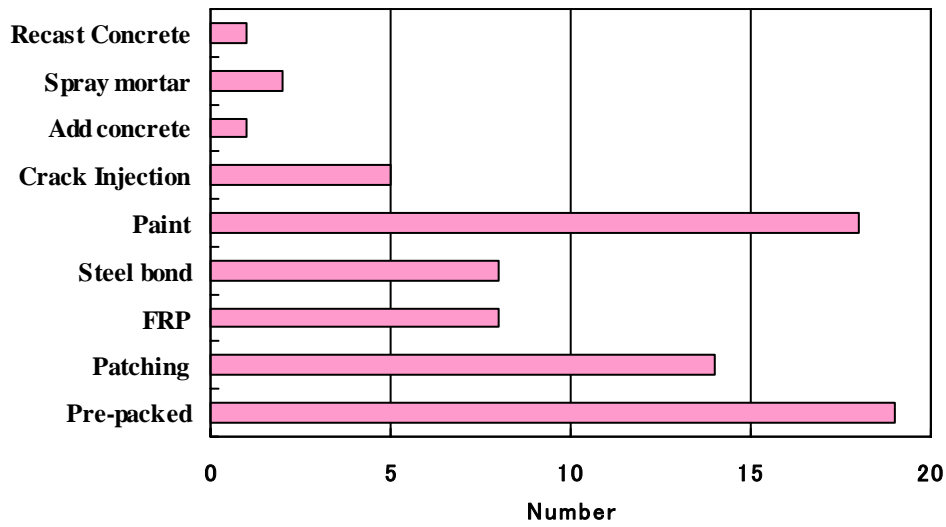
Fig.8 Repair method employed for concrete structures

Fig.8 shows the distribution of the answered repair methods employed for the structures. Surface coating and cut off repair were frequently answered. Electro-chemical repair such as cathodic protection was not answered in this survey. In the questionnaire, condition of the structure at the time just before repair operation was also inquired. The answer was expressed as the soundness index, which was estimated by visual inspection according to the criteria summarized in Table.9. The less number of soundness index means the worse condition of the structures. Fig.9 shows the distribution of the year of first repair operation after completion of the structures. The majority of the structures in the questionnaire carried out repair operation within 10 to 20 years after completion. A few structures were repaired within 10 years, which are supposed due to poor workmanship.

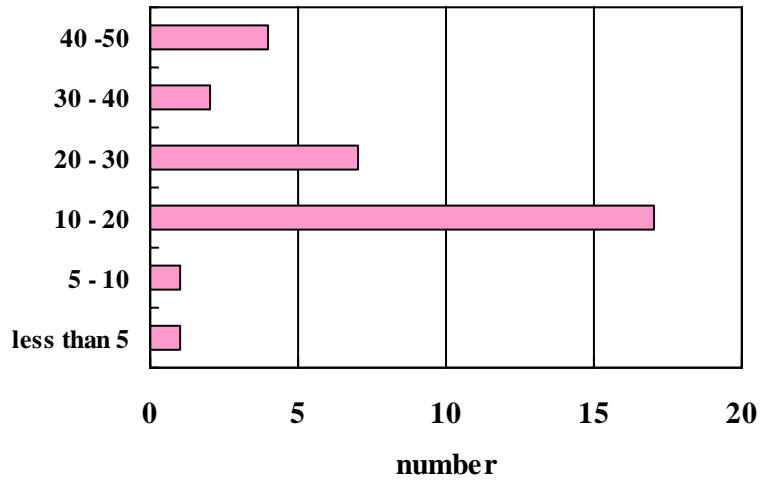
Fig.9 Year of the first repair operation

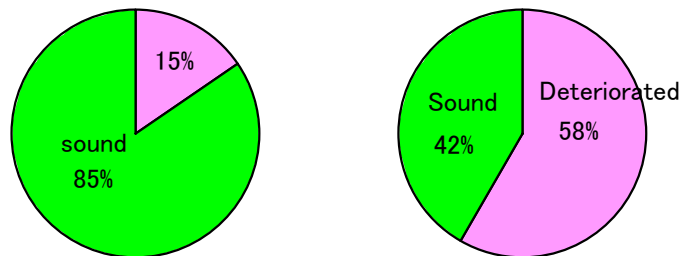
Fig.10 Performance of concrete structures after repair
 (Left: Structures located more than 100m from coast line,
 Right: Structures located less than 100m from coast line)

Fig.10 shows the result of visual inspection of the structures after repair operation. The visual inspection was carried out from 5 to 10 years after repair work completed. In case of the structures located more than 100m from coast line, 85% of them were reported as sound condition, which means repair works were effective, however, in case of the structures located less than 100m from coast line, 58% of the repaired structures showed some signs of re-deterioration, which means repair work was not effective. Durability performance of repaired concrete structures varies with environmental condition for salt attack.

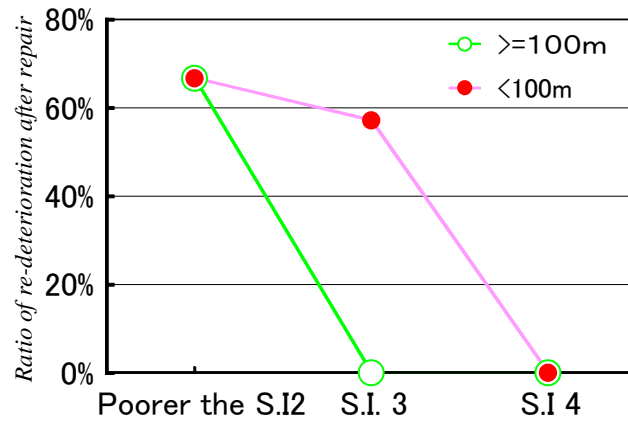
Fig.11 Re-deterioration ratio after repair

Fig.11 shows the relationship between the ratio of re-deterioration after repair and the soundness index just before repair. According to Fig.11, it can be concluded that the structures which were repaired when their soundness index were 4, showed good durability performance after repair. Whereas the structures which were repaired when their soundness index less than 3 showed bad durability performance after repair. In case of the structures which located less than 100m from coast line, the structures which were repaired when their soundness index was 3, still showed high rate of re-deterioration.

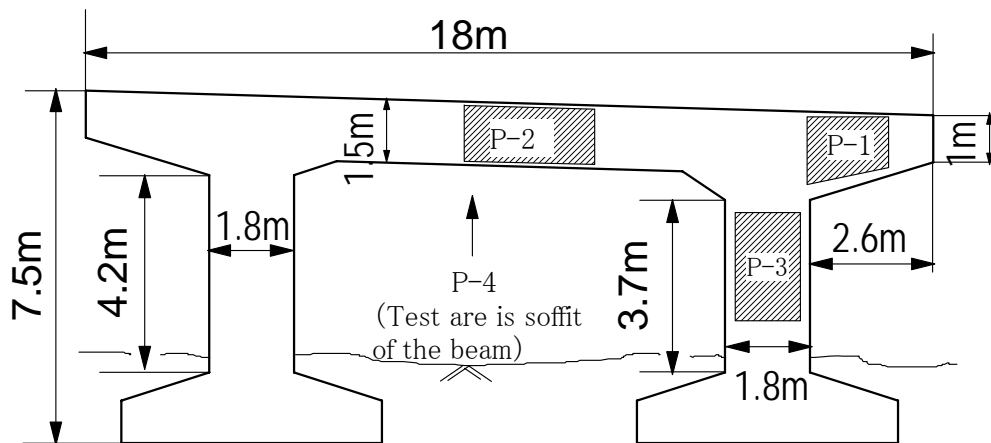
Fig.12 Dimensions of the pier inspected

The concrete structures diagnosed are RC frame piers of the viaduct which was constructed about 30 years ago. The structure locates within 100m from the coast line. We picked up 4 piers of the piers named as P-1 to P-4. Dimensions of the piers are shown in Fig.12. Photo1 shows appearance of the surface of concrete of the piers investigated in the diagnosis. It seems difficult to judge soundness of the piers by the visual inspection.

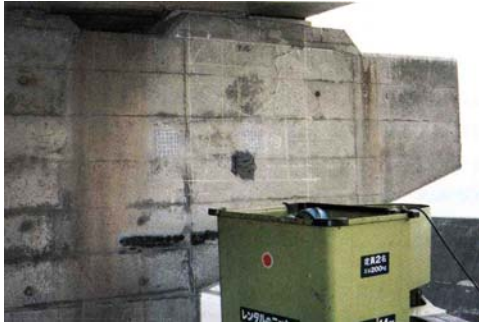
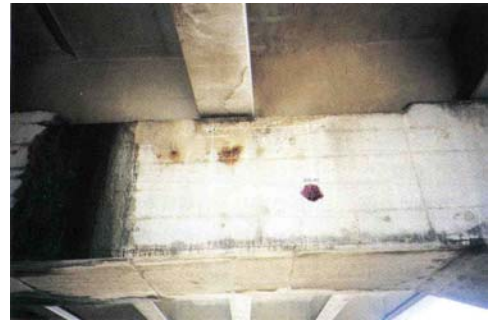
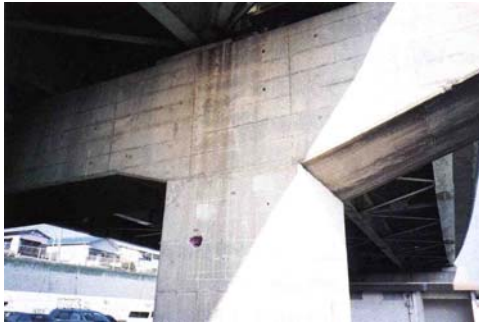
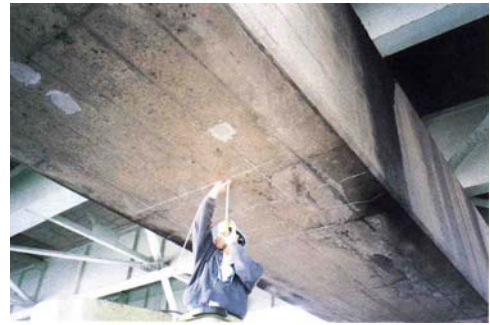
Photo.1 Visual condition of the pier

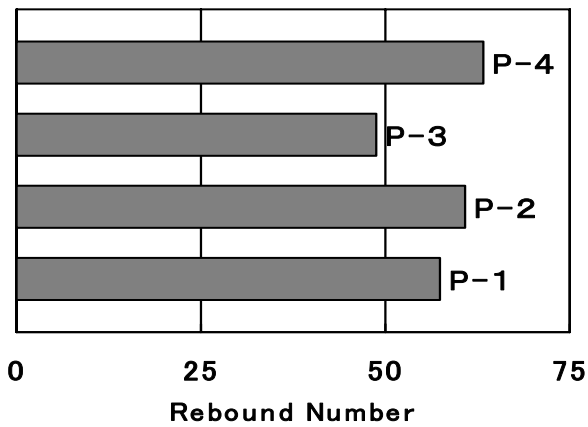
Fig.13 Measured rebound number

Fig.13 to Fig.15 shows test results of the piers. According to the rebound number, strength of concrete was fair. The carbonation depth was different among the piers. The results of rebound hammer and carbonation depth, quality of concrete of P-2 seemed worst of all the piers investigated. Fig.15 shows the distribution of half-cell potential. The result of half-cell potential measurement indicates that corrosion risk was highest for P-2, which was consistent with other test results of rebound number and carbonation depth.

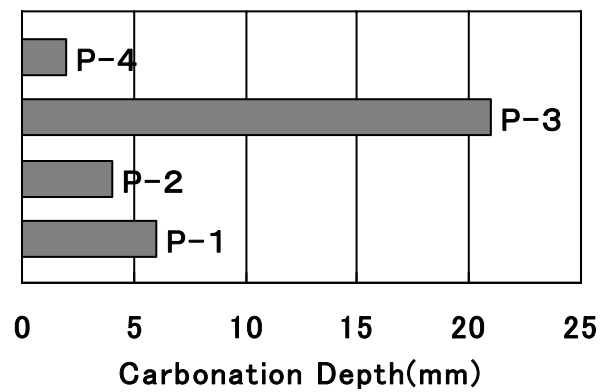
Fig.14 Measured carbonation depth

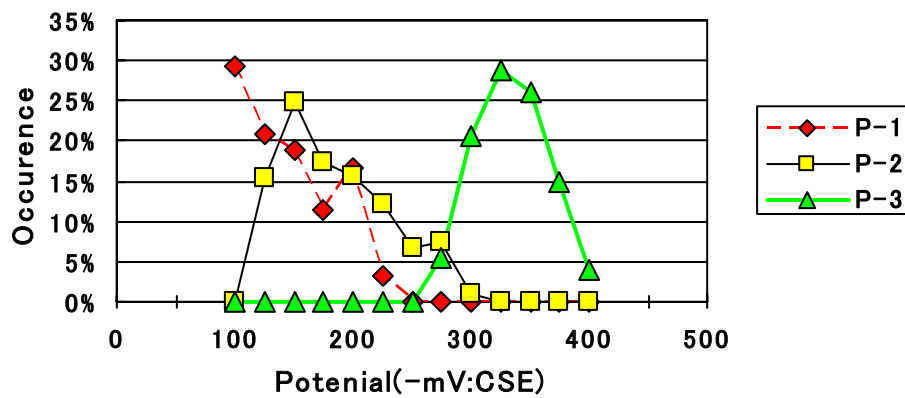
Fig.15 Distribution of half-cell potential

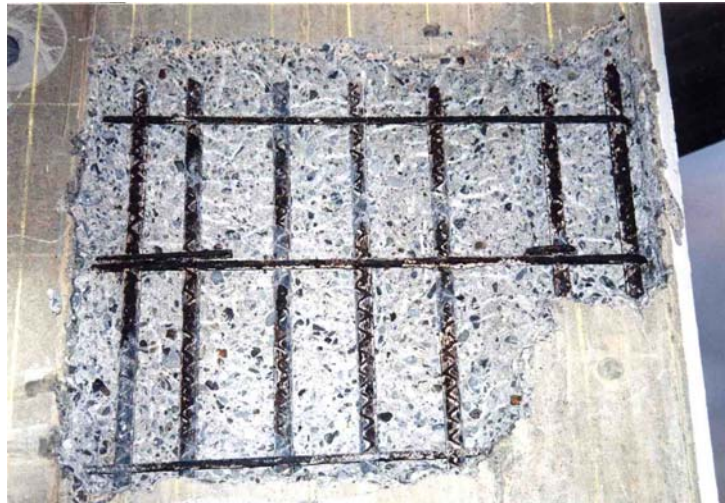
Photo2 Verification of corrosion of rebar by removing cover concrete

Photo2 shows condition of rebar corrosion of P-2 pier visualized by removal of cover concrete. We can confirm soundness of the piers can be estimated with non destructive tests.
