## **Progress Report of JSCE Committee on “Evaluation of Tsunami Force on Bridge Structures” (Subcommittee 221)**

The tsunami that followed a huge earthquake of unprecedented size (M9.0) on 11th March 2011 in eastern Japan caused unbelievable damage over a wide area. The death toll is known to have reached 15,856, while 3,070 persons remain missing as of 11th April 2012. About 600,000 houses were damaged. Many bridges were also engulfed and some were swept away. In July 2011, JSCE set up a research committee to evaluate the tsunami force on bridge structures with two objectives: (1) to survey the damage caused to bridges by the tsunami in detail and (2) to evaluate the tsunami force acting on bridges so as to allow for design and preparation for anticipated huge tsunamis in western Japan. The committee consists of specialists from several fields, including hydrodynamics, coastal engineering, bridge engineering, and structural engineering as well as concrete engineering. The committee is now operating with a two-year remit. The committee will make periodic progress reports. On 26th June 2012 the committee is planning to hold an open discussion on the findings so far.

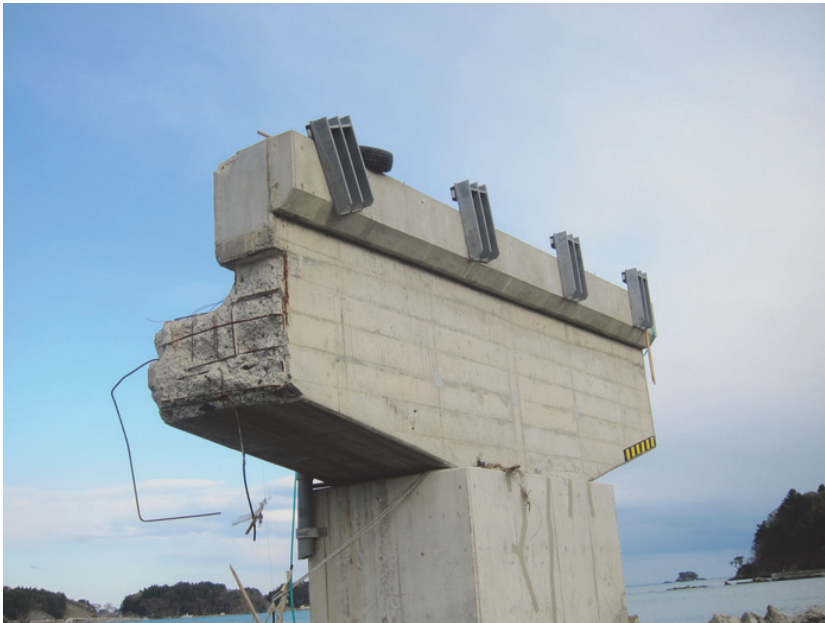
Figure 7 Stoppers on the Utsu-Ohashi bridge

As explained, the  $\beta$  value is an index of the resistance of a bridge girder to horizontal force. However, observed damage to bridge stoppers and anchors, as exemplified in Figure 7, shows that many bridge girders must have undergone rotation in the process of being washed from their piers. Therefore, a further index,  $M_R/M_A$ , is introduced as equation (3). The mechanism of rotation damage is illustrated in Figure 8.

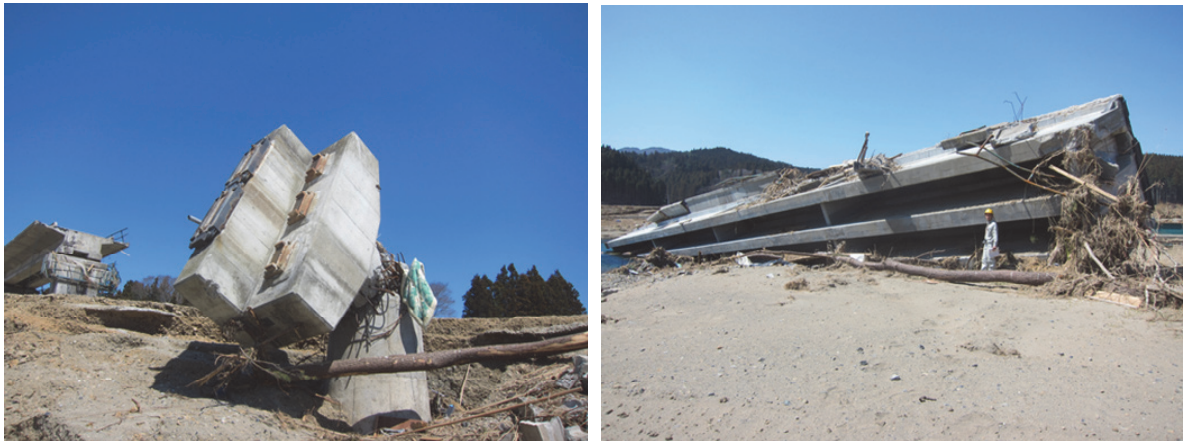
Figure 10 Overturned PC girder and damaged piers of railway bridge

Figure 10 shows an example of very severe damage in the case of a railway bridge. The PC girders were completely washed away and the piers were also severely damaged. The resistance of a bridge to this kind of damage may be evaluated using either  $\beta$  or  $M_R/M_A$ . The committee is continuing to discuss damage mechanisms and methods of evaluating resistance in

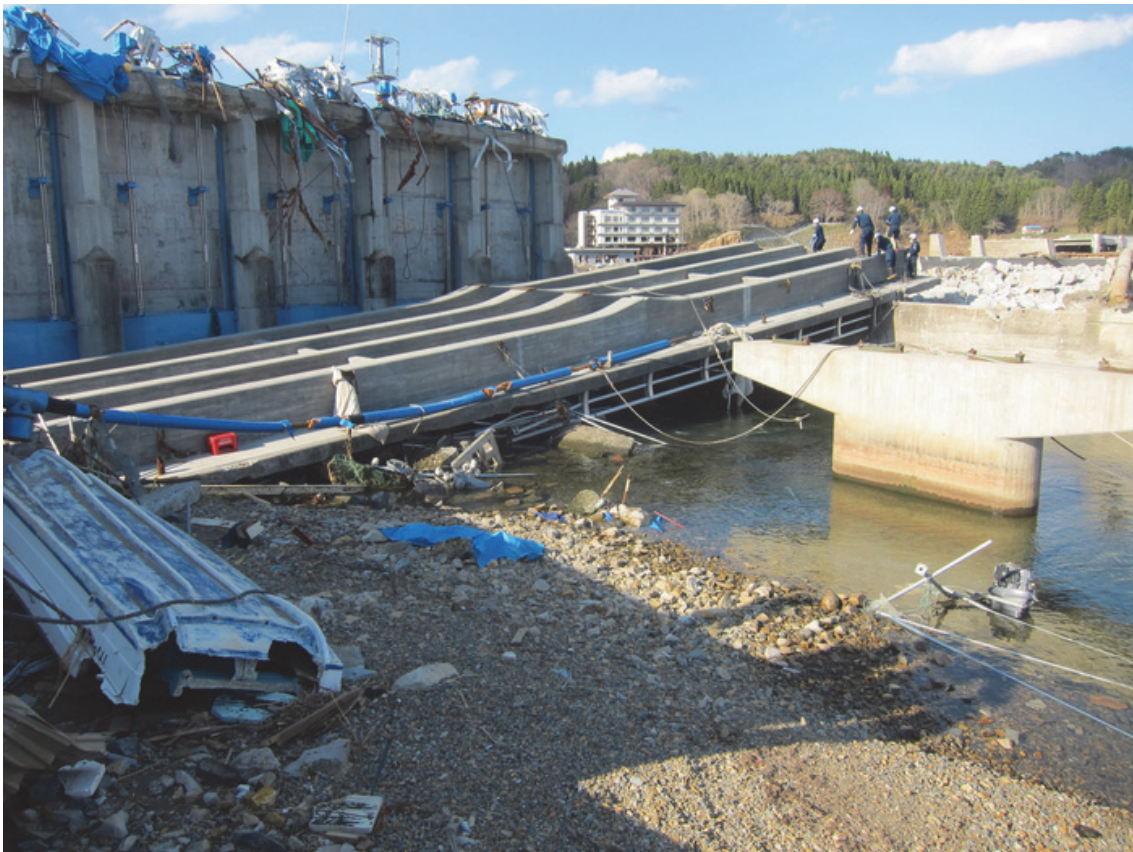
Figure 11 Overturned girder in the case of a low bridge near a sluice gate (Minato-hashi)

In some cases, bridges appear to have been damaged by lift force, as in Figure 11 for example. Here, a large lift force might have arisen due to the presence nearby of a sluice gate structure. This disaster is characterized by the many kinds of damage it caused.
