Irabu Bridge—100-Year Durability

1. Introduction

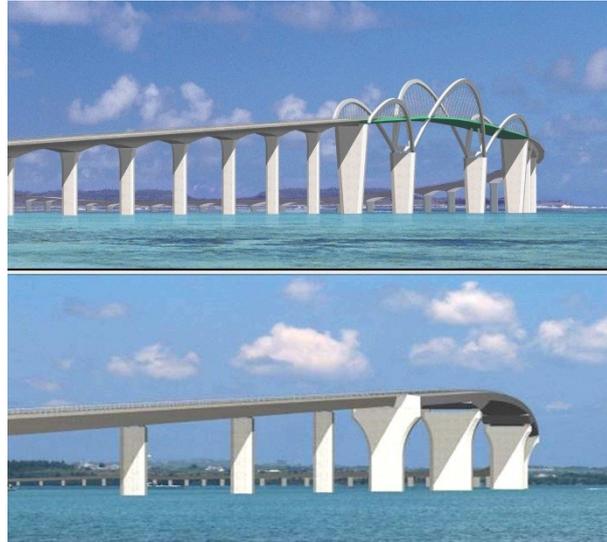
Figure 6. Top: The initial plan called for a three-span continuous half-through steel arch bridge. Bottom: The final plan called for a three-span continuous steel floor-slab box-girder bridge.

The initial plan in the basic design phase called for a half-through steel arch bridge with arch ribs rising in the air to serve as a local symbol. However, after Typhoon No. 14 hit Miyakojima Island in 2003 and caused great damage, the wind resistance (stability) of the bridge was reviewed in detail. The design reference wind velocity was also changed from 73.4m/s in the basic design stage to 82.2m/s in the working design stage. Wind tunnel experiments revealed problems of fatigue durability for the half-through steel arch bridge. As a result, the design was changed to a steel floor-slab box-girder bridge that excelled in wind resistance (Figure 6).
