Katsushima Area Viaduct on the Metropolitan Expressway Haneda Route (Route 1)

1. Bridge Data

2. Background and Outline of Project

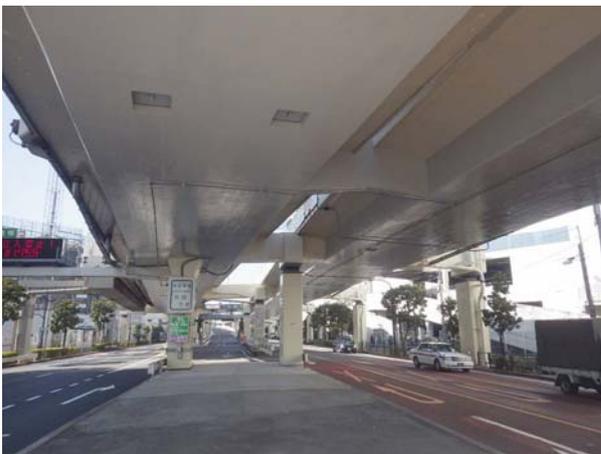
Photo 1. Post-renovation view

The Metropolitan Expressway Haneda Route (Route 1) is one route of the urban expressway system built for the 1964 Tokyo Olympic Games. The viaduct that is the focus of this project, which has been in service for over 50 years since opening in 1963, was originally a Gerber bridge with a series of three-span continuous prestressed concrete (PC) box girders that elevates the expressway over a prefectural road (**Photo 1**).

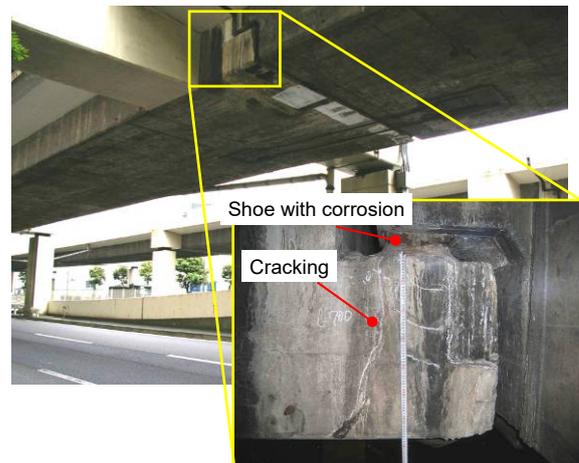
Photo 2. Damage to a Gerber joint

The bridge was found to have cracks in the Gerber joints and corrosion and other damage in the Gerber shoes during a periodic inspection (**Photo 2**). The purpose of this project was to improve the durability of the Gerber joints as well as the earthquake resistance and ease of maintenance of the entire bridge. The girders were made continuous over every nine spans by using external tendons (**Photo 3**). The resulting four continuous girders were separated from each other at the joints to eliminate the Gerber system, with new substructures built to bear the reaction force from the Gerber joints. This combined method was an approach to the structural improvement of Gerber joints without precedent.

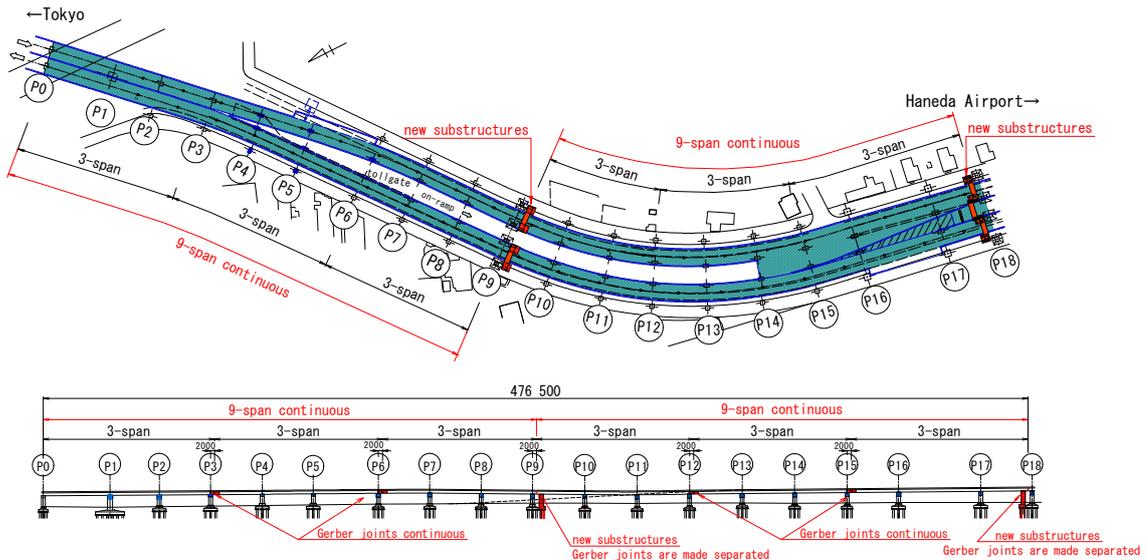
Figure 1. Overview of bridge

- The three-span continuous PC box girders of the original Gerber bridge were transformed into nine-span continuous girders, with new substructures constructed below the ends of the new continuous girders to eliminate the Gerber system.
- Non-shrinking mortar was injected to fill the Gerber joints, while the girders were made

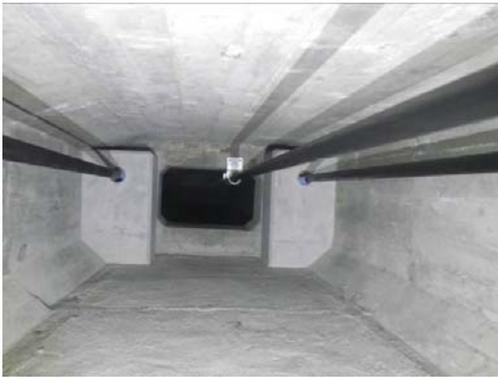
Photo 3. External tendons

continuous by external prestressing.

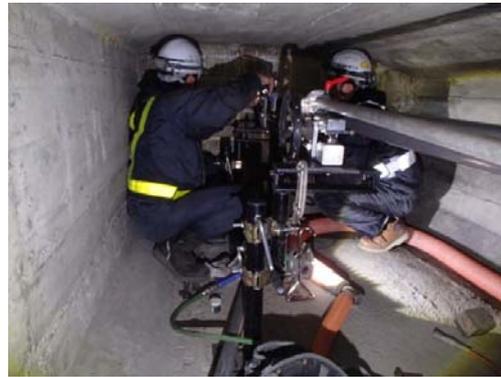
Photo 4. Water jet drilling

- 1) The gaps between girders were cleaned with water jets before work to make them continuous.
- 2) Transparent formwork was used for mortar injection in the girder gaps so as to allow monitoring of the filling process.
- 3) Through-holes were made in the cross beams for installing external tendons. Water jet drilling was used to make the horizontal holes that have a length of up to 4,250 mm (Photo 4).

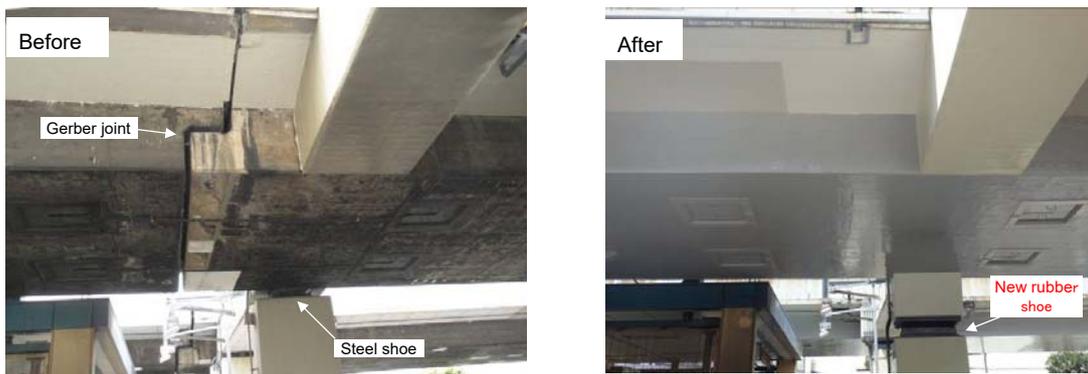
Photo 5. Gerber joints made continuous

1. Making the Gerber girders continuous (Photo 5)

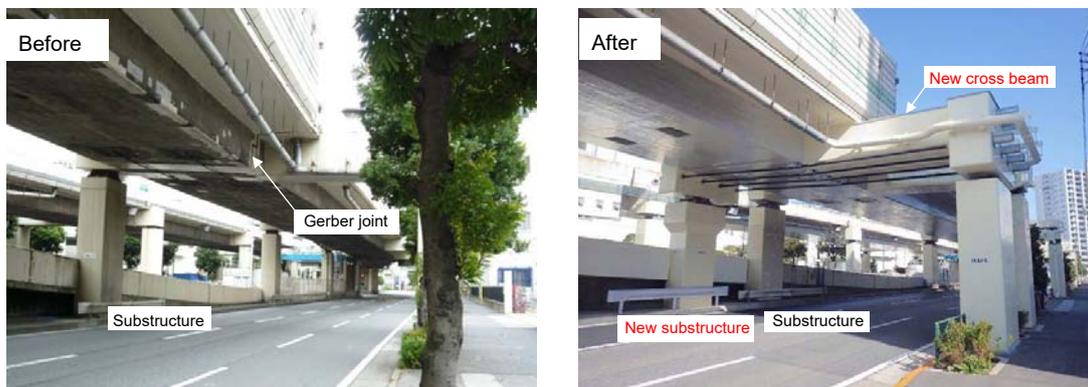
Photo 6. Gerber joints separated with new substructure

2. Separating the continuous girders at the Gerber joints (Photo 6)

- 1) The continuous girders were structurally separated from each other at the Gerber joints left at

the ends. New substructures were constructed below the suspended spans to bear the reaction force of the superstructure. The Gerber shoes were cut using wire saws to structurally separate the girders.

- 2) In order to ensure safety of the work on the in-service bridge, the reaction force was transferred in a phased manner by measuring load and displacement during the work and checking the measurements against the design values.

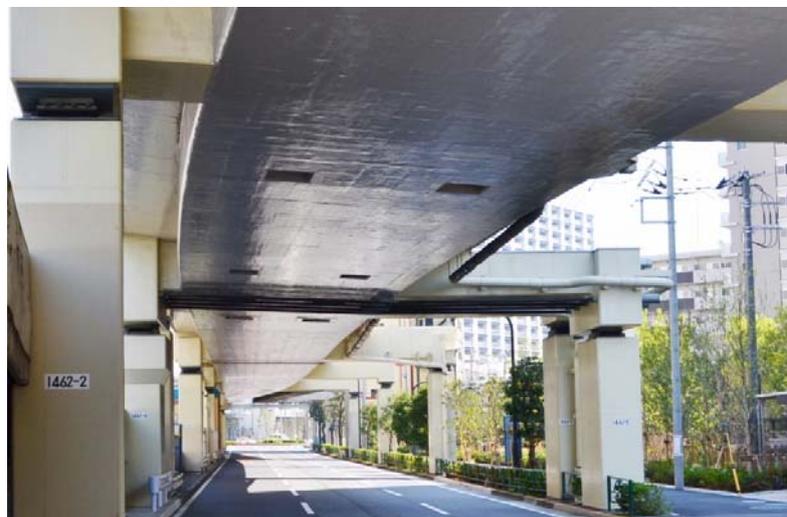
Photo 7. Completion View
