Civil engineering in the unearthing and preserving of historic ruins

Renovation of stone walls at Sendai Castle

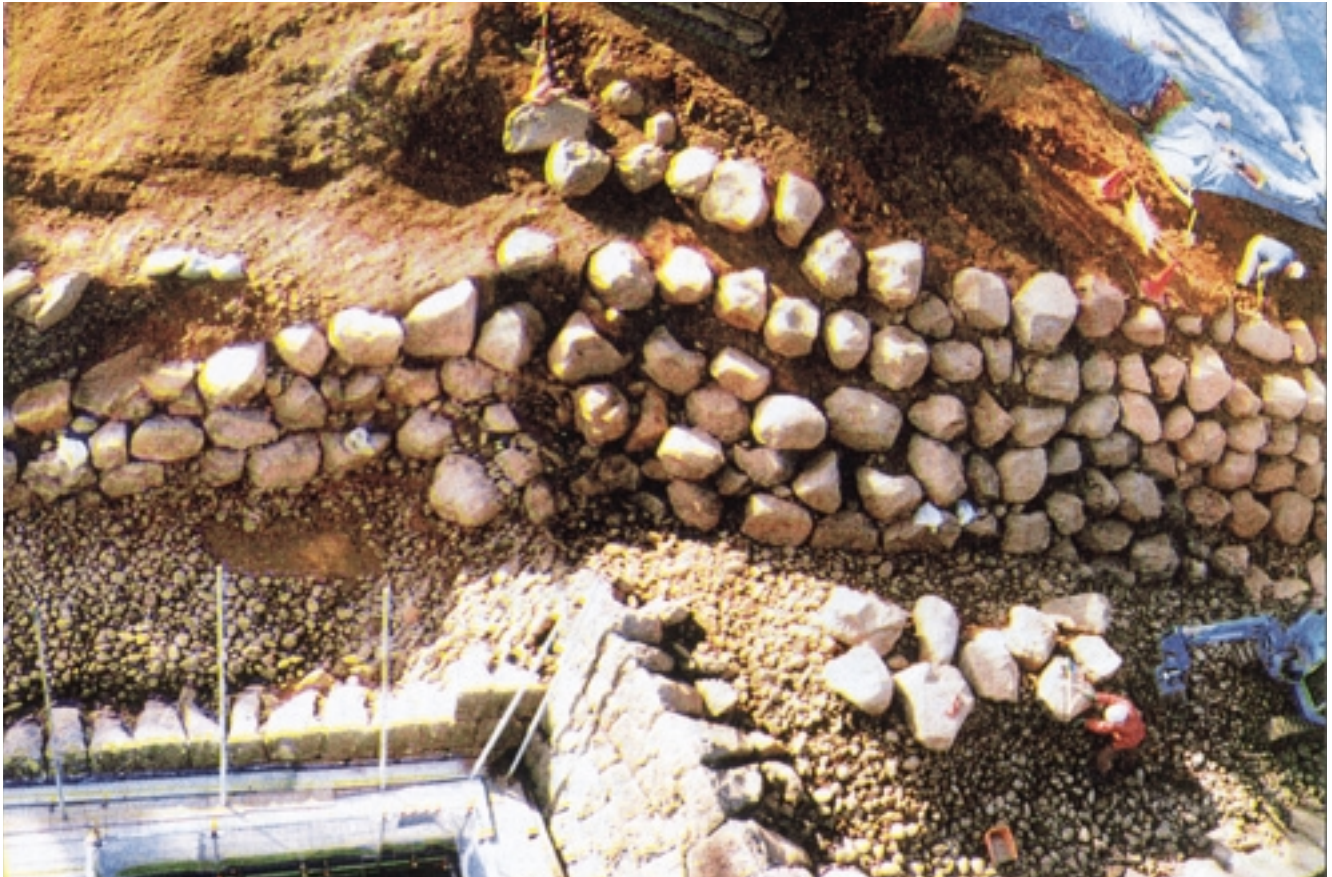
Photo 1 Stone castle walls under renovation

There is an ineffable peace of mind to be experienced standing below the moss and ivy covered stone walls that form the base of a Japanese castle. It derives, I think, from the feeling of proximity to hundreds of years of human history. Yet there is growing concern that traditional techniques of stone-wall building are being lost. This report describes the use of such traditional construction methods in the renovation of stone walls at Sendai Castle, which is now in progress. (Photo 1)

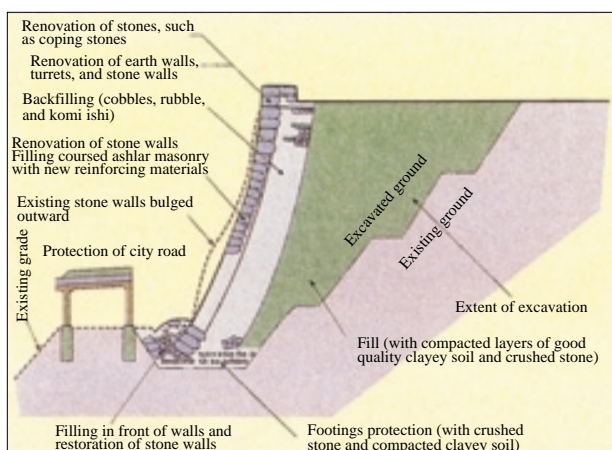
The remaining stone walls on the north side have, since around 1960, been noticeably bulging outward and loosening as a result of earthquakes, traffic-induced vibrations from Aoba-jo Road, which runs along the walls, thick vegetation growth, and general aging. In some places, bulging had reached as much as 0.8 m. (Fig. 1)

Fig. 1 Section through stone wall

Under these circumstance, the city took emergency safety measures such as installing displacement meters and introducing road closures when sudden deformations are detected. Rockfall protection fences were put in place at the foot of the walls as insurance against collapse. Further, the city arranged a plan for renovating the walls and worked toward implementing it.

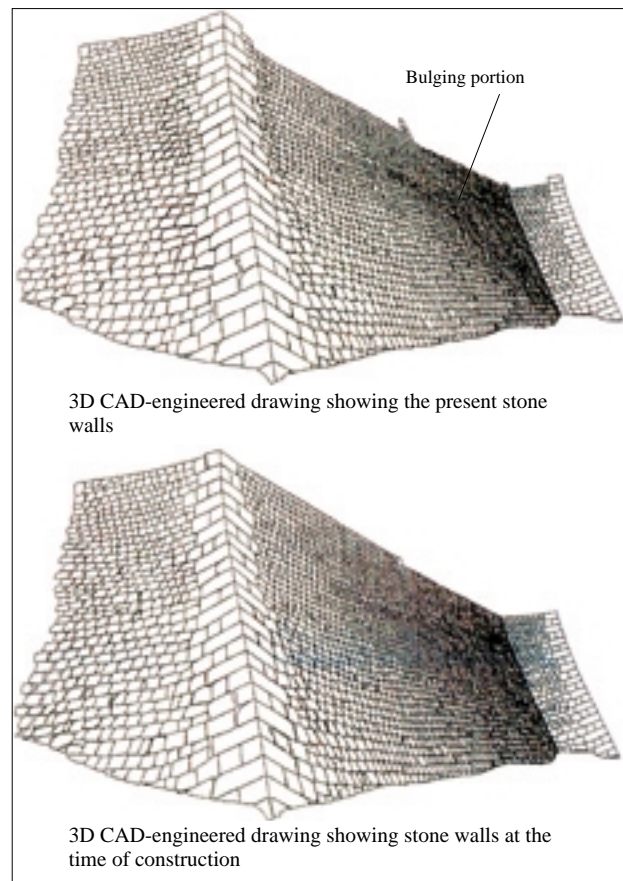
Fig. 2 3D CAD-engineered drawings

This technique entails first taking photos of the walls, then measuring the dimensions and orientation of each stone (Photo 2) before rendering 3D images based on the data. Taking clues from undeformed stones, the positions of deformed stones at the time of construction are inferred from the results of numerical analysis. Finally, an overall configuration of the walls is developed and design drawings prepared. (Fig. 2)

To ensure that the walls could be returned to exactly their original state, it was first necessary to elucidate their original configuration at the time they were constructed. Since no design drawings that could assist in making conjectures about this original configuration exist, a technique for inferring it from the present walls was devised, and from this information design drawings were prepared using a three-dimensional CAD system.

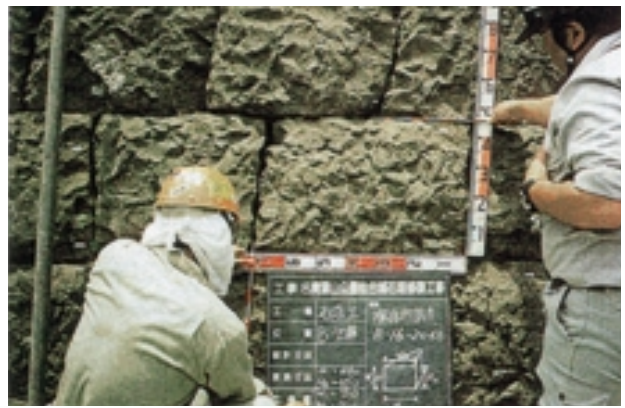
Photo 2 Measuring dimensions of stones

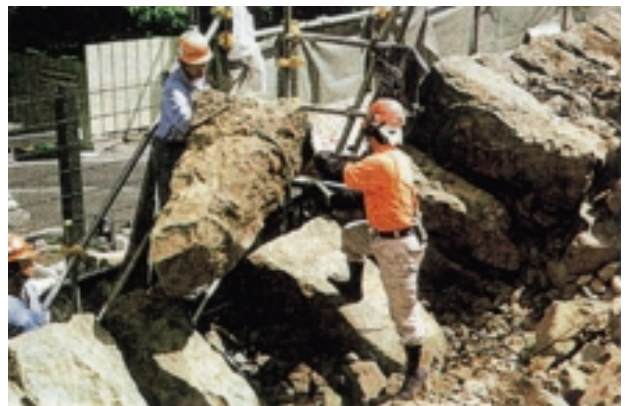
Stones are currently in the process of being removed (Photo 3), while a survey of the sectional structure behind the stones and the foundation ground at the base of the walls is being carried out. The stones are of wedge shape, with one 45-90 cm rectangular face tapering down over a depth of about 1.3 m to a smaller face, and they weigh 0.5-0.6 tons each. Every stone is given an identification number before removal and placed into temporary storage after removal.

Photo 3 Stones being removed

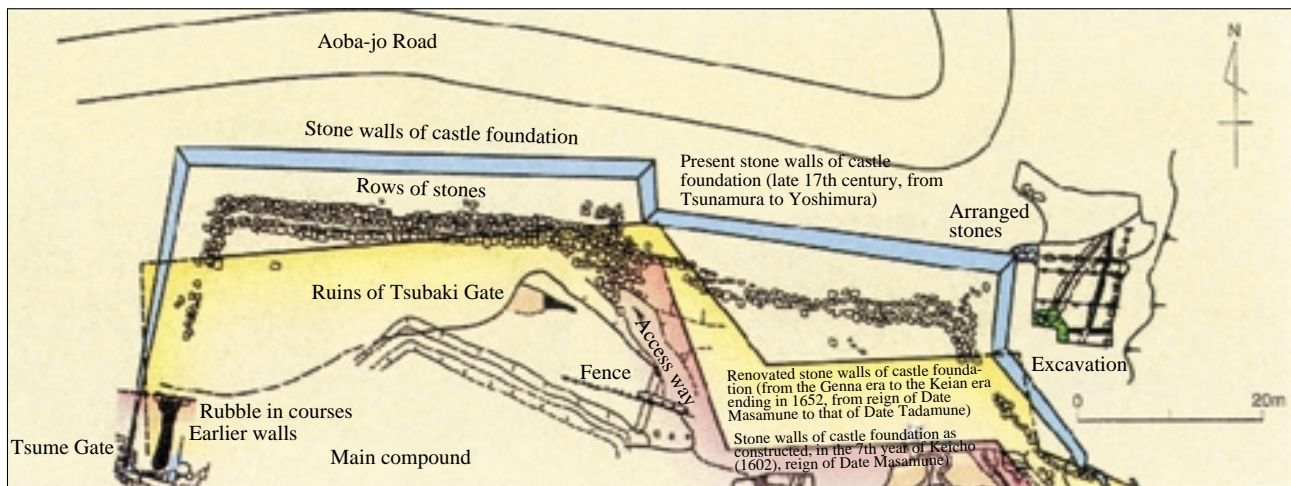
During the survey and removal work, rows of stones parallel to the walls were discovered behind the backfill layer. (Fig. 3) The structure of the walls is such that the space between the main stones being removed and the rows of stones is backfilled with cobbles.

It is conjectured, from the evidence of the construction method, that the present walls were constructed in the late Edo period, and the unearthed rows of stones are the remains of walls built during the reigns of the feudal lords Date Masamune and his son, Date Tadamune. It appears that new stones were laid in rows outside older ones as stone wall building techniques became ever more sophisticated.

Fig. 3 Plan of stone foundation walls and uncovered rows of stones

techniques of the time through reference to similar instances at other castles, and also through circular arc analysis. It is considered quite likely that these stones — they may represent part of a wall that collapsed in an earthquake — remain as evidence of a systematic rebuilding technique in which they shored up the later stones to improve workability. Their placement in rows may have been designed to help ensure the stability of the later walls built outside them.
