# Useful Roles of Civil Engineering Facilities No. 4 in a Series

## Erosion control in the Mt. Fuji area by Fuji Sabo Works

**Sadamoto WATANABE**

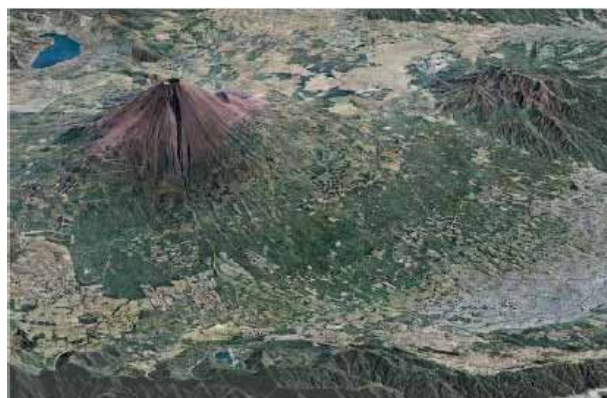
A three-dimensional bird's-eye view of the western slope of Mt. Fuji.

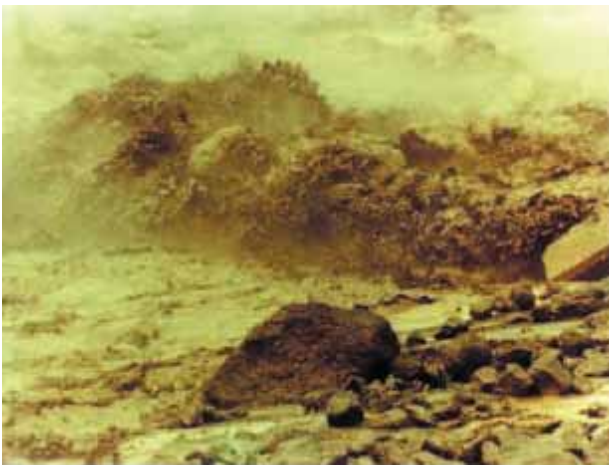
Osawa River mudslide (1972).

The mudslides from the Osawa Collapse are characterized by a high content of volcanic gravel, or scoria, from Mt. Fuji. When water is added to scoria, it flows freely and then piles up when it reaches an alluvial fan or plain, burying waterways, farmland and homes. After every torrential rain, the communities on the foothills of Mt. Fuji spent countless hours restoring their waterways and fields.

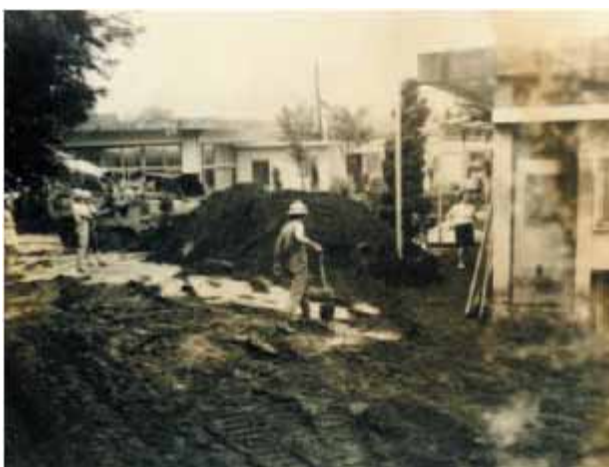
Damage to a retirement home (1972).

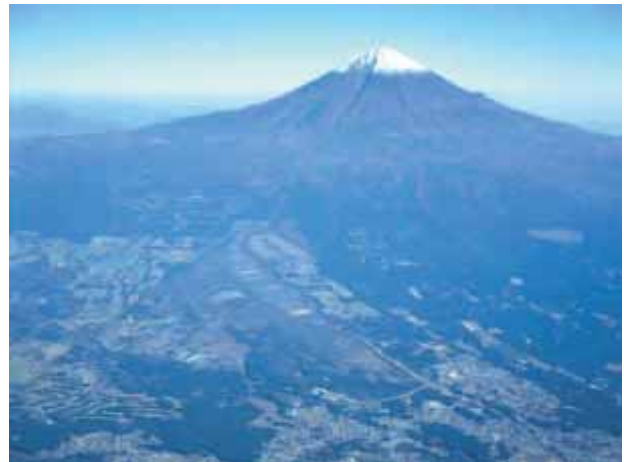
The Osawa Collapse and Osawa sand pockets.

The Urui River collects smaller rivers in the southern foothills of Mt. Fuji and pours from Tagonoura Port into Suruga Bay. Tagonoura Port is an important element of infrastructure for local industries, but it has been predicted that without erosion control facilities such as sand pockets, it could be filled up by a single mudslide and cease to function as a port.

In addition to their role in controlling erosion, the erosion control facilities on Mt. Fuji (erosion control dams, sand pockets, etc.) also function as water resource recharging facilities, in which flowing water is trapped by dams so that it can become groundwater. This function is not widely appreciated, but its benefits for the region are invaluable.
