# **Building a safe airport that resists natural disasters: The completion of three major safety projects at Kansai International Airport**

In this article, we will describe these three measures which have been implemented at Kansai International Airport.

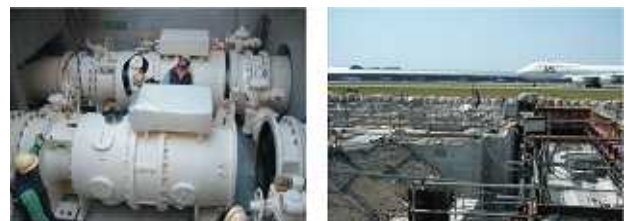
Photo 1. New, improved horizontally oriented underwater pump (left); pump pit construction next to the runway (right).

means of a comparative study including factors such as pump types, costs of pump pit construction, and ease of maintenance and management. For the drainage pumps located near a runway, large pipes must not protrude above the ground because of restrictions related to aeronautical safety. To use conventional large-scale pumps that are vertically oriented, it would have been necessary to build enormous pump pits below ground level, greatly increasing construction costs. Therefore, we modified the permanent magnet synchronous motor, which until that time had only been manufactured in small sizes, and succeeded in reducing construction costs by developing a new, space-saving, horizontally oriented underwater pump, as shown in Photo 1.

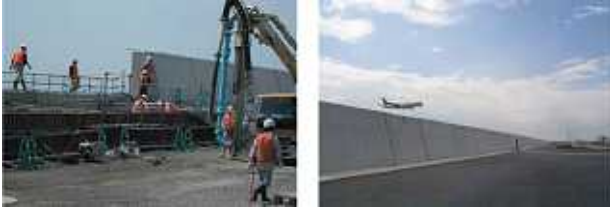
Photo 3. Construction work to raise the seawalls (left); completed seawall (right).

As a countermeasure, the top of the seawall of the first-phase airport island was raised with additional concrete to increase its height (Photo 3).

The airport island is located in a broad ocean expanse in deep water, about 20 meters; so a tsunami arriving here would not be high as a wall, as in coastal areas. In the area around the airport island, the problem would be rather one of high tides than a tsunami. The seawalls were raised in height by one to two meters along a length of about 11 kilometers in order to control high waves that would flow over the seawall, occurring about once every 50 years, at the highest tide level ever recorded for Osaka Bay (thought to be a result of Typhoon Nancy).

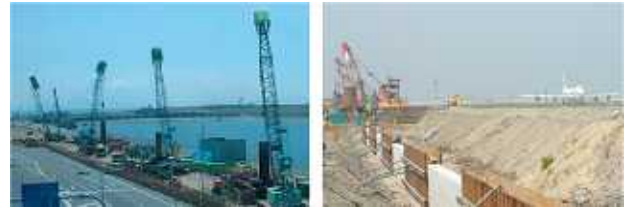
Photo 4. Construction work on the underground wall (left); underground wall construction work near the runway (right).

The project was first implemented in two areas that require strict management of the groundwater level: the passenger terminal area and the aircraft refueling tank area. Next, after confirming water cutoff effectiveness in these two areas, a large-scale underground water cutoff wall was constructed all around the entire airport (Photo 4).
