### 3. EARTHQUAKE GROUND MOTION

#### 3.1 Overview

At 1:47 am (local time) on September 21, 1999, an earthquake with magnitude 7.3 occurred 150 km southwest of Taipei. As of October 6, 1999 the casualties, number of injured and missing persons were 2295, 8731 and 92.

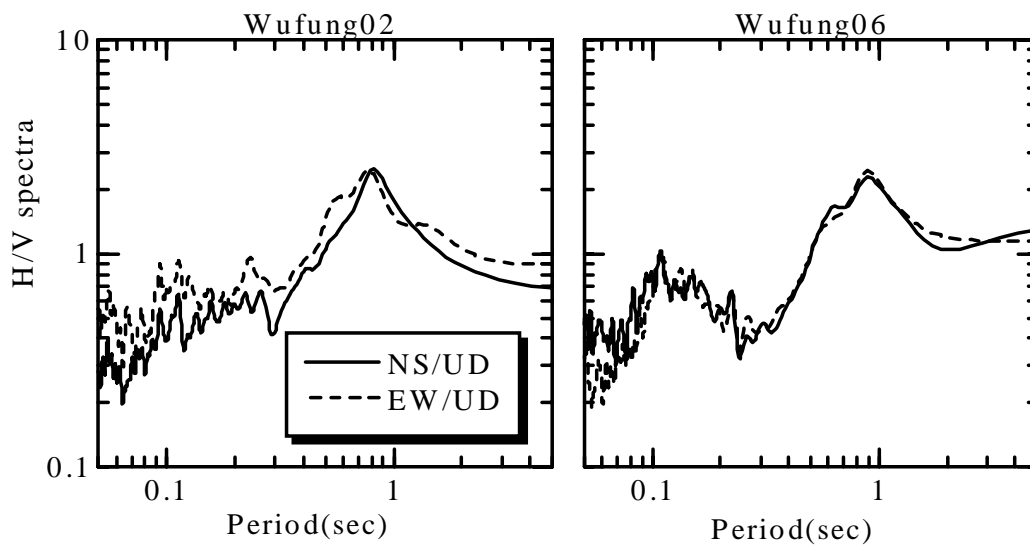
Figure 3.20 H/V spectral ratios at damaged sites in Wu-Fong (Wufung02 and Wufung06).

Figure 3.4.20 shows the spectral ratios of horizontal-to-vertical components of microtremors (H/V spectral ratios) using the technique proposed by Nakamura (1989). To obtain the spectral ratios, three sets of 20.48-sec-long records sampled at 100 Hz were selected. Fourier spectra of the records were calculated and then smoothed with a 0.5-Hz Parzen window. The horizontal spectra were divided by the vertical spectra, then the ratios were arithmetically averaged.

It is found that the H/V spectral ratios at both sites have marked spectral peaks; 0.8 sec at Wu-Fong02 and 0.9 sec at Wu-Fong06. Some native people told that the city is underlaid by silty or clayey deposits and some part of the city had been originally fish

ponds. The strong-motion records, microtremor records, and the comments of the native people suggest that the city has thick and soft subsurface soils which might cause the land settlements and ground-motion amplification during the earthquake.

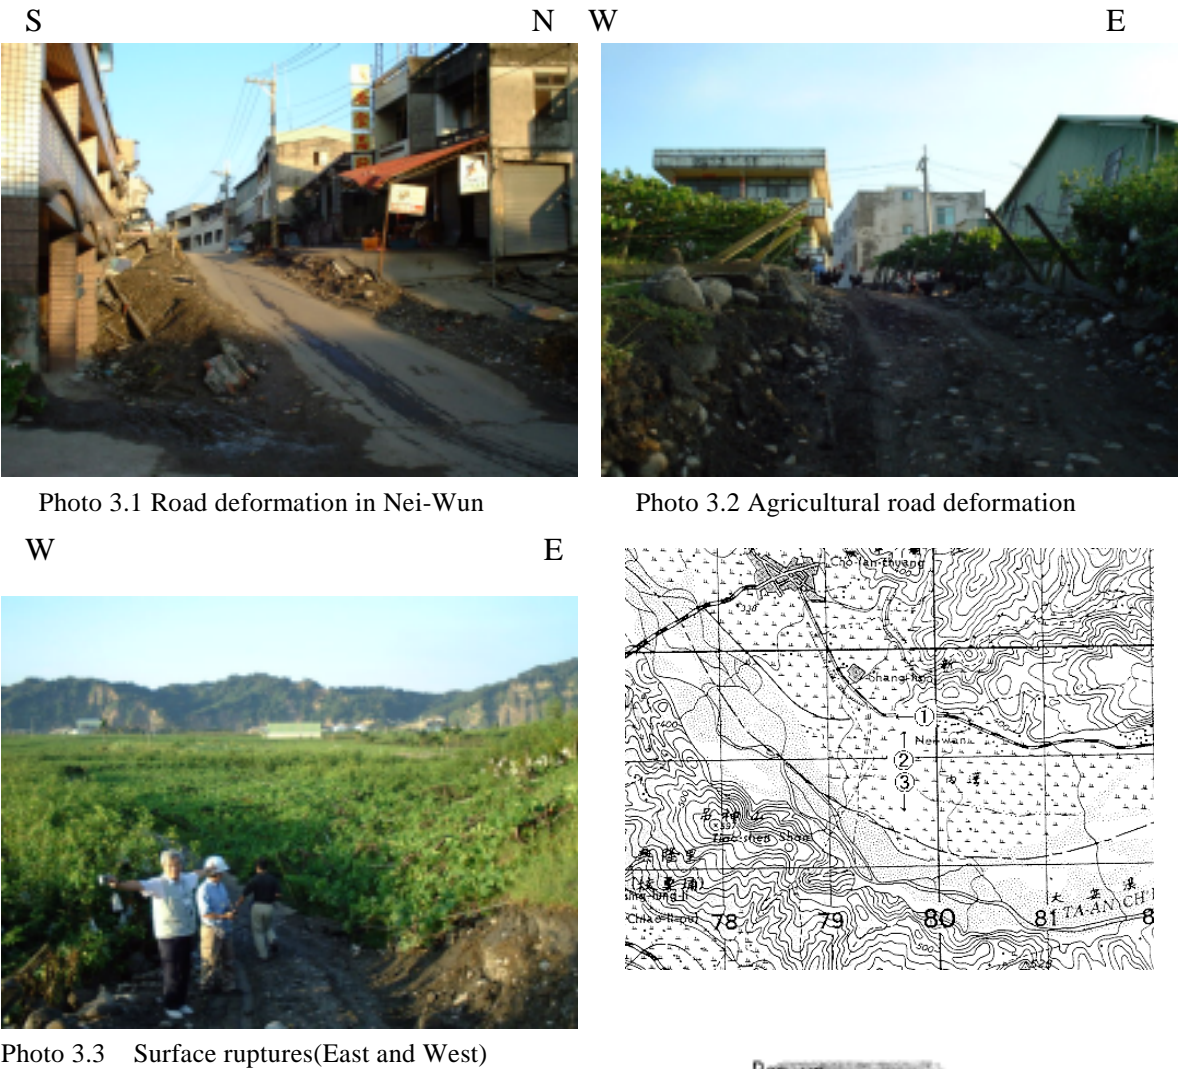
Figure 3.22 Back-thrust fault and pop-up

taken from the east. Photo 3.2 was an agricultural road deformed by the surface displacement located at about 50 m left of the location shown in Photo 3.1, and this photograph was taken from the south. Photo 3.3 was taken from the south at the point where Photo 3.2 was taken, and the surface ruptures can be seen in the east-west direction expressing by extended arms in the photograph. Appearance of surface ruptures was complicated in the north-end part of the fault and the surface ground movement caused by the dislocation of deeper part of the fault could not be simply explained by upward deformation of hanging wall. This kind of complexity usually can be seen for the case of a back-thrust fault. If a back-thrust occurred in a thrust belt an upheaval hinterland called pop-up phenomenon can be seen as illustrated by Figure 3.22.

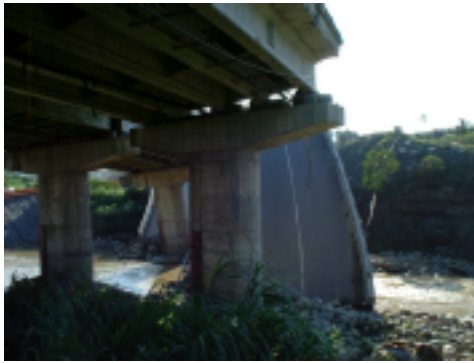
Photo 3.4 Collapsed bridge of Shih-Yuen Bridge located in the northeast of the Shikan Dam

This place is northern part of the Chelungpu fault. The fault with a strike of NE-SW was running across under Shih-Yuen Bridge. Most of damage to the bridge was induced by the fault (Photo3.4).

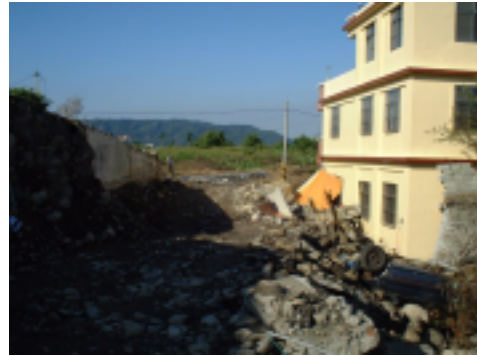
Photo 3.5 Movement of the house by the landslide

A landslide occurred near the left bank of Shih-Yuen Bridge. The house in Photo 3.5 moved about 8 m from the original position to the right-hand side of the photograph according to the landslide. Due to the ground movement the structural foundation distorted. Large surface rupture was also appeared at a surrounding of ground surface (Photo3.6).

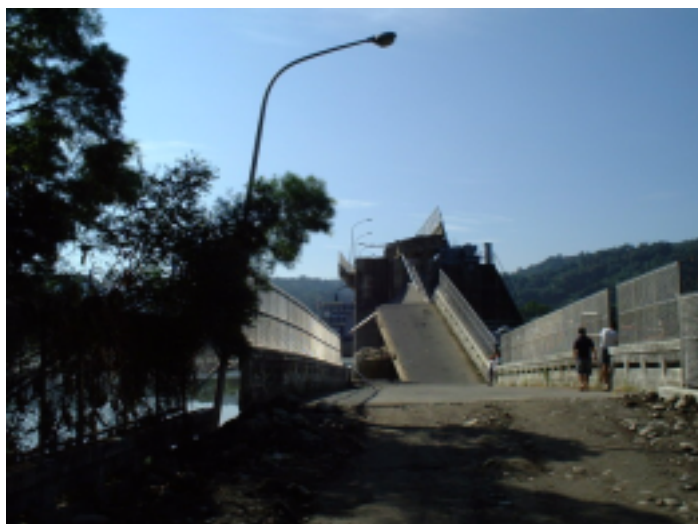
Photo 3.7 Uplift of floodgate ( 9.8 m) and right-bank abatement (2 m)

The fault crossed the edge of Shye-Gang Dam. A large vertical displacement created by the fault movement. According to a leveling conducted by the dam control organization the floodgate side uplifted 9.8 m and right-bank uplifted about 2 m (Photo3.8-3.9). The road which ran along the right bank side of the dam to a downstream, there was about 5 m deformation in the vertical direction. Pei-Fong Bridge is a bridge located lower streamside of Shye-Gang Dam.

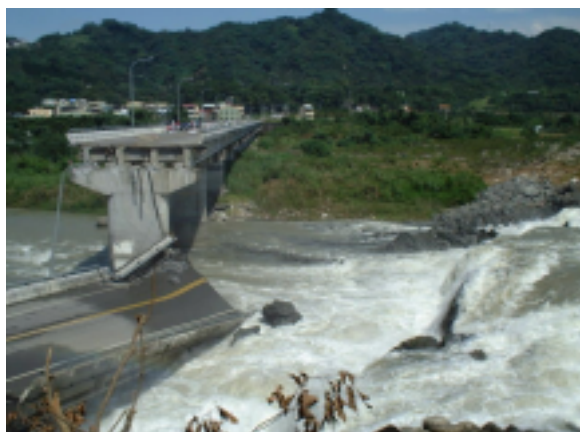
Photo 3.9 The waterfall appeared at the NE-SW direction

Tow beams were corrupted. The waterfall appeared at the NE-SW direction, showing about 2 and 3 m uplift of upper streamside (Photo 3.9). The surface rupture by the fault goes up north in the right-bank side.

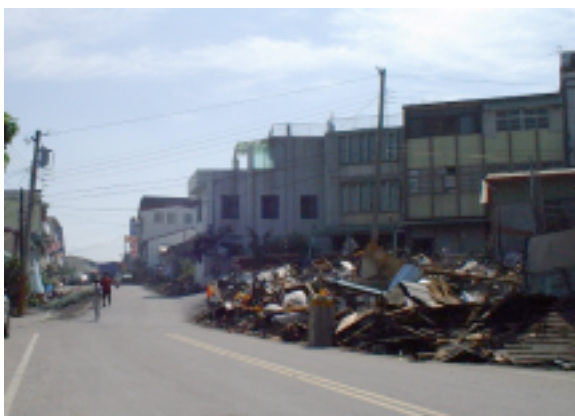
Photo 3.10 Route 3 at Tuu-Nyu Tsuen.

In Fong-Yuan area, the surface rupture can be seen at the east side of Route 3 which runs parallel to the fault traces from the north to south. Damage to structures caused by surface ruptures due to the fault movement was very severe but restricted in a small area within the distance of several tens meters from a surface rupture (Photo3.10-11).

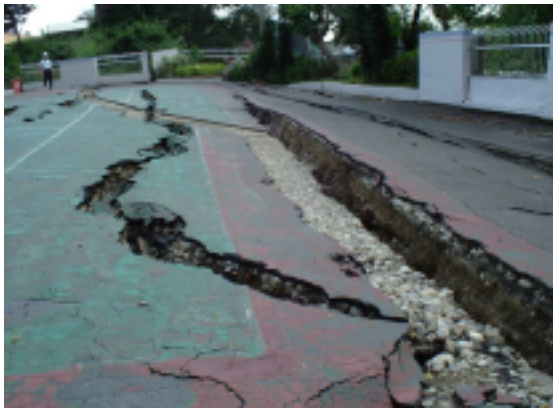
Photo3.12 The appeared fault with NS strike on the pavement ground

Jiungung elementary school and Wu-Fong athletics ground are located in the middle of the Chelungpu fault. At Jiungung elementary school, the surface rupture was appeared on the pavement ground (photo3.12). At Wu-Fong Shiang athletics ground, a distinct surface trace of the fault movement with about 2 m vertical displacement could be seen on the all weather (en-tout-car) track (Photo3.13). The vertical displacement was predominated even though a small horizontal displacement is recognized(Photo3.14).

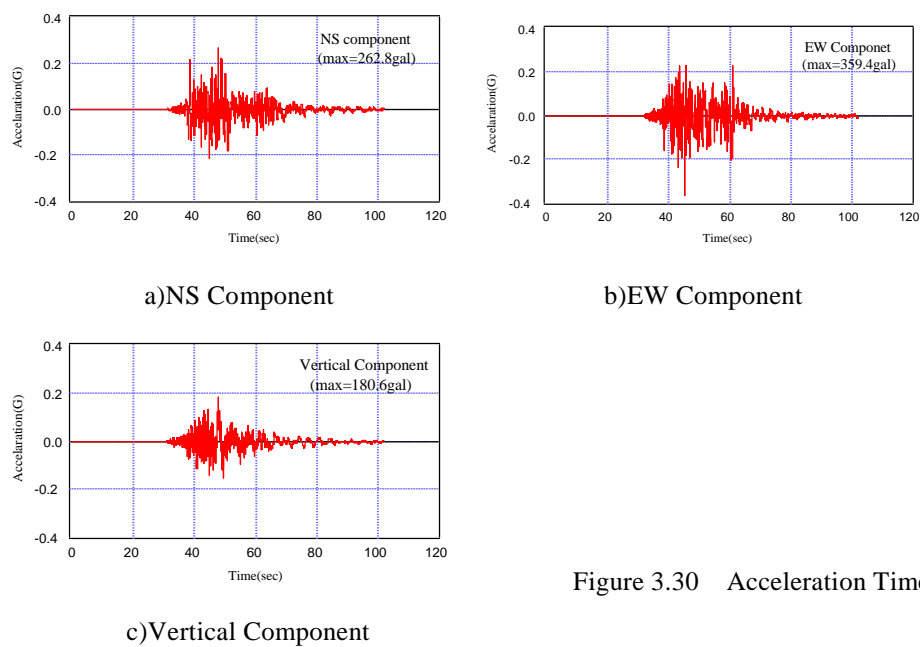
Figure 3.30 Acceleration Time histories

Acceleration time histories of three components are shown in Figure 3.32. The maximum acceleration of EW component is larger than that of NS component. The maximum acceleration of vertical component is almost half of the EW component. The amplitude characteristic of EW component changes drastically at about 10 seconds after arrival of S wave. To make clear this evidence the non-stationary spectrum of vertical component time history is shown in Figure 3.31. The strong non-stationary characteristic beyond a period of 2.0 second is remarkable in the spectrum, especially the later part of time history of recorded motion.

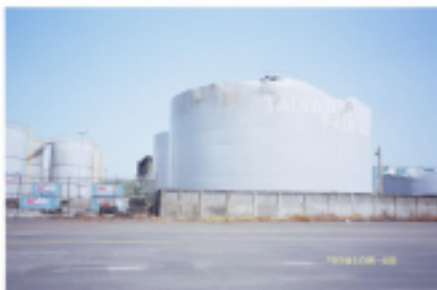
Photo 3.15 Damage of the Molasses Tank  
(Provide by The investigation team for The 1999 Ji-Ji Earthquake by The Japanese Geotechnical Society)

As an example of damage to structures caused by such low frequency component of the earthquake motion, the failure of a cone-type roof slab of the molasses tank at Taichung port is shown in Photo 3.15.

The cross section of the tank is shown in Figure 3.33. The natural period and maximum liquid surface displacement caused by the sloshing of molasses in the tank were calculated by using Houser's velocity potential theory. The height of molasses before the earthquake assumed to be 10.5m based on the information about the amount of the molasses being about 90% of filled condition. The calculated natural period is 5.2 second and the maximum liquid displacement is more than 1.6 m. The velocity spectrum value at this period is assumed to be from 170m/s to 100m/s even taking into account an attenuation effect between Taichung city and Taichung Port. The failure of the ceiling slab of the tank seems to be caused by the sloshing of molasses due to the very high velocity spectrum amplitude at such a longer period.
