# **PROVISIONAL REPORT OF THE DAMAGE CAUSED BY MUZAFFARABAD EARTHQUAKE OF OCTOBER 8, 2005, PAKISTAN**

-- OVERVIEW AND PROPOSALS TO MITIGATE EARTHQUAKE-INFLICTED LOSSES (Ver. 2) --

ADVANCE TEAM OF JSCE RECONNAISSANCE TEAM  
Kazuo KONAGAI, Aziz AKBAR, Kenji OGUNI,  
Hiroyuki KODAMA, and Takaaki IKEDA

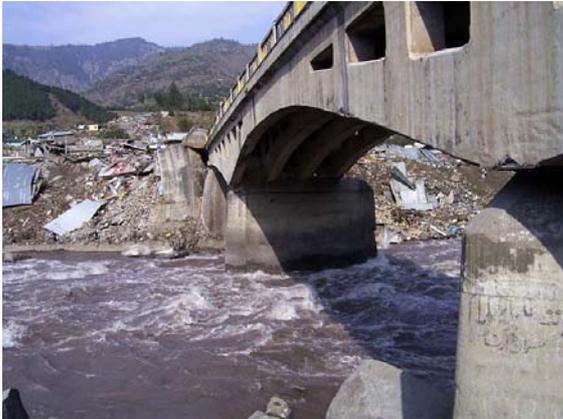
There are two bridges within this belt, Balakot bridge of National Route #15 (3-span RC arch, Fig. 5) and a pedestrian suspension bridge about 100 m downstream side (Fig. 6). The entire deck of the Balakot bridge shifted over its two piers about 1 m from north to south downstream side and a half meter towards the left abutment. The right masonry tower of the suspension bridge suffered a clear cut off at the level of 2m above the riverbed, and moved about 1m towards downstream side. Both clearly show that the shake there was very intense in NS direction, the direction in which the seismic soil wedge is pushed. Measuring traces of strong ground motions remaining in structures, which are seen everywhere and have common features, will provide useful information for discussing shakes at particular areas.

**Fig. 5.** Balakot bridge of National Route #15: The entire deck moved about 1m downstream side.

**Fig. 15.** Rehabilitation of Balakot bridge

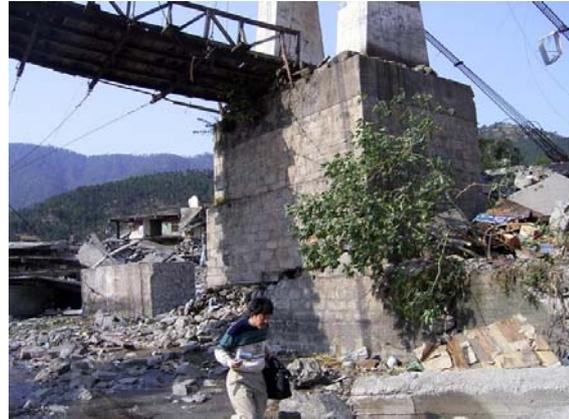
**Fig. 6.** Suspension bridge near Balakot bridge: The right tower was cut off and shifted towards downstream side.

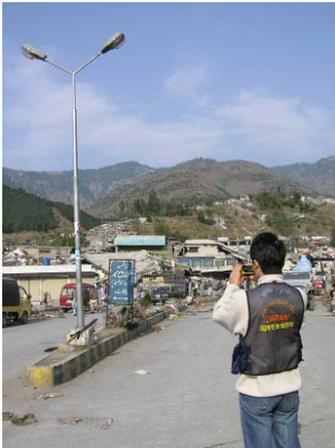
Lamppost

In our short preliminary investigation, only the direction of strong motion was estimated by measuring inclinations and directions of the inclined lampposts. We took total 9 lampposts (Fig. 7) lining Route #15 (Fig. 6). Two lampposts (1, 7) were standing almost upright and slightly damaged. Three lampposts (4, 5, 6) had screws broken at their base plates (22.5cm × 22.5cm) and stood loose. Four lampposts (2, 3, 8, 9) were bent at their toes and inclined north. All these show that the ground motion was strong in NS direction.

**Fig. 7.** Location and the inclination of the lampposts (●: sound, ○: shaky, ○: bent). Arrows show the direction and the amount of the inclination (20degree=1cm). Imagery taken from UNOSAT website (<http://unosat.web.cern.ch/unosat/asp/>)

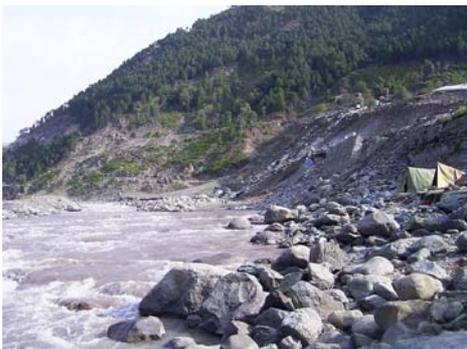
**Fig. 8.** Terrace slope northeast of Balakot bridge

Hills and terraces near the northern end of Balakot basin are composed of either highly weathered sand rock or conglomerate of rounded to sub rounded boulders, cobbles, gravel, sand, silt, clay and other suspended matters that River Kunhar (or glacier) have carried over centuries (See Fig. 8). They are heterogeneous in nature. Foundations of buildings on these terraces may have not been properly designed. Fig. 9 shows a foundation found in the rubble covering up the entire slope of the abovementioned long-bean-shaped hill. The foundation was lying on the sandy slope surface with its column-foundation joint intact, indicating that the foundation didn't suffer any cracking but the foundation lost its soil support. A similar pattern of damage was also found in Muzaffarabad (Fig. 10). Houses along the rim of the terrace were completely destroyed, while those on the flat land are seemingly standing upright. Soil cracks were visible along the rim.

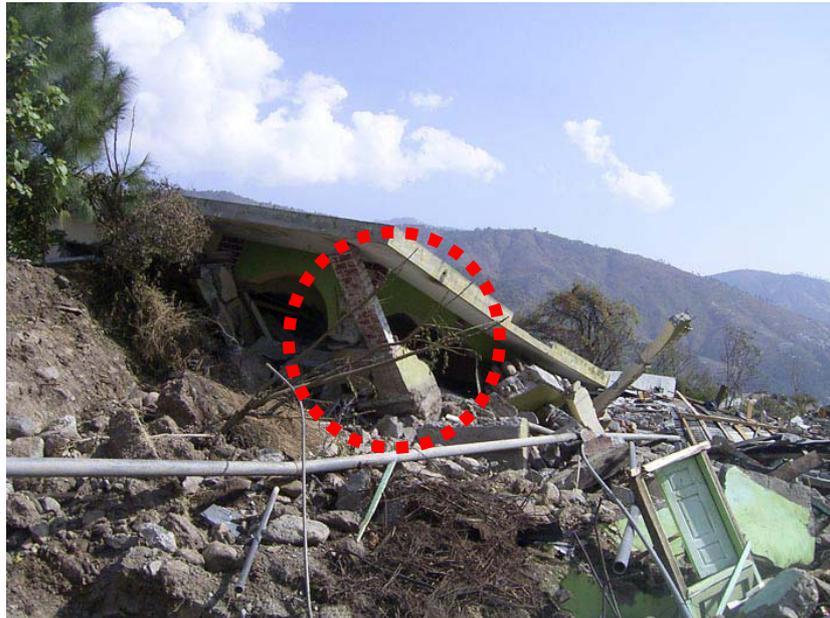
Walls of structures are mostly made from cement sand blocks. Roofs are made from RC slabs. Almost complete collapses of these structures were often found on sloping grounds. These houses were attached to each other. When one house anywhere on the slope collapsed, it triggered the collapse of the others in domino-like manner and the result was the collapse of entire houses. Half-detached or completely detached houses also suffered cracking, but there were some narrowly escaped from complete collapse.

**Fig. 9.** Foundation and column of a dwelling at the long-bean-shaped hill

1. There is a need to study engineering (physical) and geological features of soils and rocks of mountains existing in the affected areas for rational measures to stabilize slopes.
2. Where possible, two or more storey structures should be constructed on piles. Where not possible or difficult such as on slopes, shallow foundations can be used if they are properly designed to withstand/resist differential settlement. Providing a connecting beam on or slightly below the ground level can reduce the effect of the differential settlement.
3. Frame structure buildings consisting of RC columns, beams and slabs will be more resistant. Alternatively, if affordable, steel frame structures will definitely be more resistant.
4. If possible, houses on slopes should be kept detached from each other.

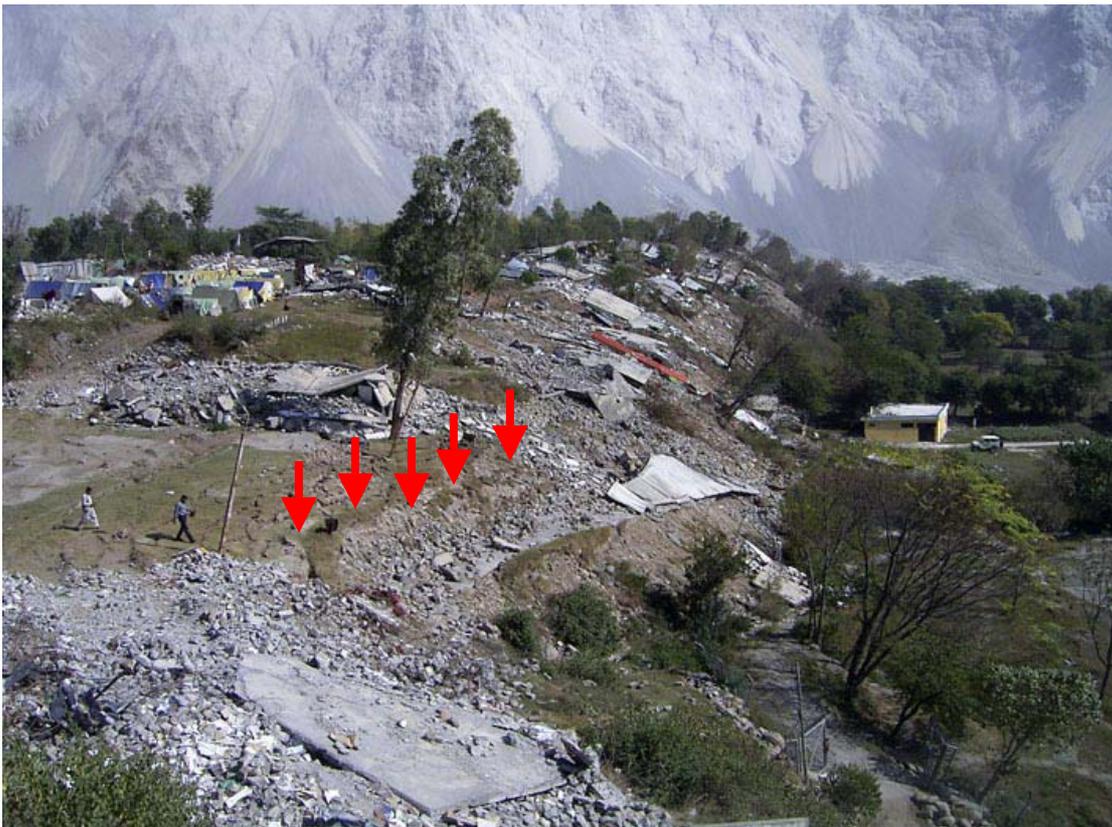
**Fig. 10,** Houses along terrace rim and those on flatland, north of Muzaffarabad: Cracks open along the rim

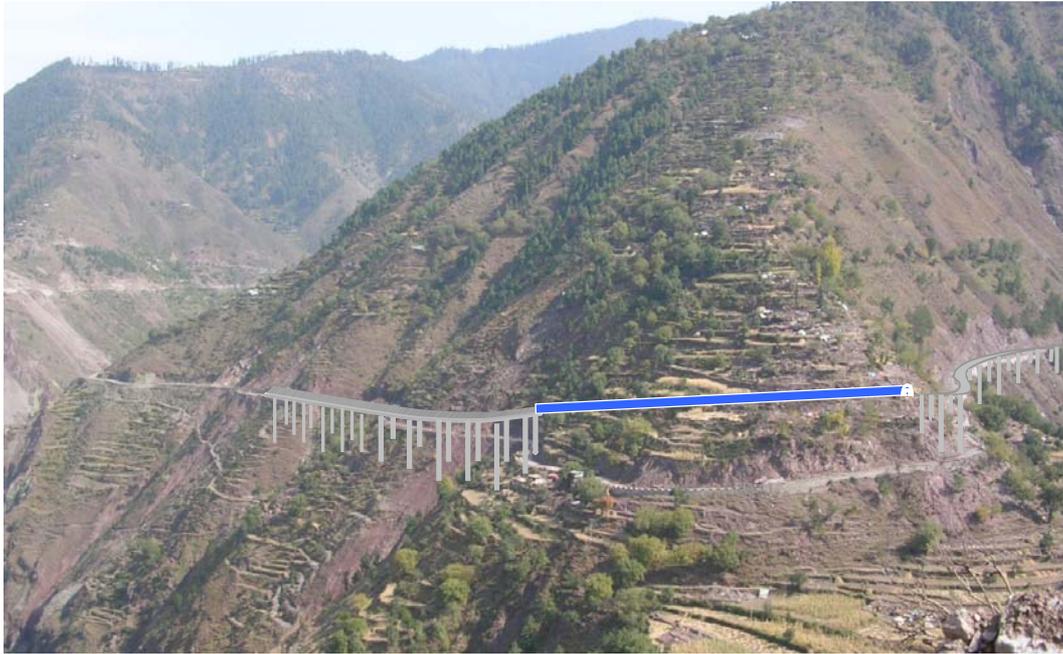
**Fig. 14.** Image of land bridge and tunneling

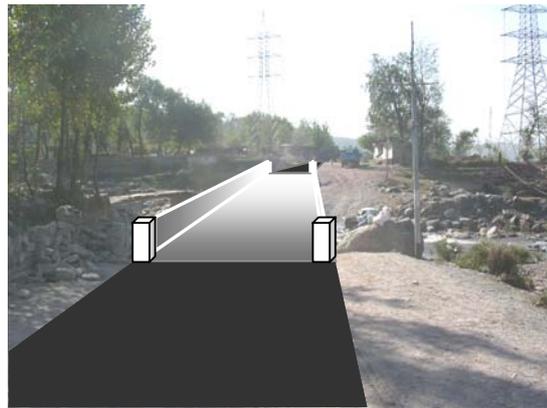
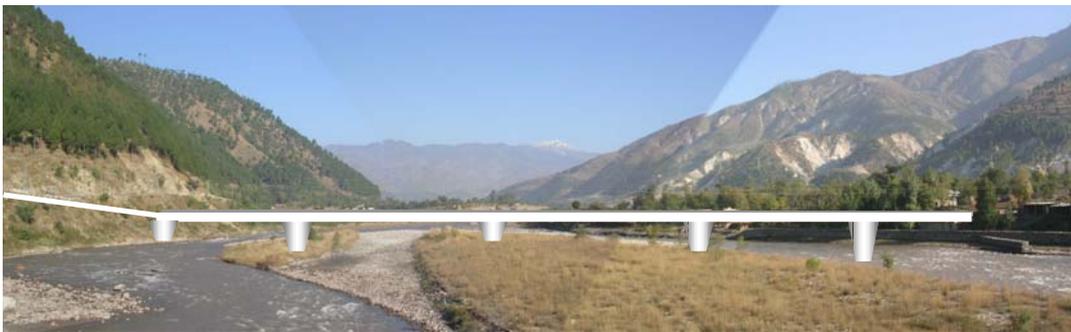
Connecting existing roads point-wise by constructing new bridges etc, a cost-effective bypass can be constructed allowing bi-directional traffic to be realized. One of candidate sites for Balakot can be approx. 4km south of the city. Realizing a smooth traffic would make people to migrate easily, and new colonies will be formed.

\* Avoid landslide/rockfall zones

**Fig. 16.** Enhancing redundancy by constructing bypass

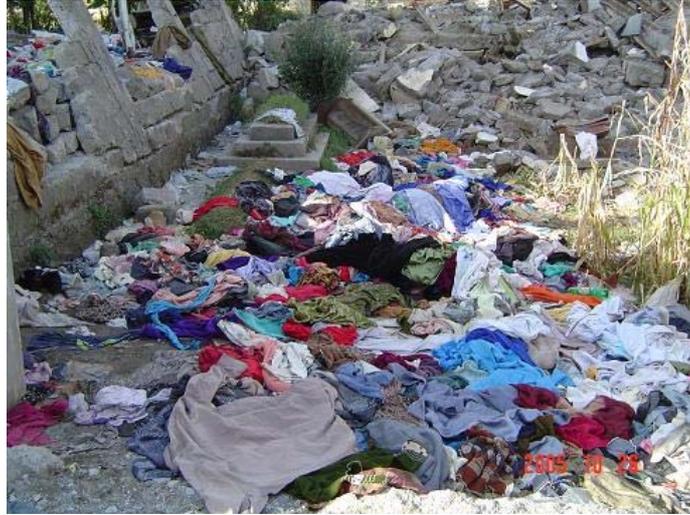
**Fig. 18.** Cloths thrown away

This shows the mismatch between supplies and demands on the rescue goods. Also, the spontaneous delivery of the rescue goods makes people stand in the line and waste time for the goods, which are possibly of no use.
