**Investigation Report on the Storm Surge Disaster
by Cyclone SIDR in 2007, Bangladesh**

June 2008

Investigation Team of Japan Society of Civil Engineering

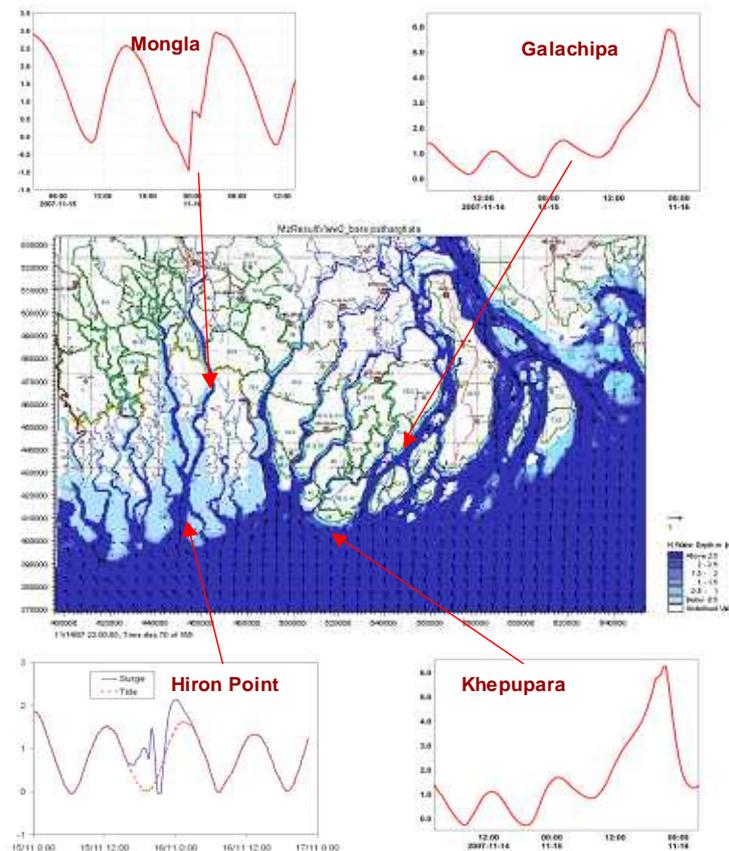
Figure II-2 Records of Water Level by courtesy of IWM

In the case of SIDR, although the cyclone had landed in the dry season, the maximum water level, which was formed by the superpose of storm surge and full tide, exceeded about 6m from MSL in the coastal area. The height would be comparable to the maximum water level in 1991. This means that SIDR had the same scale of power as the cyclone in 1991.

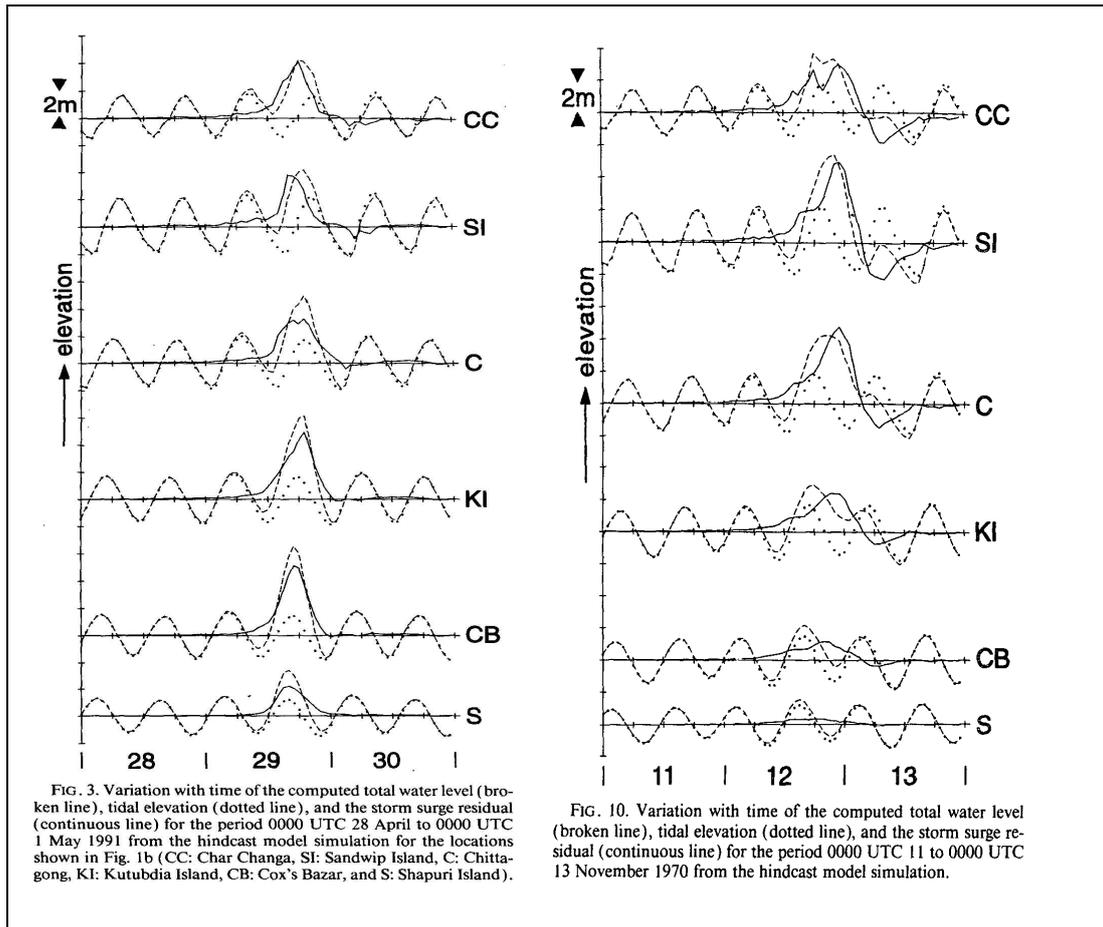
Figure II-3 Simulation of Storm Surge in 1970 and 1991 Cyclones. Roger A. Flather (1994)

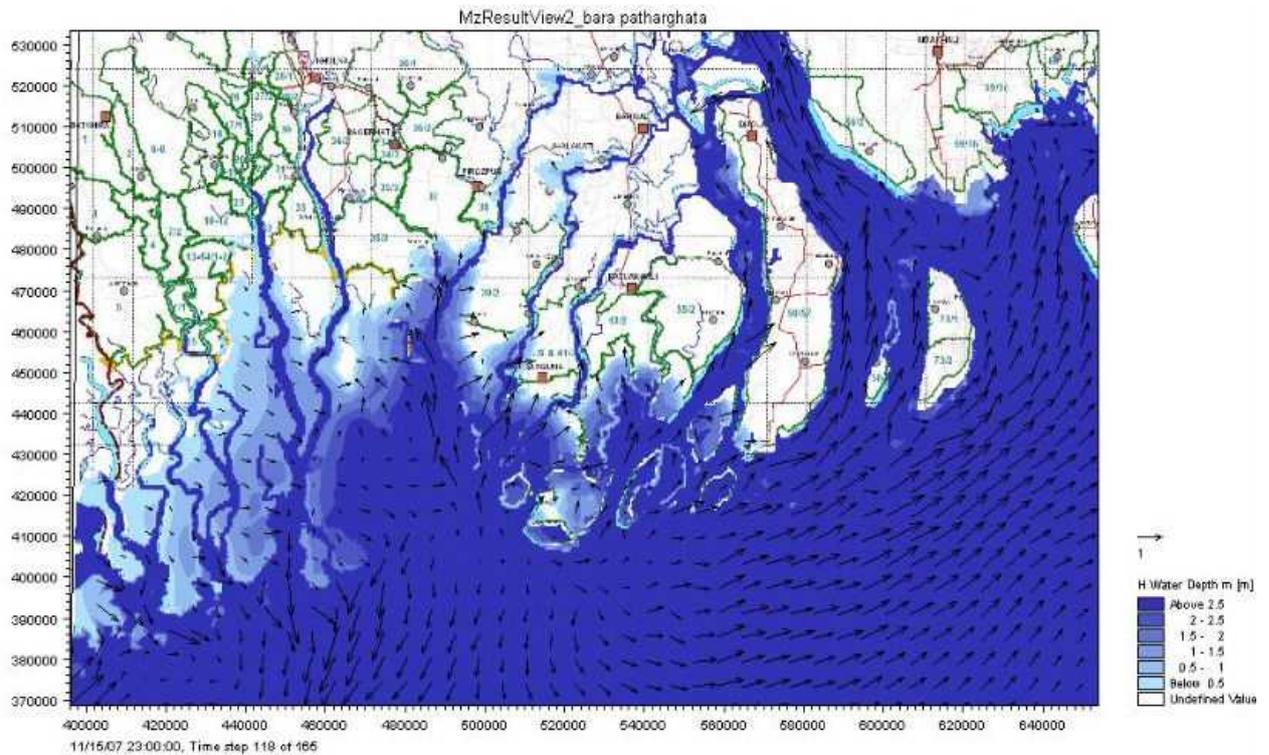
Figure II-4 Simulation of Storm Surge in 2007. By courtesy of IWM

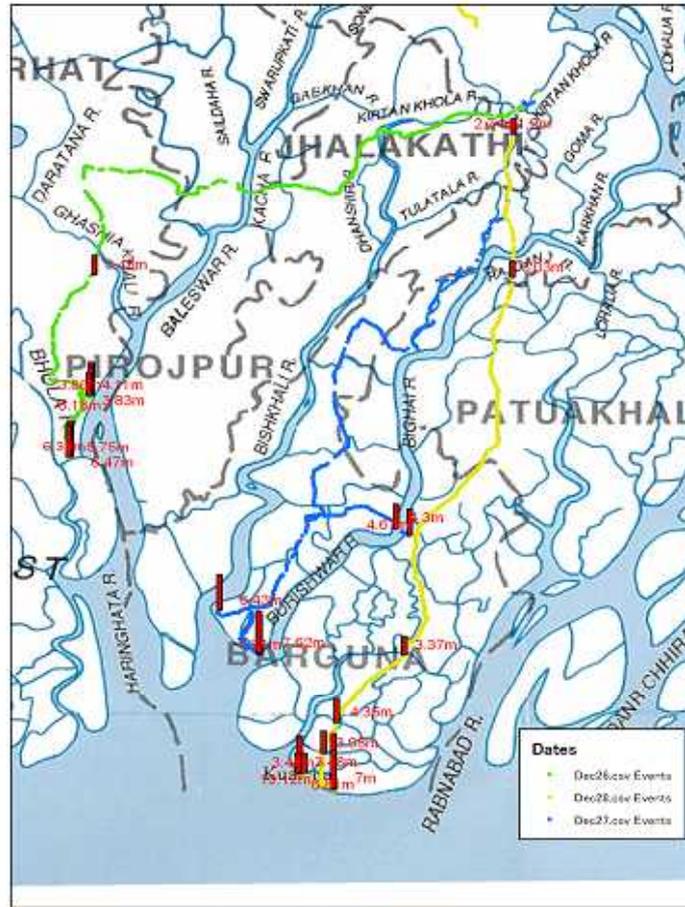
Fig. 1.1 shows the survey route and distribution of measured storm surge heights. Basic method was to detect flood height and to measure distanced by using laser distance meters and to measure locations by using GPS.

Fig. 1.1 Survey route and measured storm surge height

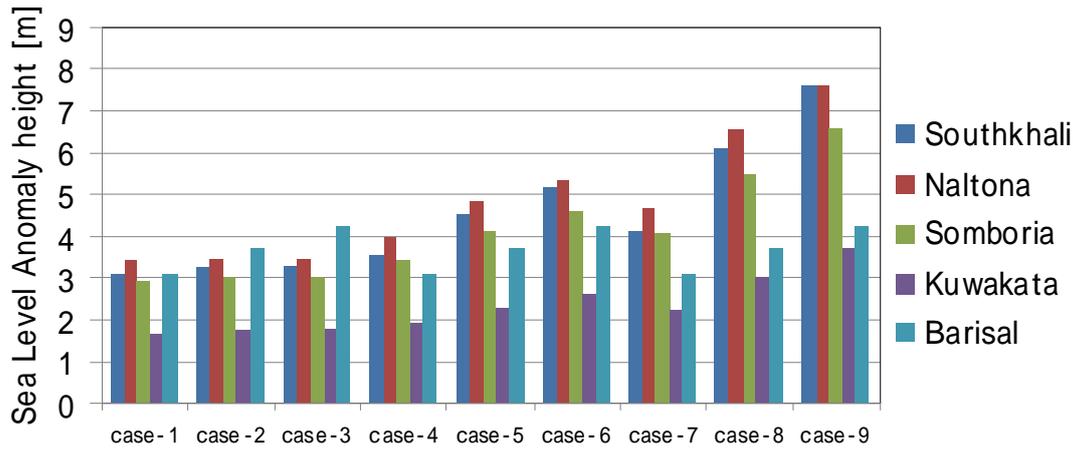
Comparing sea level anomaly heights with the nine cases of the simulation are shown in Fig. 1.3. The heights were forced by wind set up with pressure suction. The heights at Southkhali, Naltona and Somboniya are varied much by different wind fields. Those points were closed to center of the cyclone, where SGW works much. Beside, results between case-4 to case-6 or case-7 to case-9 show a radius affects the heights. For the results at Barisal, an effect of radius and SGW to height is not so strong.

Fig. 1.3 Comparing sea level anomaly height (by wind set up with pressure suction) with the nine cases.

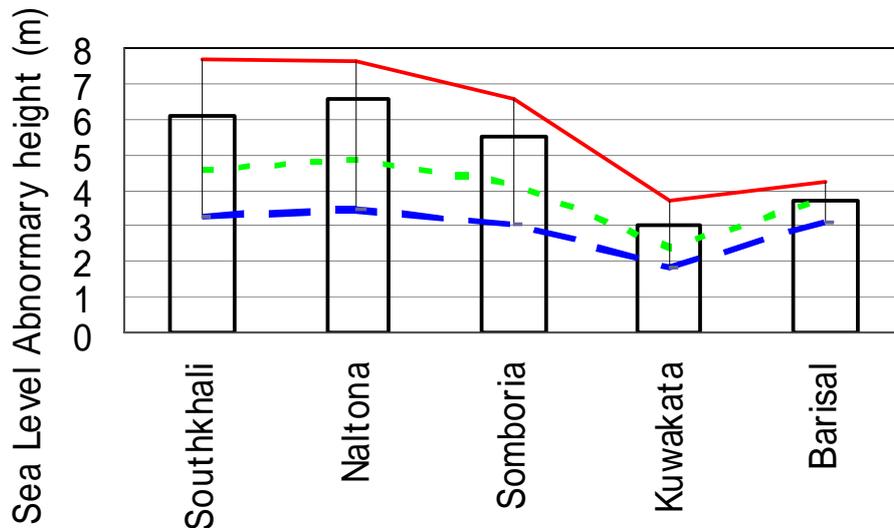
Fig. 1.4 Maximum, minimum and average of sea level rising by wind set up with pressure suction in the nine cases.

Fig. 1.4 shows sea level anomaly at 5 points due to wind setup and barometric pressure suction except wave setup. Bars are result of case-8 and three lines, a solid line and a dotted line and a broken line, are maximum, average and minimum results of all cases. Maximum and Minimum line is the result of case-9 and case-1 respectively. The difference heights of both lines at Southkhali and Naltona, that are 4.4 to 4.2 m, were calculated by the uncertain of pressure and wind field. At Southkhali and Naltona, the peak heights of case-8, '6.1m and 6.5m', are the closest to the measured height, '6.2 m and 6.8m' on survey results by our team, respectively. The heights become lower from Southkhali to Kuakata, that direction is as same as west to east. Barisal faces to large river mouth of the Ganges and Brahmaputra River, which are like a bay. This is the reason why the height at Barisal is higher than that at Kuakata, though Barisal is west.

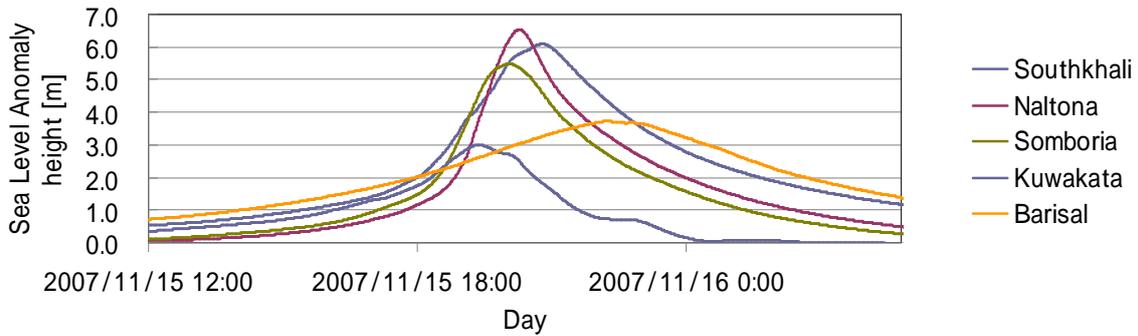
Fig. 1.5 Time series of the sea level anomaly height (case-8)

Time series of the sea level anomaly of case-8 is shown in Fig. 1.5. The time of peak height at Southkhali and Naltona are 20:15 to 20:45 on 15th November. These times are almost good agreement with the time gotten in survey. The time spans from 5m to peak at each point are 57 and 34 minutes respectively. These speeds of sea level rise are slower than the speed gotten in survey, 15 minutes.

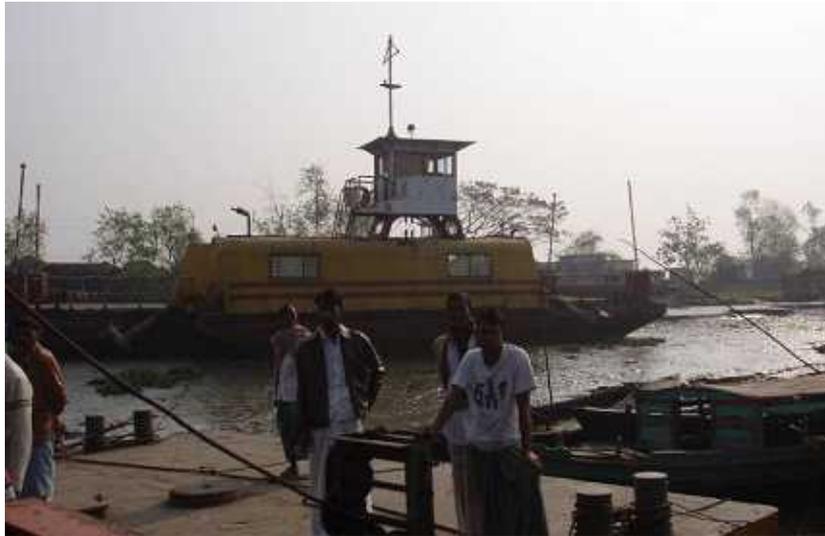
A ferryboat stranded by the high tide due to Sidr was left near the ferry gate on the left bank of the Baleswar River (Photo 2.5).

Photo 2.5 Stranded ferryboat

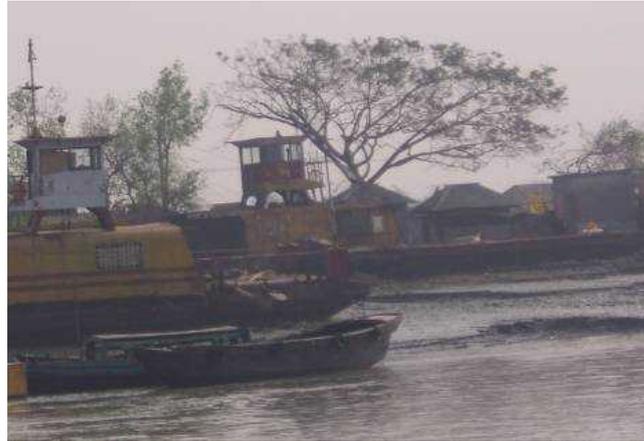
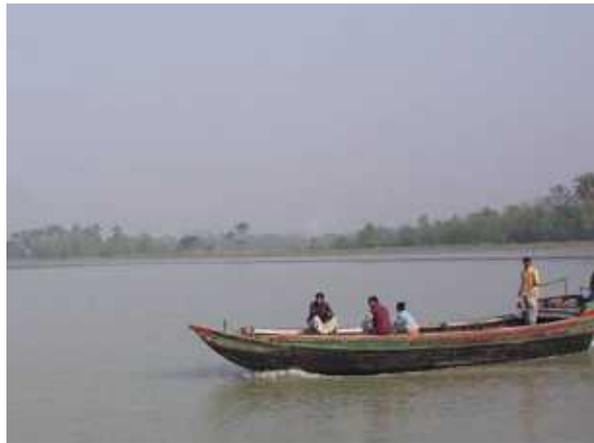
In the upriver district on the left bank of the Baleswar River in Solombaria, many houses near the river were flashed away, where some people died, while in the downriver district, the houses were not flowed because they were built on a height. It is also supposed that the ferryboat which was stranded in front of the houses in the downriver district, worked as a breakwater against the high tide. According to Photo 2.6, there is a height under the houses in the downriver district, while the ground slope in the upriver district is mild without a height.

Photo 2.6 Downriver (left-hand side) and upriver (right-hand side) districts on the left bank of the Baleshwar River in Solombaria

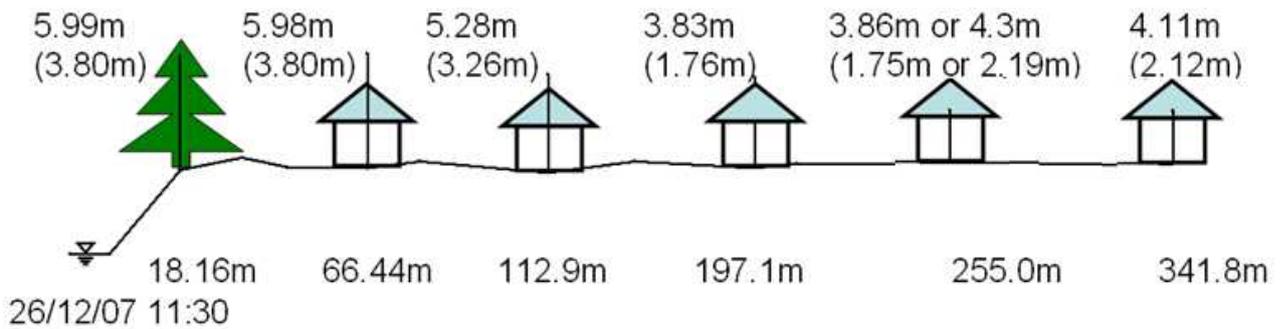
We reached a bank of the Baleswar River in Royenda Bazar, where we started the second measurement of inundation at 11:30. We extended the traverse line upward, where a lot of collaborative people gave us in-depth information. The measurement result of a cross section is shown in Fig. 2.2.

Fig. 2.2 Measurement result of a cross section in Royenda Bazar

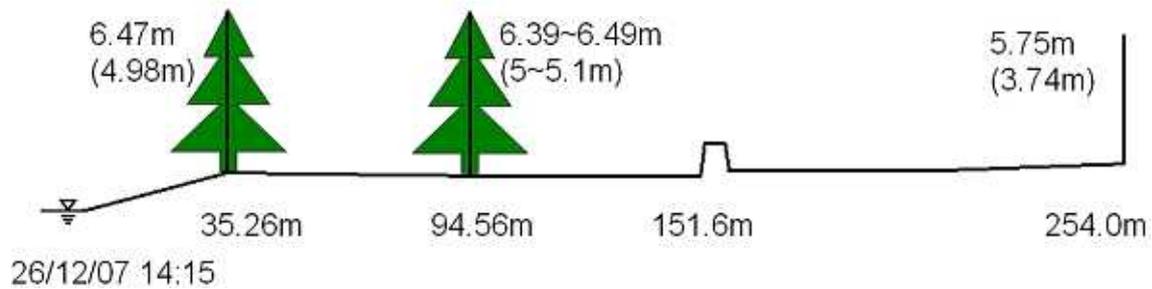
We started measurement of inundation at 14:15. The position of the starting point on the river-water surface was (N22 14 3.8, E89 50 3.8). The measurement result of a cross section is shown in Fig. 2.3.

Fig. 2.3 Measurement result of a cross section in Southkhali

River banks were built around thirty years ago but they were broken due to erosion as shown in Photo 2.10 before Sidr attacked them. Though newer banks had been built recently about 150 m inside from these older banks, the high tide due to Sidr flowed over their top of about 2.5 m over the river water at the measurement time. These newer banks are shown in Fig. 2.3 around $x = 151.6$ m.

In Fig. 2.3, the inundation levels at $x = 35.26$ m and 94.56 m were shown on palm trees.

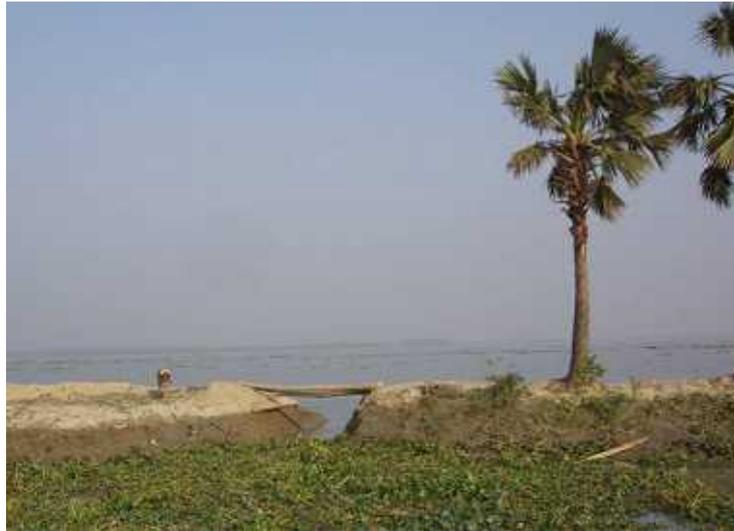
Photo 2.10 Broken river bank in Southkhali

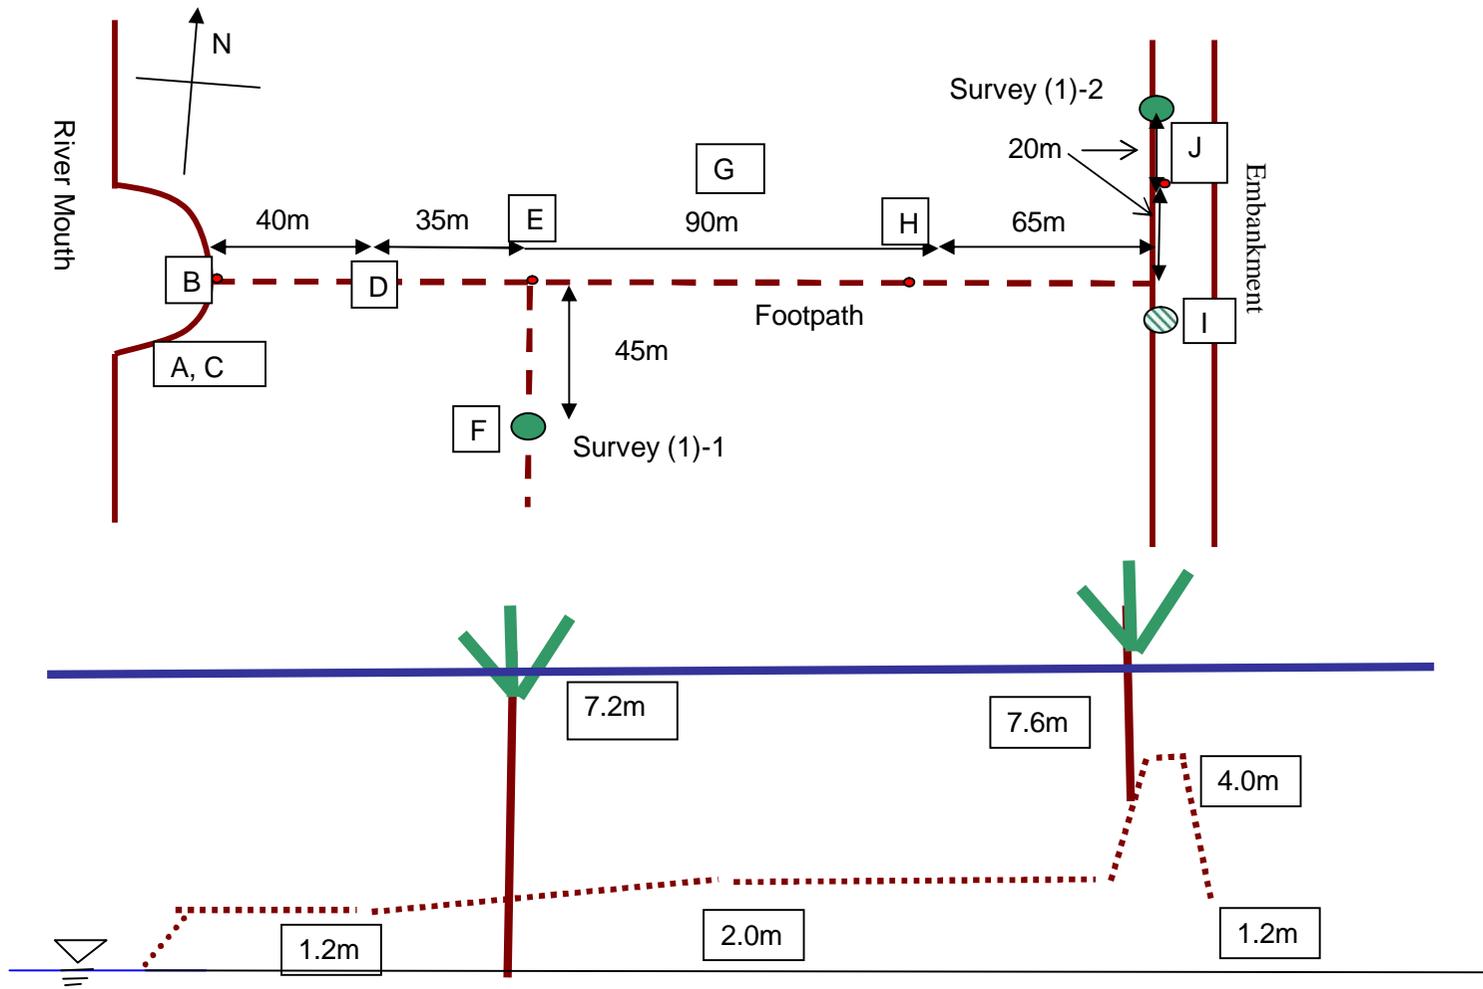
The high water level at one high palm tree nearest the river ((1)-1 in Fig. 3.1) was based on two witnesses of inhabitants. The one is that some people watched water level on the palm tree from trees on the embankment (right side in Fig. 3.1) during the storm surges. The other is that some people climbed the palm tree and checked the trace of water line on the next day of storm surge. There was other witness about water level at other palm tree on the embankment ((1)-2 in Fig. 3.1). This water height was almost same as height of the palm trees on embankment based on information of another inhabitant who had survived at other tree. Both water levels were almost same and the levels were agreed in almost of the inhabitants so that the height is confidence [B].

Fig. 3.1 Survey result of high water in Somboniya

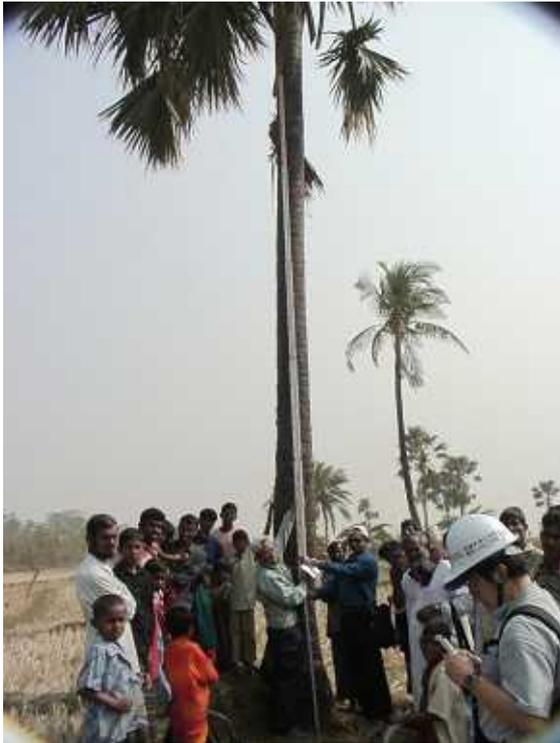
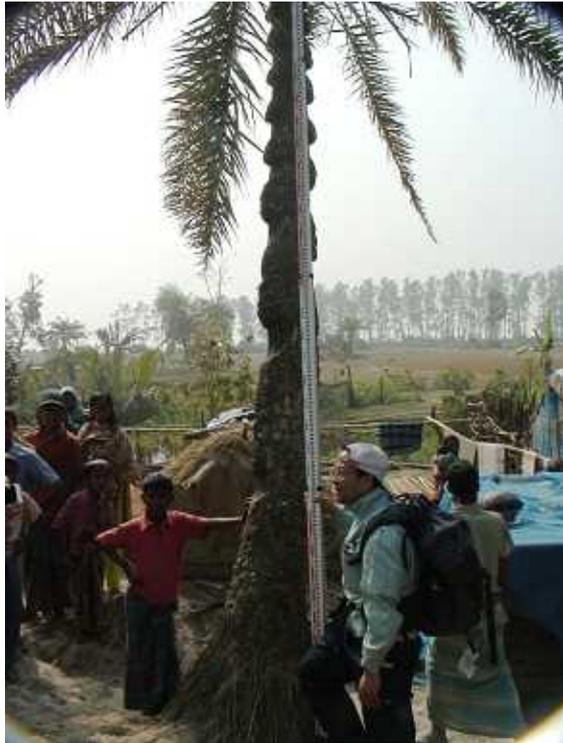
Photo 3.3 Inundated palm tree ((1)-1 in Fig. 3.1)

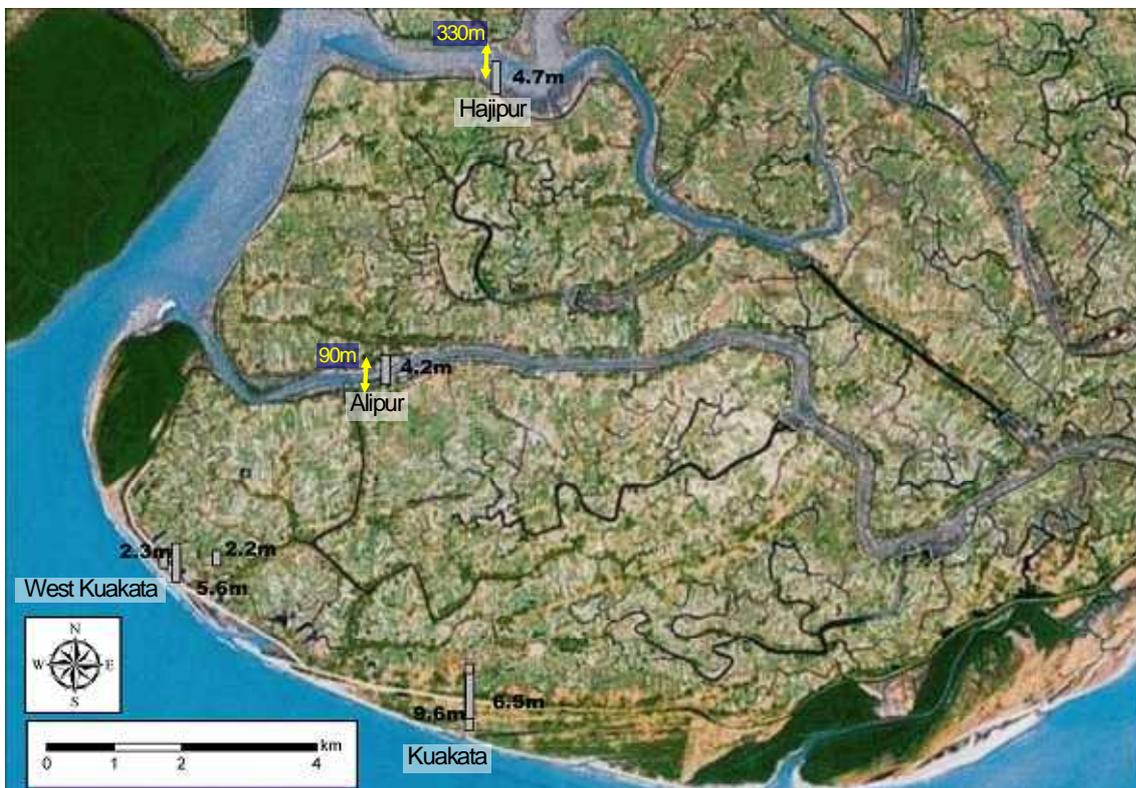
Fig. 4.1 shows satellite image around Kuakata with measured inundation heights based on mean water level. White line running east to west along the shoreline is the embankment filled in 1962. Figure 4-2 shows the picture taken on the embankment. Around West Kuakata, width and height of embankment were 12m and 5m above the mean water level, respectively. Behind the embankment, various buildings such as fishermen's houses and hotels were constructed and wide and low area behind the houses were used for farming. Ground elevation behind the embankment was about 1.2m above the mean water level.

Fig. 4.1 Spatial distributions of measured inundation heights around Kuakata district

Fig. 4.1 shows measured inundation heights along the coast as well as at ferry stations along the waterways such as Alipur and Hajipur. The highest inundation heights observed around West Kuakata was 5.6m on the crest of the embankment. Storm surge overtopped the embankment and inundated the area behind. However the inundation heights behind the embankment was relatively low, i.e., we observed inundation height, $h=2.3\text{m}$ at the fisherman's house (Fig. 4.4) just behind the embankment and $h=2.2\text{m}$ at cyclone shelter (Fig. 4.5). This feature clearly shows the embankment significantly functioned to reduce the damage of the residential area behind.

Inundation heights at Alipur and Hajipur were higher than those behind the embankment by about two meters. Although Hajipur is located further from the coast, the inundation height at Hajipur was higher than the one at Alipur. Hajipur however is closer to the river mouth and the width of the waterway, $B=330\text{m}$, was wider than the one of Alipur, $B=90\text{m}$. We also found two ferries washed on the bank in Hajipur (Fig. 4.6). According to these observed features, we deduced that the momentum forces due to storm surge were greater around Hajipur rather than Alipur. It is therefore essentially important to consider the run-up flow not only from the coastal area but also along the river, branches and waterways.

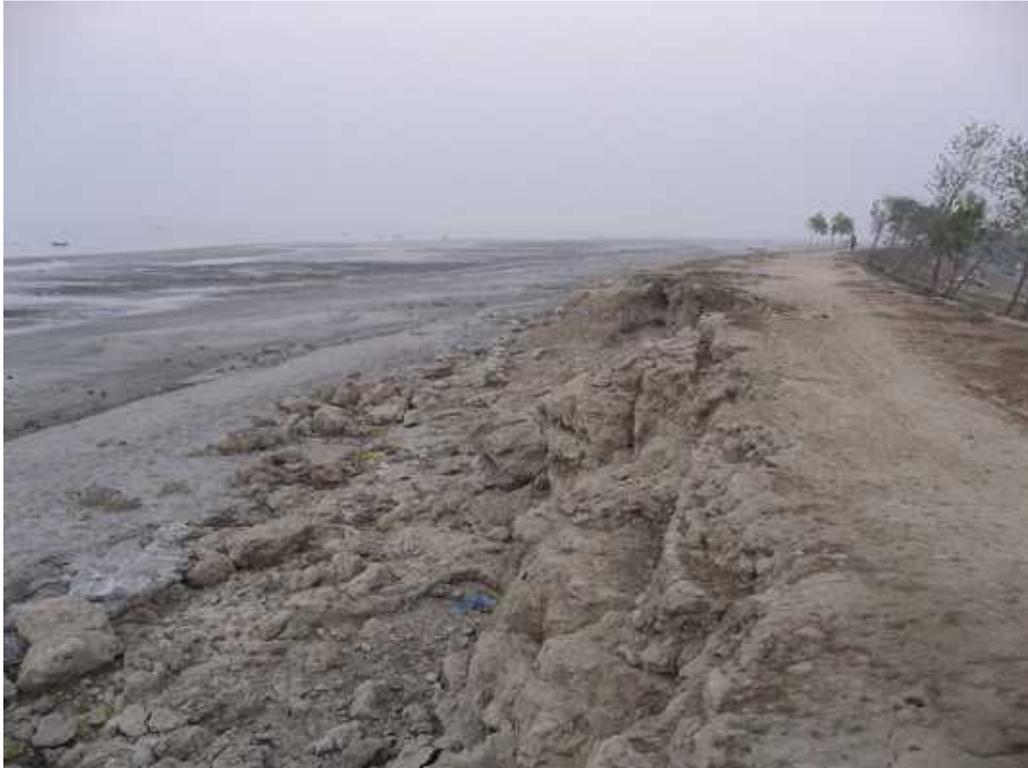
Fig. 4.2 Embankment at West Kuakata (Looking westward on the embankment. Seaside is on the left.)

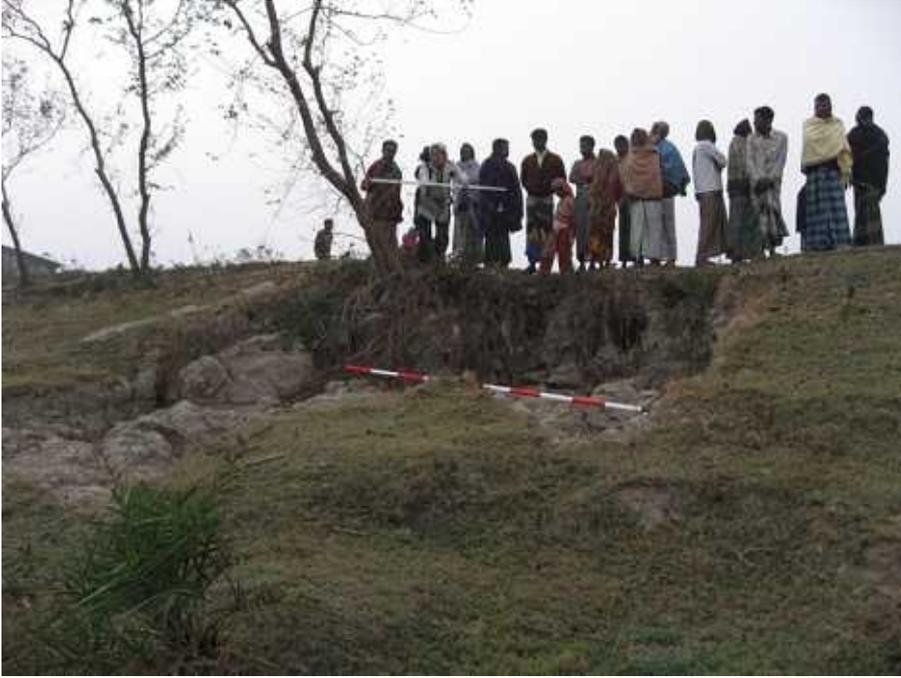
Fig. 4.3 Water mark found on a tree on the embankment along the coast of West Kuakata

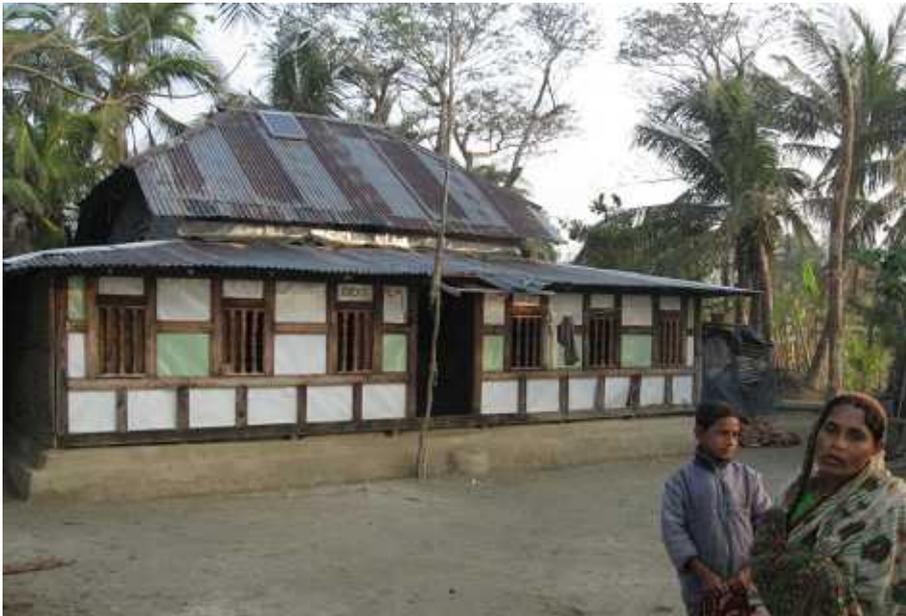
Fig. 4.4 Fisherman's house placed just behind the embankment of West Kuakata

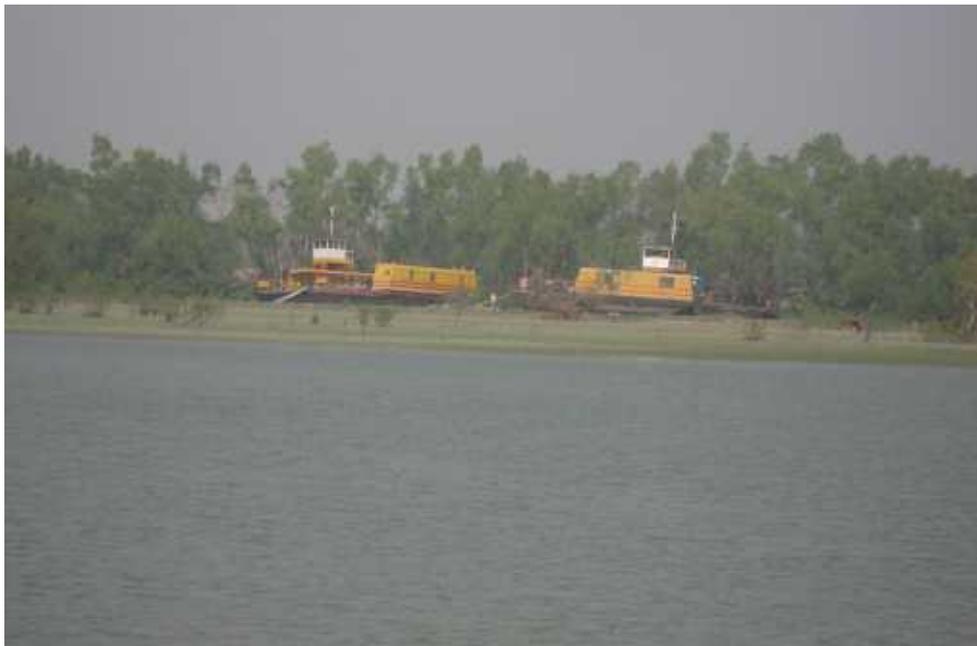
Fig. 4.6 Two ferried washed on the north bank of Hajipur

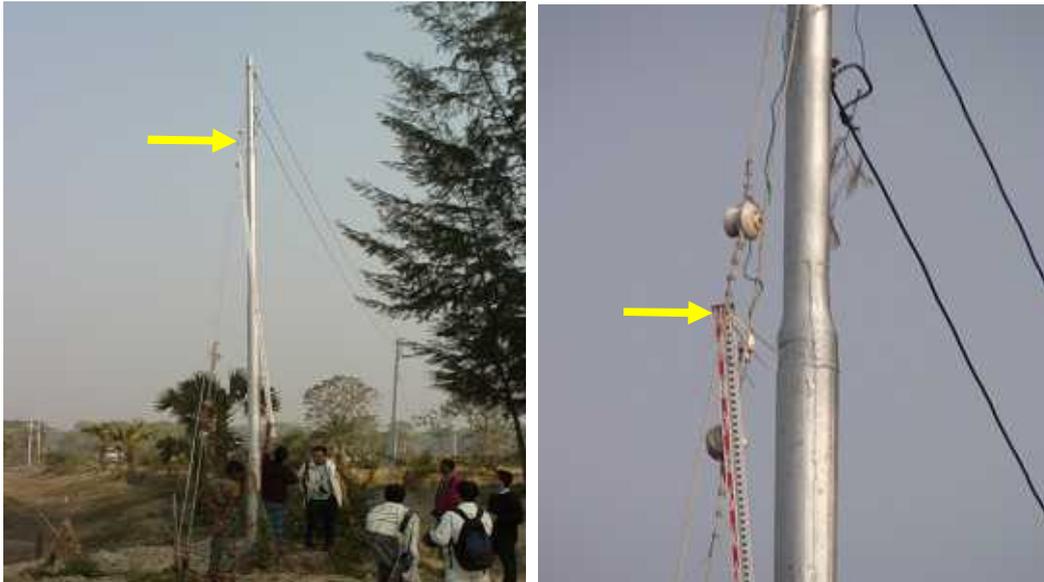
In the south end of Kuakata coast, we found two water marks. One is straw entwined on wire to support a steel tower which was about 140m away from the shoreline (Fig. 4.7). The other mark was found on the wall of botanical garden which is about 330m away from the shoreline (Fig. 4.8). Although only one straw was found when we measured the inundation heights, a seen in Fig. 4.7, we confirmed that multiple marks of straw and debris were witnessed just after the storm. The reason why inundation height at a steel tower, $h=9.6\text{m}$, is much higher than the other measured inundation

heights may be because the area faces to the sea and thus should have strong influence of stormy waves.

Fig. 4.7 Straw on a wire

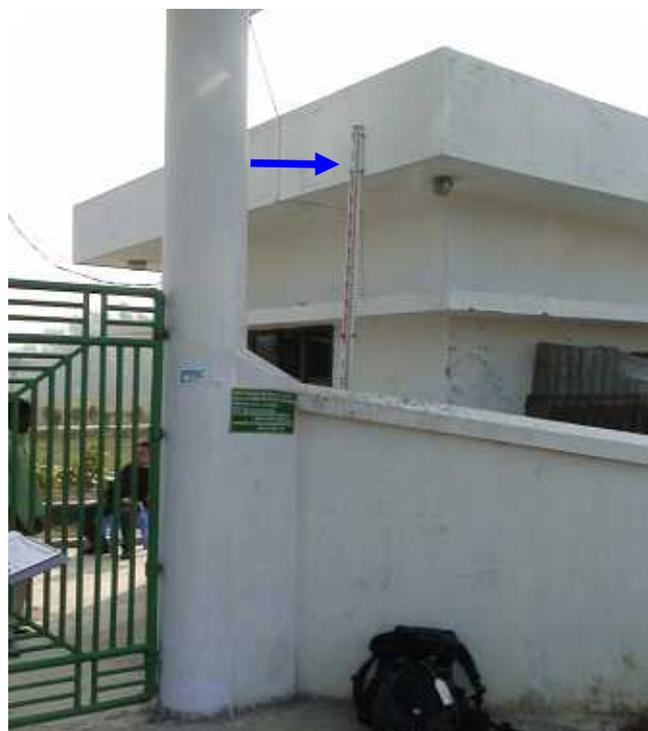
Fig. 4.8 Water mark on the wall of botanical garden

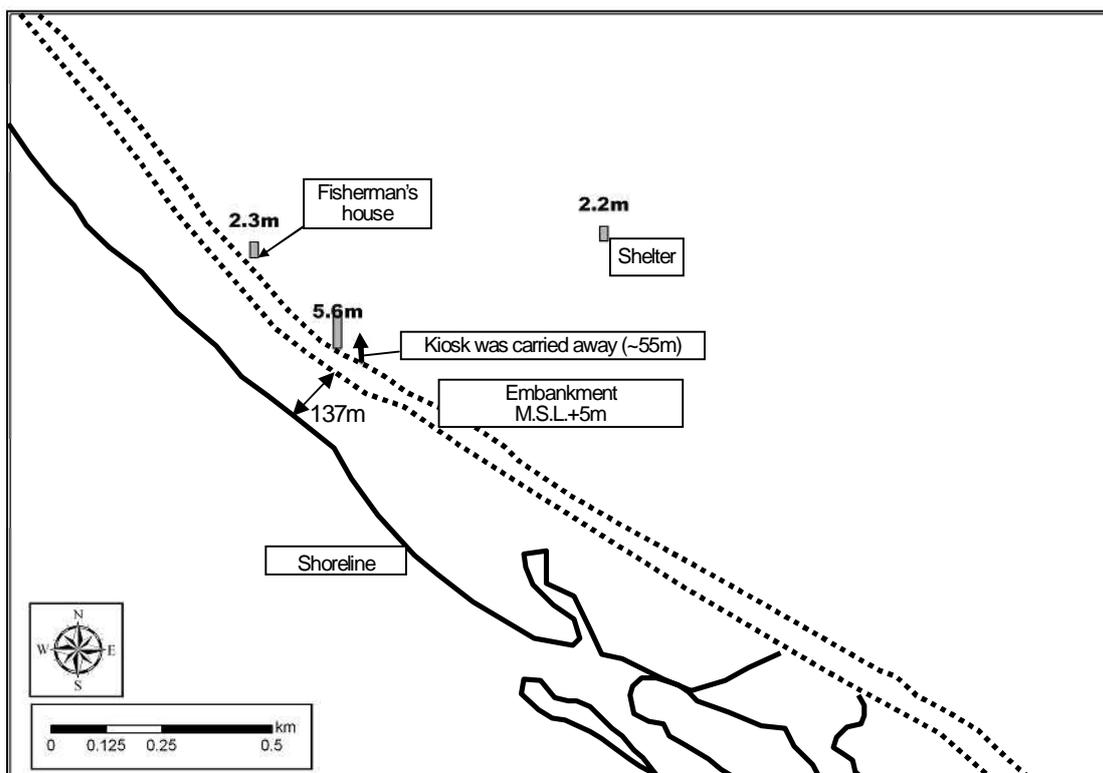
Fig. 4.9 shows overview of West Kuakata. Characteristics features observed in West Kuakata are as follows:

- Many houses, built on the seaside of the embankment before the storm, were all washed away.
- Backside slope of the embankment is 3:10. Several scours were observed behind the crest of embankment.

- Inundation depth around the shelter was about 1m.
- The shelter was built beside school since the school provided the land for the shelter.

Fig. 4.9 Overview of observed features in West Kuakata

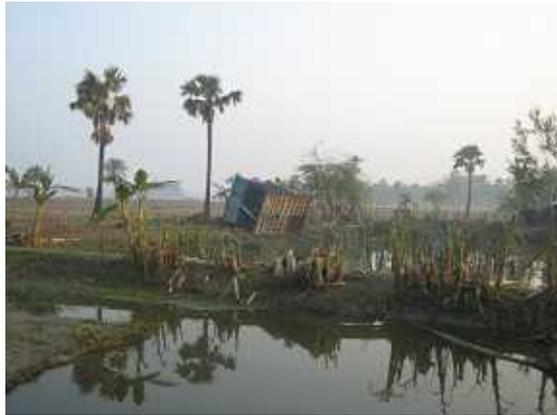
Fig.4.10 Kiosk placed on the embankment in West Kuakata was washed and reached 55m behind the embankment

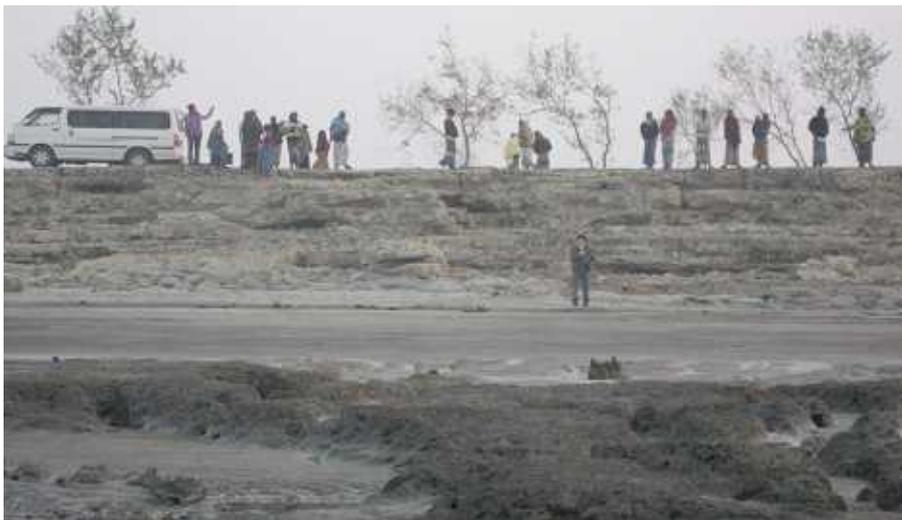
Fig. 4.11 Front side of the embankment in West Kuakata

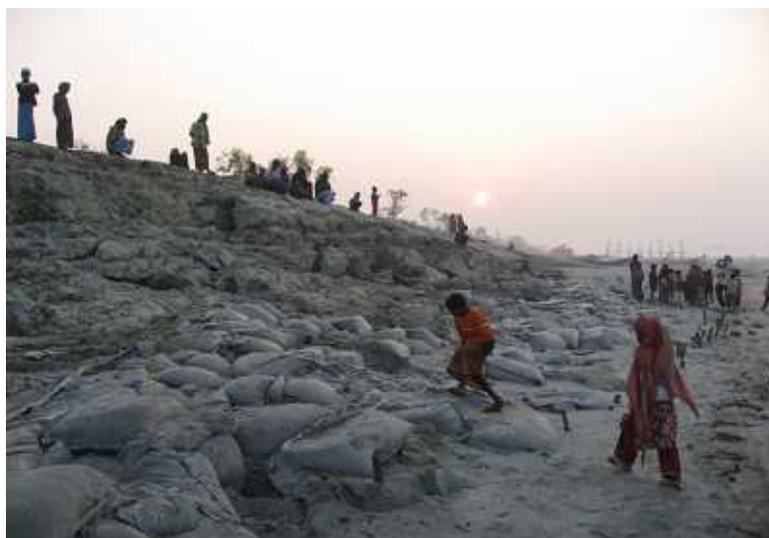
Fig. 4.12 Front side of the embankment with sandbags in West Kuakata

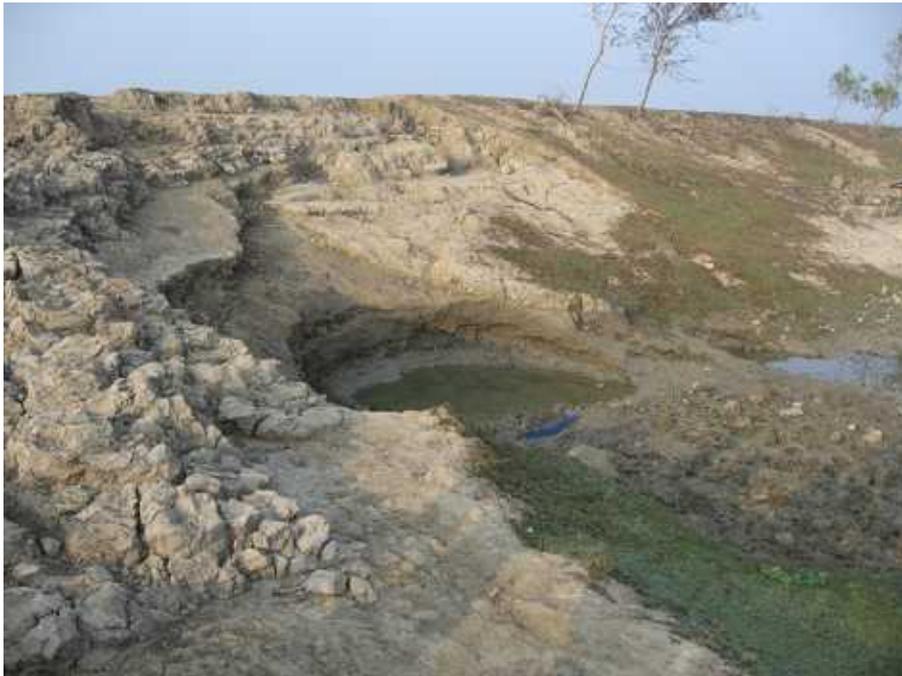
Fig. 4.13 Scour behind the crest of embankment in West Kuakata

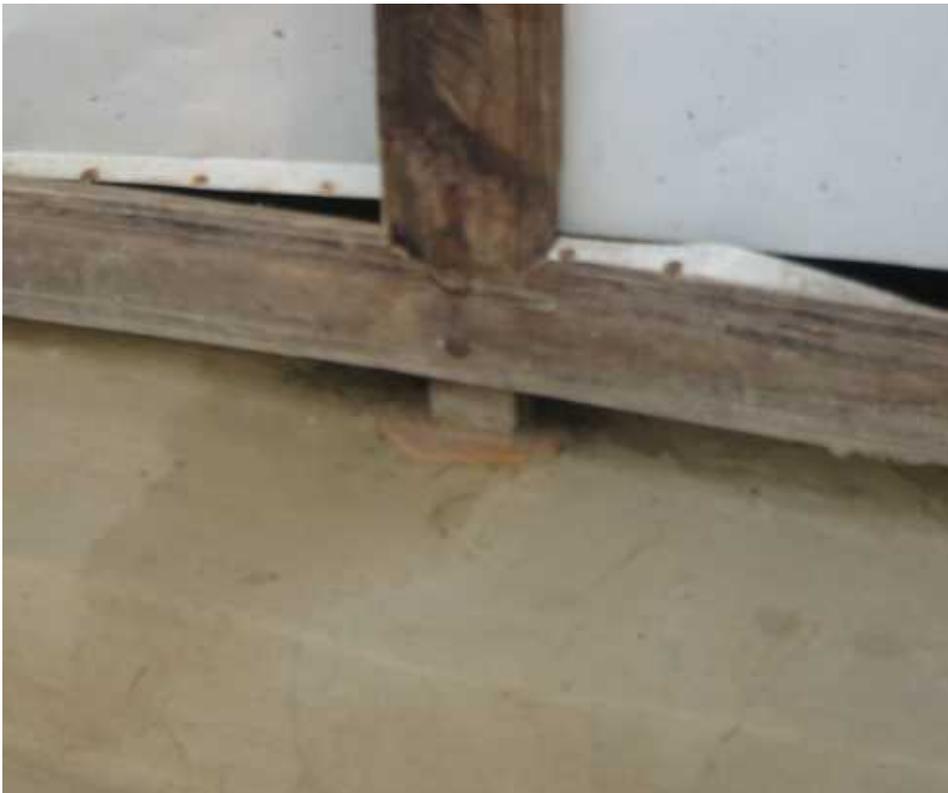
- Inundation depth at fisherman's house just behind the embankment was 72cm. This house was not settled on the foundation and was washed around 1m without suffering structural damages (Figure4.14).

Fig. 4.14 Foundation of the fisherman's house

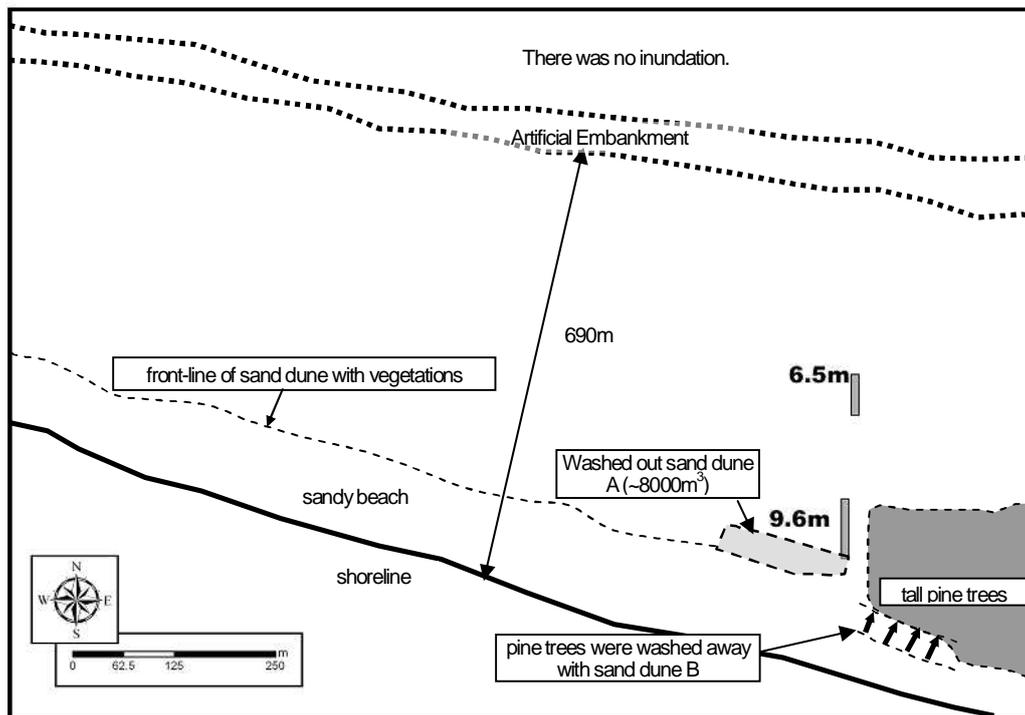
Finally, characteristic features observed in Kuakata are outlined as follows. Fig. 4.15 overviews observed features in Kuakata.

Fig. 4.15 Overview of observed damages around Kuakata

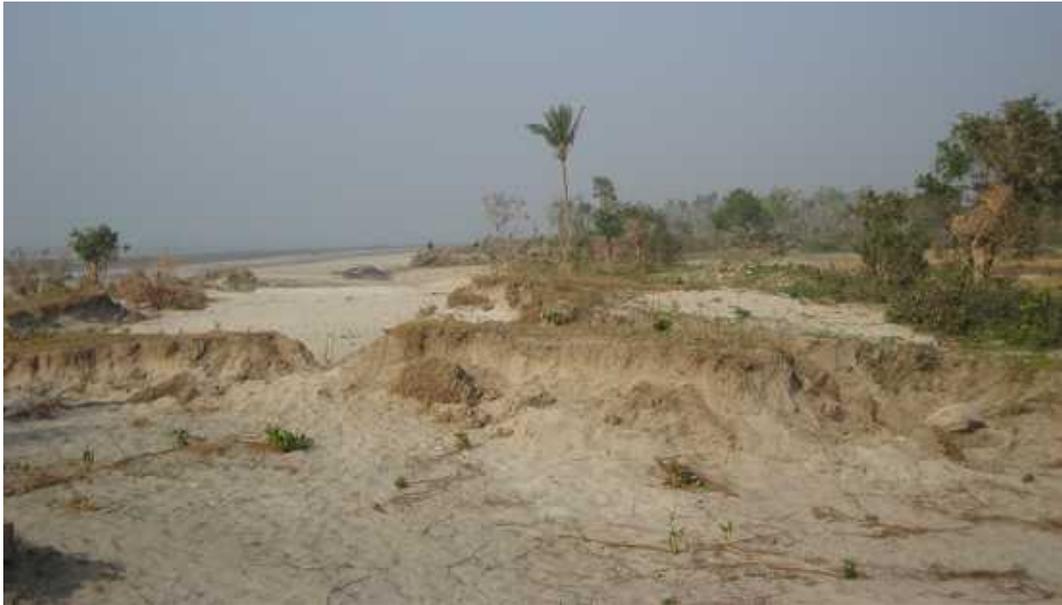
Fig. 4.16 There used to be sand dune (A) which were washed away due to the storm

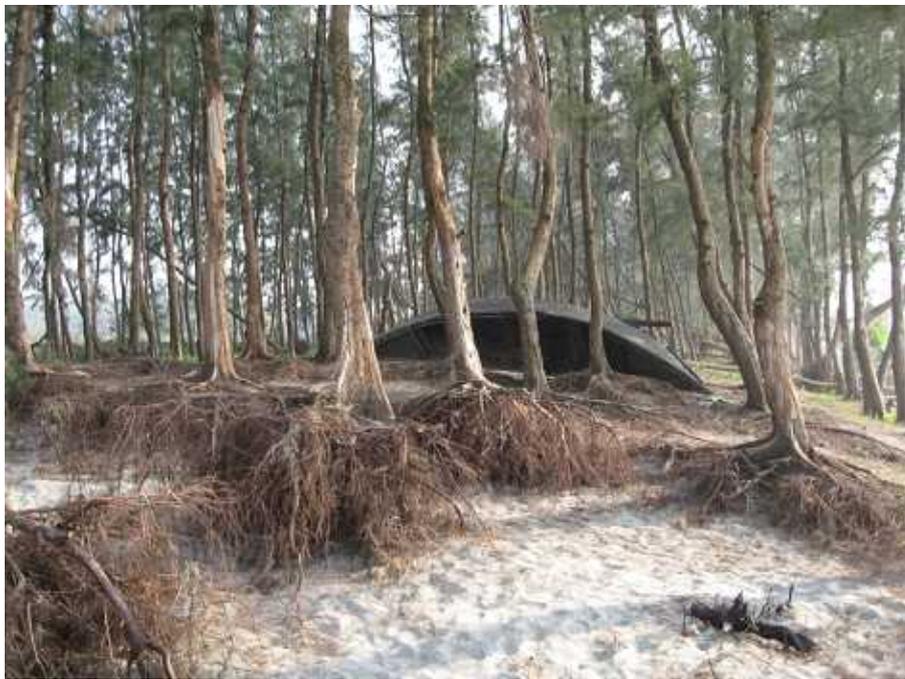
Fig. 4.17 Pine trees near dune (A). Sand bed was eroded for 50cm around the roots.

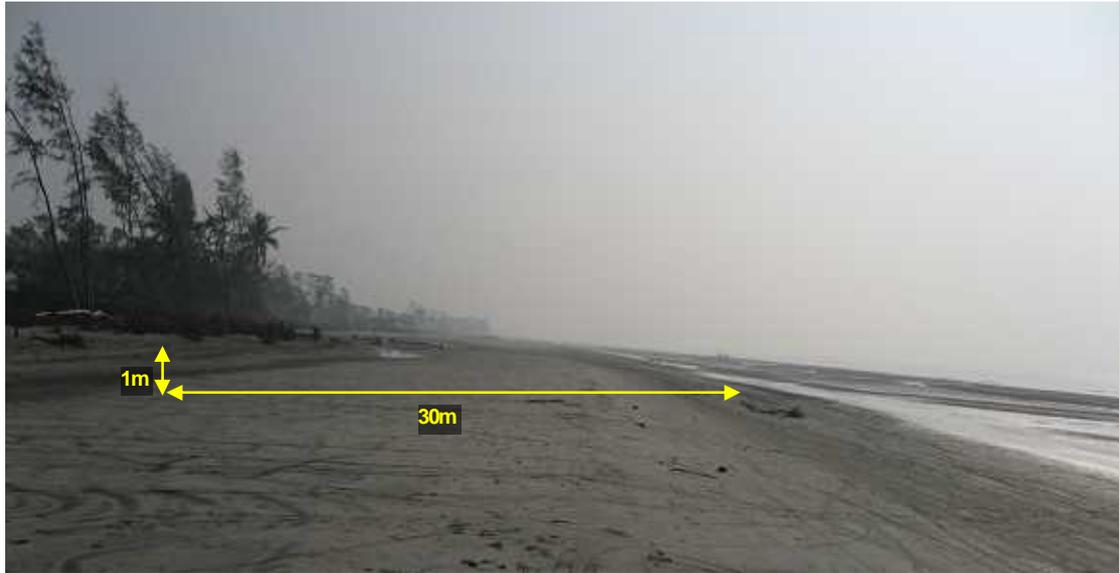
Fig. 4.18 Beach that used to be covered by sand dune (B) with pine trees.
