**Investigation Report on the Storm Surge Disaster
by Cyclone SIDR in 2007, Bangladesh**

June 2008

Investigation Team of Japan Society of Civil Engineering

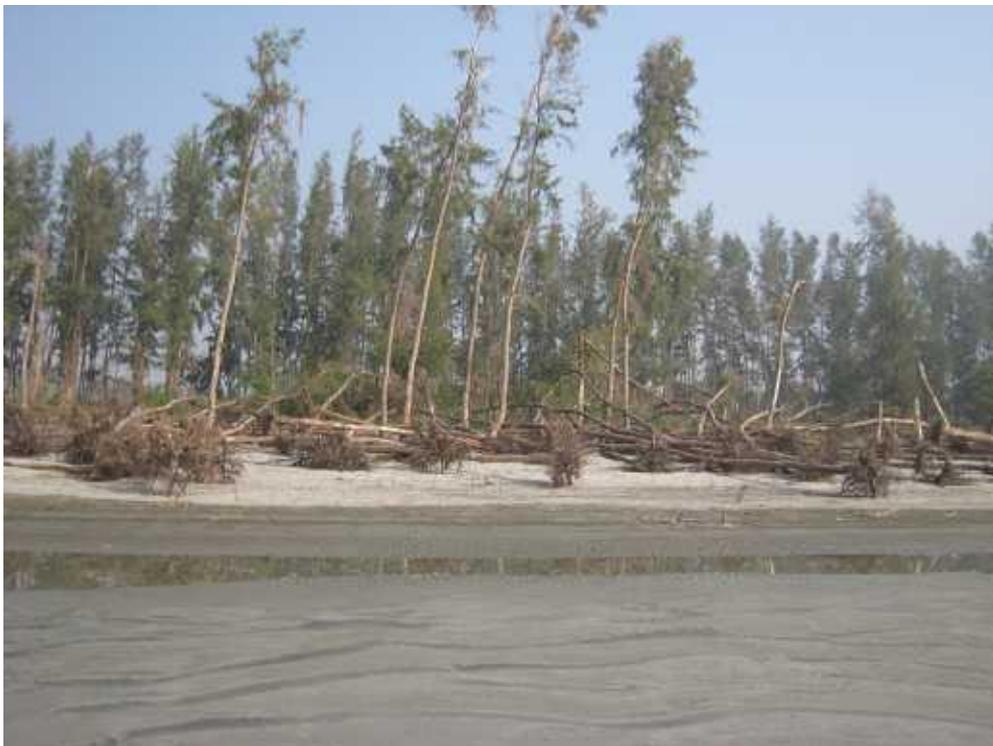
Fig. 4.19 Washed pine trees at dune (B)

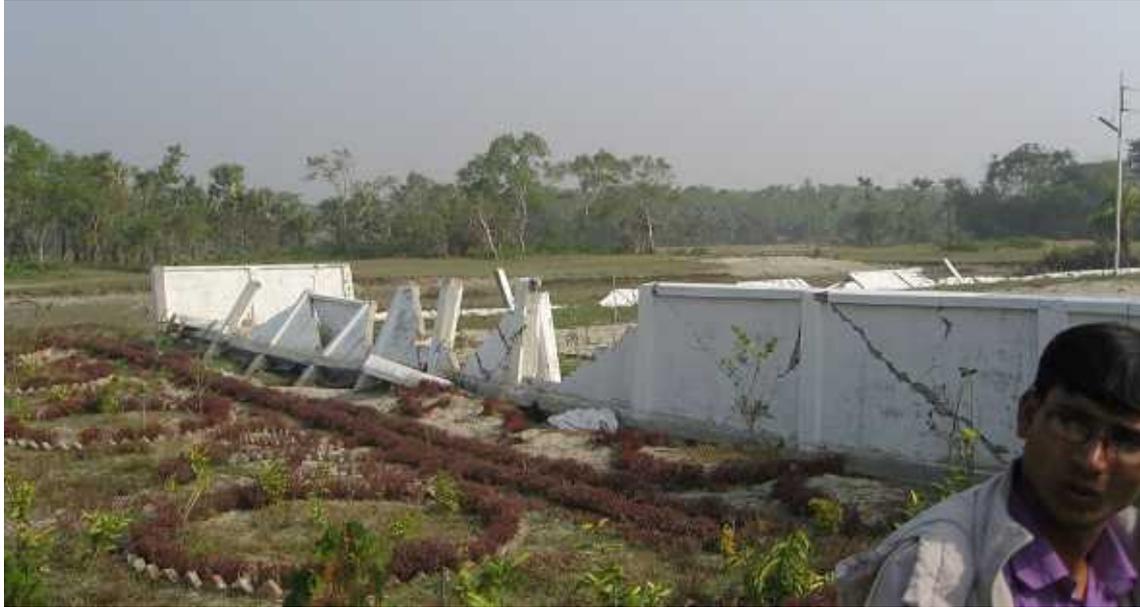
- All the walls around the botanical garden parallel to the shoreline were collapsed while some walls perpendicular to the shoreline survived (Fig. 4.20).

Fig. 4.20 Concrete walls around the botanical garden. Walls parallel to shoreline were all collapsed while some walls perpendicular to the shoreline survived.

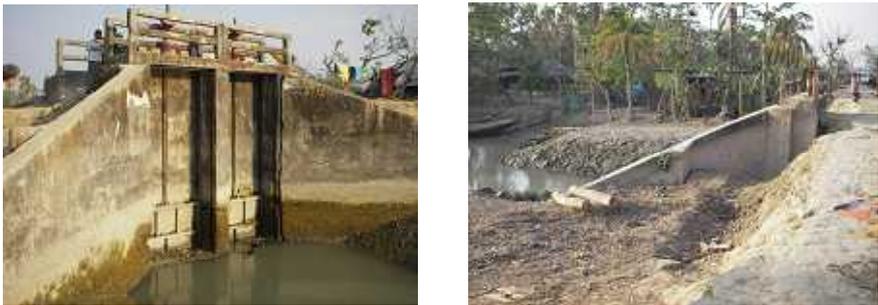
Fig. 1-2-3 Damaged Gate cum Bridge

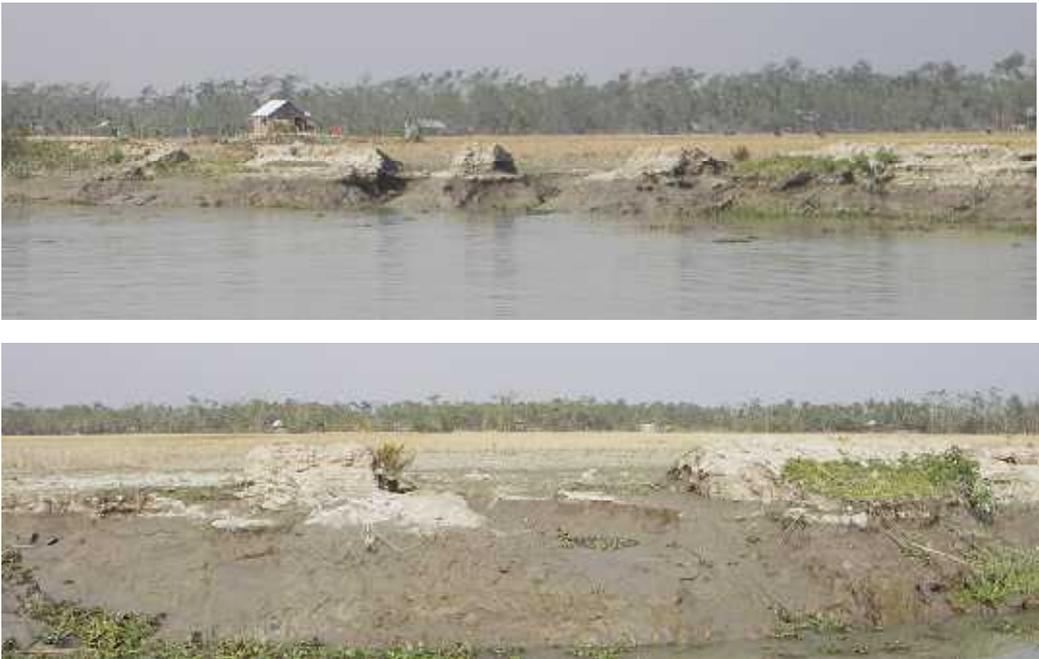
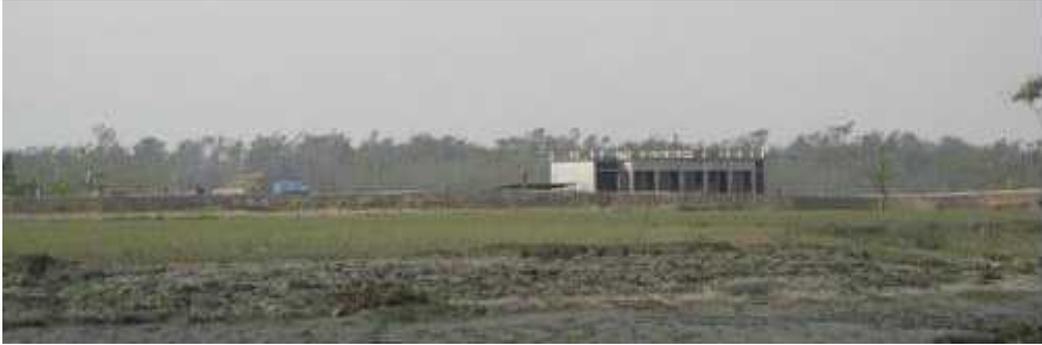
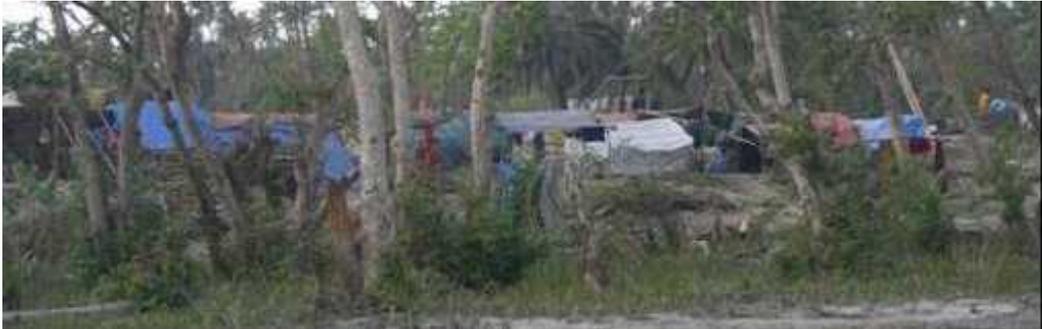
Fig. 1-2-4 Condition of Right Bank in Baleswar River, Dakshinkhali Union

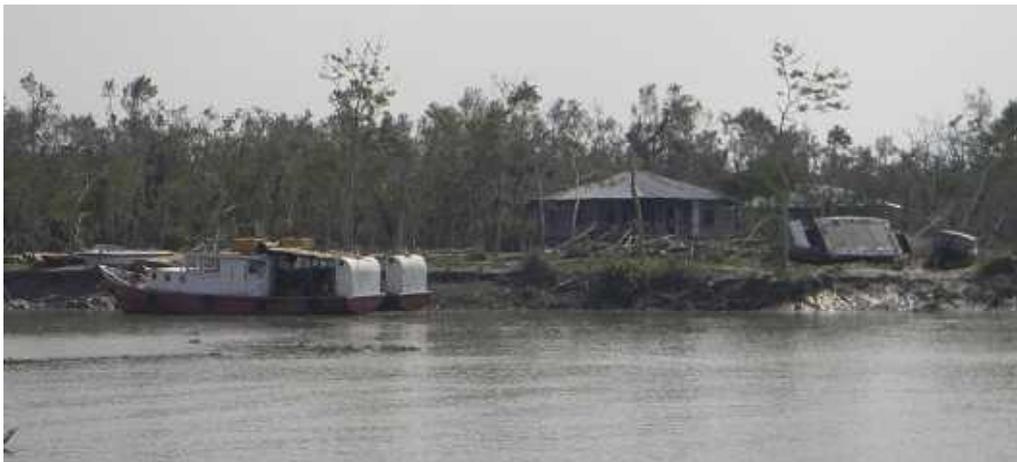
Figure 1-2-5 shows the state of mangrove protection area of Sundarban. Facilities for forest management can be seen, which were comparatively little damaged. The storm surge caused high tree overturns or branch breakages in the mangrove forest.

Fig. 1-2-5 Sundarban Mangrove Forest

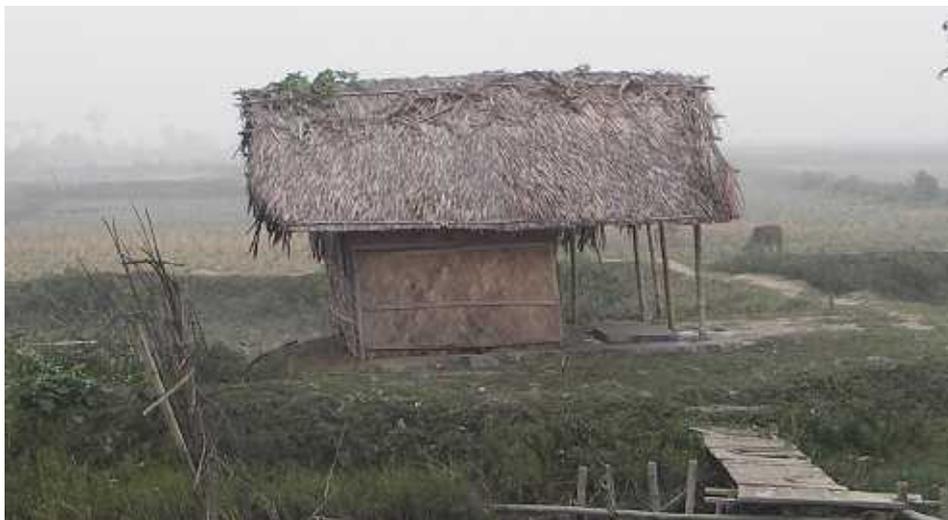
Fig. 1-2-8 Typical classic house made of floating local materials

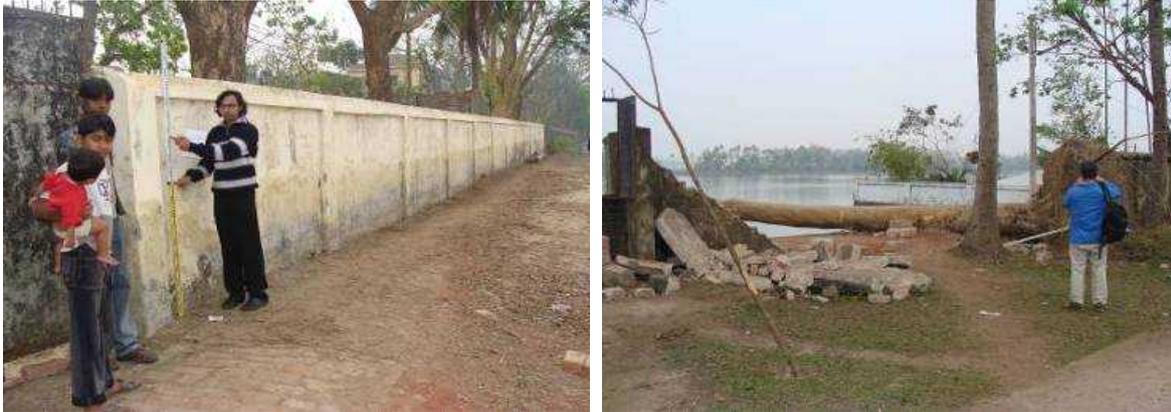
Fig. 1-3-1 Flood mark at BWDB local office at Pirojpur

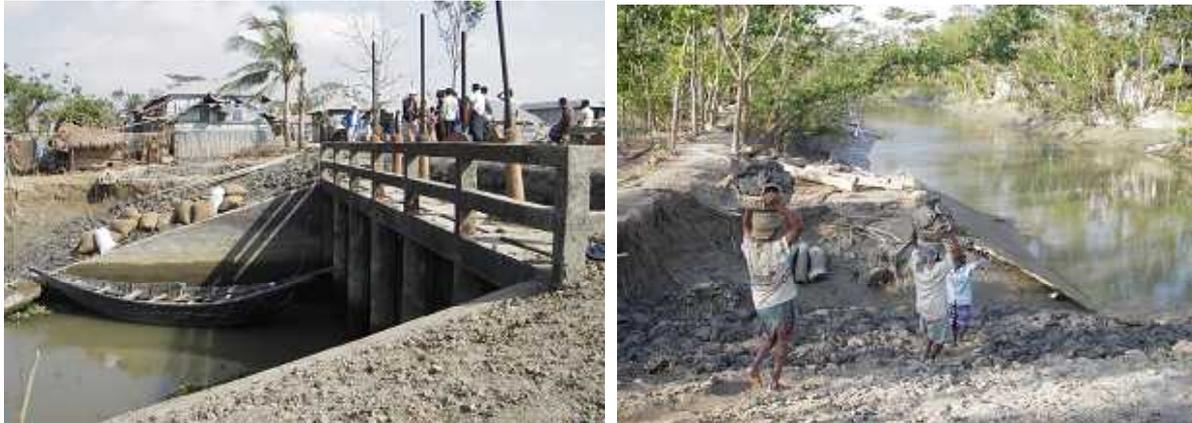
Fig. 1-3-3A Bridge damaged by the storm surge and the Rehabilitation work

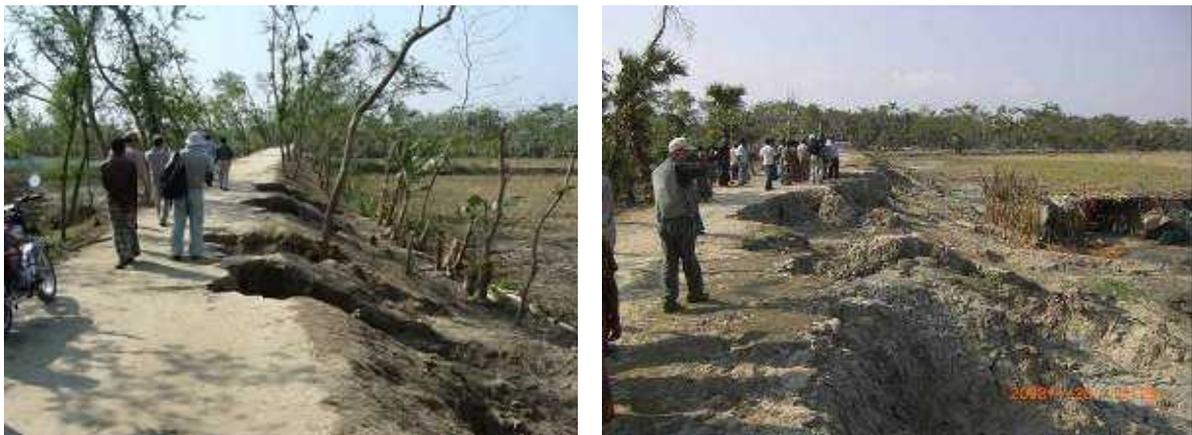
Survey around the river and coastal embankments along the Baleswar River was carried out at Sapleza Union near the most southern border of Pirojpur. This area is enclosed with the sea bank along the left riverside of Baleswar River in the west, and with the inner banks along the channel-nets spreading in the south and the east. These embankments are constructed in the age of 1960 for purposes of prevention against seawater inundation raised by a normal tide without cyclone storm surge, and of prevention against salt damage in rice crops.

Fig. 1-3-4 Inner banks damaged by the storm surge at Sapleza, Mathbaria

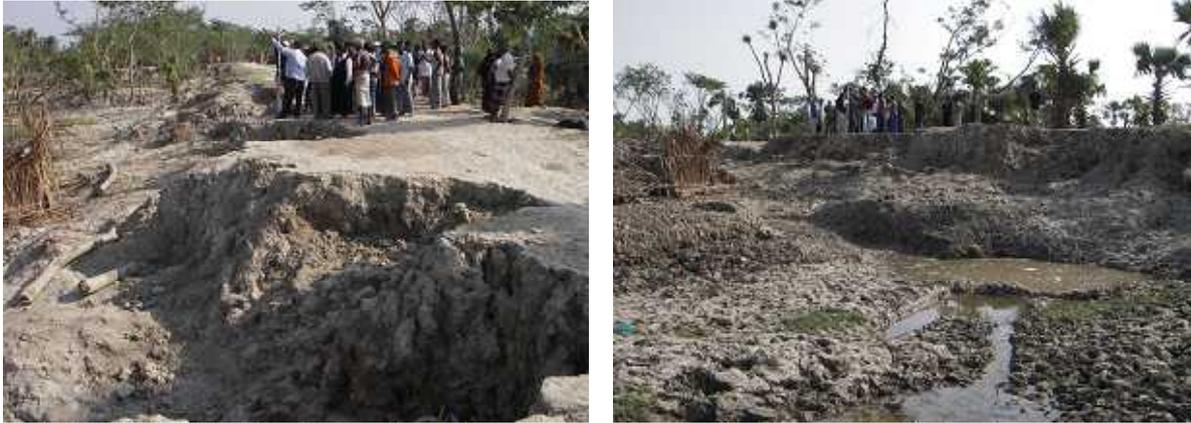
Fig. 1-3-5 Outer sea banks damaged by the storm surge

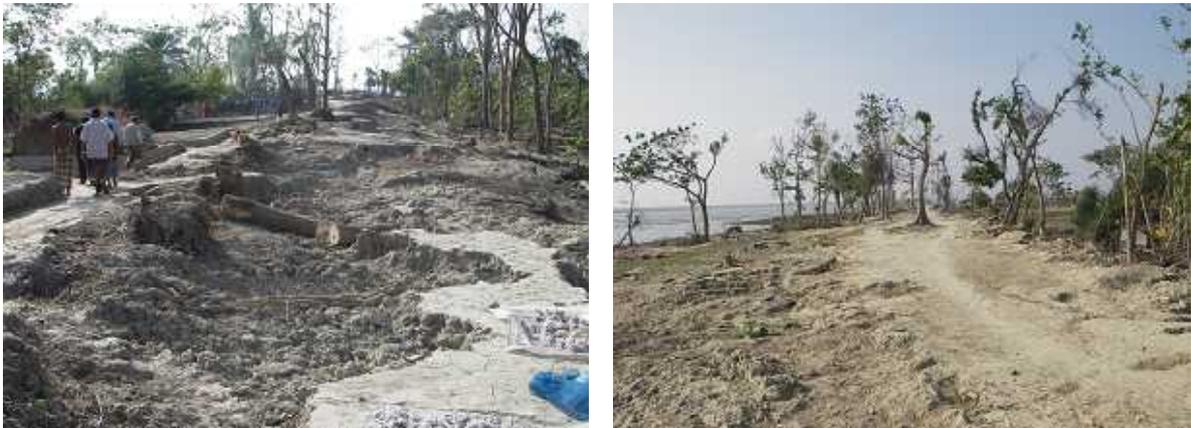
Fig. 1-3-6 Bank Slope being tampered for encroachment by landless people

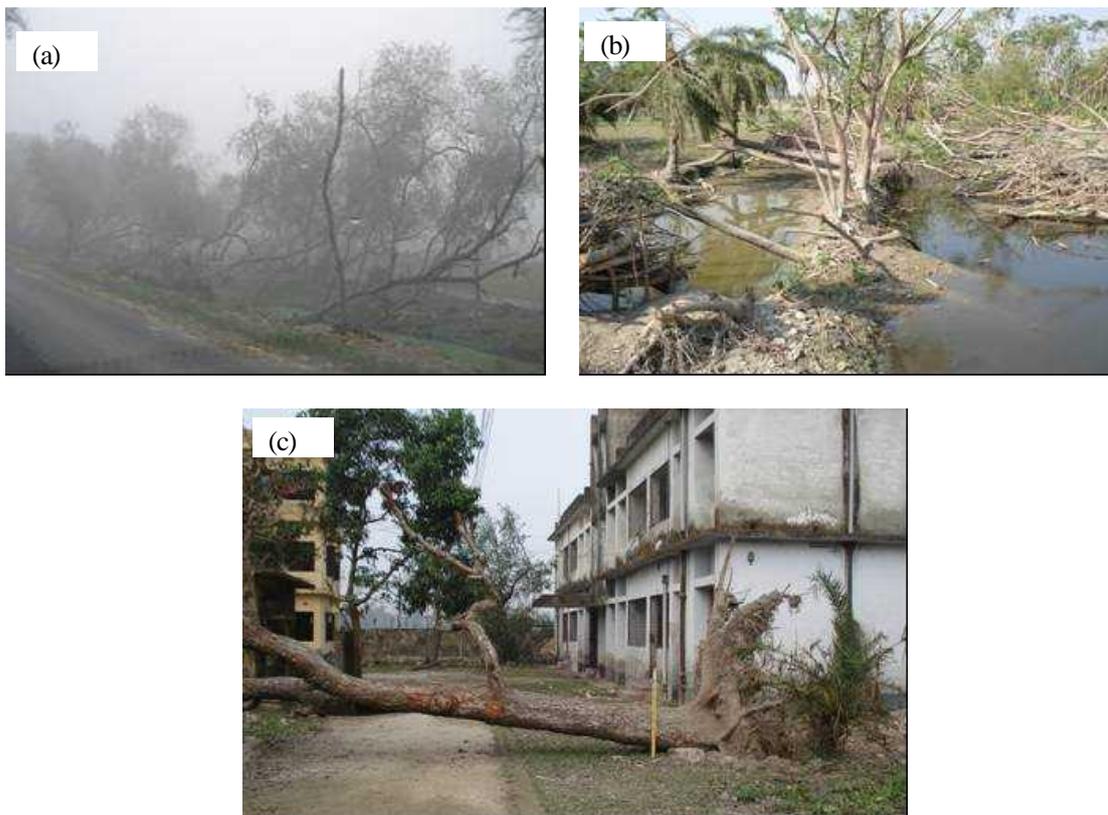
Figure 3-1-1 Situation of the tree damages, (a) at the bank of the road, (b) at the bank of the paddy field, (c) high tree overturned

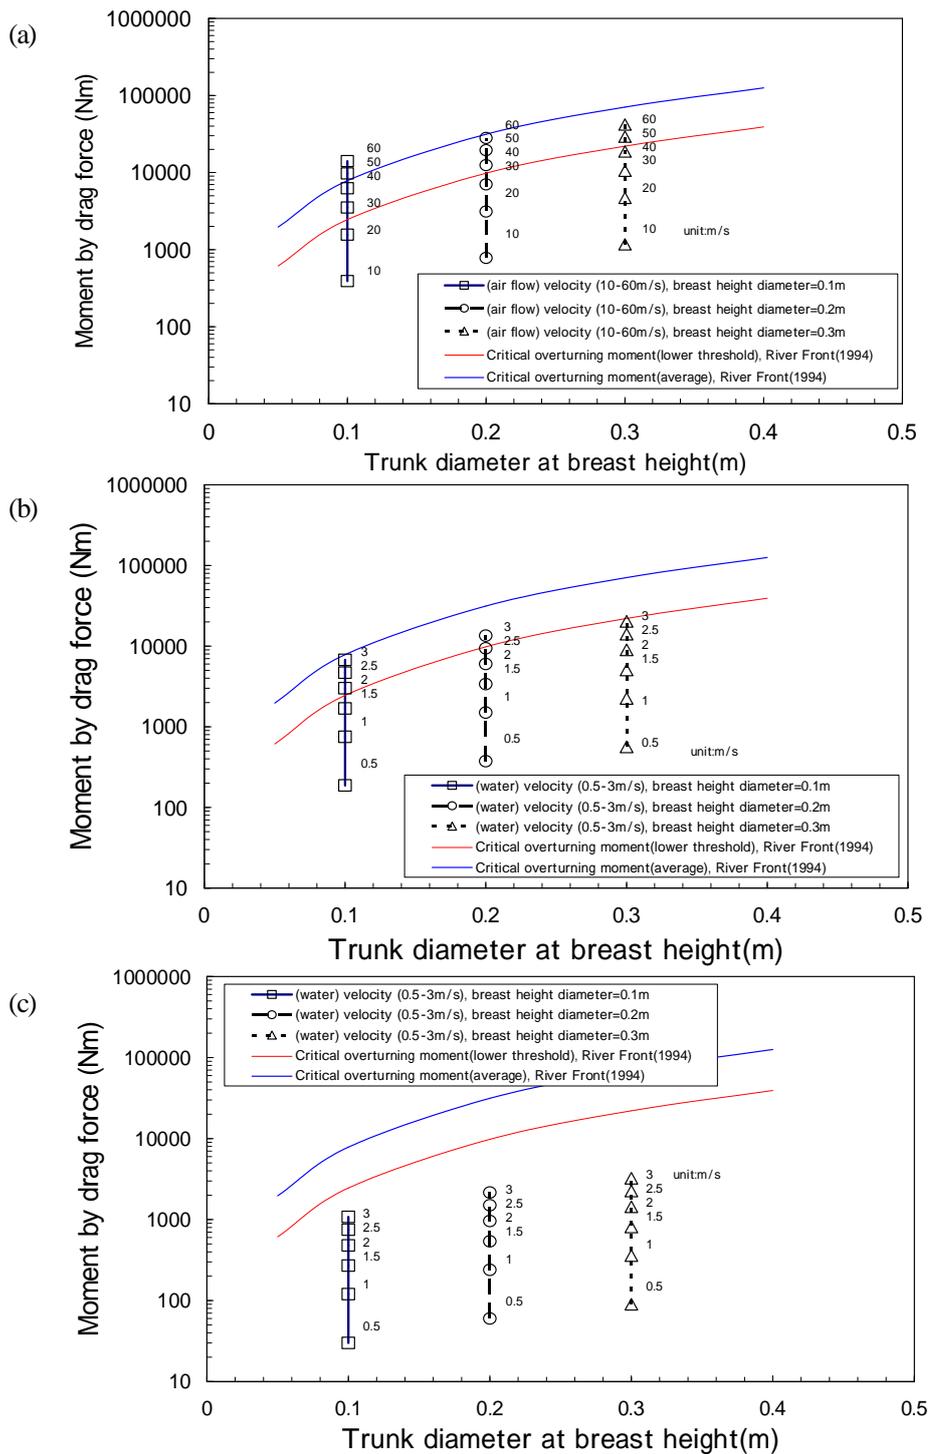
Figure 3-1-2 Evaluation of the moment by drag force acting on a tree, (a)wind (velocity = 10-60 m/s), (b) water flow (velocity = 0.5-3.0 m/s, water depth=5m), (c) water flow (velocity = 0.5-3.0 m/s, water depth=2m), Red and blue line show the lower limit and average line for overturning trees that derived by the tree pulling test in river floodplains (Technology Research Center for Riverfront Development (TRCRD), 1994).

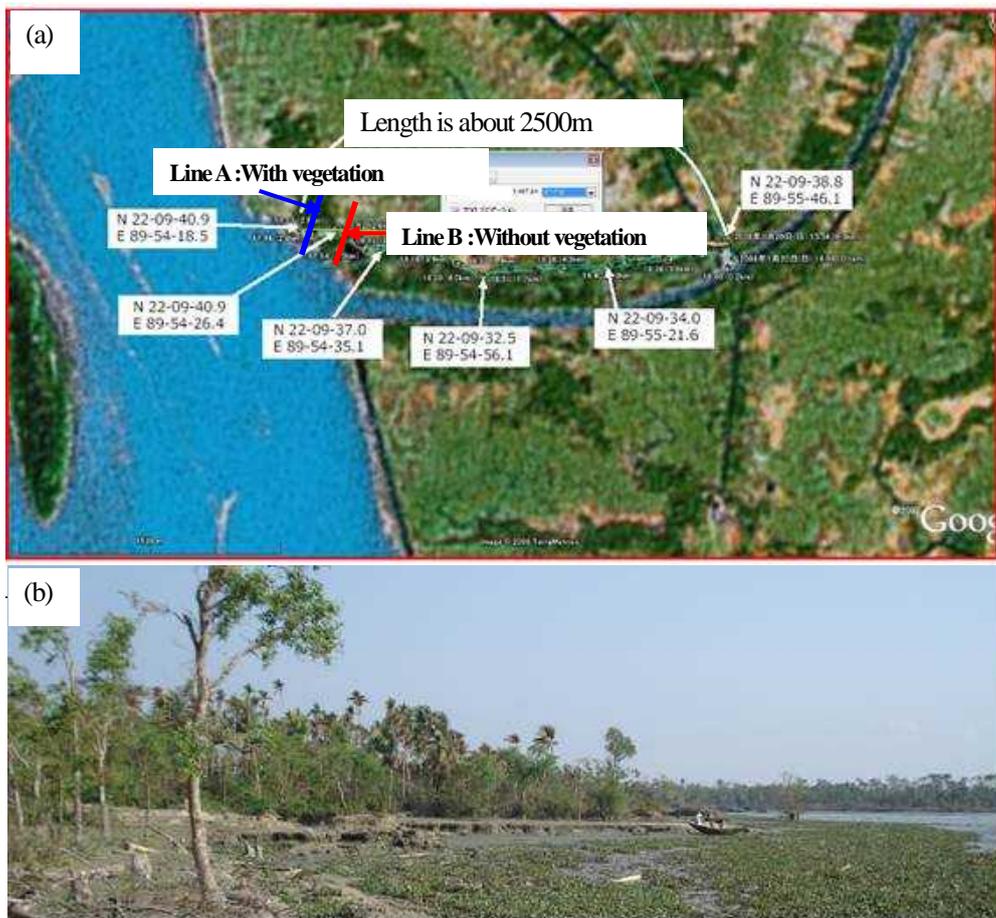
Figure 3-1-3 Representative site that coastal vegetation assume to affect the inundation water depth of the storm surge , (a)Plan view (modified from Google Earth, line A is with vegetation and line B is without vegetation), (b)Photo of the coastal vegetation in line A

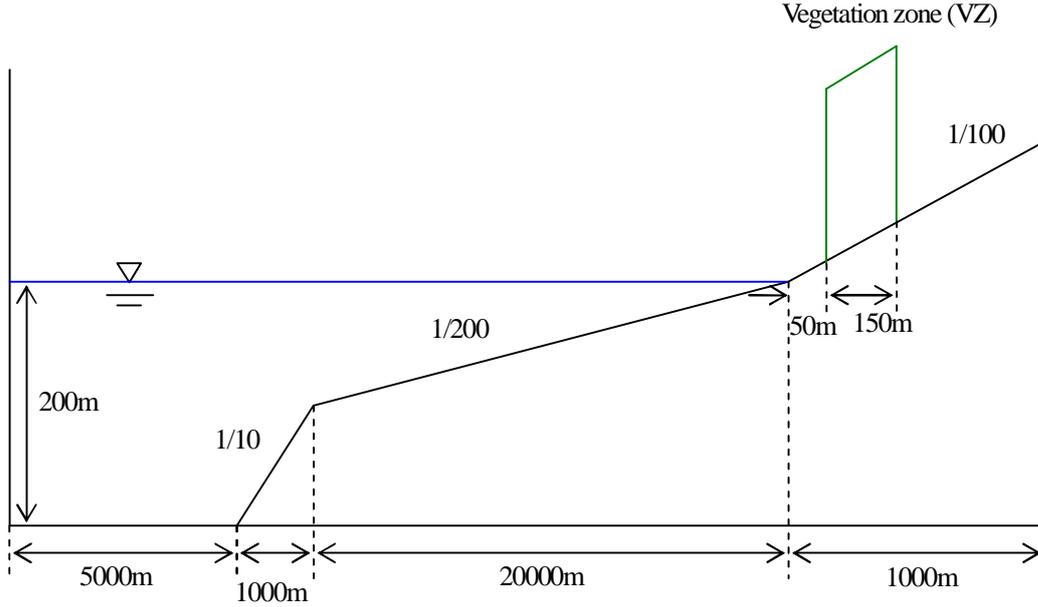
Figure 3-2-1 Geological and vegetation condition for numerical simulation

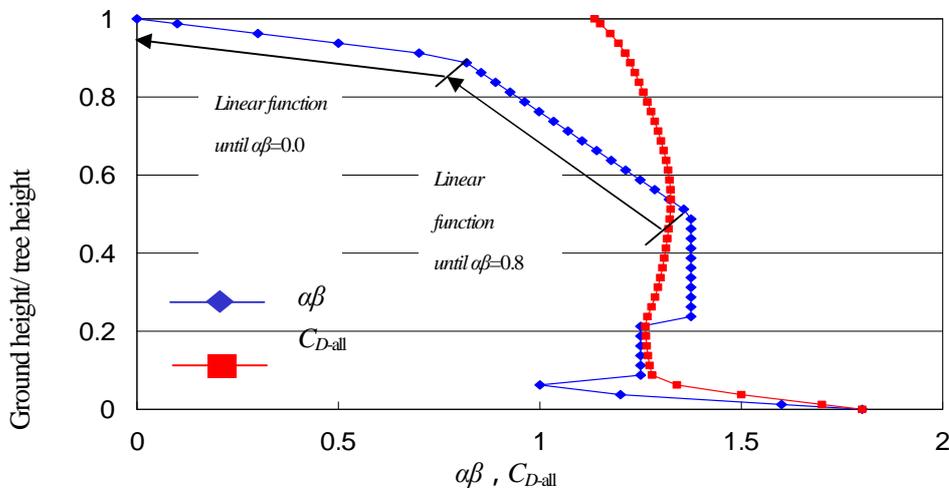
Figure 3-2-2 Vertical distribution of drag characteristics (modified from Tanaka et al. (2007))

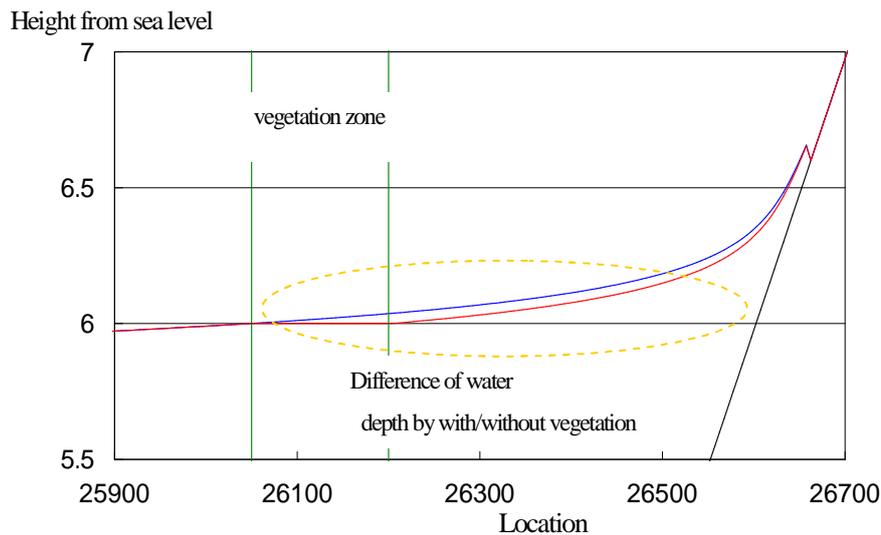
Figure 3-2-3 Simulated results of the vegetation effect to prevent the average increment of the water level by the wind, (— blue line=without vegetation, — red line=with vegetation)

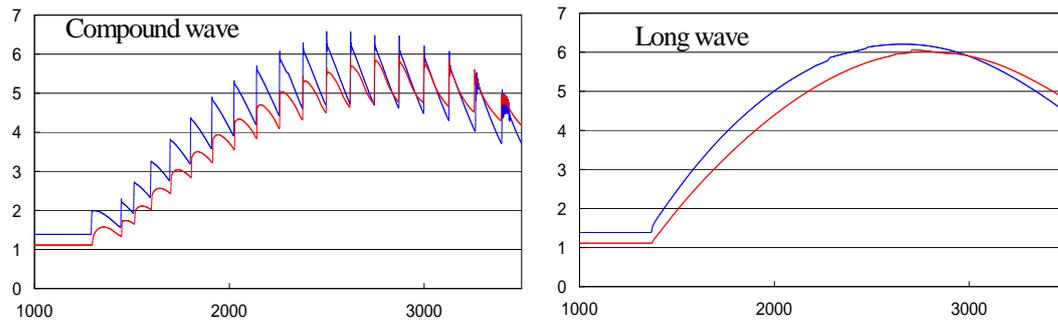
Figure 3-2-4 Simulated time series of water depth behind vegetation zone that show the vegetation effect to decrease the water depth in CASE7 (Long wave condition is the same with CASE6. Short wave condition is the same with CASE5 (wave period =2 minutes, wave height =1.0 m at upstream B.C., Land slope is changed to 1/250, blue line=without vegetation, red line=with vegetation)

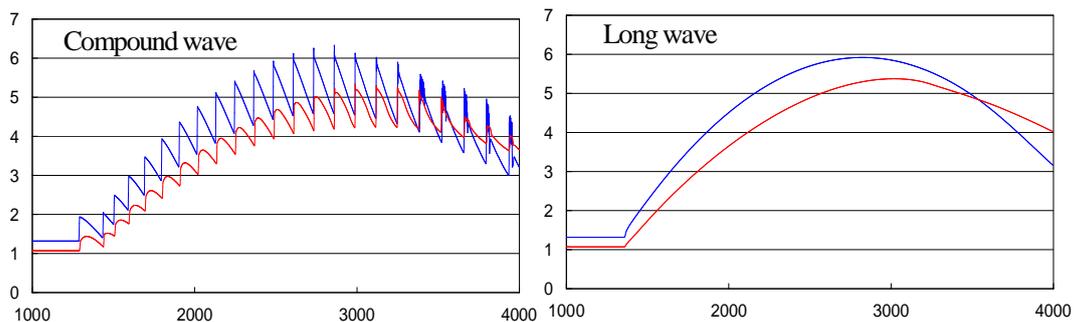
Figure 3-2-5 Simulated time series of water depth behind vegetation zone that show the vegetation effect to decrease the water depth in CASE8 (Land slope is changed to 1/500, other condition is the same with CASE7, blue line=without vegetation, red line=with vegetation)
