6. TSUNAMI

6.1 POST TSUNAMI SURVEY

6.3 ESTIMATED WAVE HEIGHTS AND DIRECTION OF TSUNAMI SURGE AT LA PUNTA

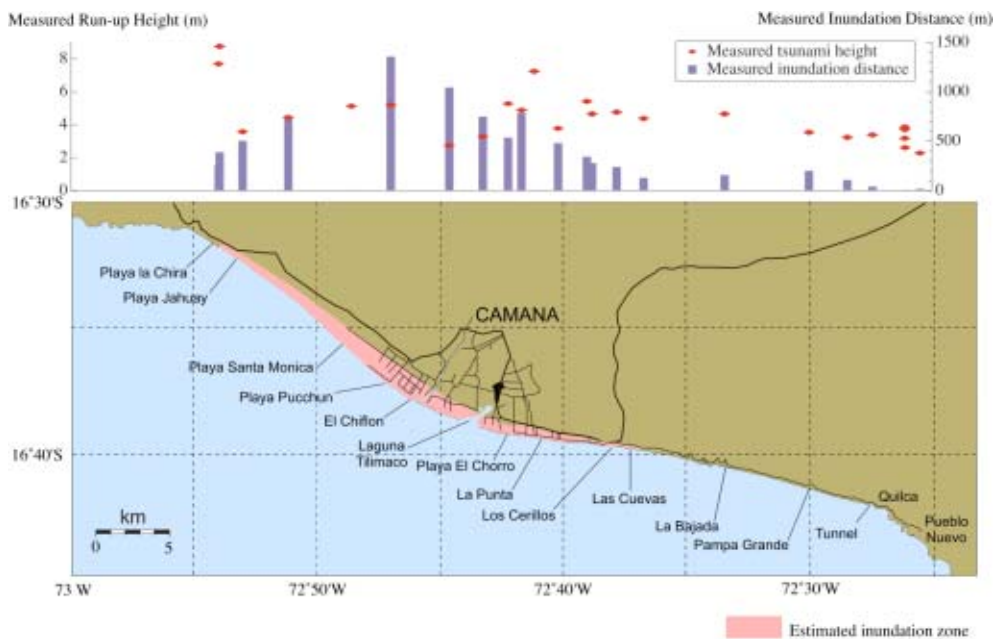
Figure 6.4 Measured run-up height and extent of inundation at Camana

Figure 6.4 indicates the distribution of tsunami run-up height and extent of inundation at Camana measured by the ITST. According to the eyewitness accounts, the tsunami arrived at Camana with strong leading depression followed by a series of positive waves. It was reported that four waves struck the coast of Camana and the second or third one was the largest. The average value of run-up heights was approximately 5 m. The sandy beach at Camana is very flat so that the tsunami could easily cause substantial inland penetration, typically 200 to 700 m and reached over 1 km at one location.

La Punta (see **Figure 6.4** for the location) was likely to be the most significantly affected by the tsunami. **Figure 6.5** is the photo showing the erosion of the beach of La Punta. The Pacific Ocean is at the right behind the road. The tsunami would penetrate through the beach from right to left, then the strong back wash current was occurred to cause the erosion. The maximum measured run-up height at La Punta was more than 7.25 m. **Figure 6.6** is the photo of the hotel building where the maximum run-up in La Punta was measured. The building was standing at approximately 70 m inland from the shoreline. Fortunately, the building withstood the wave force, though it was likely to be struck directly. Ws well as the other destroyed houses, scouring was occurred in front of the building.

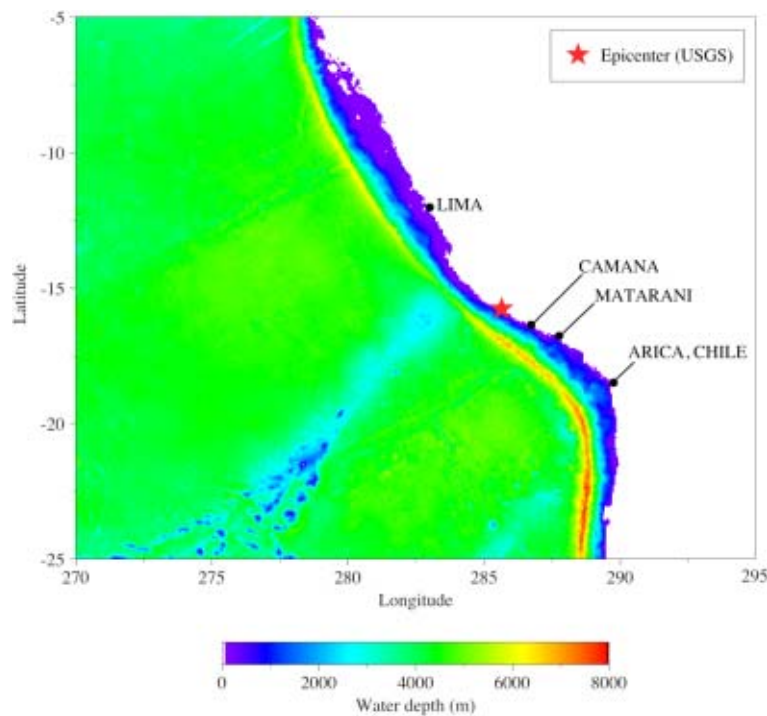
Figure 6.10 Bathymetry of the computational domain.

For the modeling of tsunami propagation, we used the 2 minute digital bathymetry grid published by Smith and Sandwell (1997), available at [http://topex.ucsd.edu/marine_topo/mar_topo.html]. We re-sampled this grid and produced 1 minute grid (approximately 1744 m from west to east and 1845 m from north to south) for the propagation model. **Figure 6.10** shows the bathymetry of the computational domain.

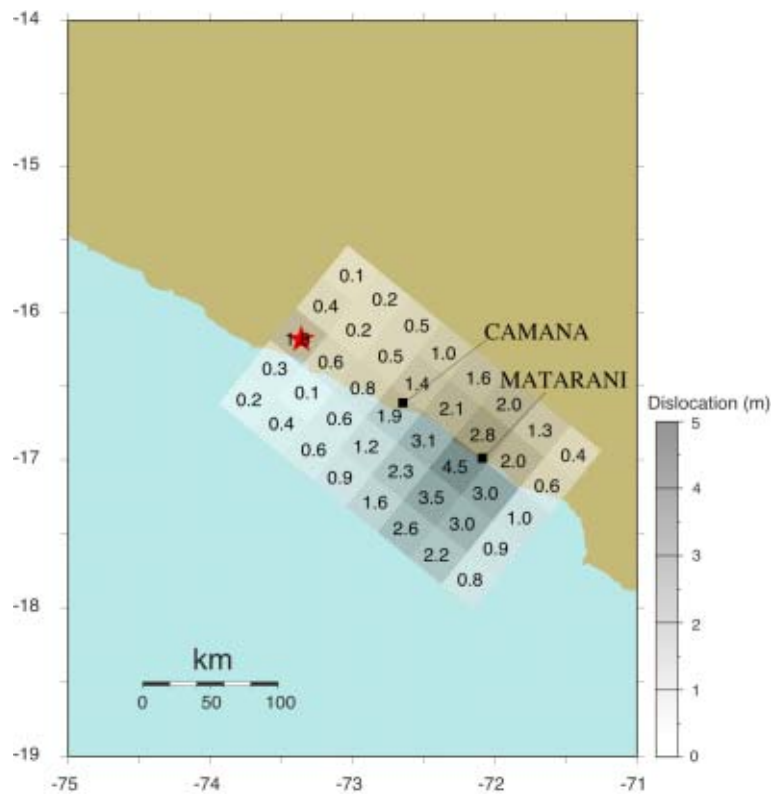
Figure 6.11 Fault slip distribution within the rupture area.

Also, they determined the moment release distribution in detail and slip angles on 40 fault segments within the rupture area of 150 km by 240 km. **Figure 6.11** shows the fault slip distribution within the rupture area, obtained from the results of Kikuchi and Yamanaka (2001). Each fault segment indicates the area of 30 km by 30 km. Large asperity is concentrated at approximately 150 km south from the initial break point (epicenter). However, because their analysis is based on the teleseismic waves, the estimate of the location of epicenter should be flexible, considering the observation of the local seismic deformations.

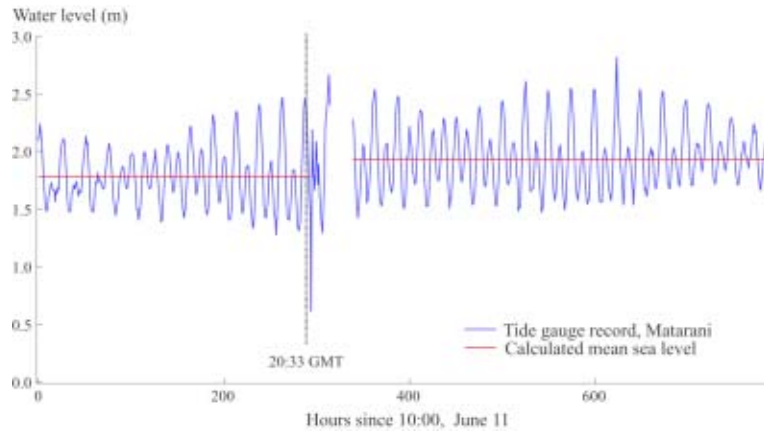
Figure 6.12 Sea level change at Matarani.

Here is a good example of tsunami record indicating the existence of local seismic deformation during the event. **Figure 6.12** shows the 1 hour-averaged tidal record at Matarani (Ortiz et al. 2001) and the mean sea level computed from the data. There is a discrepancy between the mean sea levels before and after the earthquake. The mean sea level rose approximately 15 cm after the tsunami struck. This sea level change indicates that the local subsidence was occurred during the earthquake.

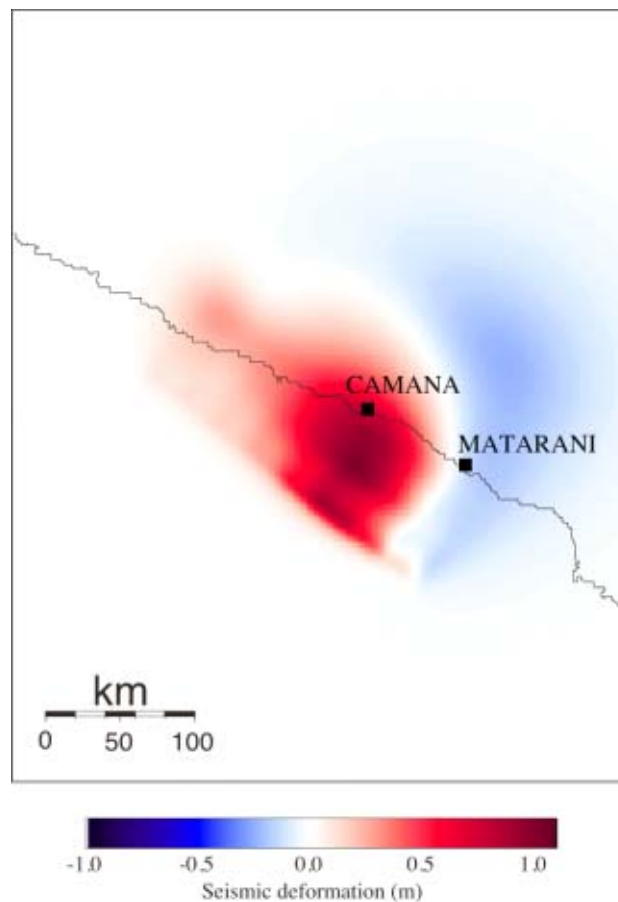
**Figure 6.13** Computed seismic deformation.

In order to be consistent with the observed subsidence at Matarani, we modified the position of the epicenter as 20 km northwest of the estimated epicenter of USGS. **Figure 6.13** is the computed seismic deformation based on the seismic inversion results of Kikuchi and Yamanaka (2001). However, there is still uncertainty on the location of the epicenter. We have not obtained any evidence indicating the co-seismic uplift at Camana.

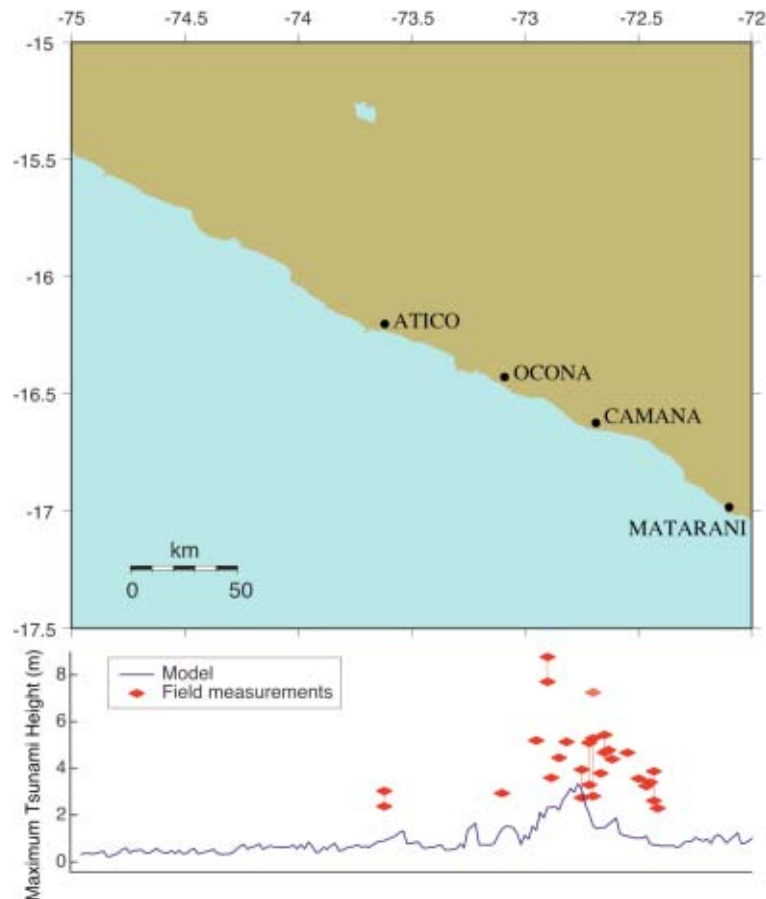
Figure 6.14 The comparison of computed maximum tsunami height with the measurement.

Figure 6.14 indicates the comparison of computed maximum tsunami height and field measurements obtained by the ITST. Note that the computed tsunami height only reflects the offshore maximum water level of 30 m deep along the coast because of lack of the detailed bathymetry / topography data. Thus, the qualitative agreement between these two results in terms of the tsunami height should not be expected. However, the tsunami run-up profiles along the coast obtained from both results have good agreement. Both results indicate that tsunami energy is concentrated to the coast of Camana, which is approximately 50 km wide from west to east.

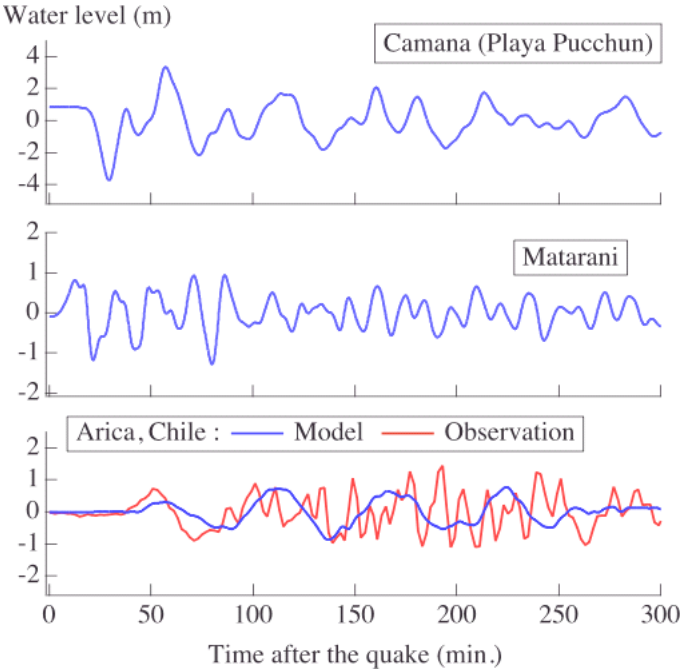
Figure 6.15 Computed and observed tsunami waveforms.

Figure 6.15 shows the computed tsunami waveforms at Camana, Matarani and Arica, Chile. In the diagram of Arica waveform, the model result is compared with the observed tsunami. The zero line of this diagrams is the mean sea level before the tsunami. Because Canama is included in the uplifted region, the initial sea level is estimated to be positive (above the mean sea level) shortly after the earthquake. The positive wave strikes Camana as the first arrival of tsunami. However, it doesn't exceed the amount of uplift of the land. This means that the significant positive wave as the first arrival of tsunami would not be recognized. Then, the water is receded and created negative wave. After that, the largest positive wave strikes the coast of Camana. This feature is consistent with the eyewitness accounts on the coast of Camana. Many of the witnesses described that "The water was receded after the quake and the strongest inundation occurred during the strike of second or third wave". The modeled and observed tsunamis at Arica indicate that the discrepancy exists in terms of the estimation of tsunami arrival time. The accuracy of estimated tsunami arrival time is affected by the estimate of tsunami source location (epicenter). Further discussion including determination of tsunami source location is necessary for the improvement of the model. Also, for more detailed

simulation such as the estimation of strong current and high frequency oscillation within the harbor as shown in the observed tsunami at Arica, more detailed bathymetry and topography data are required.

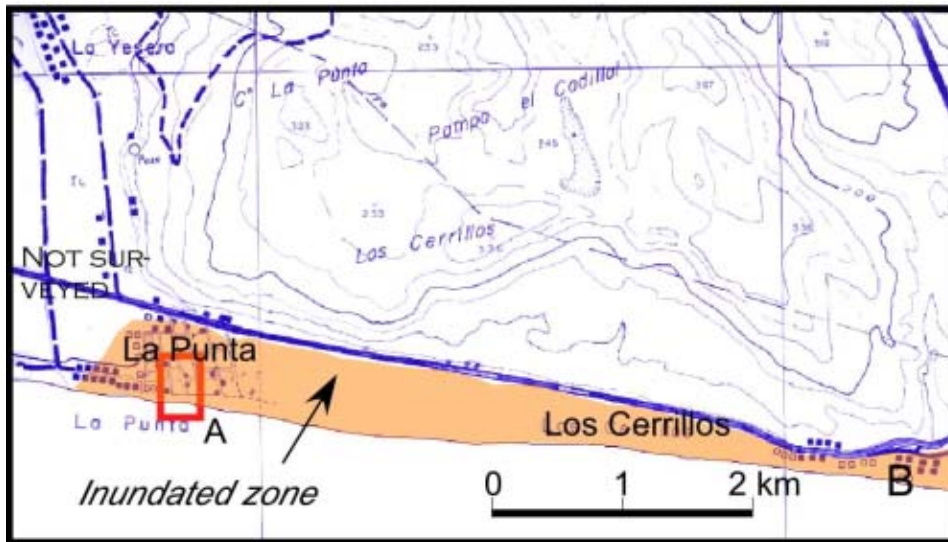
Figure 6.16 Inundated zone, La Punta

As was described in Sections 6.1 and 6.2, Camana and its vicinity including La Punta located directly in the center of the affected coastline was the hardest hit zone. La Punta is a summer resort located along a narrow strip of beach with Los Cerrillos Hill rising behind. 26 people were reportedly killed by the tsunami, with roughly 70 still missing. Though tragic, this death toll was fairly light considering the location of the resort, because the tsunami occurred during the southern hemisphere winter. The orange colored zone in **Figure 6.16** is considered to have been inundated with water. The surges destroyed a great number of dwellings, hotels and restaurants there (**Figures 6.16**, **17** and **18**).

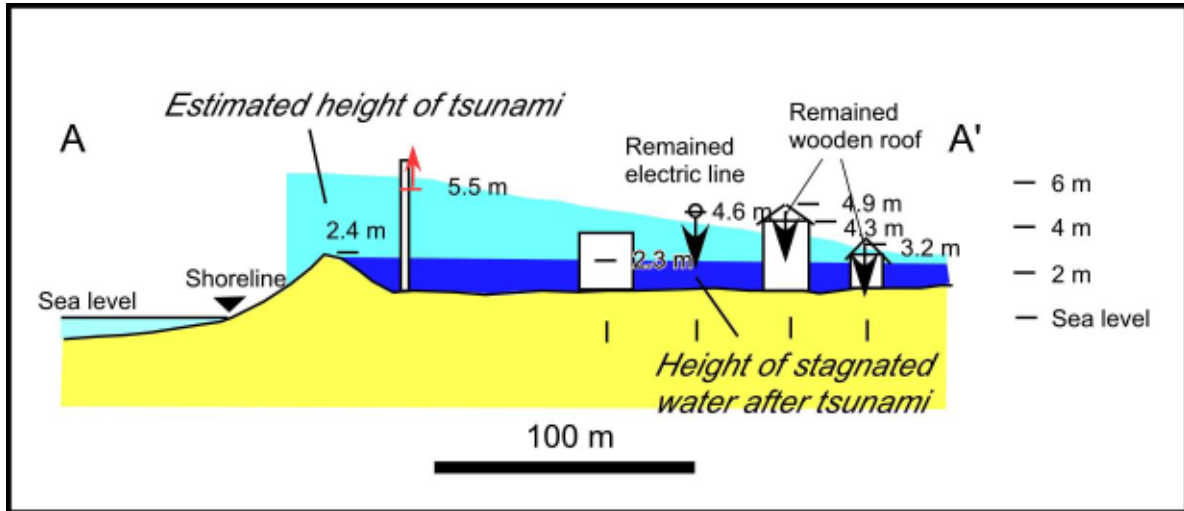
Figure 6.18 Cross sectional view of estimated height of tusnami. The location of the section is shown on **Figure 6.16**.

The inundated zone was covered thin with wet fine silty soils (**Figure 6.17**) suggesting that the water surged over the zone was stopped there for a while as is shown in **Figure 6.18**. The estimated height of tsunami is decreasing towards the land (**Figure 6.18**).

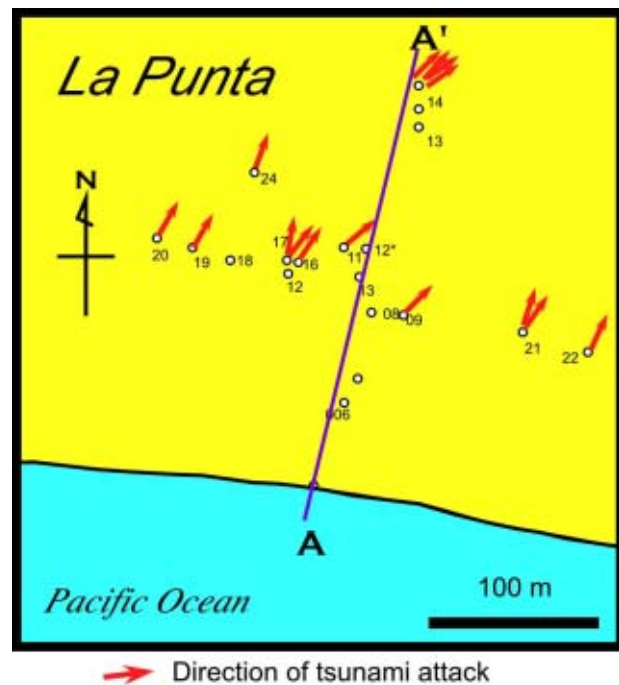
From a number of RC columns pushed down (**Figure 6.19**), possible directions of tsunami surges were estimated (**Figure 6.20**). Direction of the surge was also estimated from spalled utility poles (Figure 23). Two lines of utility poles along the coast were examined. Most poles on the front were still standing almost upright while those about 100m inland were more or less tilted because their foot soils were scoured by the surge. Probably for this reason, spalled poles were mostly found on the front. Lateral hair cracks were found on some poles, which seemingly suggest that the poles have experienced lateral shake before the area was inundated. The red arrows show inferred directions of strong ground motion, which seem to have been intense in about EW direction.

Figure 6.19 Reinforcing bars bent by tsunami.   **Figure 6.20** Possible directions of tsunami surge.

Possible direction of tsunami surges, deduced from the bent of reinforcing bars and spalling of utility poles, was from SSE to NNW at La Punta, Camana.
