Structural Eng./Earthquake Eng., JSCE, Vol. 19, No. 2, 99s—111s, 2002 July
(J. Struct. Mech. Earthquake Eng., JSCE, No. 710/ I —60)

SEISMIC RISK IN GREECE: WHAT RECENT EARTHQUAKES HAVE TAUGHT US

Vassilis LEKIDIS[1] and Petros DIMITRIU[2]

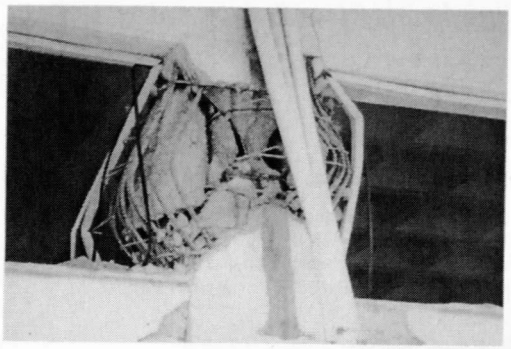
The overall damage picture in the meizoseismal area is very similar to what had been observed in previous earthquakes in Greece. Typical examples include: (1) damaged columns and failures at joints in buildings with "pilotis" (**Photo 1**); (2) damage due to lack of shear walls, particularly around staircases; (3) shear failures of short columns (**Photo 2**); (4) damage due to lack of stirrups in columns. Also, concrete in Ano Liosia was apparently of lower quality than elsewhere. Furthermore, a number of adjacent buildings suffered because of pounding (**Photo 3**). The overall performance of new buildings (1984 and 1995 Codes) was rather satisfactory. A summary of the second-level inspection results for the broader metropolitan area of Athens is presented in **Table 8**, where the buildings were categorized and marked according to their state following the standard "green-yellow-red" classification (see above).

Photo 1 3-story RC building with pilotis, Ano Liosia.

Photo 3 Damage due to pounding, Menidi.

Photo 2 Column failure, due to the short-column effect, in a 5-story building in Ano Liosia.
