Chapter 10

Damage to Ports and Coastal Facilities

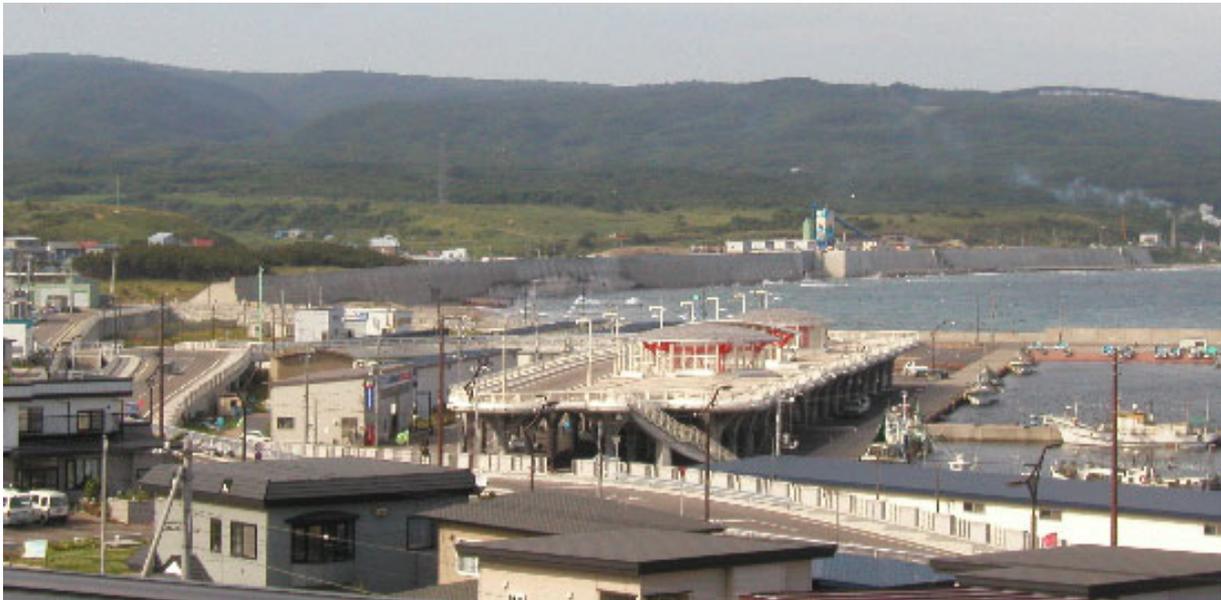
Photo 10.8 Tsunami Refuge Terrace at Aonae fishery port, Hokkaido, JAPAN
(Refugees run up the terrace and then evacuate to mountain area through the overpass deck when tsunami warning alert is announced.)
