- ## ネパール最重要道路のハザードマップとリスク管理
- 1.はじめに
 - 2.調査対象
 - 3.道路斜面危険箇所の特徴
 - 4.道路ハザードマップ
 - 5.道路リスク管理の考え方とハザードマップの重要性
 - 6.今後のネパールでの道路防災のあり方
 - 7.まとめ

Landslide Damages in Changunarayan Hill of Nepal and the Conservation of World Heritage Site

Kankyo Chishitsu Co. Ltd Hideki Inagaki
Ehime Univ. Netra P. Bhandary
Ehime Univ. Ryuichi Yatabe

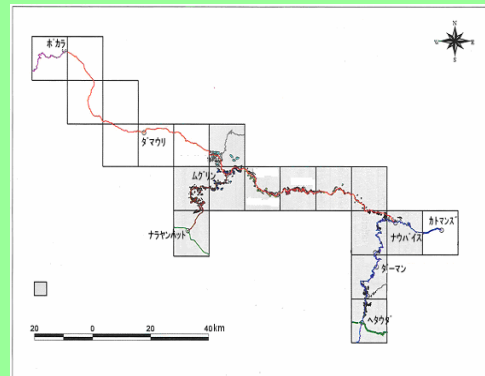
図-9 道路ハザードマップ案内図

- 縮尺 1/25000で12枚作成
- 1 峡谷沿いのハザードマップ
- 2 盆地沿いのハザードマップ
- 3 山岳地でのハザードマップ
- 4 大断層沿いのハザードマップ

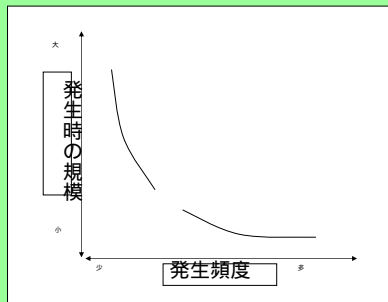
図-14 ハザードの分類

- 被災規模や地表の変状などによる災害のせまり具合や現地での聞き込み調査による発生頻度から、31箇所の被災地のリスク分類
- 対応策の優先順序をつける意味で、簡便的なリスク評価
- リスク分類が大となったNo. 3, 4, 11, 15, 20, 21, 27, 28地点などが、道路保全対策の優先順位が高い

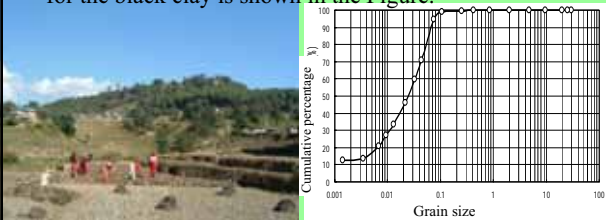
- The temple is situated on top of diluvial lake deposit and meta-sandstone with a narrow ridge as shown in the Photo .
- The diluvial deposit consists of semi-consolidated clay layers (including black clay) including sand and gravel.
- The back clay is characterized by finely graded grain size and weak shear strength. The cumulative grain size curve for the black clay is shown in the Figure.

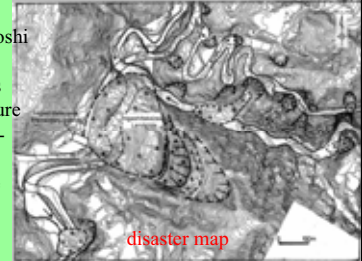
I was involved in preparing slope disaster map of Yamakoshi Village immediately after the Chuetsu Earthquake, which is shown in the Figure. This figure shows the recurrence of large-scale landslides in Higashitakezawa area and the creation of a natural dam.
