Preliminary Report on December 26, 2003 Iran Bam Earthquake

Prepared by JSCE Iran Bam Earthquake Disaster Investigation Team

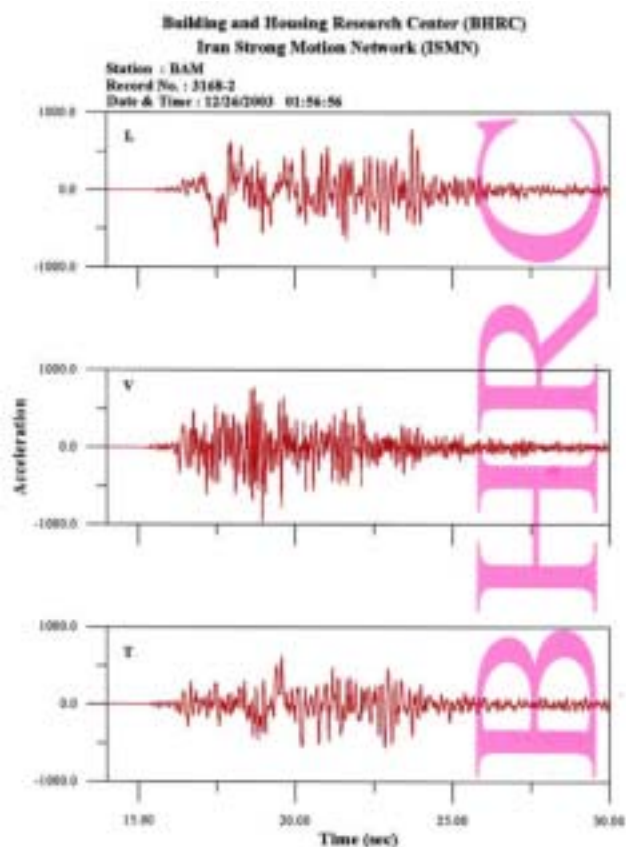
Figure-2: Strong-motion seismograms recorded in the city of Bam²⁾

Table-2 shows the maximum acceleration at various sites. In Bam, a vertical motion of over 1G is observed, and the horizontal motion has marked a very high value of 800gal as well. Figure-2 is the strong motion waveforms that BHRC disclosed. It may be considered that the horizontal component (L) expresses the characteristic of the site near the fault. As the strong-motion seismograph was placed under a desk, on the first floor of a two-storied concrete reinforced brick structure, there was no impact from falling objects. However, as the adjacent locker fell, there is a possibility that the record reflects the impact of this fall, or of the shaking of the structure itself, which was partly damaged.

(From the top: horizontal, vertical, horizontal-transverse components. The maximum rates are shown in Table-2)

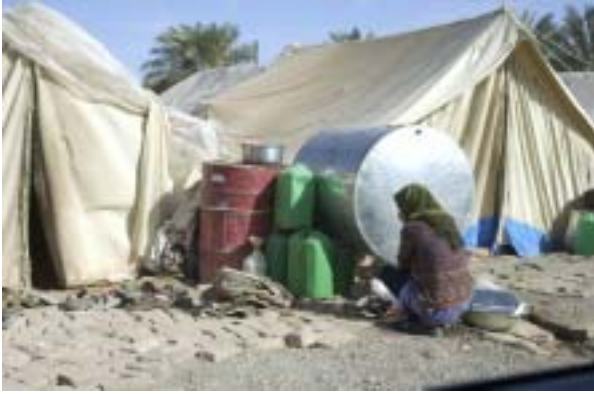
Photo-4: Water tank supplied to the residents

The water supply systems in both Bam and in Baravat suffered no damage in tanks and other facilities, except in the underground pipes. The underground pipes made of Asbestos-cement, P.V.C. and polyethylene were damaged at their T or straight joints as well as at their body. There have been a great number of collapsed houses and due to that, excavation work has been impossible in many areas. In many of these areas, temporary ground pipe systems have been introduced. For residents living in tents, water tanks like the one shown in Photo-4 were supplied.
