Japan Society of Civil Engineers
Yotsuya 1, Shinjuku-ku, Tokyo 160-0004
<http://www.jsce.or.jp/>

Provisional Report on the January 13, 2001 Earthquake Occurred Off The Coast of El Salvador (updated 15, February, 2001)

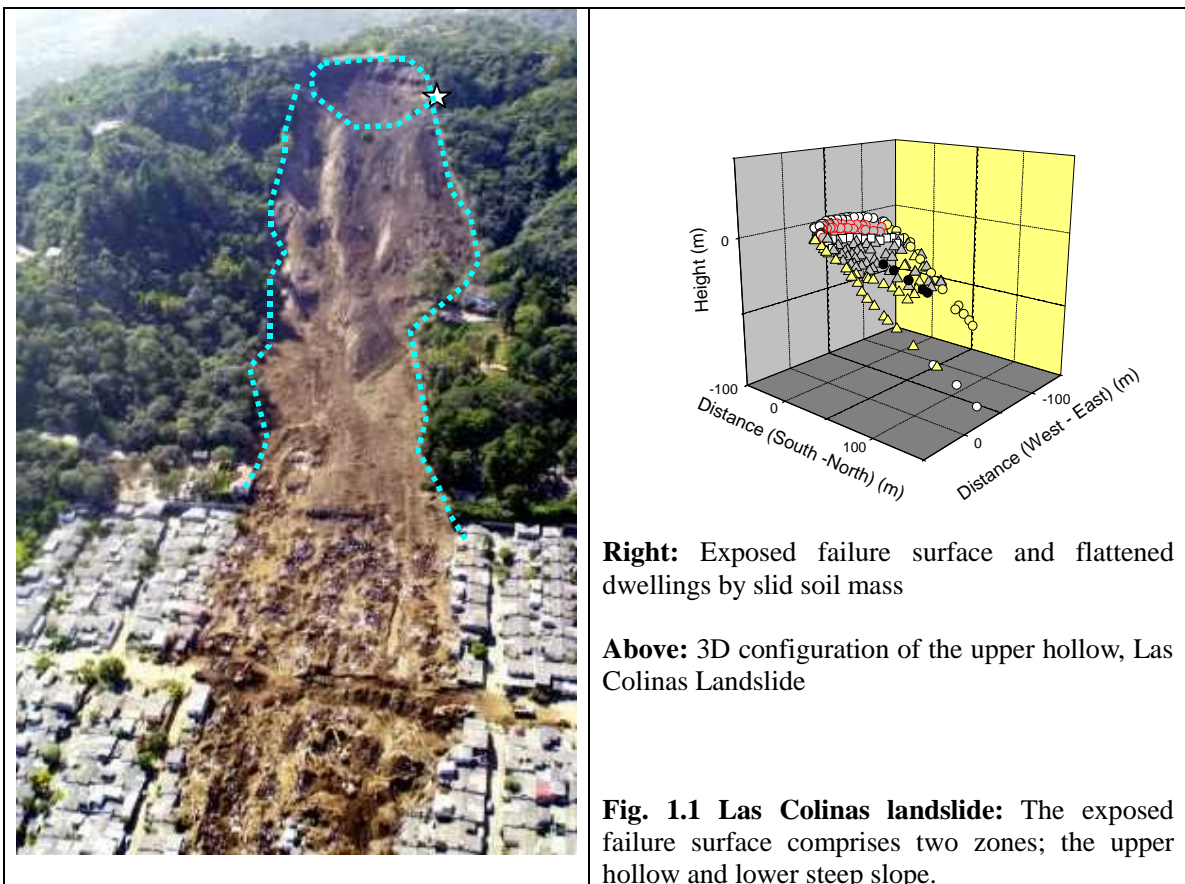
Using a laser rangefinder with a digital compass built in, the 3D configuration of the upper hollow (zone 1, **Fig. 1.1(a)** and **(b)**) was first surveyed from two reference points, one on the left edge of scar (closed circle in **Fig. 1.2**: N13 396.87', W89 17.168') and the other on the right (not plotted in Fig. 1.2). The distances from the top end of the scar to the toe of the slope and to the farthest reach of the soil mass are 480m and 750m respectively. A possible soil mass that was fitted in the upper hollow is roughly estimated to be about 75,000 m³, and is presumably the greater part of the soil, which flushed more than 600 lives to death.

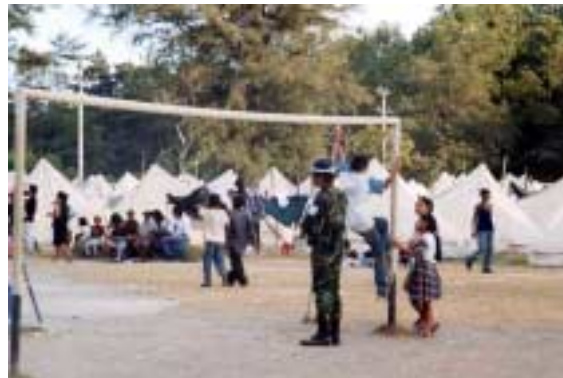
Fig. 1.11. Refugees' camp

Extensive cracks running along the ridge crest are the serious threat of further slides. The city of Santa Tecla is controlling the potential hazard zones, the red zone with the highest risk and the yellow zone of slightly less danger (**Fig. 1.10**). A week after the earthquake, the number of residents evacuated from the zones exposed to the menace of possible landslides reached 14,000, and as of Feb. 3, about 4,000 refugees were still being forced to live in tents (**Fig. 1.11**).
