A QUICK REPORT
ON
MIE-KEN KAMEYAMA EARTHQUAKE ON APRIL 15, 2007

Ömer AYDAN
Chairman
Earthquake Disaster Investigation Sub-Committee

April, 2007

Japan Society of Civil Engineers

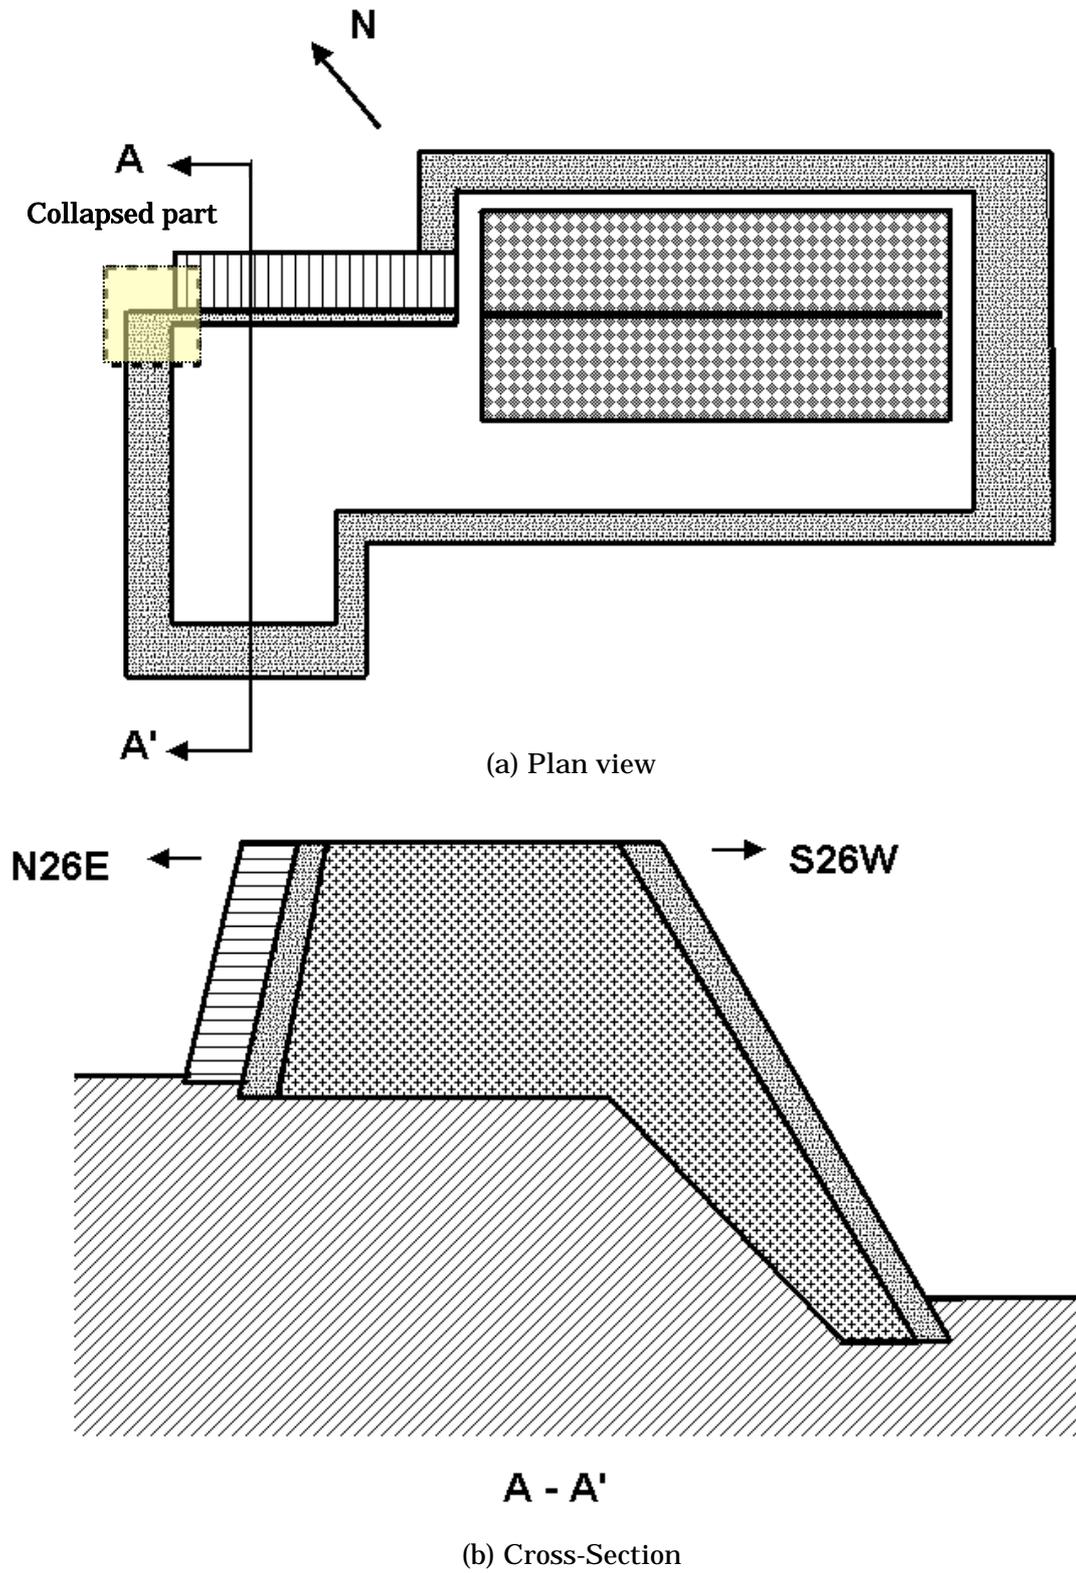
Figure 6.5: Plan and cross sectional view of Kameyama Castle (not to scale)

Kameyama castle was built in 1590 on a 10m high hill. The inclination of south, east and west walls is about 50° while the inclination of north wall is much steeper and it is about 70-75°. The earthquake caused the collapse of NW corner of the 5m high northern wall, where a masonry stone stair is located. The collapsed section was 2m wide and this section was actually damaged by a typhoon in 1972 and it was repaired. The stone used at corners was 30 cm wide, 30cm high and 55cm long and rock itself is either andesite or diorite. Figure 6.5 shows plan and cross-section illustrations of the castle while Figure 6.6 shows some views of the intact and collapsed sections of the castle.

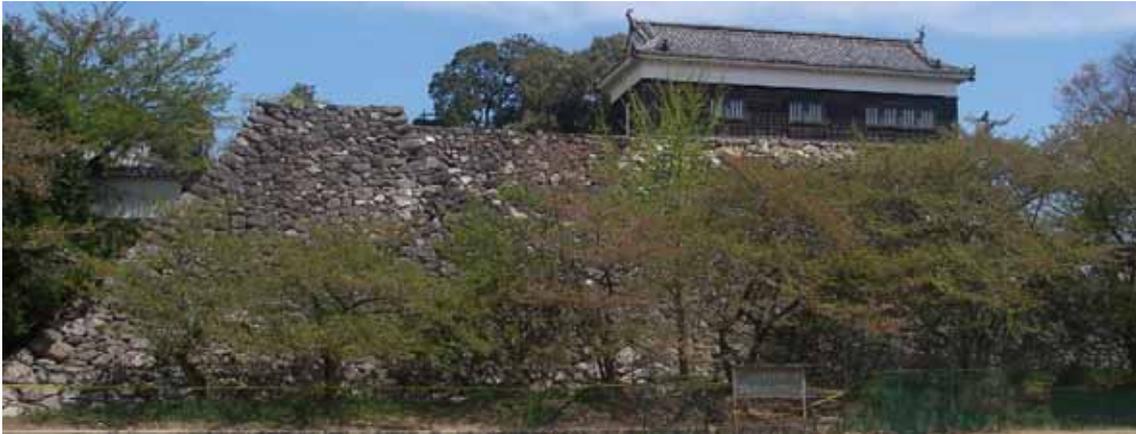
(a) View of Castle from south

Figure 6.6 Views of intact and collapsed section of Kameyama Castle

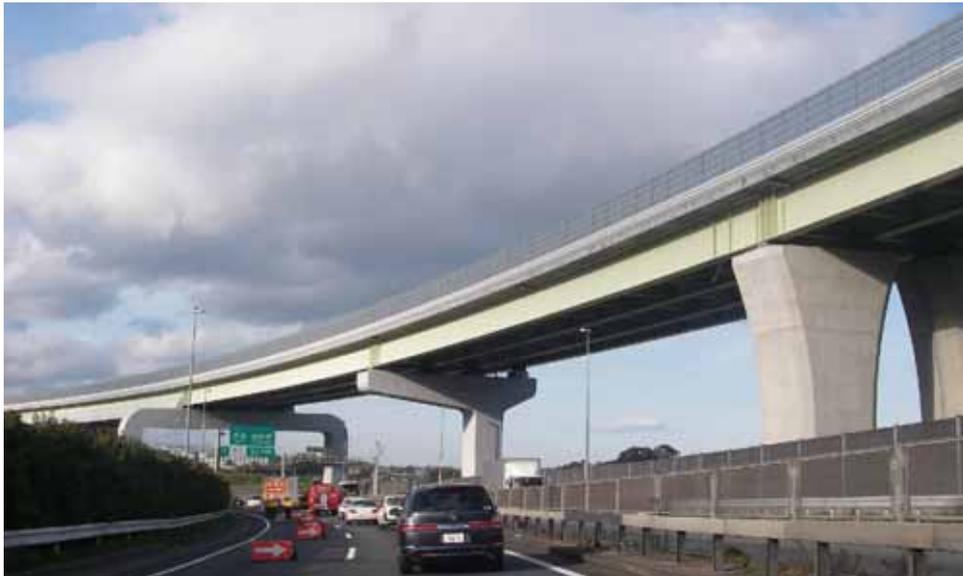
Land transportation in Mie Prefecture is done through state and prefectural roadways, Meihan National Highway and Ise-wan Expressway (Figure 1.1). Meihan National Highway and Ise-wan Expressway run next to the epicenter area. The visual inspection of the expressway and viaducts indicated there was no damage to the expressway and viaducts (Figure 6.7).

Figure 6.7: Non-damaged Ise-wan Expressway and overpasses

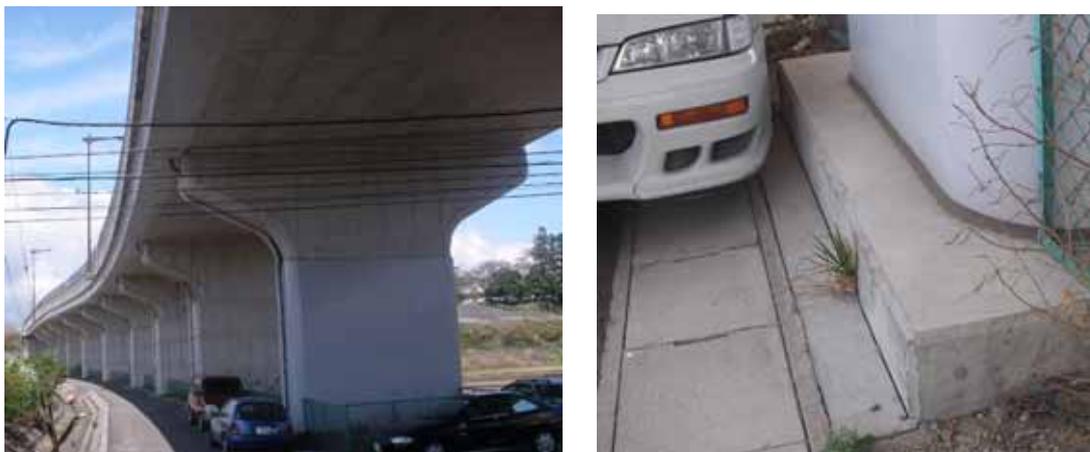
The authors also inspected the both state and prefectural roadways. The visual inspection indicated that there was no damage to roadways and viaducts. However, the ground was slightly settled nearby the foundations of the viaducts of an overpass on Route 3006 in Kameyama city over a railway line (Figure 6.8).

Figure 6.8: Overpass on Route 3006 spanning over a railway line in Kameyama City

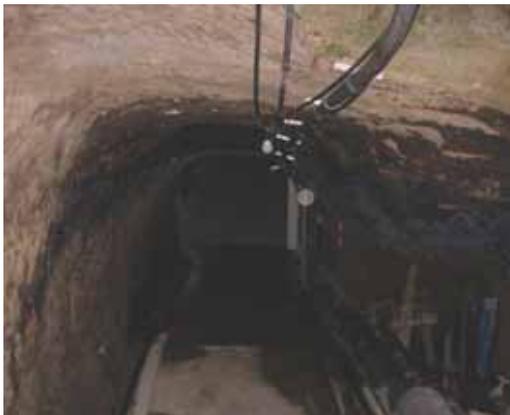
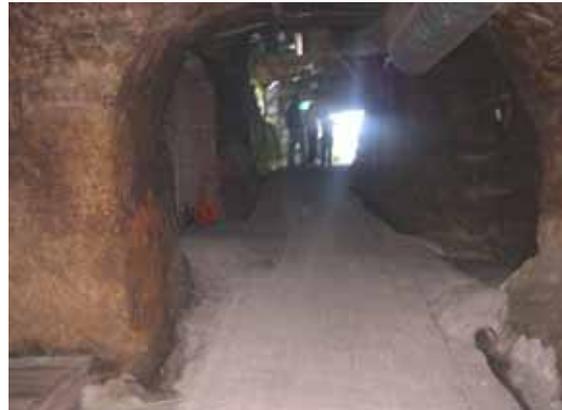
The authors visited an abandoned underground quarry for abrasion sand in the same district. Adits are generally 250cm wide and 220cm high. The visual inspection of the accessible adits did not display any effect of the earthquake on the underground quarries. One reason may be the difference of ground conditions at such localities. Although the authors did not have any chance to visit abandoned lignite mines, there is so far no report of cave-in or subsidence of ground in Tsu City or other cities and towns in the epicentral area.

Figure 6.15: Non-damaged adits of an abandoned underground quarry in Tsu City

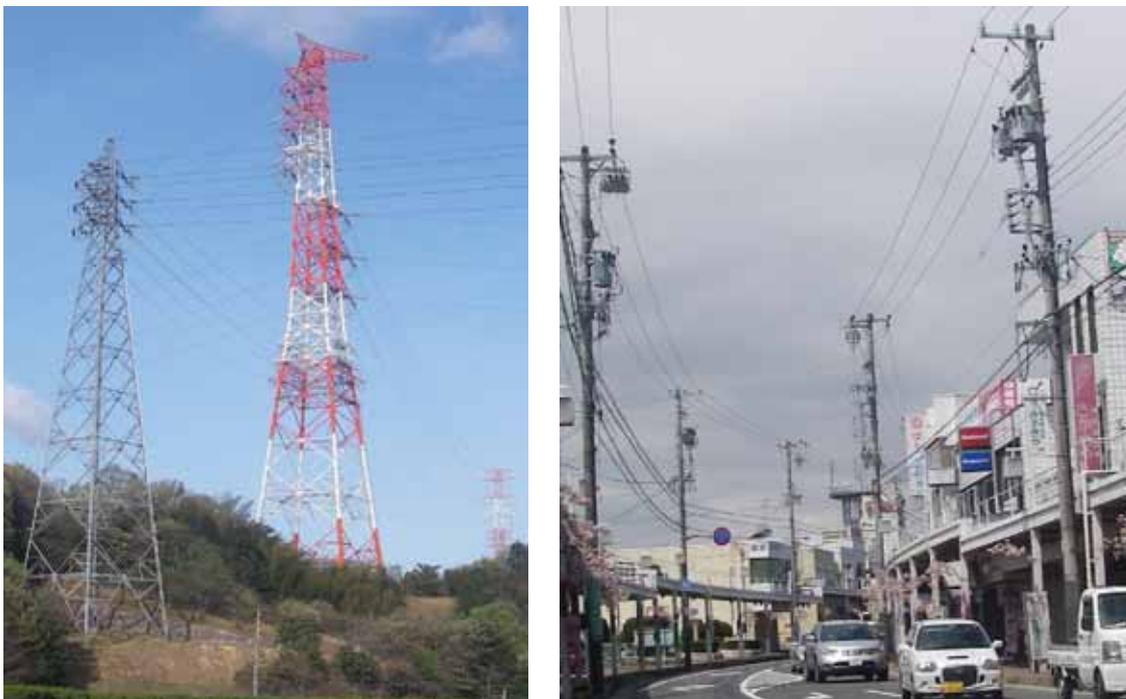
The electricity distribution system in the region is done through poles and high-voltage transmission lines. None of transmission towers or electricity poles were damaged or toppled during this earthquake (Figure 7.1). Although the poles having transformers mounted particularly suffer more during the earthquakes, none of such poles were not damaged in-spite of high ground motions recorded in this earthquake. The main transmission lines are elevated and supported through 40-50m high steel pylons. Since power plants and the electricity distribution system were intact, the recovery of electricity was quite rapid.

Figure 7.1: Non-damaged pylons near Seki I.C. and non-damaged poles in Kameyama City
