12 LIQUEFACTION, GROUND SUBSIDENCE AND SLOPE FAILURES

12.1 Liquefaction and Its Effects

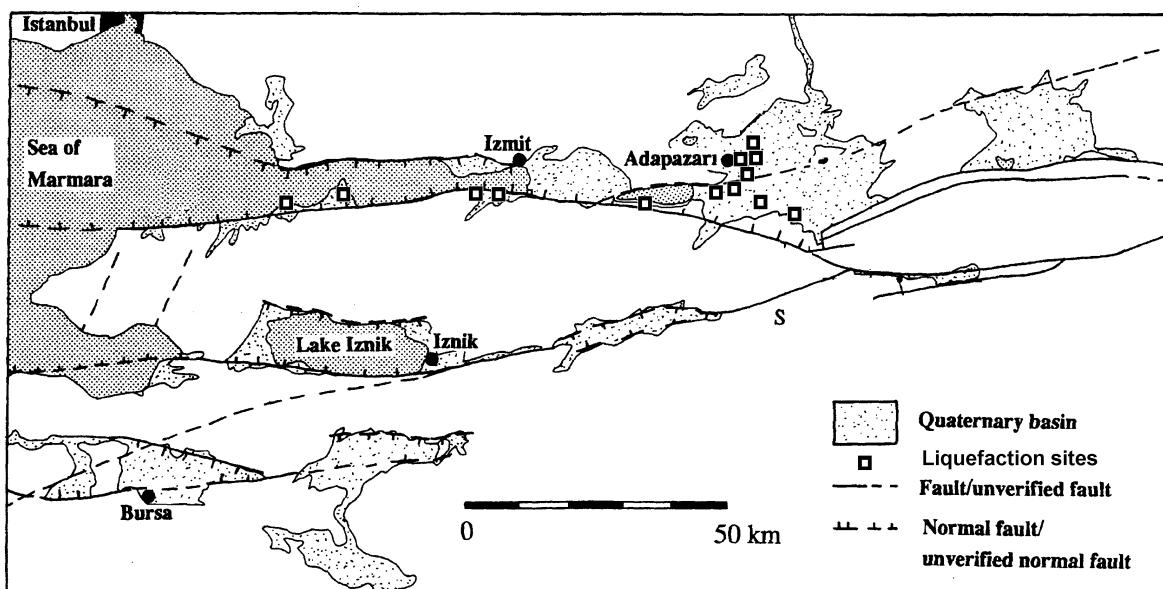
Figure 12.1 Distribution of liquefaction sites observed in this earthquake

Liquefaction was widely distributed and caused damage to structures and lifelines in the region between Adapazarı and Yalova. Liquefaction was observed for a length of 120 km almost along the earthquake fault break within a band of about 10 km (Figure 12.1). The most devastating effect of liquefaction was observed in Adapazarı which was about 6 km away from the fault break on the northern block. According to people interviewed, the liquefied sand and water came out of ground gradually. Figure 12.2 and 12.3 show some typical examples of liquefaction in Adapazarı.

Liquefaction fissures and sand boils are evidently observed along the Sakarya River in Adapazarı City and Akyazı, the southern shore of Sapanca Lake and İzmit gulf as far as Yalova whenever saturated quaternary loose deposits exist.

It is of great interest that the locations shown in Figure 12.1 are almost the same as those shown in Figure 12.9. The figure implies that the grounds at the locations of liquefied ground were again liquefied in this earthquake.

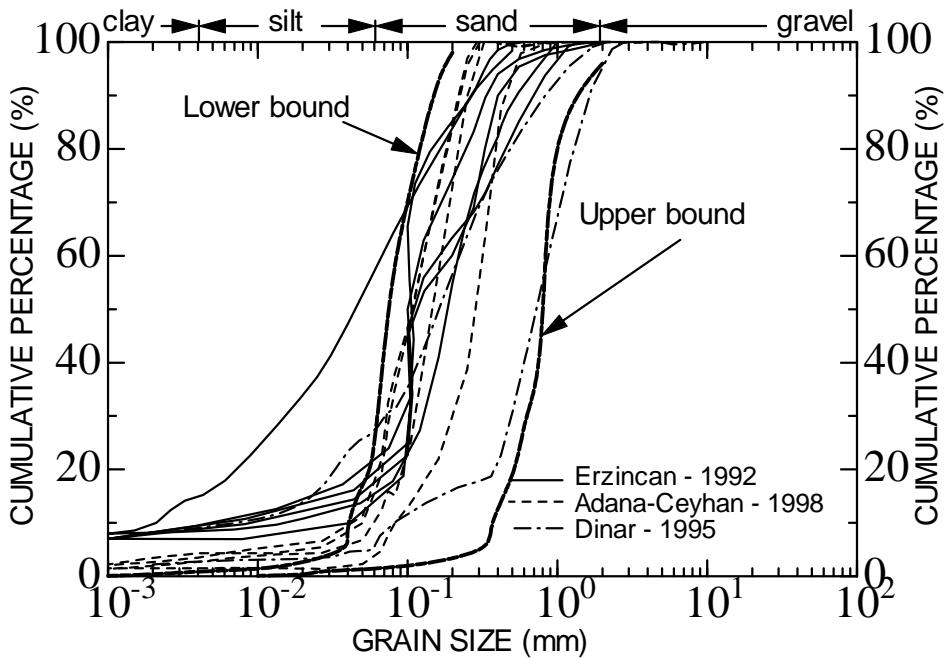
Figure 12.7 Grain size distribution curves of the soil samples taken from the liquefied at various locations of liquefaction in the previous earthquakes of Turkey

Grain size of the liquefied soils was examined on specimens collected from the sand volcanoes. Figure 12.7 shows cumulative particle size distribution curves of the liquefied soils from previous earthquakes in Turkey (Hamada and Aydan 1992, Aydan and Kumsar 1997). Figure 12.8 shows that fine-to-medium sand is dominant in the liquefied soils obtained

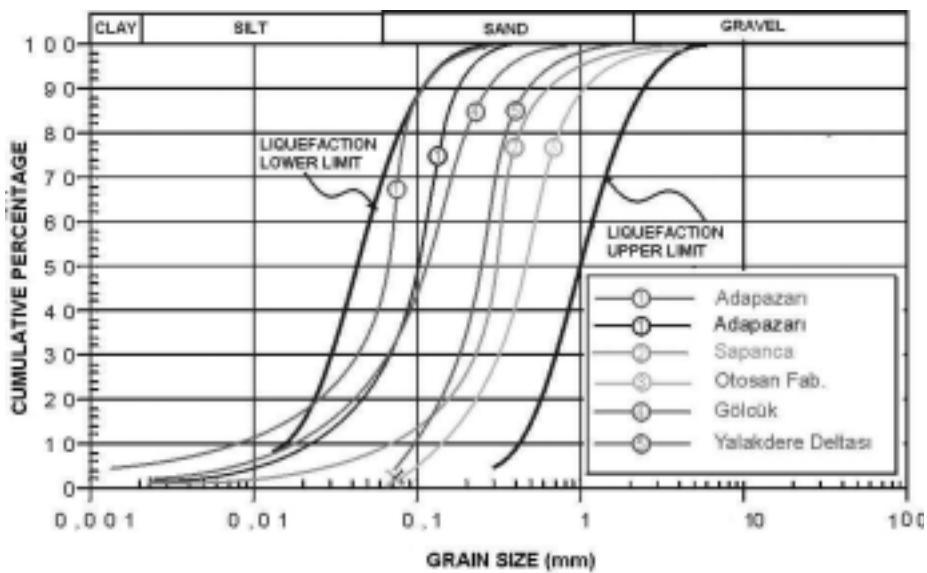
Figure 12.8 Grain size distribution curves of the soil samples taken from the liquefied at various locations of liquefaction in the Kocaeli earthquake (after Kasapo lu et al. 1999)

from various locations in the Kocaeli earthquake. The grain size distribution of these liquefied soils fall between the well known upper and lower limits for liquefaction (see Figure 12.8). Both the practical characteristics of the soil and high groundwater levels in conjunction with active seismic features of the region result in a condition which is favorable for the occurrence of the liquefaction. Porosity of the same samples is about 30-46%.

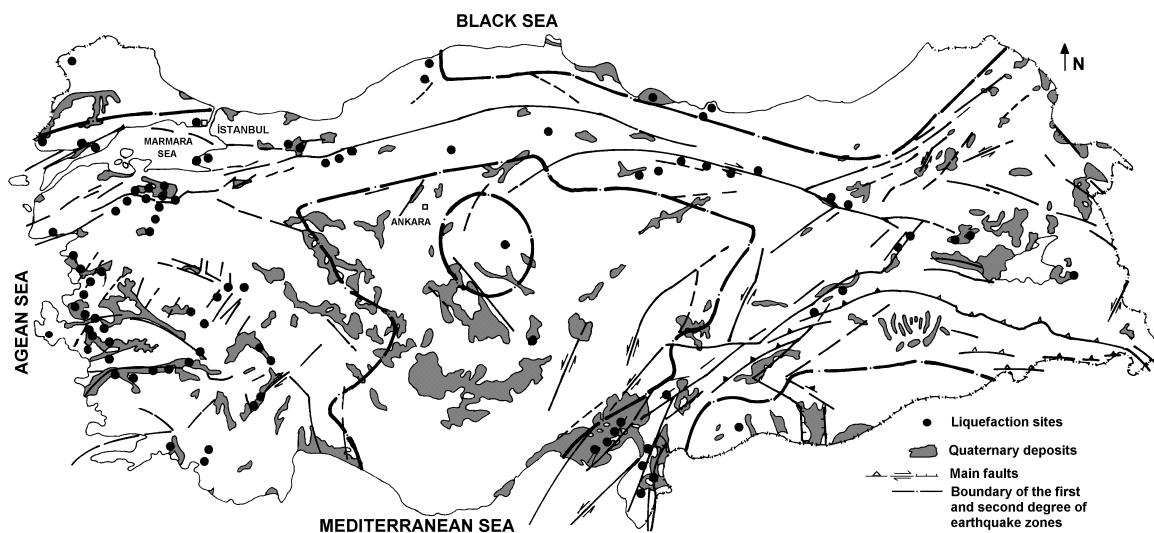
Figure 12.9 Distribution of the Quaternary alluvial deposits and liquefaction sites, and main structural features of Turkey with 1st and 2nd degree seismic risk zones (After Aydan et al. 2000)

Although many liquefaction related damage occurred in the past Turkish earthquakes, the liquefaction phenomenon has not received much attention in Turkey until the Erzincan earthquake of March 13, 1992. Aydan et al. (2000) investigated many reports and catalogues of past Turkish earthquakes to indentify the locations and extent of liquefaction. From this investigation, a data-base was developed to study the liquefaction characteristics of Turkish earthquakes. The parameters of the data-base involve the geometrical condition of the sites, the magnitudes of earthquakes, the hypocentral distance to the site and soil parameters. Figure 12.9 shows the liquefaction locations observed until 1998. It is also of great interest that the locations almost coincide with quaternary deposits along the active faults of Turkey. Although some liquefaction locations were observed along the shores of Kara Deniz (Black Sea), they were away from the North Anatolian Fault in the Erzincan earthquake of 1939.

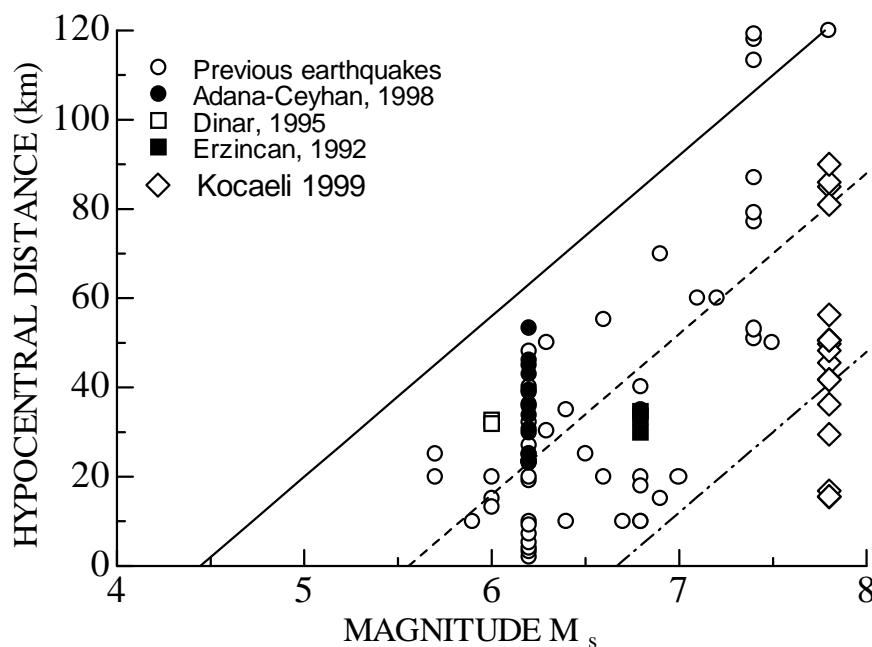
Figure 12.10 Comparison of the observed relation between the magnitude and distance of liquefied sites with empirical relations

Aydan and Kumsar (1997) compiled some data on the locations of earthquakes and developed some empirical relations between magnitude of earthquake and hypocentral distance for liquefaction - non-liquefaction states. The relation between the magnitude of the earthquake and the hypocentral distance to the site of liquefaction is given in Figure 12.10. The following three functions are fitted to the observed results (Aydan et al. 1998):

These three empirical lines may also be regarded as non-liquefaction to light, light to moderate and moderate to severe liquefaction boundaries in Turkish earthquakes. Figure 12.9 compares data obtained in this earthquake with the data from previous Turkish earthquakes. The data gathered in this earthquake are within the empirical bounds.

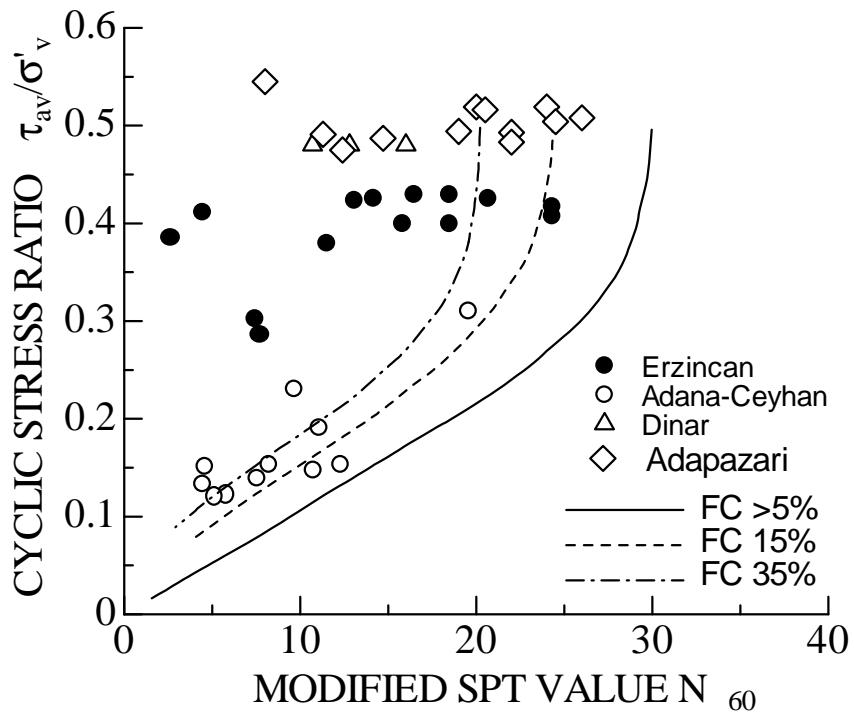
Figure 12.11 The relation between modified SPT value N_{60} and cyclic stress ratio CSRE together with bounds for liquefaction/non-liquefaction proposed by Seed and DeAlba (1986)

Figure 12.10 shows the relation between modified SPT value N_{60} and cyclic stress ratio CSRE together with bounds for liquefaction/non-liquefaction proposed by Seed and DeAlba (1986). The data shown in Figure 12.11. are taken from the work of Ansal et al. (1994) and Erken et al. (1998) and Ülker et al. (1998) and the investigations of the author (Aydan and Kumsar, 1997; Aydan et al., 1998; Aydan et al. 2000a). The data of liquefied soils fall generally within the range of liquefiable soils.
