## **5 DAMAGE TO TRANSPORTATION FACILITIES**

### **5.1 DAMAGE OF ROAD FACILITIES**

### **5.1.2 Arifiye Overpass**

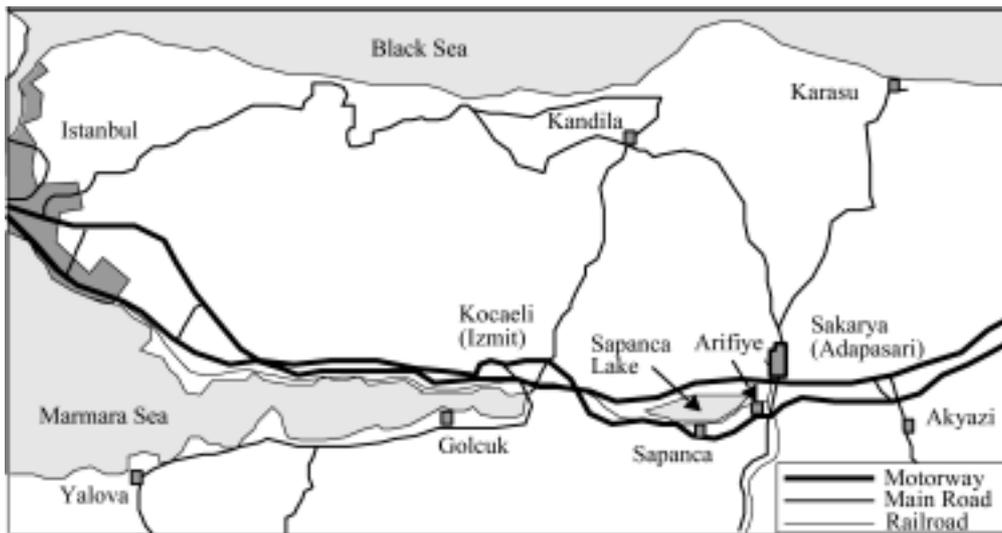
Fig. 5.1 Damaged Area

In the Kocaeli, Turkey earthquake of August 17, 1999, extensive damage of transportation facilities occurred in the Kocaeli and Sakarya region, Turkey as shown in Fig. 5.1. A part of the right-lateral strike slip Anatolian fault ruptured in east-west direction for about 100-km from Golcuk to Duzce. Since the Trans European Motorway was almost parallel to the fault, the fault rupture crossed the Motorway at several locations. The fault rupture crossed railways at least three sites. Damage of transportation facilities concentrated at the locations where the tectonic ground movement crossed the roads and railways.

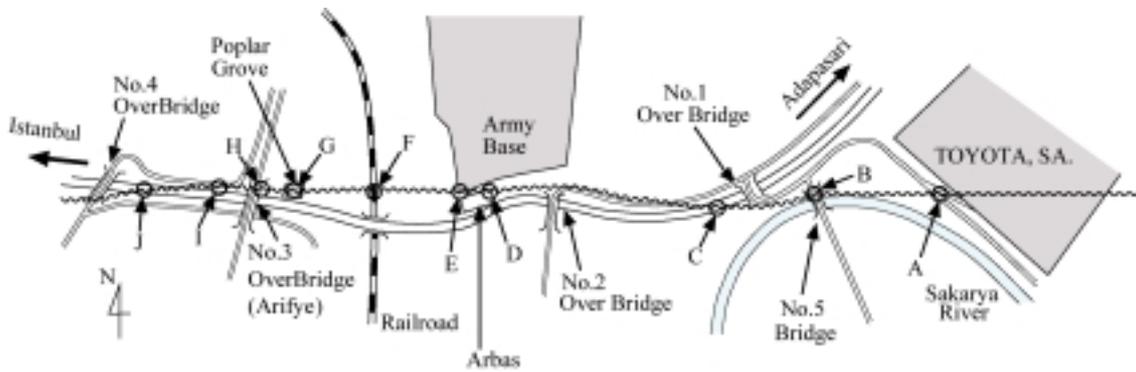
Fig. 5.2 Damaged Transportation Facilities and Fault-Induced Ground-Dislocations near Arifiye

In the east of Arifiye area, the fault rupture was first observed at the Toyota S.A. Factory. At an approaching road to the entrance of Factory (Point A, refer to Fig. 5.2), the fault rupture crossed the road with a shallow angle, and damaged the concrete pavement as shown in Photo 5.1. From the movement of equally spaced steel guardrail poles along the road, the road offset was estimated 1.2 m and 2.65 m in transverse and axial directions, respectively.

The fault rupture continued west to reach Point B where it collapsed the Sakarya Bridge. Detail of the bridge damage will be described in 5.1.4. The fault rupture then crossed the Motorway at Point C (near south abutment of the Overpass No. 1), and passed through the Overpass No. 2 near its north abutment. It then developed a 4.3-m offset of a concrete fence of an automobile factory (Arbas Arac Kadlama Fabrikasi) at northeast corner (Point D), as shown in Photo 5.2.

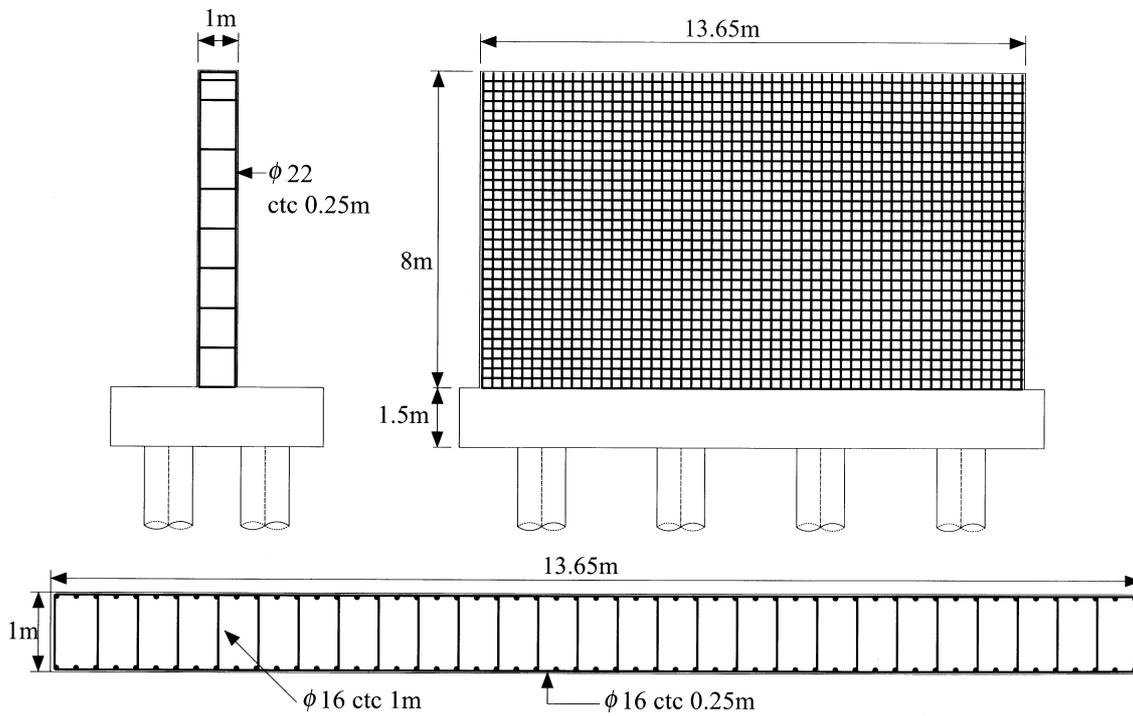
Fig. 5.5 Section of Piers, Arifiye Overpass

Assuming the reinforcement as shown in Fig. 5.5 and concrete strength of 30 MPa, the lateral force vs. lateral displacement relation was evaluated based on the standard moment-curvature

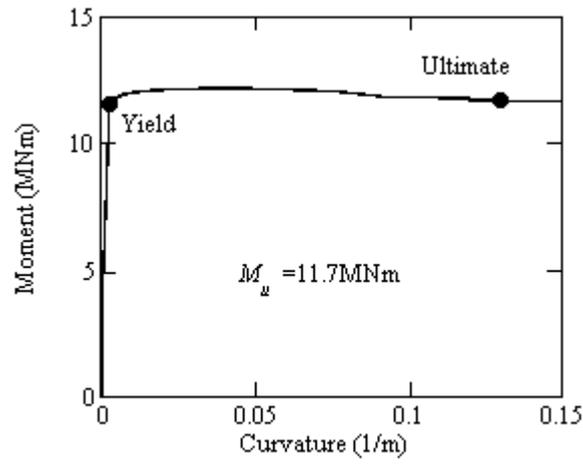
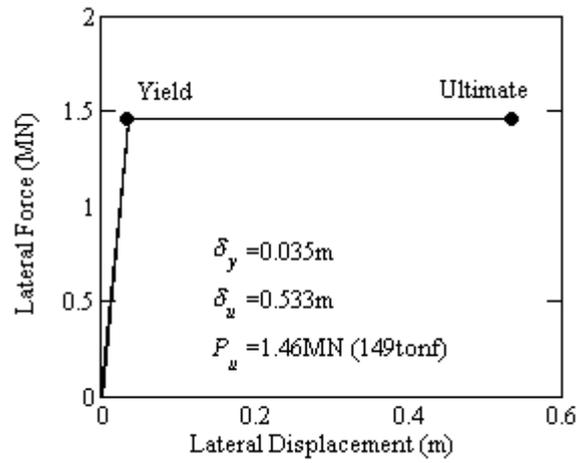
Fig. 5.7 Lateral Force vs. Lateral Displacement Relation of Piers

analysis<sup>4</sup>) as shown in Fig. 5.7. The stress-strain relation of concrete developed by Hoshikuma et al was used to represent the confinement effect<sup>5</sup>). Assuming that the tributary mass of a pier is 5800 kN, the response acceleration that resulted in yielding of piers was approximately 0.2 g.
