## 7 DAMAGE TO INDUSTRIAL FACILITIES

### 7.1 TÜPRA Refinery

## 7.2 TOYOTA-SA Car Plant

## 7.3 Damage to Other Industrial Facilities

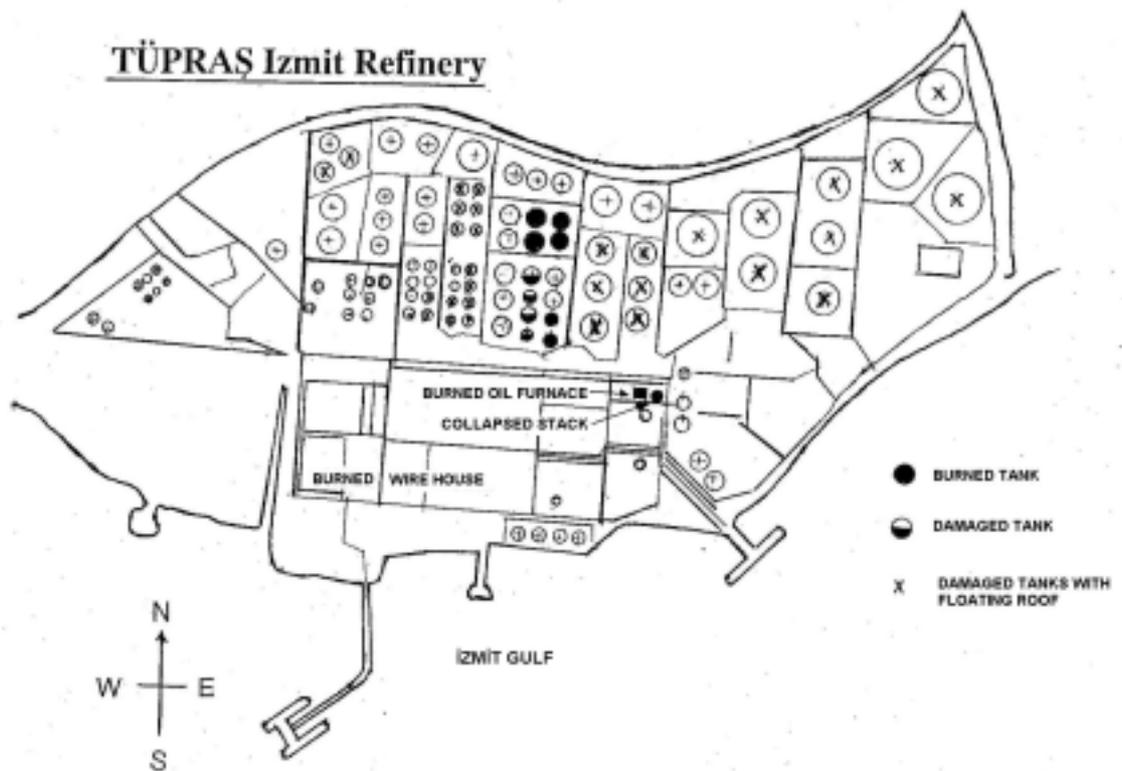
Figure 7.2 Locations of damaged and burned tanks

6 cylindrical tanks having floating roofs burned due to the earthquake. Out of 6 tanks, 4 middle size tanks has a diameter of 20-25 m and 2 small size tanks has a diameter of 10 m. Naphtha in the middle size tanks were completely burned. Tanks were damaged as a result of thermal deformation. The estimated naphtha is about 36,000 ton. Figures 7.3 and 7.4 show the deformed state of burned tanks.

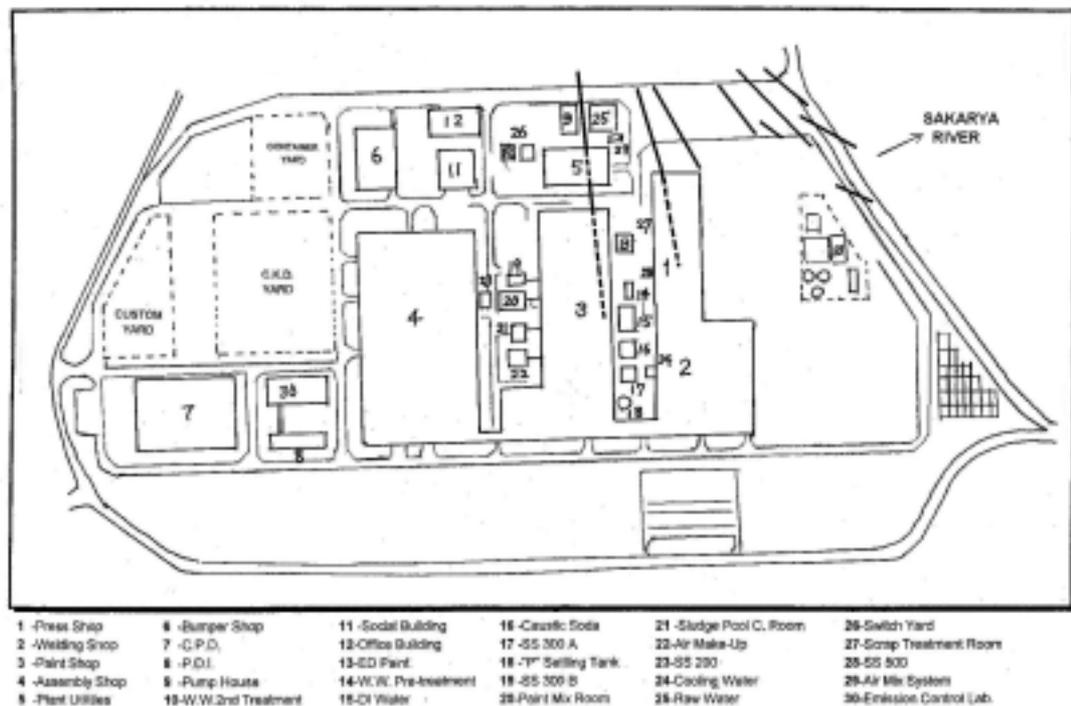
Figure 7.13 Plan view of TOYOTA-SA Car Plant

Although it is not certain, it seems that the fault bifurcates and 4 ground breaks were observed in the north-east corner of the plant. The plan of the plant and damage locations are shown in Figure 7.13

Since the ground breaks due to faulting pass through the North-East part of the plant, the floor and side-walls of press shop and welding shop were deformed. Nevertheless, this damage could not cause any obstruction to the production.
