8 DAMAGE TO LIFELINES

8.1 Electricity

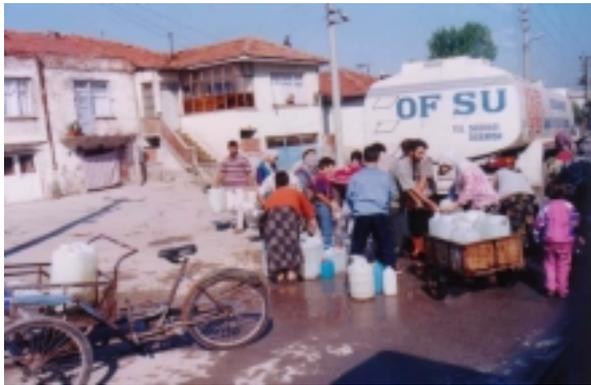
The Red Crescent (K z lay) camps were set up in many places (Figures 8.6 & 8.7) to provide basic needs such as water, food, tent, medical care as well as the disaster relief information. The lifeline support management in the camps is one of the most important issues for the emergency management. According to an official working for the disaster application center for victims in a camp at Gölcük, currently, the substitutes for lifeline systems are functioning without major troubles, so that the fundamental needs of people are satisfied in the camp.

Figure 8.6 Emergency water delivery

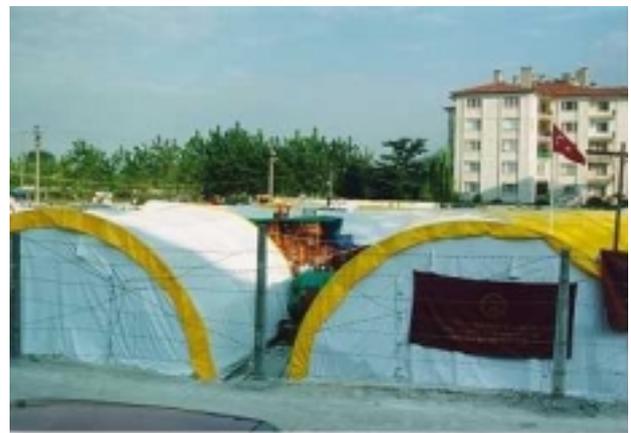
Figure 8.7 Tents in a park

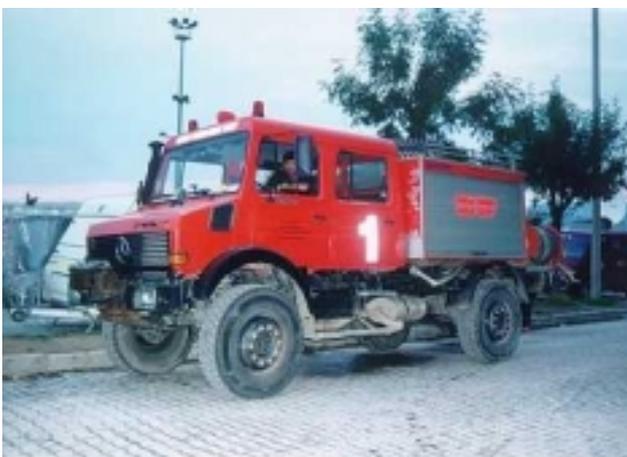
As of September 9, the water supply network has not been restored yet in Gölcük. Hence, the water is delivered by water wagons and stored in the water tanks located in the camps (Figures 8.8 and 8.9). The refugees could get water from the tanks.

Figure 8.8 Water wagon

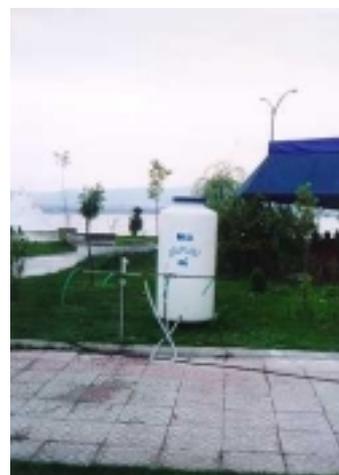
Figure 8.9 Water tank

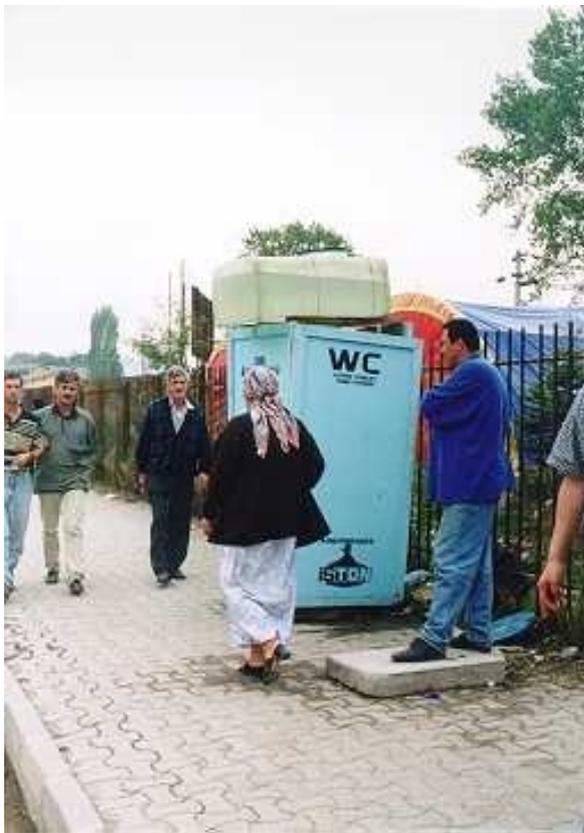
As for the sewage system, portable toilet units are set up on streets and in camps (Figure 8.10). The toilet unit has a water tank for flushing so that water has to be supplied to this tank as well.

Figure 8.10 Portable toilet unit

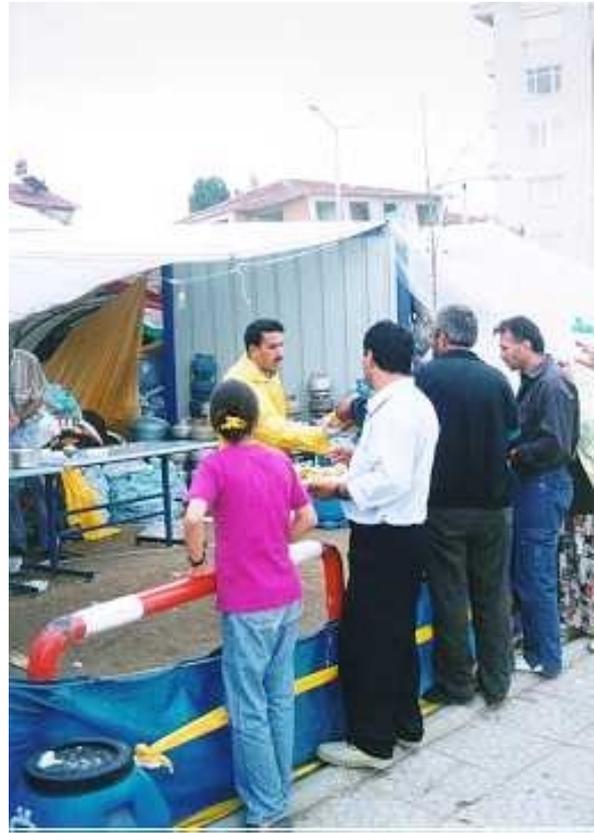
Figure 8.11 Portable food supply unit

Food supply stations were set up in the camps. The menu of a meal that we observed is bread, meal and fruit. The number of the supply stations is not enough. Therefore, the people has to be wait in line to get foods at each meal time (Figure 8.11).

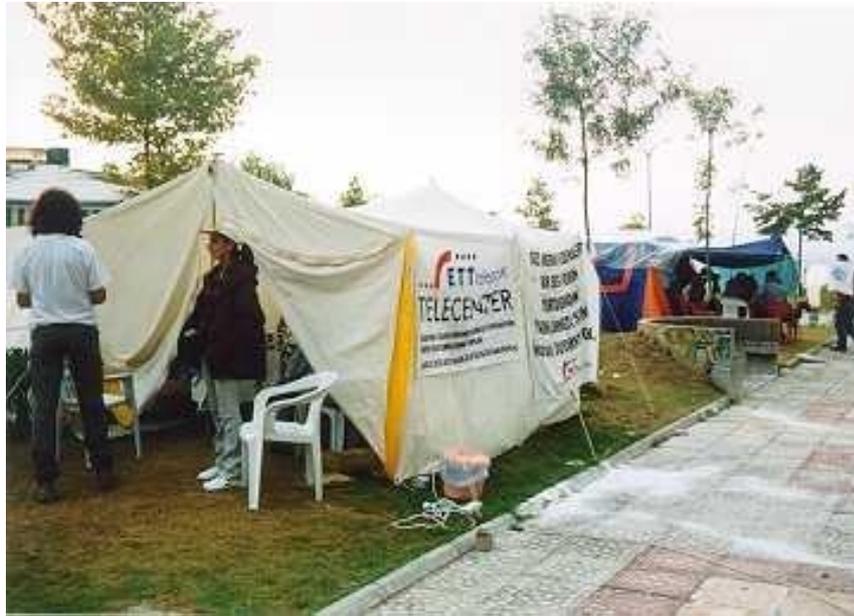
Telephone units free of charge are set up in the camps (Figure 8.12). In addition mobile phones are quite popular as the communication situation is quite good.

Figure 8.12 A telecommunication Tent
