A QUICK REPORT
ON
NOTO PENINSULA EARTHQUAKE ON MARCH 25, 2007

April, 2007

Japan Society of Civil Engineers

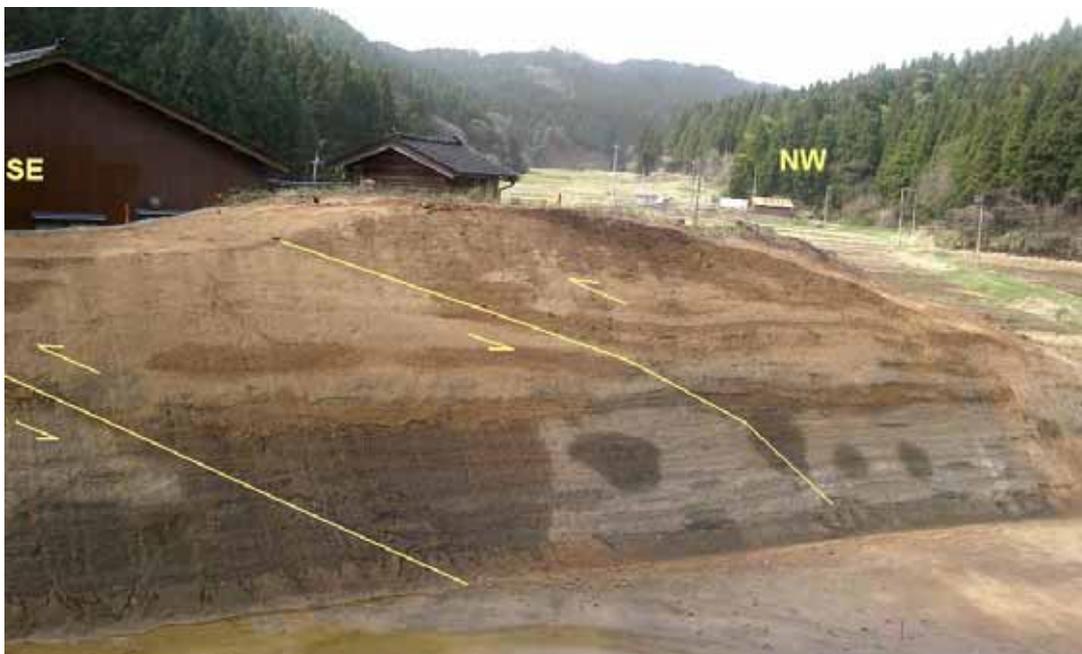
Figure 3.4: Thrust fault outcrop in Nakanoya district in Hakka valley

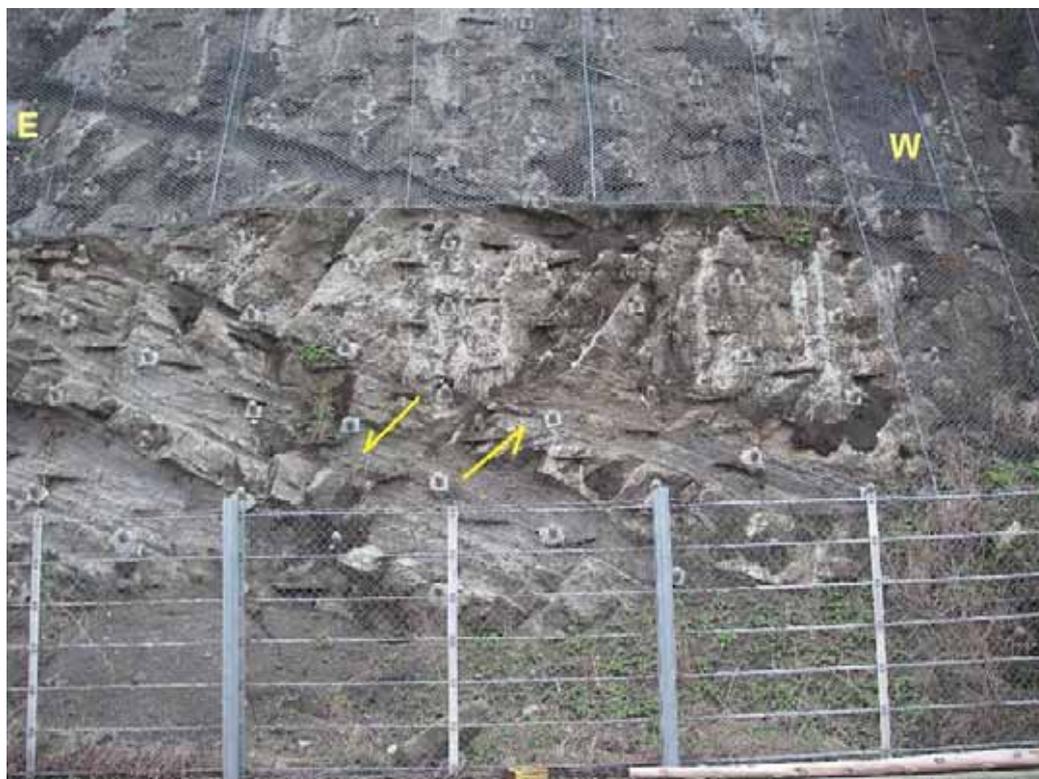
Figure 3.5: Normal fault outcrop nearby Ozawa at Northern shore of Noto Peninsula

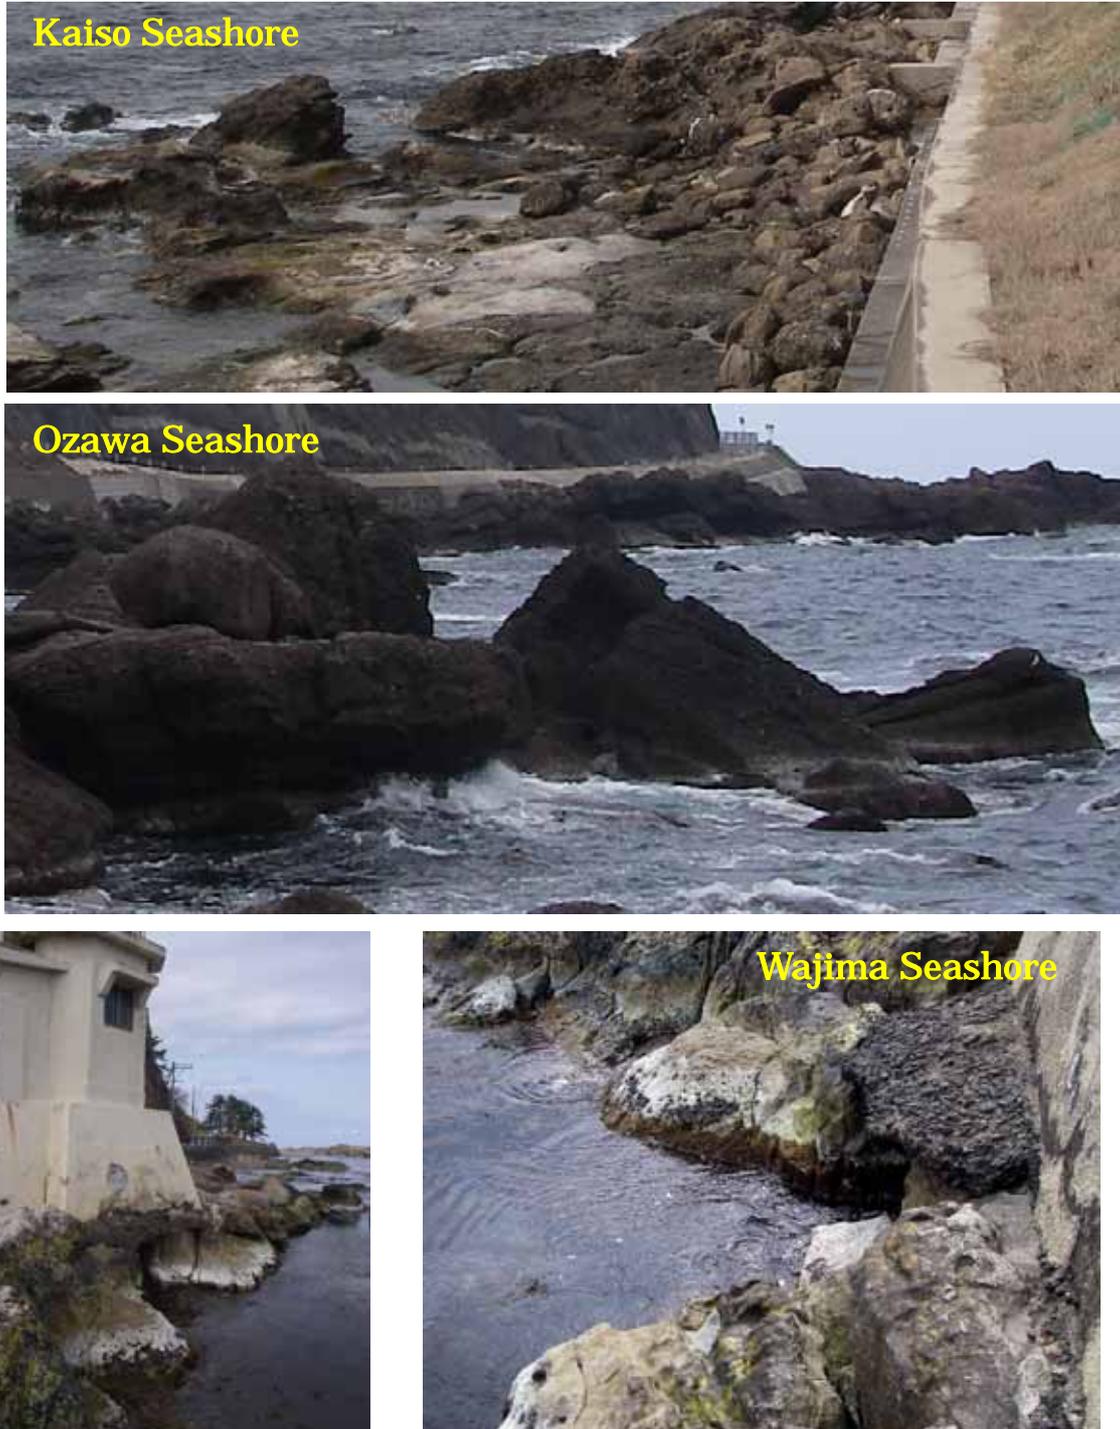
The authors also noted some vertical movements of seashores at three localities, namely, Kaiso, Ozawa and Wajima shores (Figure 5.5). Although it may be difficult to differentiate the effects of tides on the shore line, it seems that the vertical ground movements would be more than 500mm at the seashore nearby Kaiso ports while it would be about 200-250 mm at Wajima Tide Gauge Station.

Figure 5.5 Possible uplifts nearby Kaiso, Ozawa and Wajima ports

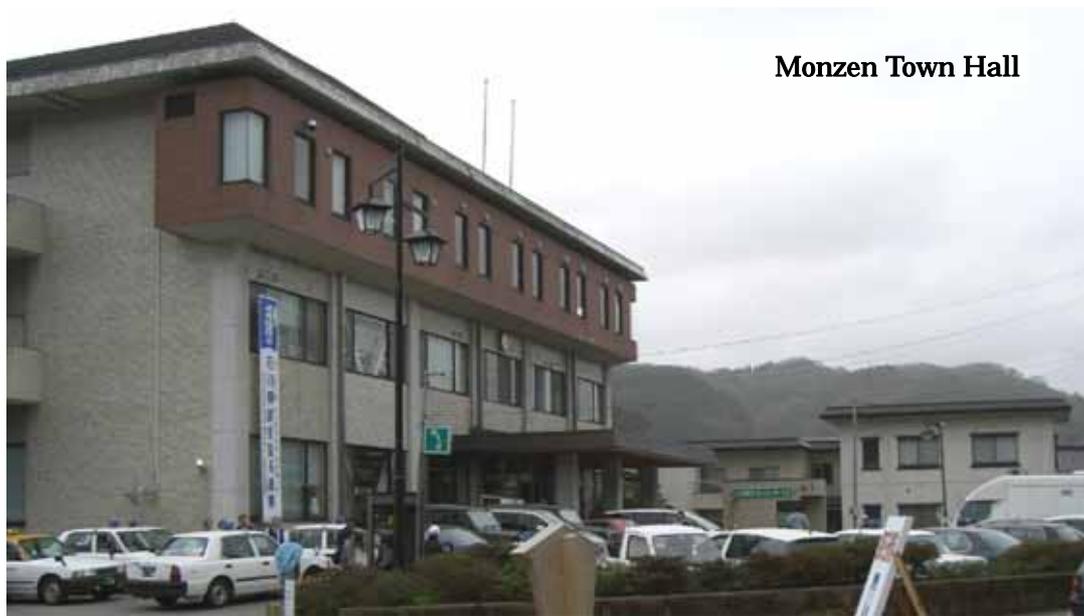
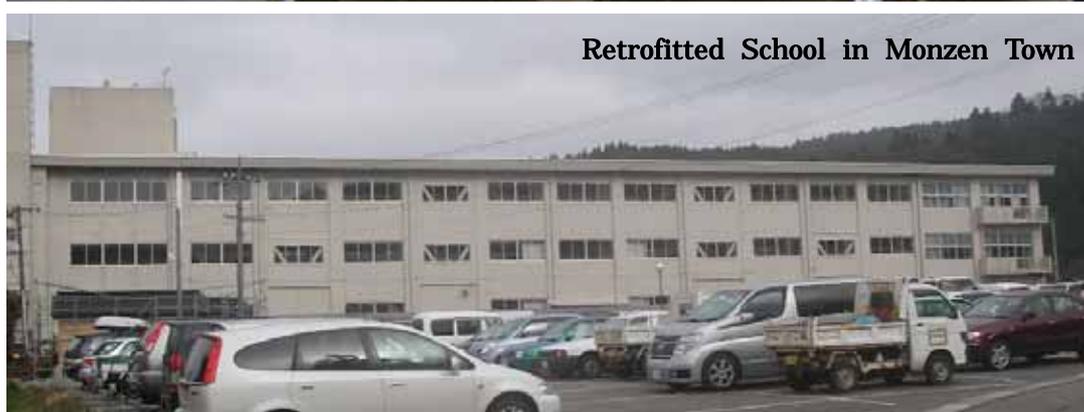
Figure 7.2: Non-damaged reinforced concrete building in Monzen town

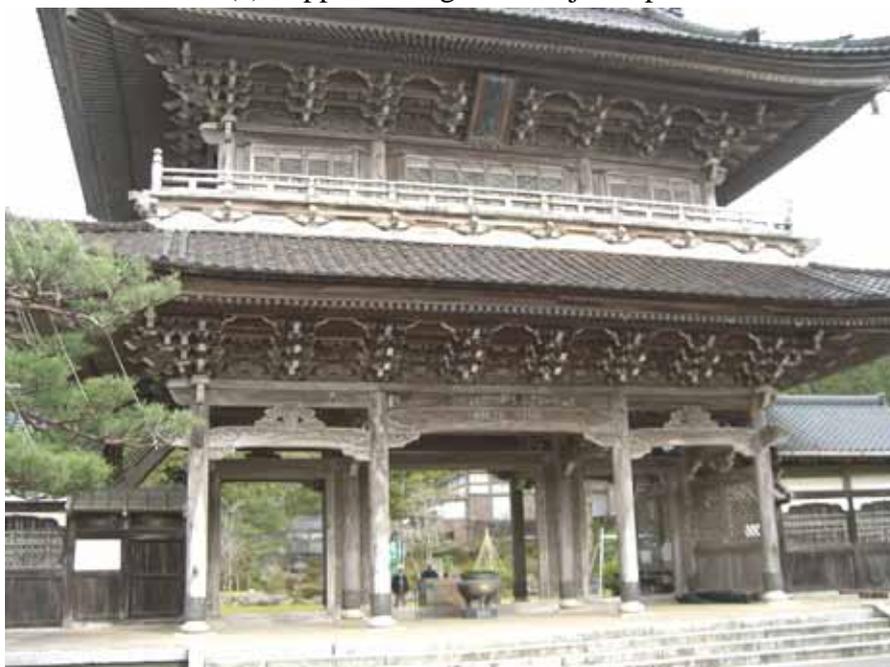
Damage to temples was generally observed at fort-gate (torii) made of granitic columns and beams. One spectacular example was observed at Soji Temple next to the NTT building. The granitic column were uprooted from their base and toppled as seen in Figure 7.3(a). The main compounds were generally non-damaged (Figure 7.3(b)) due to superior earthquake-resistant-ability.

(b) Intact compound of Sojiji Temple

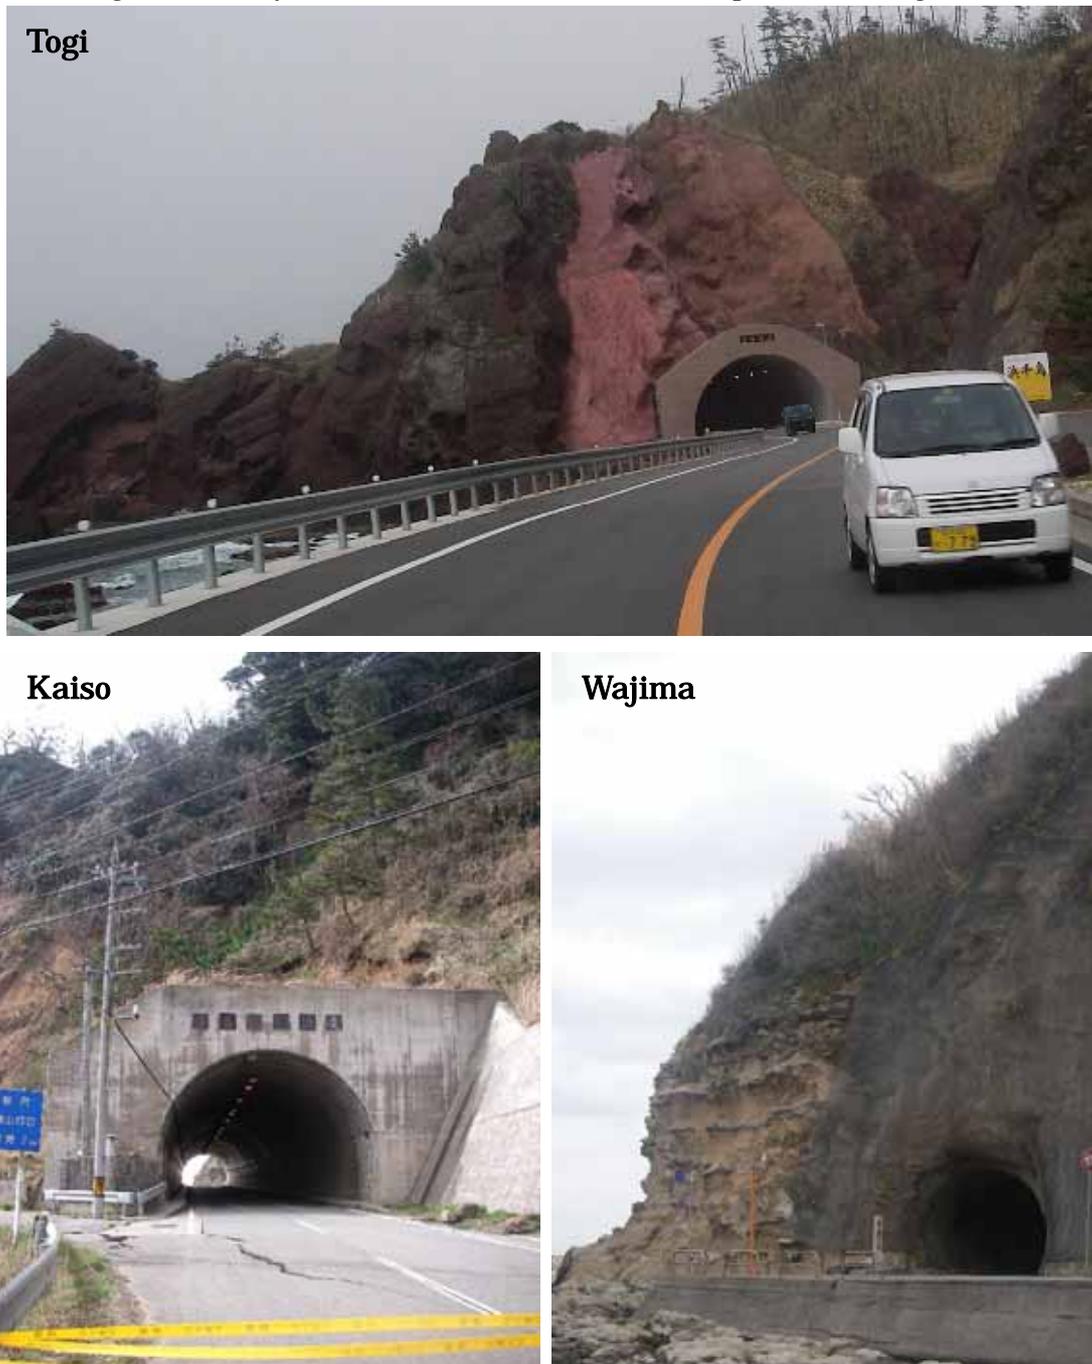
Since the area is quite hilly and it is well-known sites of landslides, many tunnels were constructed in association with highways, tollways and railway lines. None of tunnels was damaged even they were located next to extensive slope failures (Figure 7.9)

Figure 7.9: Non-damaged tunnels

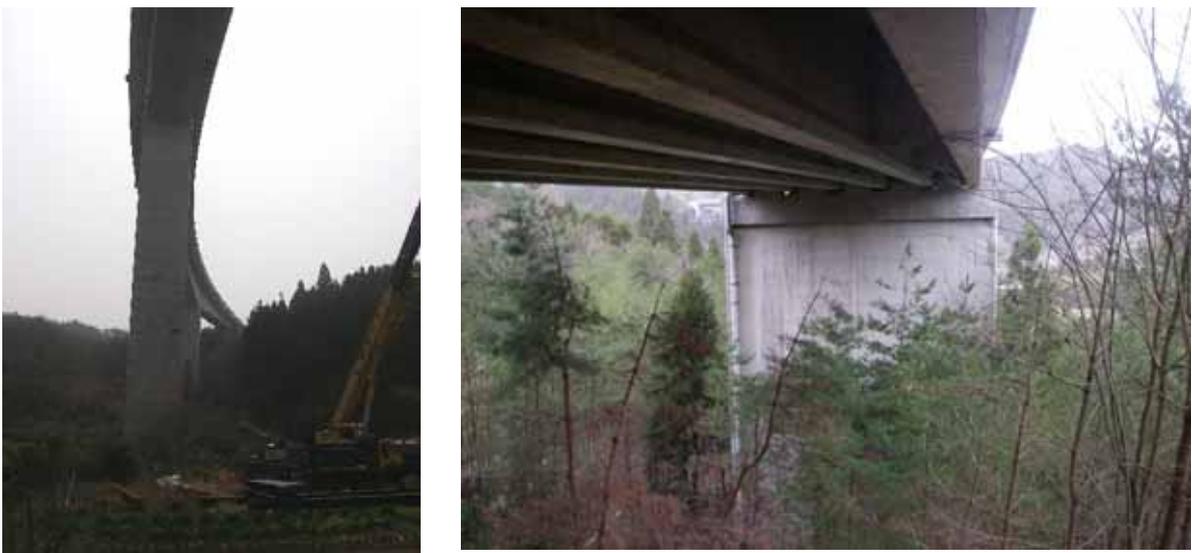
Noto bridge (viaduct) consists of 4 piers and prestressed curved girders are connected to each other at the mid. It is 400m long and 9.5m wide and it was completed in 1983 (Figure 7.10). The southern embankment of the viaduct was separated from the pier by more than 150mm and it had several open fractures. Furthermore, there were ruptured fragments on the western side of the girders at the middle of the viaduct (Figure 7.11). Although the separation was about 10mm, it seems that the girders might have collided with each other during the earthquake shaking. The observations from the ground indicated that the eastern side of the connection part is much wider than that on the western side.

Figure 7.10: Views of Noto Viaduct of Noto Tollway

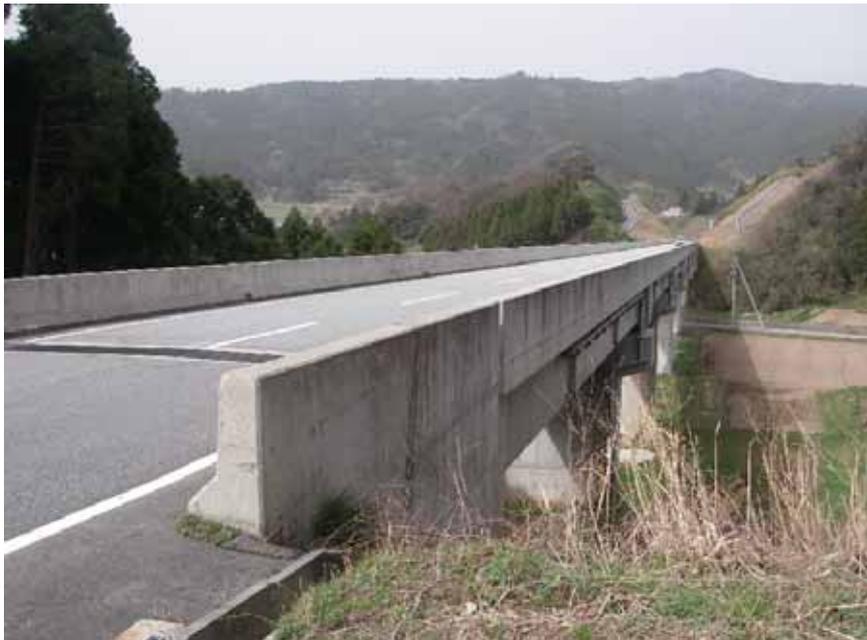
Toge viaduct is just south of Toge district of Monzen town. The viaduct consists of 5 piers with a height ranging between 10-13m and separated from each other by a distance of 33m and it has a continuous prestressed girder (Figure 7.12). The girder sits on rubber bearings and It was completed in 1999. The close inspection of this viaduct indicated that the girder was displaced by about 10mm southwardly with a slight rotation. Although none of piers were damaged by ground shaking, one of the rubber bearings at the northern abutment was ruptured as seen in Figure 7.13. The rubber bearings were subjected shearing at both abutments.

Figure 7.12: A view of Toge viaduct (view from south to north)

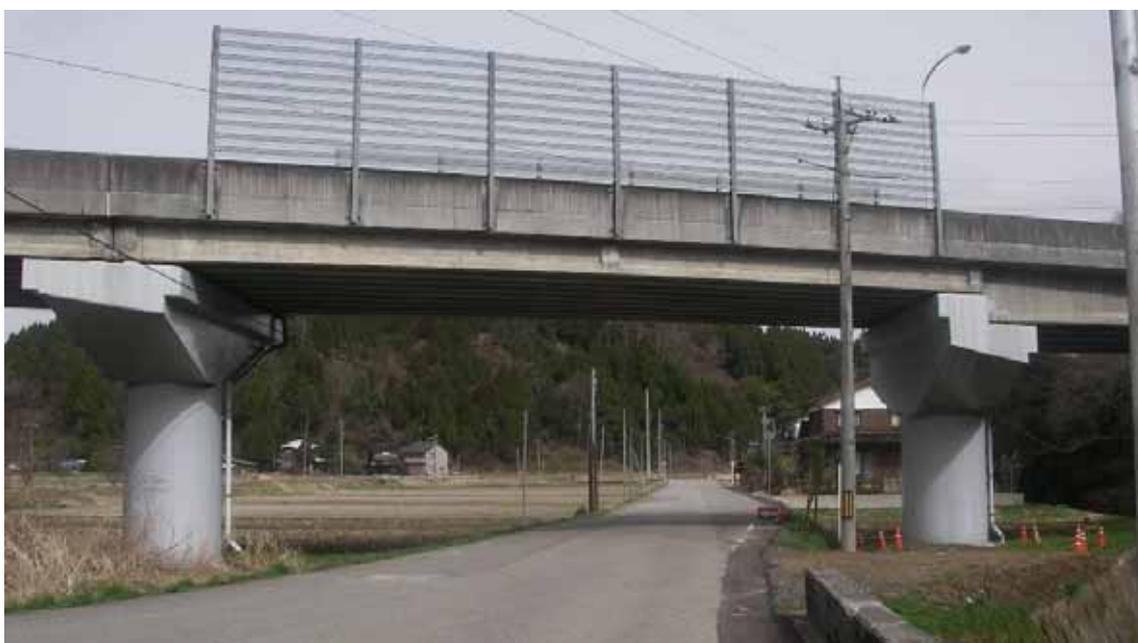
Ichinosaka is a four-span simple-beam type viaduct (Figure 7.14). The piers are of T-type and they were retrofitted with steel plates. Although there was no visible damage to bearings of the girders, the upper part of the piers underwent some cracking and spalling initiating from the junction between the steel-plates and upper concrete slab (Figure 7.15).

Figure 7.14: A view of Ichinosaka viaduct

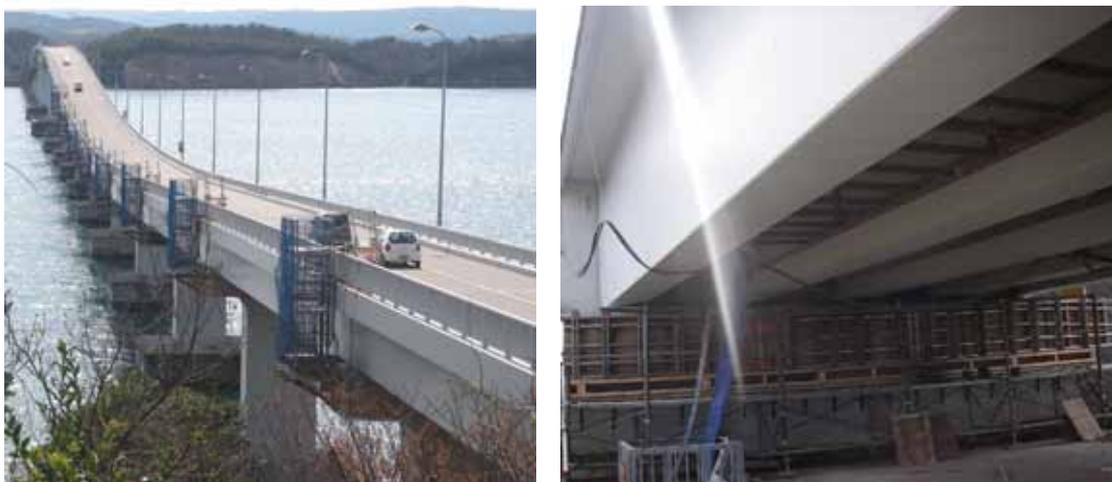
Notojima bridge was completed in 1982 and it is 1050m long. The central part of the bridge is 24.24m high to allow the passage of ships and designed as redundant 3-span box girders. The sides of the bridge consist of simple-structure girders on T-type piers. The bridge was undergoing retrofitting at the time of the earthquake. The earthquake did not cause any damage to superstructure except some embankment and slope failures nearby the abutments.

Figure 7.16: View of Notojima Bridge

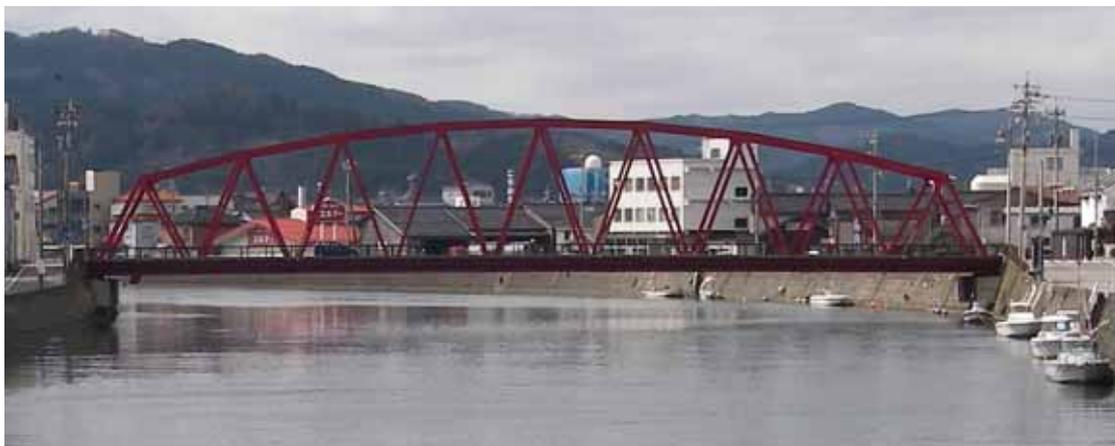
The construction of Iroha Bridge on Kawaharata river was completed in 1962 and it is a single span 50m long simply supported truss bridge (Figure 7.18). The abutment piers of the bridge were recently retrofitted. Cracking occurred at the southern side of the both piers and bearings were deformed at the west abutment due to sliding and rotation (Figure 7.19).

Figure 7.18: Iroha truss bridge (view from north to south)

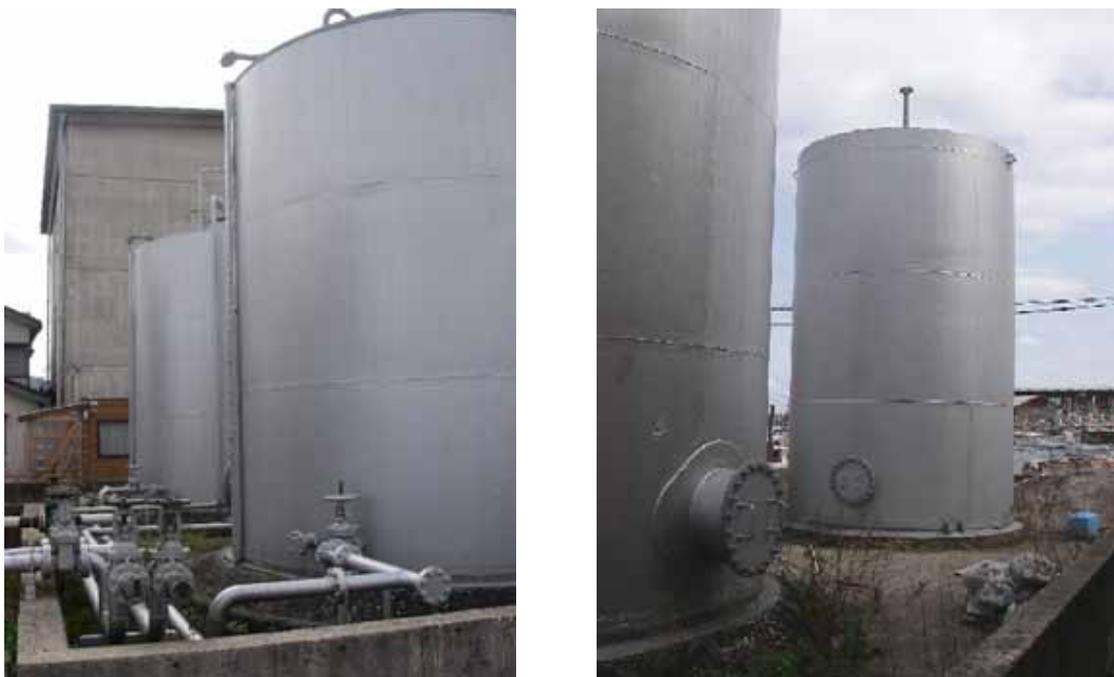
(a) Tanks at Wajima port

There is so far no report of damaged storage tanks in the epicentral area. Some storage tanks of petroleum and natural gas are located in major cities in the epicentral area. The authors were only able to inspect petroleum tanks in Wajima and Kaiso ports (Figure 7.25). These tanks are small in size and have a cylindrical shape. The close inspection of the tanks at Wajima and Kaiso ports did not reveal any visible damage.

Figure 7.25: Views of tanks at Wajima and Kaiso ports

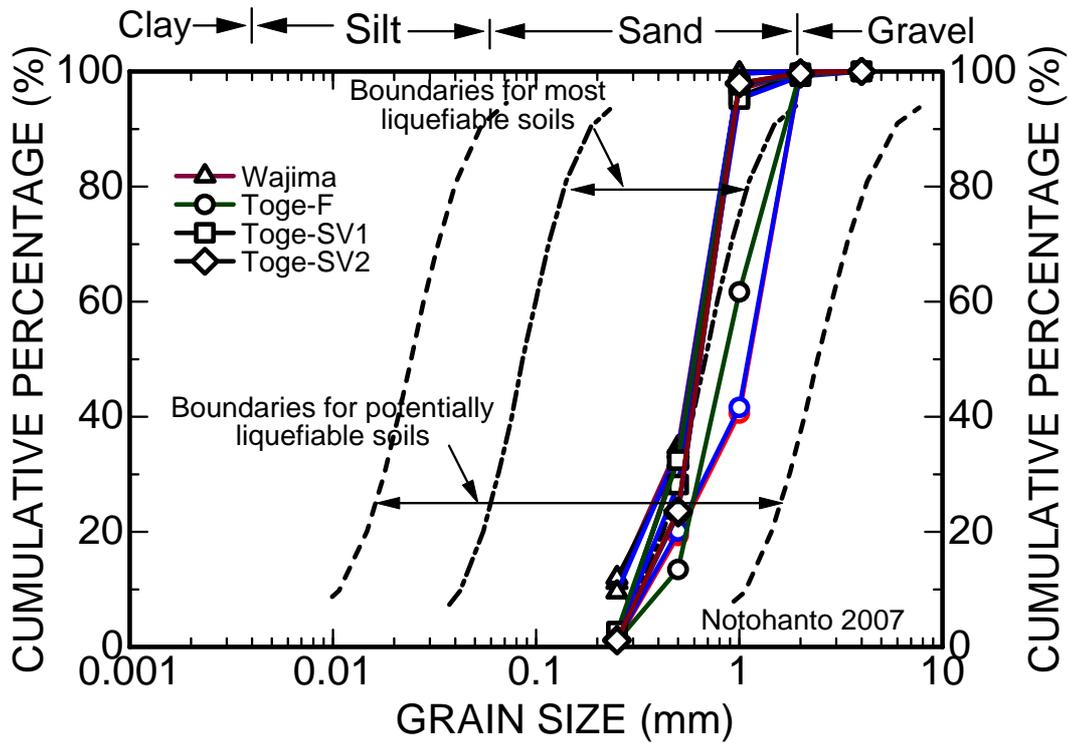
Table 8.1: Properties of liquefied soil samples collected from sand volcanoes

Soil Sample Location	Dry Unit Weight (kN/m ³)	Porosity (%)	Mean Grain Size D50 (mm)	Friction Angle (°)
Toge-F	14.7	38.4	0.8-1.0	27-30
Toge-SV1	14.9	43.4	0.56	29-32
Toge-SV2	13.4	39.8	0.58	28-31
Wajima	12.6	42.9	0.57	29-32

Figure 8.1: Grain-size distribution of liquefied sand

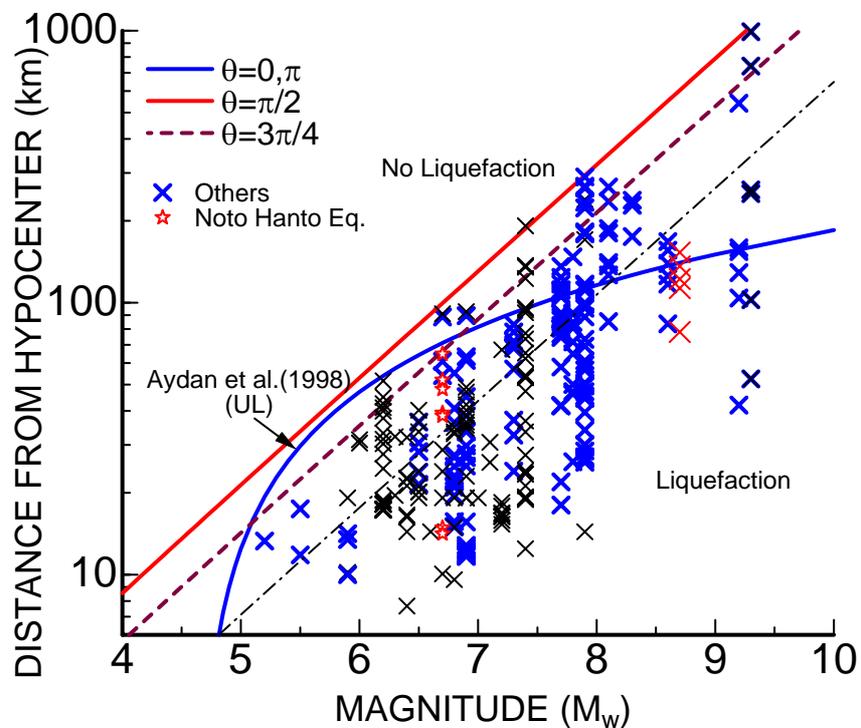
Figure 8.2: The relation between the hypo-central distance and earthquake magnitude for liquefied sites together with liquefaction state limits

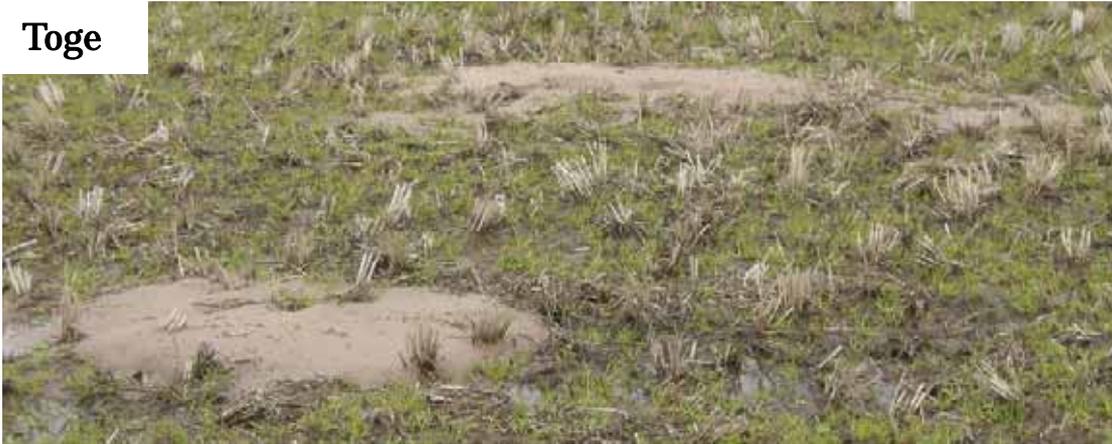
Soil liquefaction was observed at several locations. The authors found traces of liquefaction in the upper and lower parts of Toge district, where the damage was the severest. The liquefaction of ground also occurred in Wajima port area, where the expansion of the port is now implemented. It was very interesting to note that the soil boils observed in a sports ground covered with clayey embankment material while no sand boils were observed along the shore where sand was exposed. The authors consider that the sandy ground should had been also liquefied. The main reason for sand boils might be such that the embankment material acts as an impermeable lid on the liquefied ground and result in prolongation of liquefaction state while ground without such a lid quickly dissipates the excess pore pressure. Since the embankment layer ruptures during shaking, the ruptures acts as vents for sand to come out the surface due to excess pore pressure.

Liquefaction was observed at other locations such as Anamizu, Tatsuruhama and Shika towns, Nanao city of Ishikawa prefecture and Himi town of Toyoma Prefecture. Compared to the effects of ground liquefaction observed during Chuetsu-Niigata earthquake, this earthquake did not cause much damage to structures due to ground liquefaction. The physical and geotechnical properties of one of the soil samples collected are given in Table 8.1 and grain-size distributions are shown in Figure 8.1. Figure 8.2 shows the relation between the hypo-central distance and earthquake magnitude for liquefied sites together with liquefaction state limits. Figure 8.3 shows several views of soil liquefaction in the earthquake-affected area.

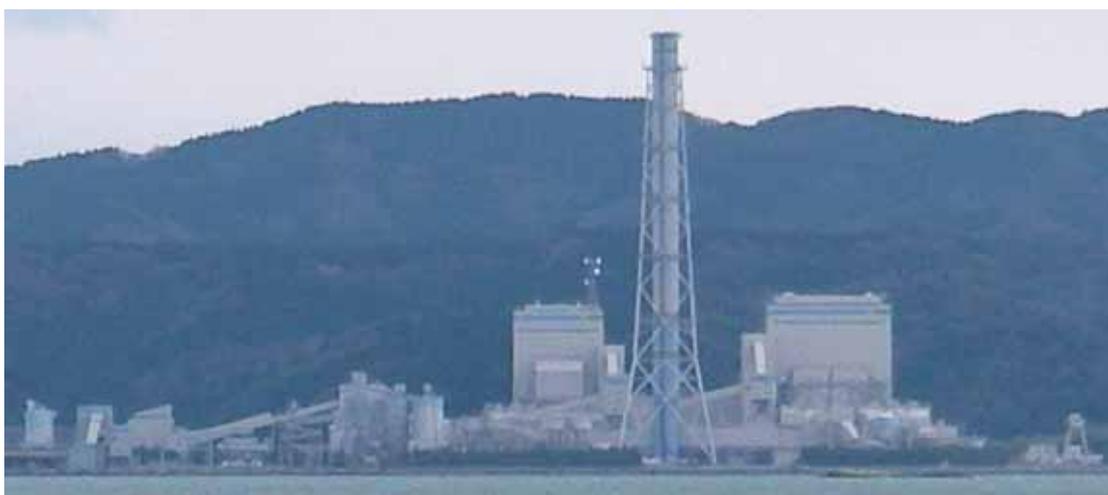
The electric supply to the earthquake stricken area was shutdown following the earthquake. Except heavily damaged areas, the electricity was restored on the same day following the earthquake. Hokuriku Electric Power Company provides the electricity supply of the area. In the epicentral region, the power company has a thermal power plant and a nuclear power plant. The units of the power plants were automatically shot-down after the earthquake. Ohta thermal power plant of Hokuriku Electric Power Company was re-activated on March 27. Since problems were observed with pumps for cooling water, the plant operation was suspended until April 1. The thermal plant is in full operation now. The nuclear power plant was not operating during the earthquake due to maintenance work. However, the earthquake caused some spill of radioactive water in the plant.

Figure 9.1: A view of Ohta Thermal power Plant in Nanao City
