## 2003年アルジェリア北部の地震 報告2 : ALGER – BOUMERDES, ALGERIA EARTHQUAKE OF MAY 21, 2003

Kheir-Eddine Ramdane, JSPS Research Fellow  
Building Research Institute, 1 Tachihara, Tsukuba, Ibaraki 305-0802  
[eddine\\_r@yahoo.fr](mailto:eddine_r@yahoo.fr) or [eddine\\_r@kenken.go.jp](mailto:eddine_r@kenken.go.jp)

### PART I : INTRODUCTION, EARTHQUAKE CHARACTERISTICS AND DAMAGE

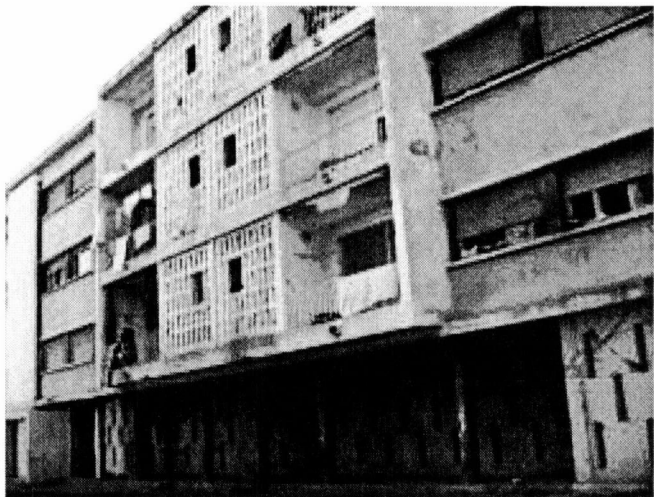
(ii) The structure underwent structural and non-structural damages:

One line of structural columns underwent bursting of concrete at the plastic hinges (at the base and top), without rupture of the reinforcement. The bursting is accompanied by a light buckling of longitudinal reinforcement.

(v) Only the ground floor which underwent structural damages.

General vue of the building block

From this study, it is imperative to proceed with the retrofitting of the building by jacking the columns of the ground floor. It is to be noted that:

- If the structure is to resist a future earthquake, it is very important to proceed to the column jacking by symmetry, because strengthening one direction only can cause an important torsion at the time of strong shaking ground. This type of strengthening is oriented for both vertical and horizontal loads.
- If the structure is just to be repaired because of the damage caused by the earthquake, then only the damaged columns have to be jacked. This type of strengthening is oriented for vertical load solely.

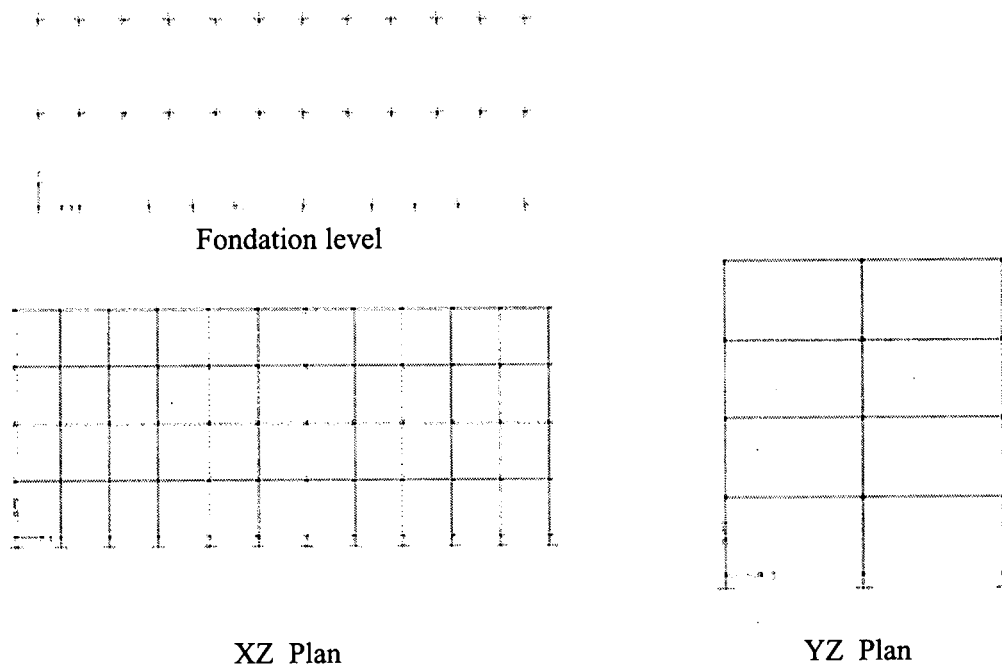
Figure 12 : structural model

The strengthened structure (jacking) is studied supposing that the structure is implanted in III zone, and the solution of strengthening is verified by mean of the software SAP2000 version 7.4. A 3-D finite element is used. Besides, the soil considered for the structure is a strengthened Earth.

It is important to note that this structure is analyzed while considering a reduced modulus of elasticity of 1/3, in order to take account of the rigidity deterioration caused by the earthquake.

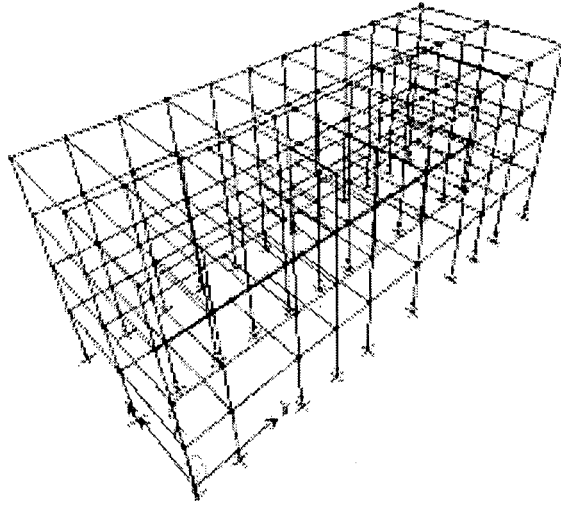
Figure 13 : the considered 3-D Structure for analysis

In absence of reliable data on the site, it can be considered that the category of site is  $S_3$ , where  $T_1 = 0.15s$  et  $T_2 = 0.5s$ .

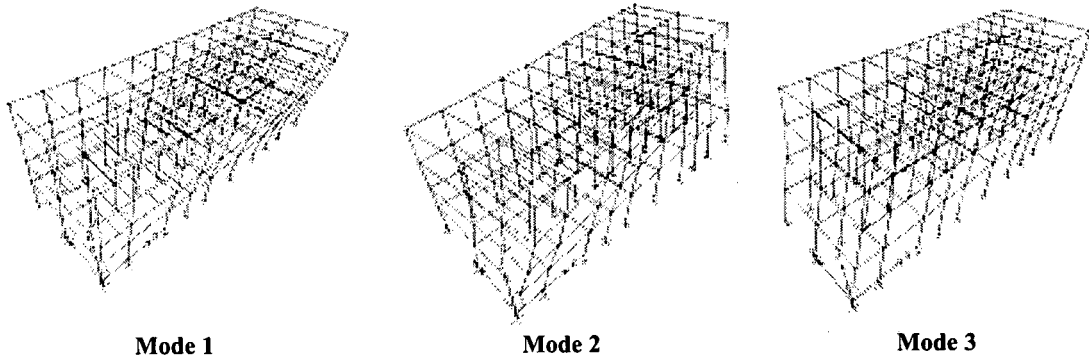
Figure 14 : Modes of vibration

The forces - as well as the generalized deformations - of all structural elements of the structure are now known for the dynamic analysis (spectral response); these are given for all considered combinations. The shape of the structure brought us to keep the first 12 modes of vibrations for the structure.
