10. LIQUEFACTION AND GROUND FAILURES

10.1. Liquefaction and Its Effects

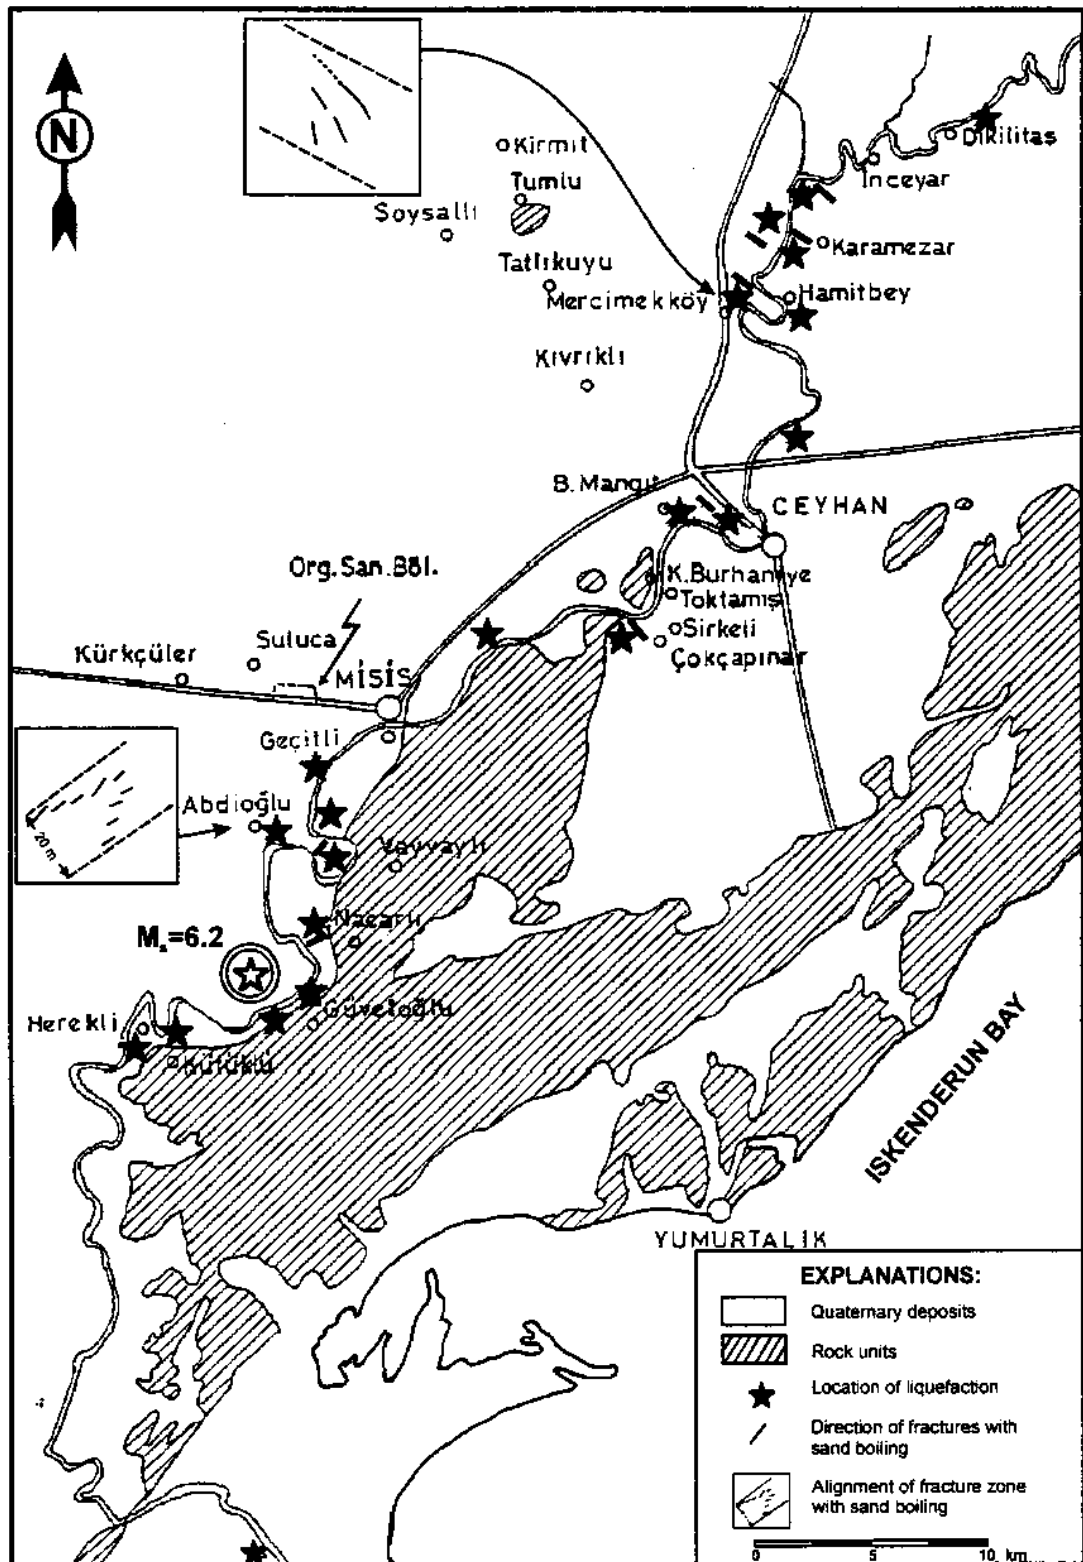
It is interesting to note that the liquefaction sites ranged in the alluvium along the Ceyhan River and on its flood plains as shown on the map given in Figure 10.5. The general distribution of the ground fissures and sand boils on the floodplains were surveyed. Liquefaction fissures and sand boils are evidently observed in Abdioğlu, Nacarlı, Geçitli, Misis, Çakıldere, Çokça, Toktamış, K. Burhaniye, SW of Ceyhan town, Büyük Mangıt, Mercimekköy, Hamitbey, Adapınarı, İnceyar and Dikilitaş settlement areas. The general trends of the eruption fissures are N 50-70 E and N 60-70W of the southern and northern parts of Ceyhan town, respectively (Figure 10.5). Liquefaction trends appear systematically along the extension fractures developed during this earthquake. According to local people, liquified soil and water rised up to 7-8 m above the surface during the main schok. Ground fissures and sand boils were the most widely distributed permanent surface effects generated by Adana-Ceyhan earthquake. Besides, damages beneath the structures were also observed in the earthquake area. The most spectacular damage to structures at Abdioğlu settlement area was the tilting of a fountain in the garden of primary school (Figure 10.6), and a

Figure 10.5 Locations of liquefaction sites

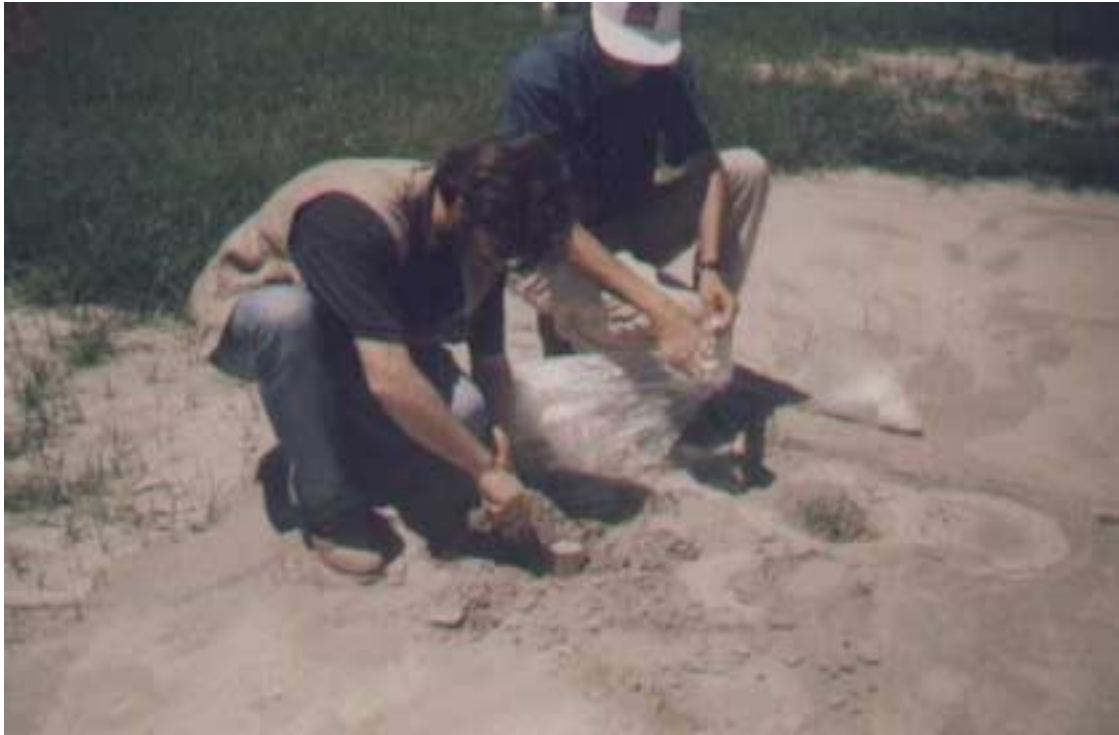
Figure 10.9: Tube and bag sampling at a liquefaction site

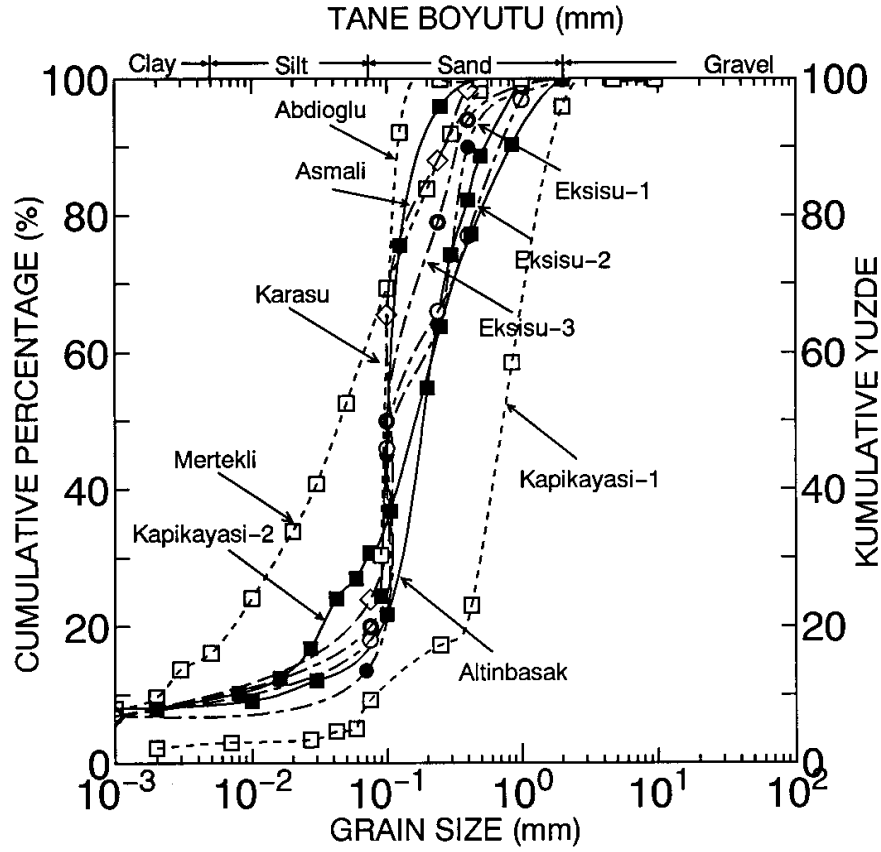
Grain size analyses were conducted on 8 specimens from both liquefied and non-liquefied soils. Figure 10.10 shows particle size distribution curves of liquefied soils

Figure 10.10: Grain size distribution curves of the soil samples taken from the non-liquefied uppermost layers of the alluvium in Ceyhan Basin

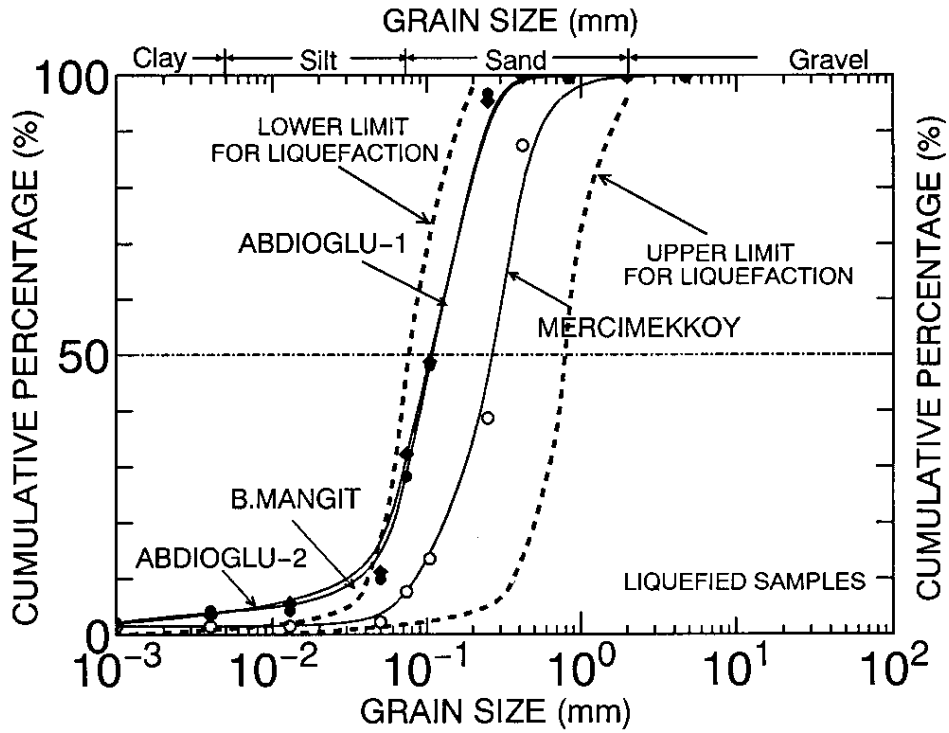
from previous earthquakes in Turkey. Figure 10.11 shows that fine-to-medium sand sized material ranging between 82 and 94 % is the dominant in the liquefied soils in Çukurova basin. The grain size distribution of these liquefied soils fall between the well known upper and lower limits for liquefaction (see Figure 10.11). It is evident that all the samples from the liquefied layers do not meet the requirements of the Unified Soil Classification System where a well-graded sandy soil should both $C_u > 6$ and C_c between 1 and 3. Their properties indicate that these soils are poorly-graded fine-to-medium sands with a very low percentage of fines. By employing the procedure suggested in the Unified Soil Classification the soil samples from this zone fall into SP group. The D_{50} of the soil grains of this sand does not show a scatter and ranges between 0.11 and 0.3 mm indicating that the soil is highly susceptible to liquefaction (Iwasaki, 1986). Both the partial characteristics of the soil and high groundwater levels in conjunction with active seismic features of the region result in a condition which is favorable for the occurrence of the liquefaction.

Figure 10.11: Grain size distribution curves of the soil samples taken from the non-liquefied uppermost layers of the alluvium in Ceyhan Basin

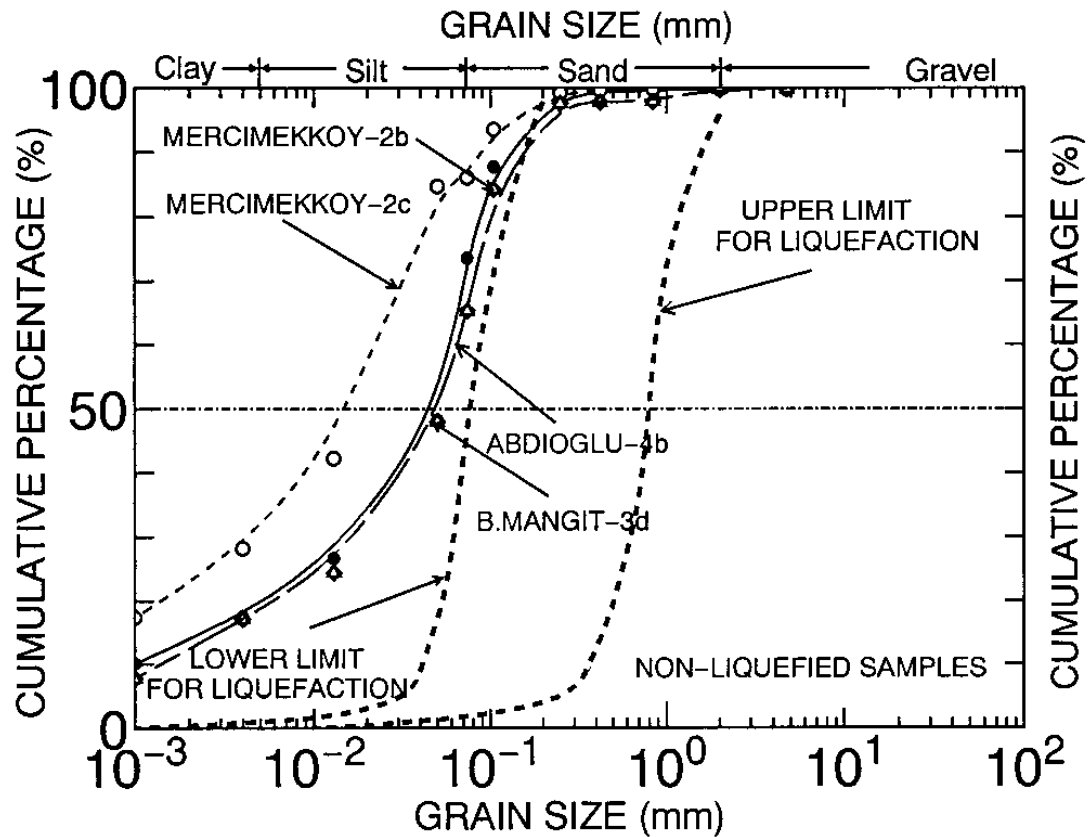
Based on the results obtained from three specimens (Figure 10.12), the uppermost soil overlying the sandy liquefiable level is a fine-grained soil (40-84 % silt and clay with some sand (16-60%)). D_{50} values obtained from this level vary between 0.019 and 0.07 mm. Except one specimen (2b) which is non-plastic, the index properties of this fine-grained soil indicate that the liquid limit (LL) and the plasticity index (PI) range from 27.4-35.7 % and 6.4-8.8 %, respectively. Evidently all samples have liquid limits less than 50 %, suggesting low plasticity. These soils are classified as ML group soil and defined as silty clay. The reason for not occurring liquefaction in this layer could be its fine grained composition, mean grain size, its position with respect to groundwater table and the amplitude of acceleration waves. It is also noted that the grain size distribution of the non-liquefied soils do not fall within the well known liquefaction range and they are consistent with non-liquefaction based on grain size (see Figure 10.12).

Figure 10.12: Grain size distribution curves of the soil samples taken from the non-liquefied uppermost layers of the allivium in Ceyhan Basin

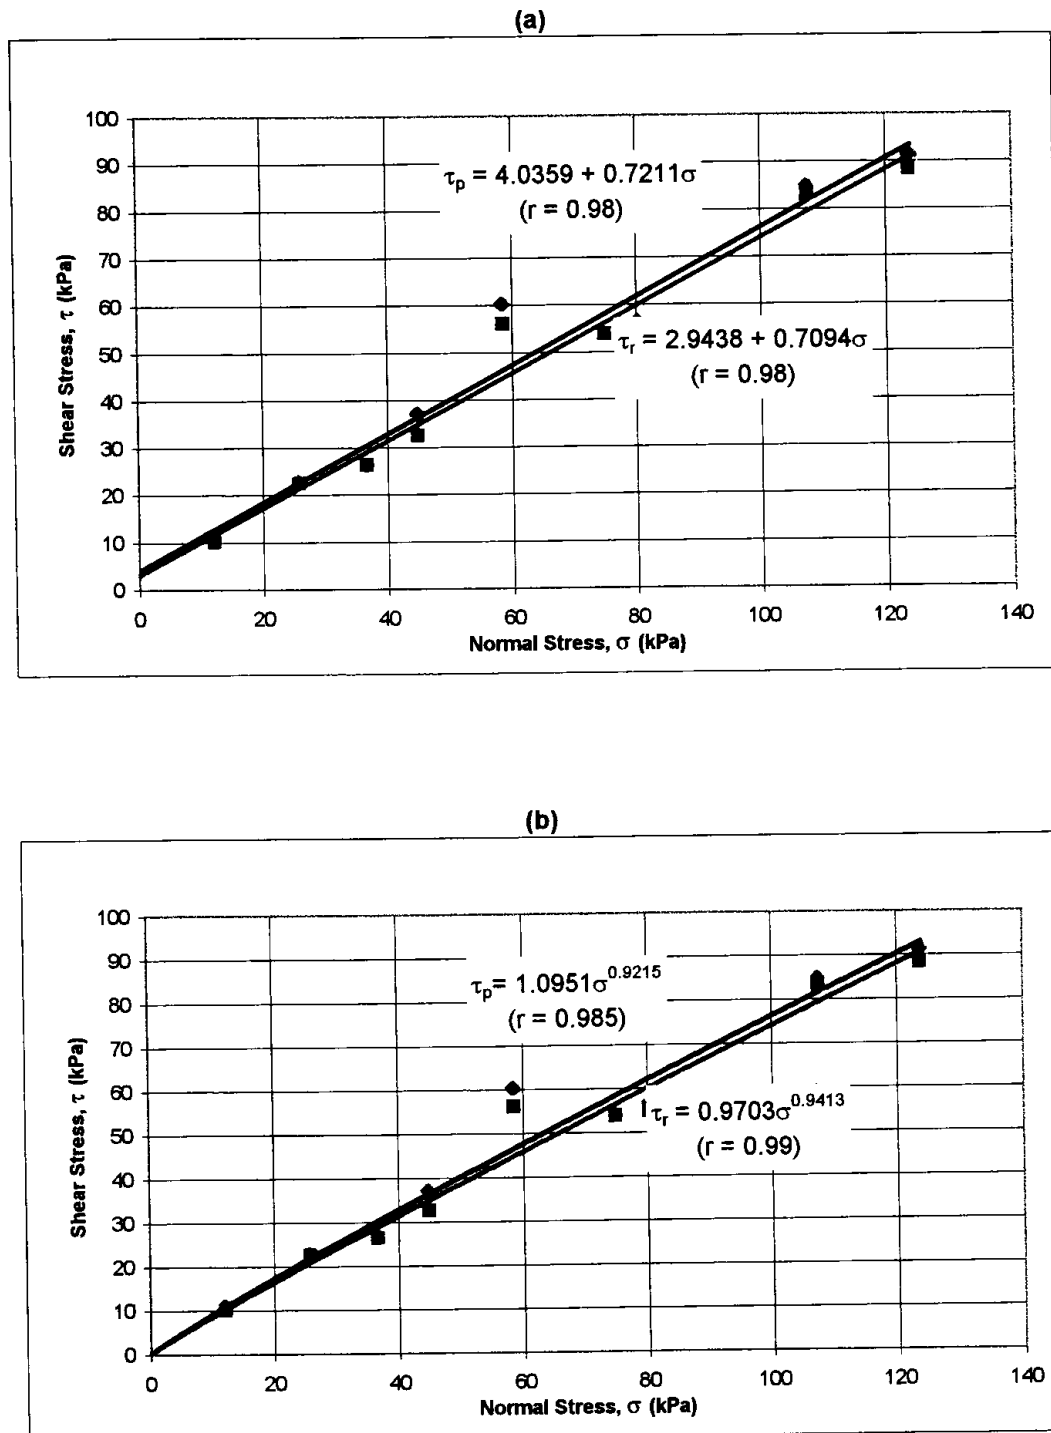
Shear strength parameters from the failure envelopes based on the linear and geometric regression analyses show a consistency and yield similar coefficients of correlation. Considering this agreement, shear strength parameters obtained from the linear envelopes can be used. Peak cohesion and peak internal friction angle of the specimens vary between 0 and 8.7 kPa and 33.7° and 36.4° , respectively. It is also noted that the residual parameters are very close to peak parameters. The cohesion intercept obtained from two samples (samples 1 and 3a) is probably due to the presence of low amount of fines. To obtain general failure envelopes of peak and

residual strength representing the liquified soil, all test data were plotted on a single σ - τ graph (Figure 10.13).

Figure 10.13: Generalized linear (a) and non-linear (b) failure envelopes of the liquefied soils

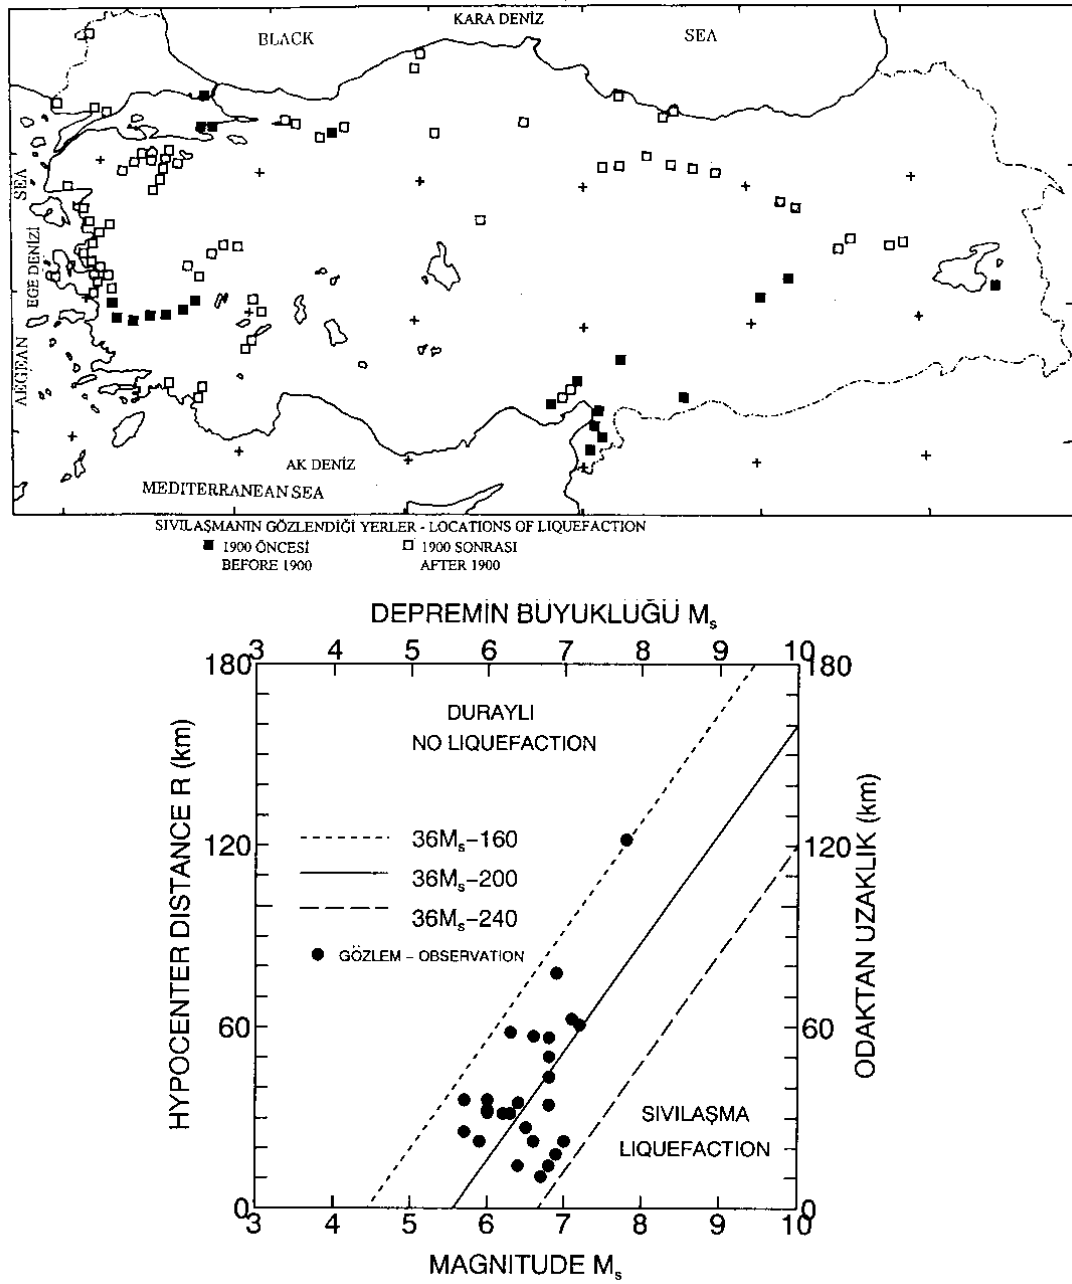
Aydan and Kumsar (1997) compiled some data on the locations of earthquakes and developed some empirical relations between magnitude of earthquake and hypocenter distance for liquefaction - non-liquefaction states. Figure 10.14 compares data obtained in this earthquake with the data from other Turkish earthquakes. The data gathered in this earthquake are within the empirical bounds.

Figure 10.14 Locations of liquefaction in Turkey and comparison of data from this earthquake with other Turkish earthquakes
