## **7. DAMAGE TO STRUCTURES**

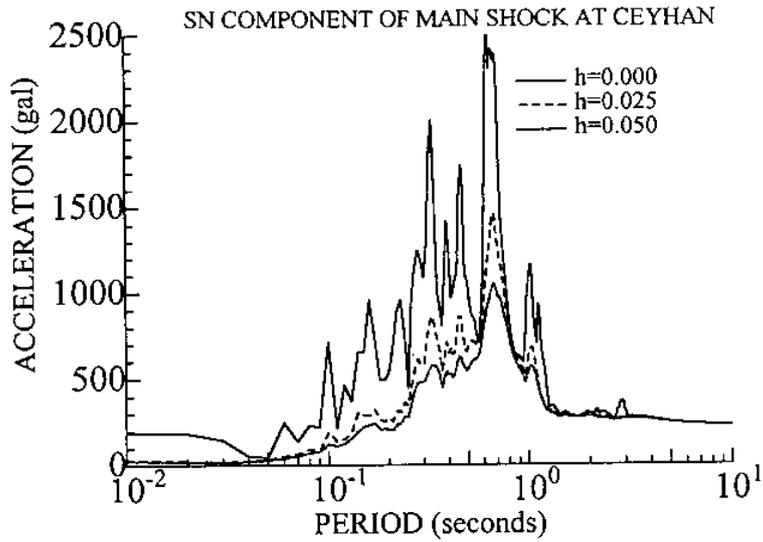
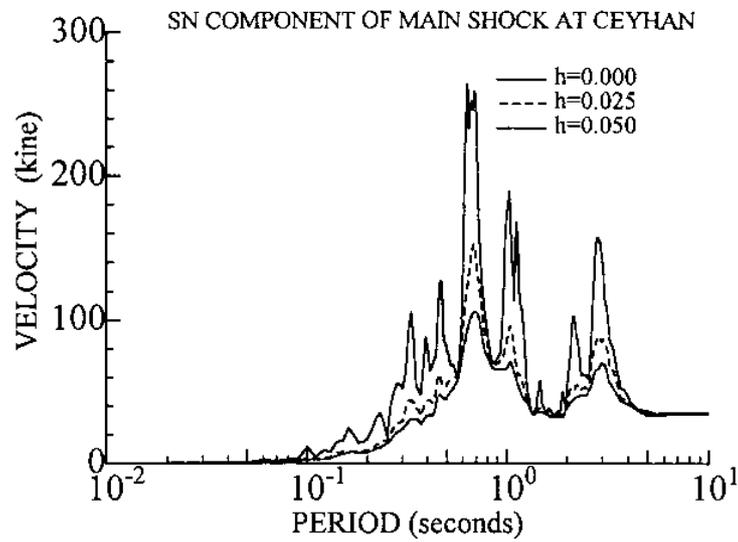
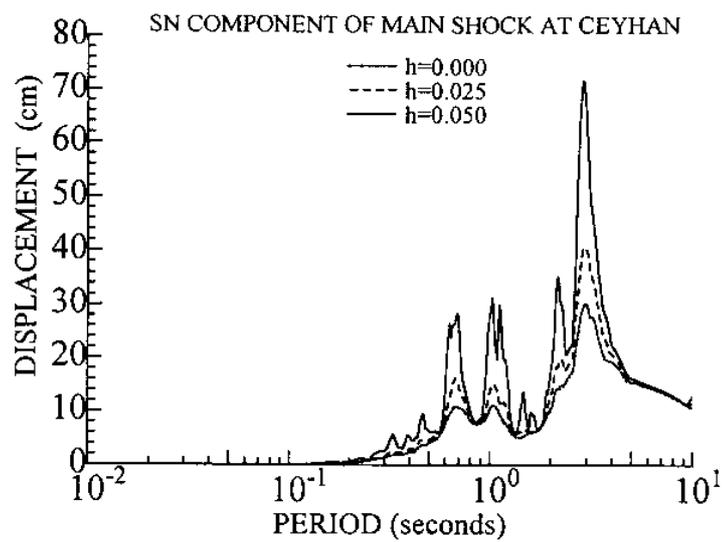
The response spectra of the main shock are shown in Figures 7.1, 7.2 and 7.3. The SN spectra have peaks at periods of 0.33s, 0.45s and 0.70s (Figure 7.1). The EW spectra analysis shows peaks at periods of 0.15s, 0.25s, 0.35s, 0.47s, 0.68s and 1.10s (Figure 7.2). The UD spectra yield peaks at periods of 0.06s, 0.15s, 0.32s, 0.35s, 0.47s, 0.68s and 1.10s (Figure 7.3). It is of great interest that the response spectra is very flat for periods between 0.25s and 0.80s. The width of flat response spectra is much more evident for UD component and it ranges between 0.15s to 1.1s.

Figure 7.1 The SN acceleration, velocity and displacement response spectra of the main shock.

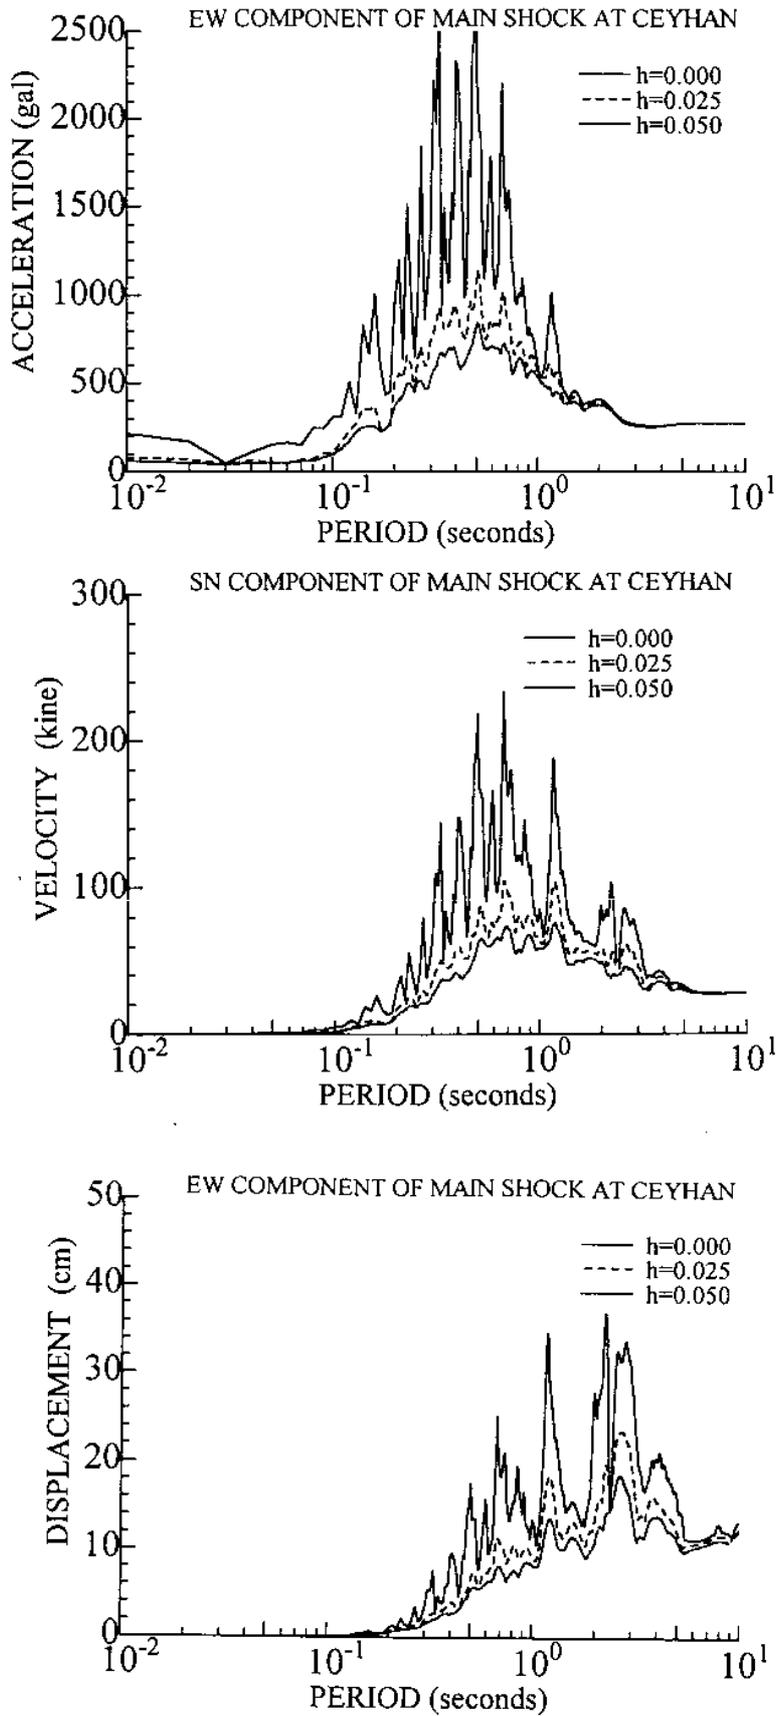
Figure 7.2 The EW acceleration, velocity and displacement response spectra of the main shock.

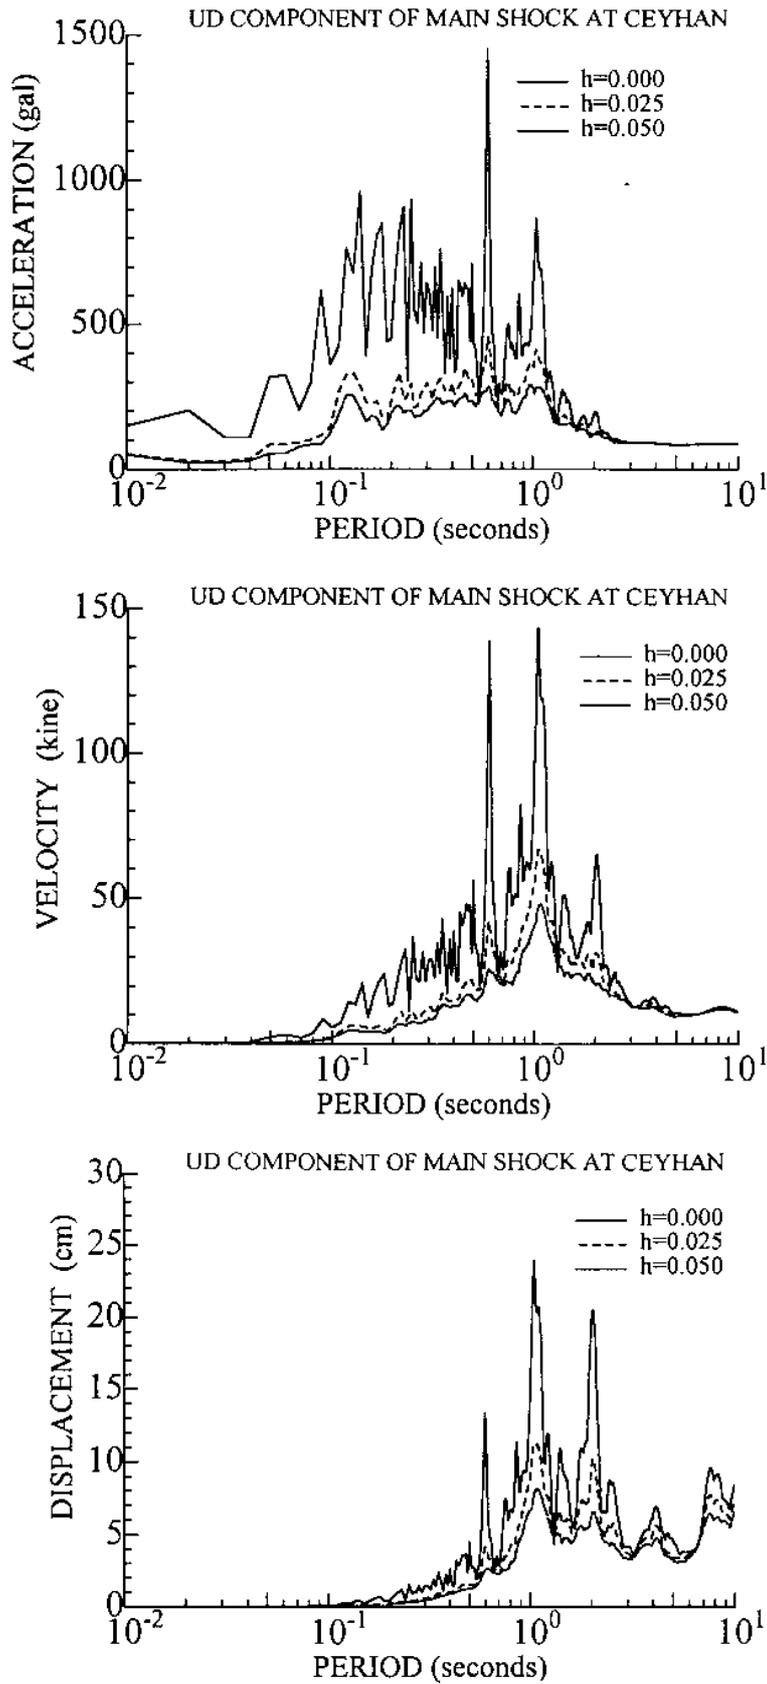
Figure 7.3 The UD acceleration, velocity and displacement response spectra of the main shock.

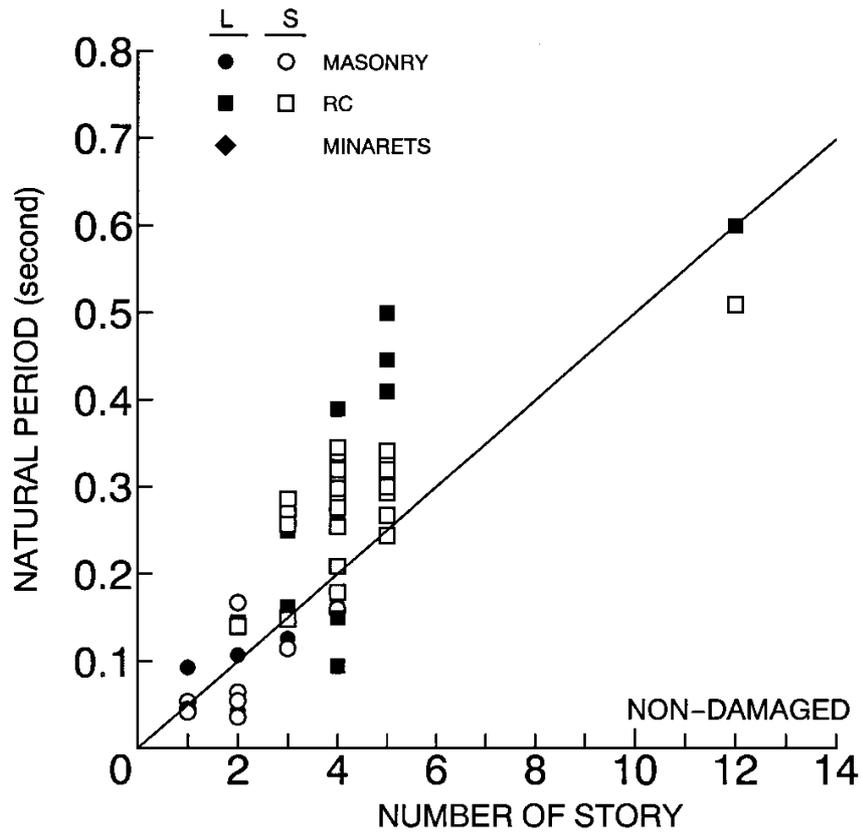
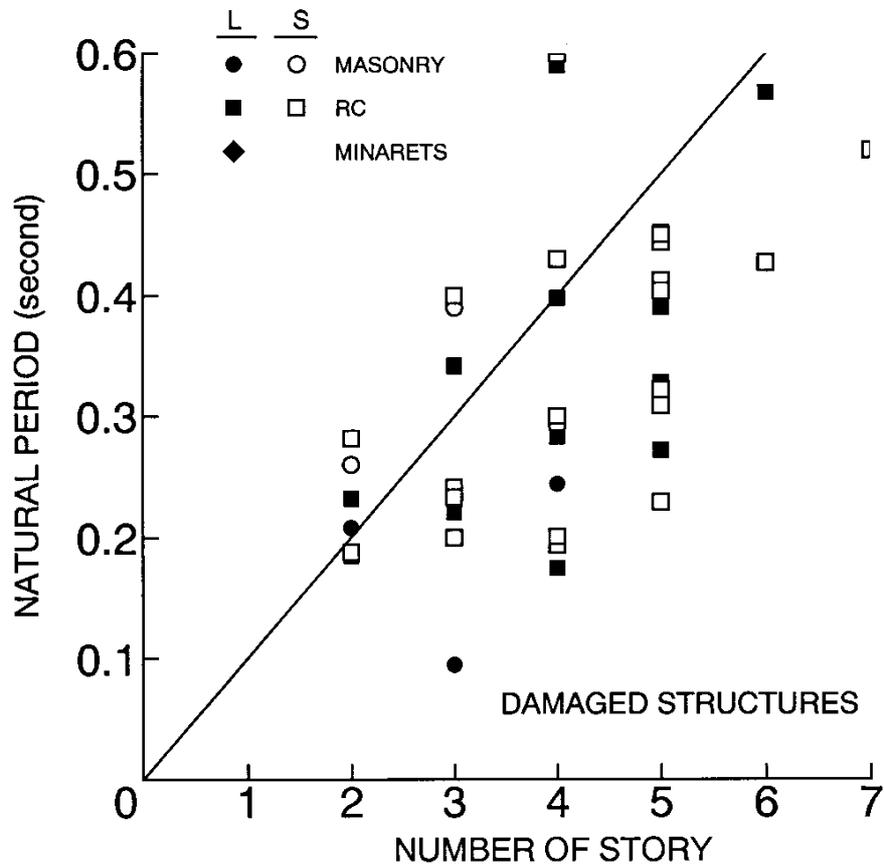
Data reported by Bayulke (1978) and with new additional ones are plotted in Figure 7.4. This experimental data were fit to a linear function. The following relations approximately hold between the natural period  $T$  of the building and the number  $N$  of stories:

Figure 7.4 The relations between the natural period  $T$  and the story number  $N$  of the structures in Turkey

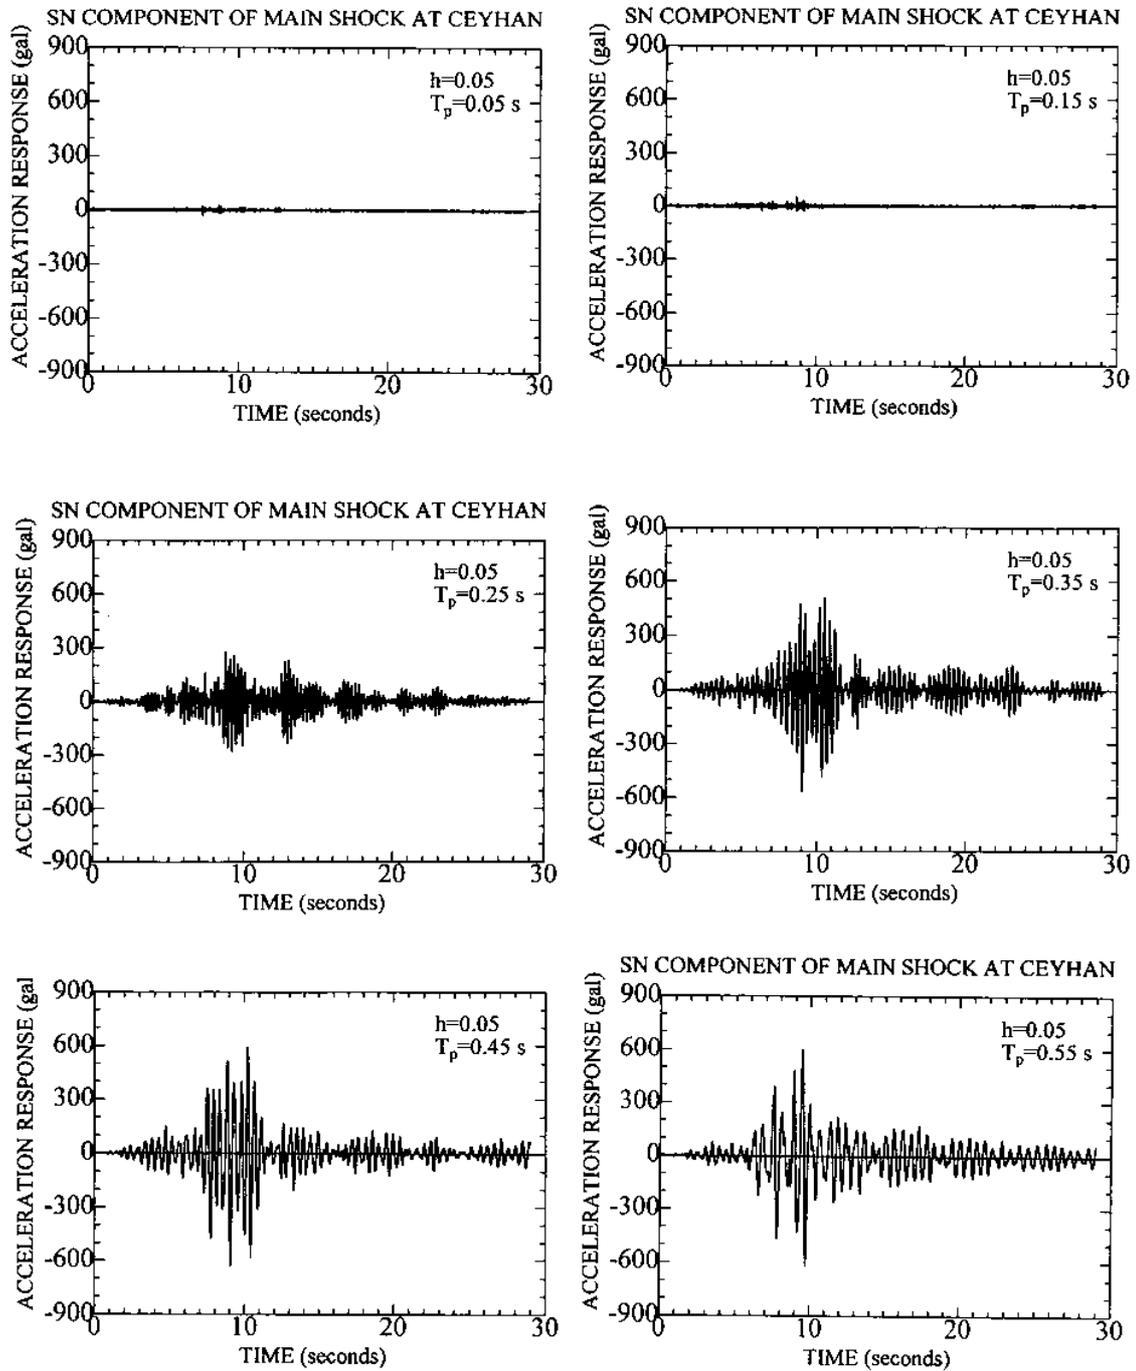
Figures 7.5, 7.6 and 7.8 show acceleration response of structures with natural periods of 0.05, 0.15s, 0.25s, 0.35s, 0.45s, 0.55s. As seen from these figures, buildings with natural periods ranging between 0.25 to 0.55s should be subjected to very large earthquake loading. Therefore, it is expected that these structures having a natural period ranging between 0.25s and 0.55s, founded on alluvial deposits should be more severely damaged if their resistances are not sufficient against the resonance phenomenon.

Figure 7.5 SN acceleration response of structures with natural periods of 0.05, 0.15s, 0.25s, 0.35s, 0.45s, 0.55s

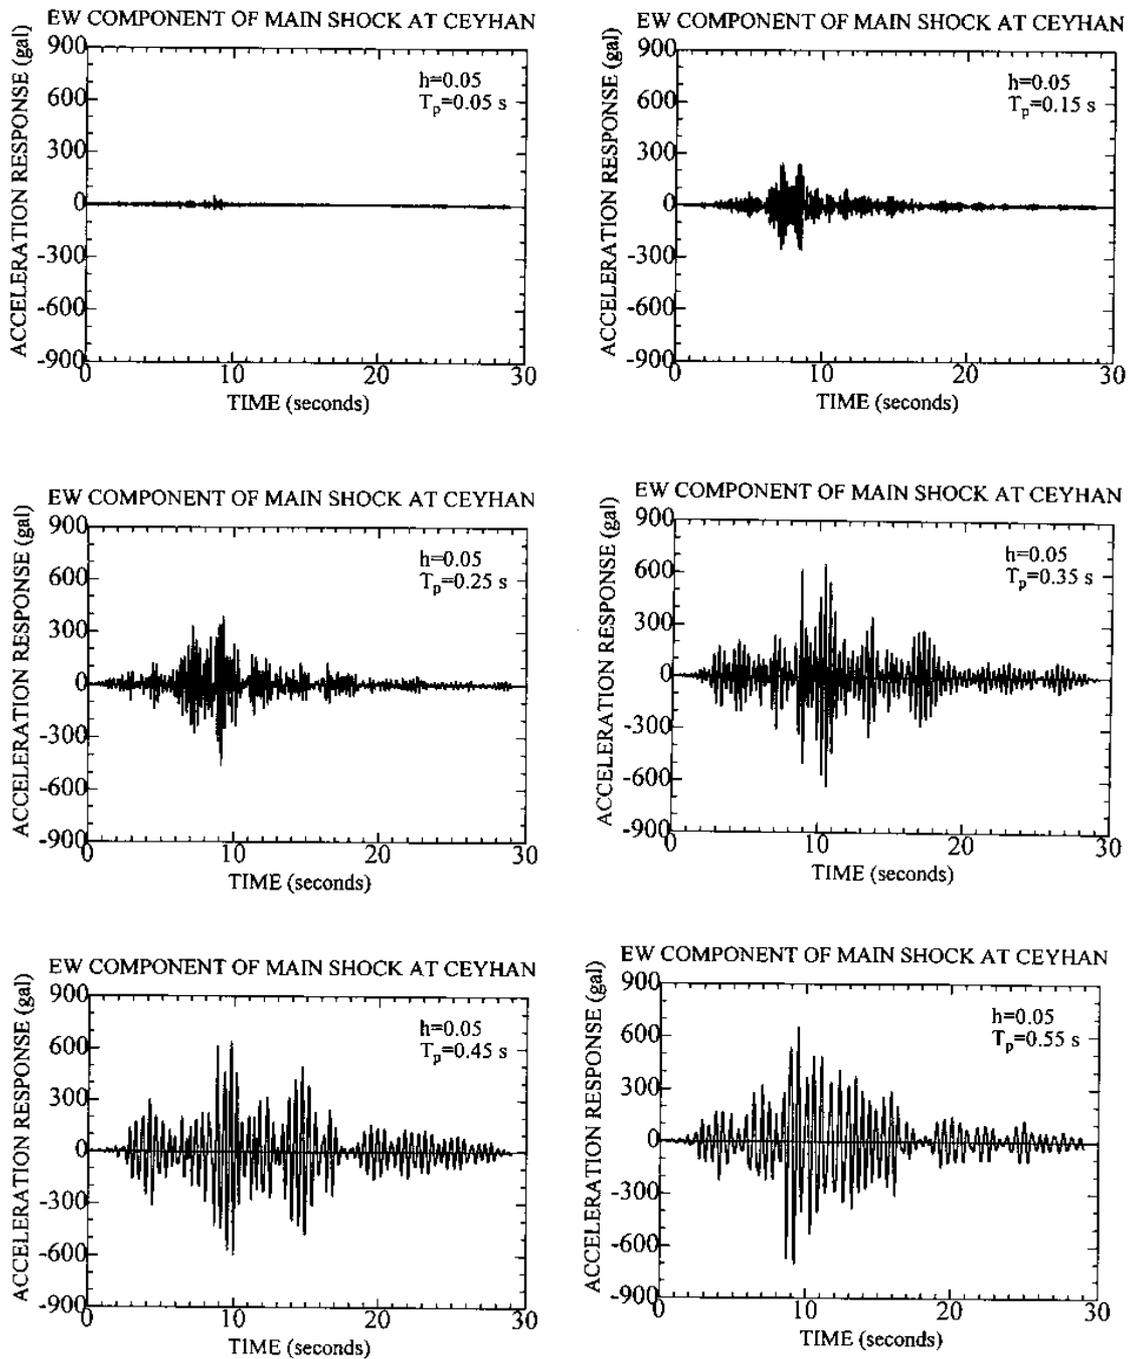
Figure 7.6 EW acceleration response of structures with natural periods of 0.05s, 0.15s, 0.25s, 0.35s, 0.45s, 0.55s

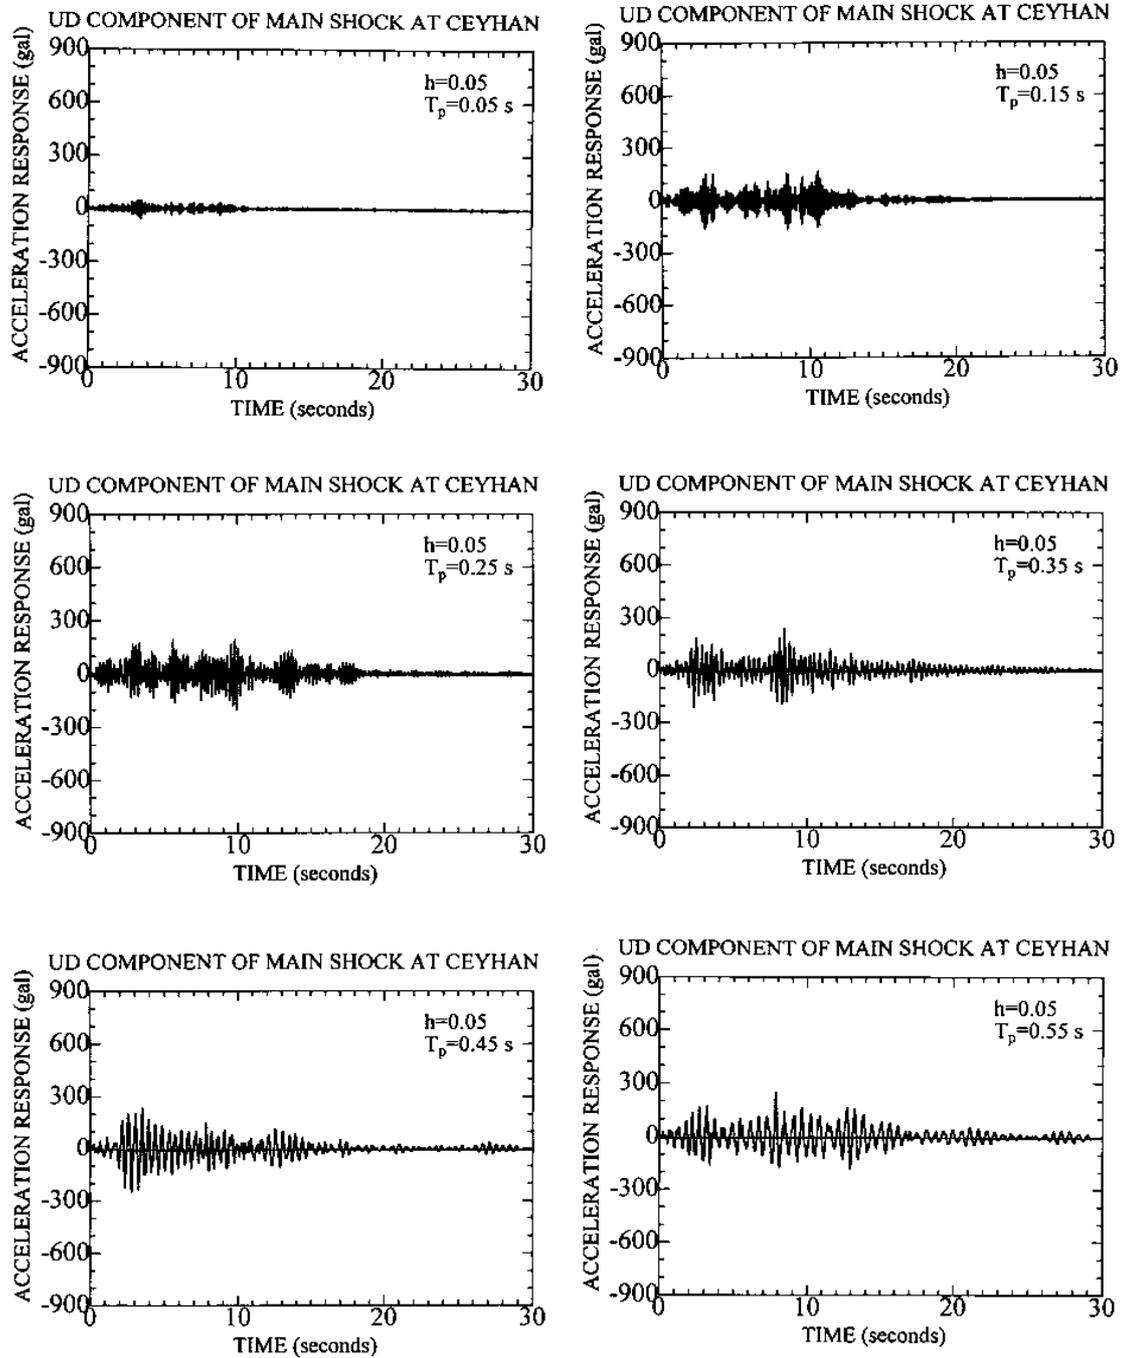
Figure 7.7 UD acceleration response of structures with natural periods of 0.05, 0.15s, 0.25s, 0.35s, 0.45s, 0.55s

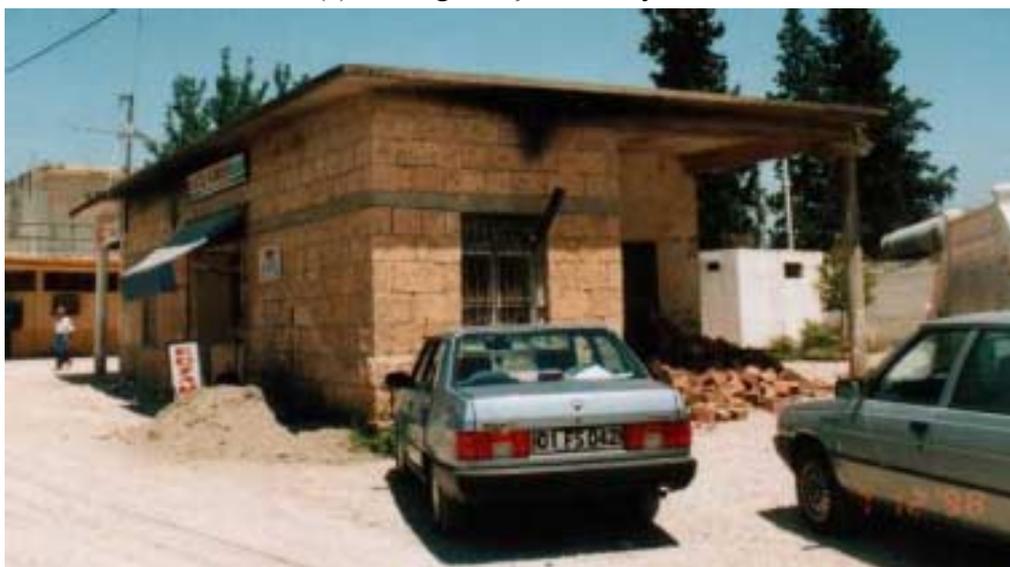
Angular and rough surfaced rock masonry structures, adhered by a mortar and with some concrete slabs or layers suffered almost no damage during the earthquake even they were founded on alluvial deposits (see Figure 7.9 and Figure 7.25). These structures are common in the region as stone can easily found in the region. However, when it is dry masonry or soil used as mortar, these structures become very fragile. The mosque, which was initially a church, collapsed together with its minaret and killed 5 people at Geçitli village (Figures 7.26 and 7.27).

(b) non-damaged taş masonry building in Abdiöğlü

Figure 7.25 Damaged and non-damaged taş masonry buildings

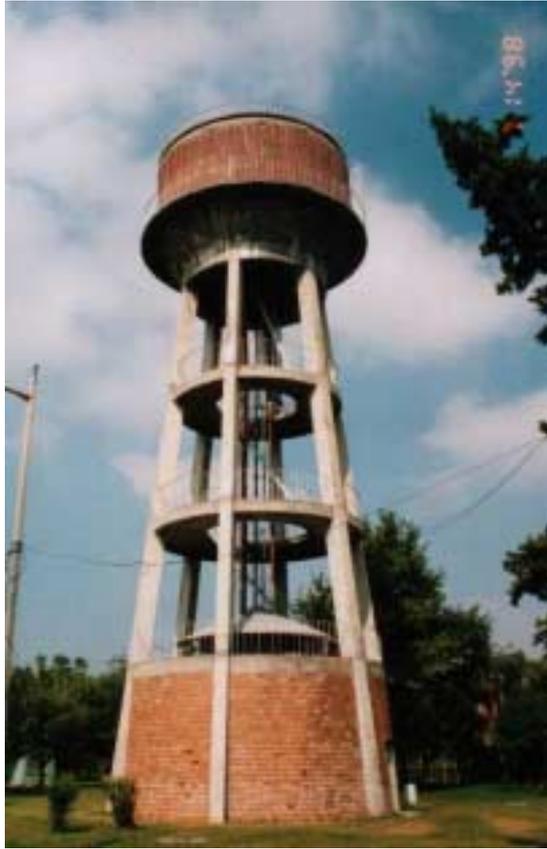
Water towers are RC structures and their height generally ranges between 25-30 meters. The towers have 6 columns and they are symmetric structures. Figure 7.29 shows a water tower in Adana city next to Seyhan dam. No damage was observed at this water tower. The water tower in Abdiođlu village was only slightly damaged (Figure 7.30). A close examination of the columns showed spalling of cover concrete of columns and the settlement of ground by 5 cm around them due to limited liquefaction.

Figure 7.29 Non-damaged water tower in Adana city next to Seyhan dam

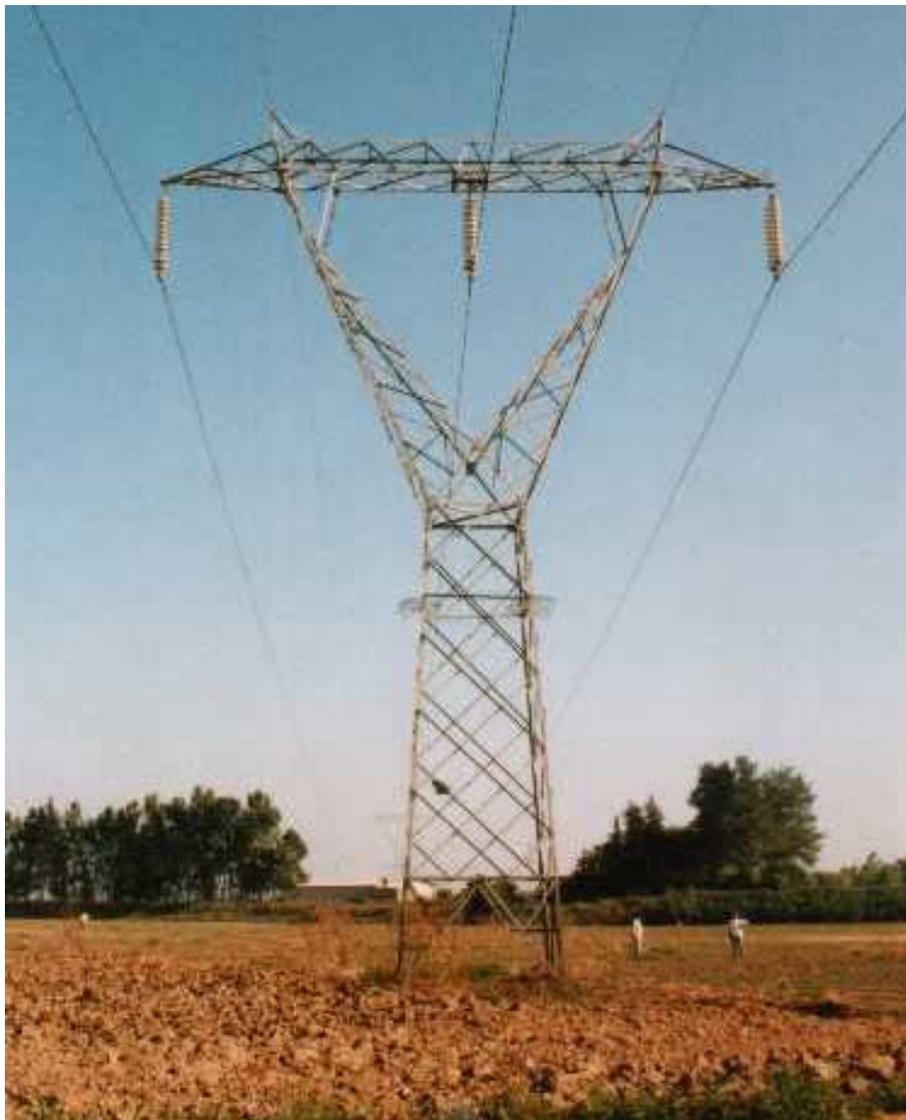
During the earthquake, no pylon was broken or toppled. Figure 7.32 shows a pylon at Asmalı bridge area near Ceyhan town. Although the ground in front and behind of the pylon shown in Figure 7.32 was ruptured and sand boiling was observed wide-spread in this area, there was no visible damage to this pylon. There is no report on damage to any pylons during the earthquake. Poles are generally used to carry electric cables and electric distributions in towns and villages. None of pole was broken during this earthquake.

Figure 7.32 Non-damaged pylon at Asmalı bridge area near Ceyhan town. Note sand boiling around this pylon due ground liquefaction

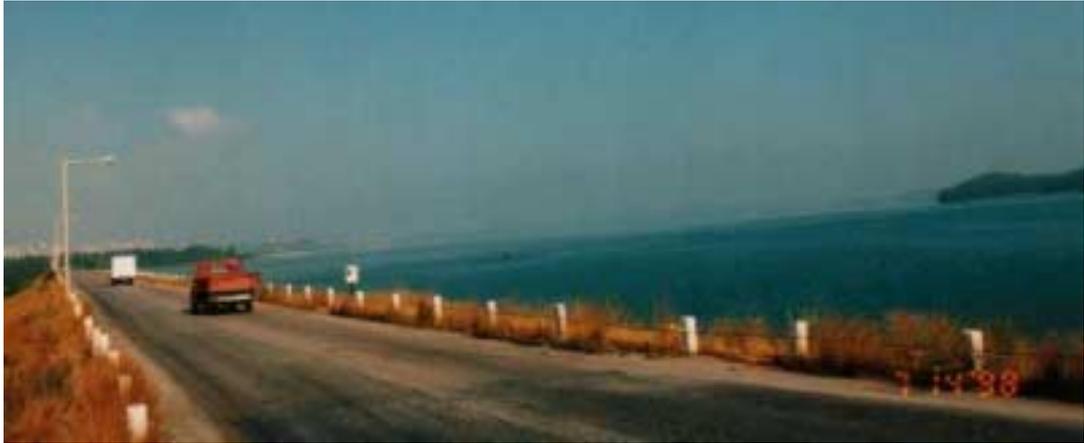
Figure 7.37 Non-damaged Seyhan dam

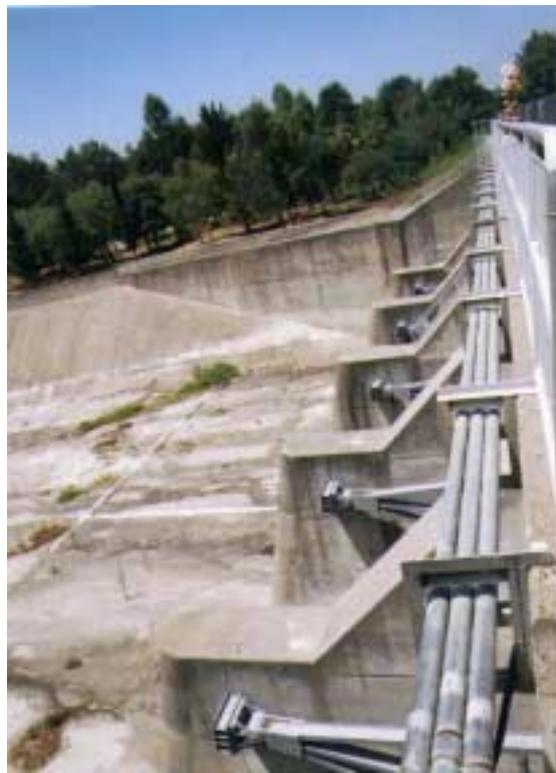
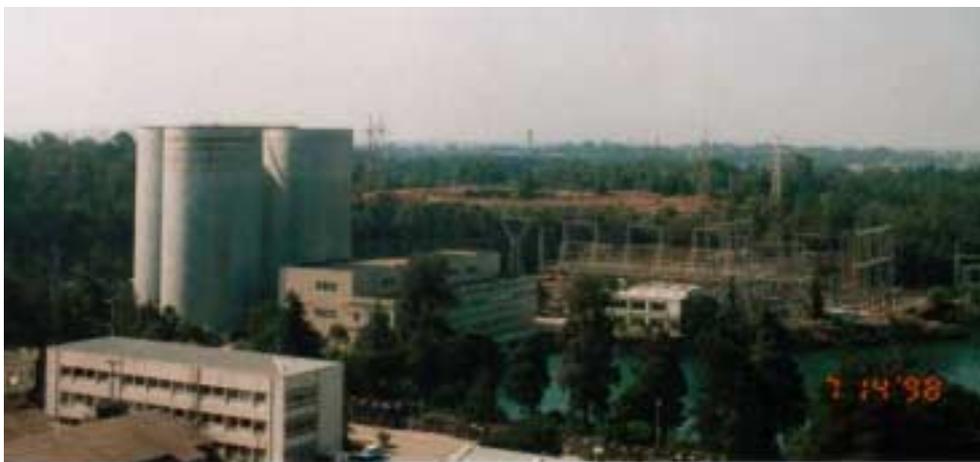
There are 9 dams in the region which are either earth-fill or rock-fill type. (Figure 7.36'). The nearest dam to the earthquake epicenter is 40 km in Hakkıbeyli. The dam is earth-fill with a clay core and its height is about 22 m. It is used for irrigation purposes. A crack occurred at the crest of this dam along its axis. The other nearest dam to the epicenter is Seyhan dam, located on Seyhan river next to Adana city (Figure 7.37). This dam is used for electric generation and irrigation purposes. No damage at this rock-fill dam and its spillways was observed and there is no report on any damage to its turbines or surge tanks (Figures 7.38).

Figure 7.38 Non-damaged spillways, power generation house and surge tanks

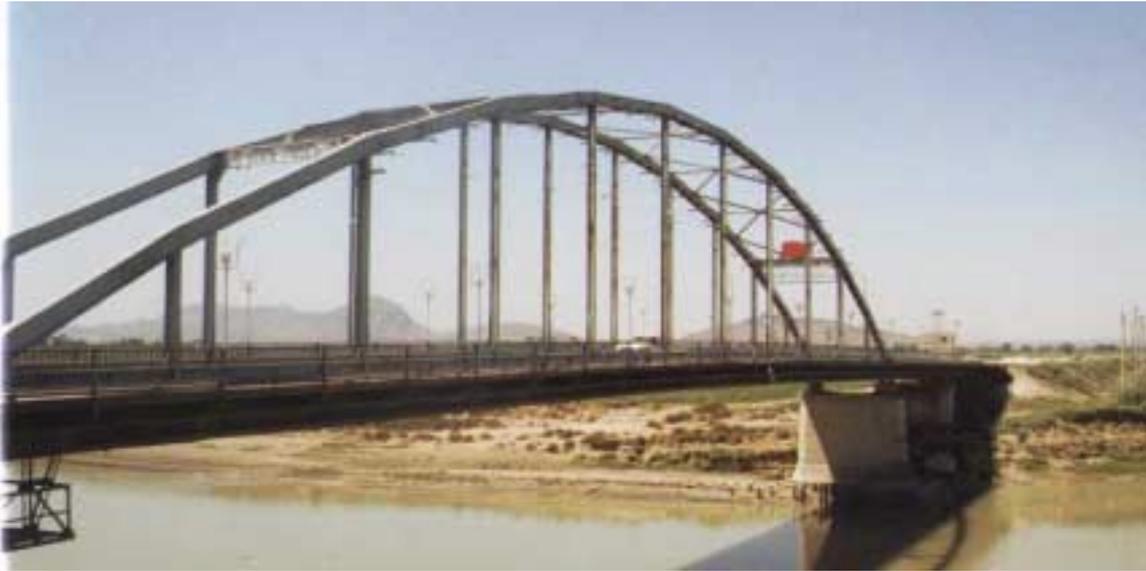
There were also steel arched roadway and railway bridges in the region. No visible damage can be observed at the bridges shown in (Figures 7.44 and 7.45).

Figure 7.44 Non-damaged steel arch roadway bridge over Ceyhan river in Ceyhan

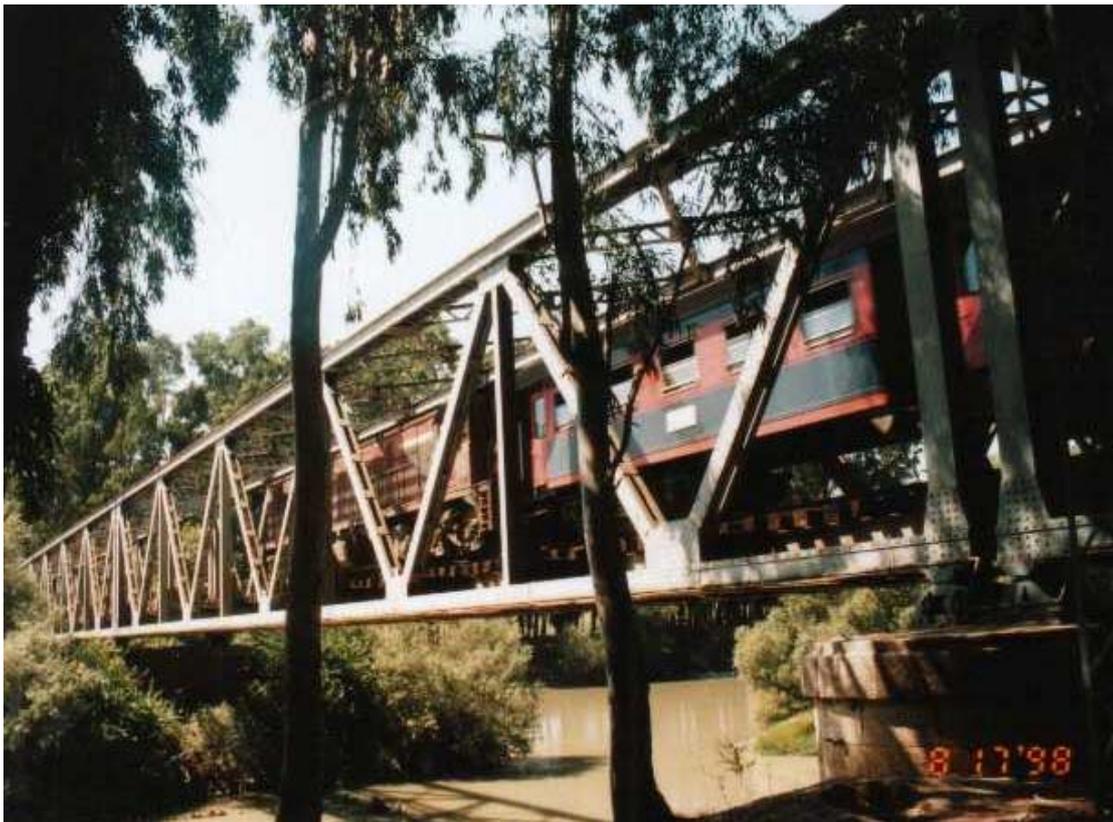
Figure 7.45 Non-damaged steel arch railway bridge over Ceyhan river near Çokçapınar

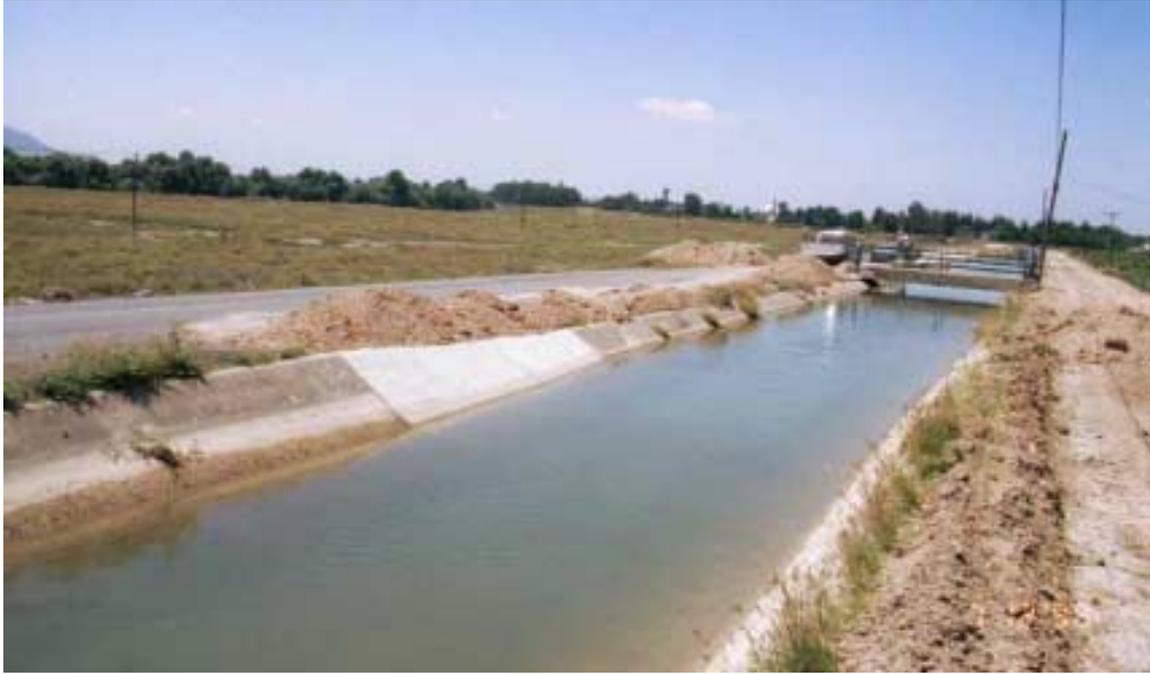
During the investigation at several locations, no severe damage to the network was observed. At several locations, where lateral spreading of ground was observed, some concrete panels were slid down or ruptured (Figures 7.46 and 7.47). At a location near Abdioğlu village, there was a relative displacement at a junction between the canal and V-type conduit as a result of lateral spreading of ground (Figure 7.48).

Figure 7.47 A view of the same canal in operation after re-construction

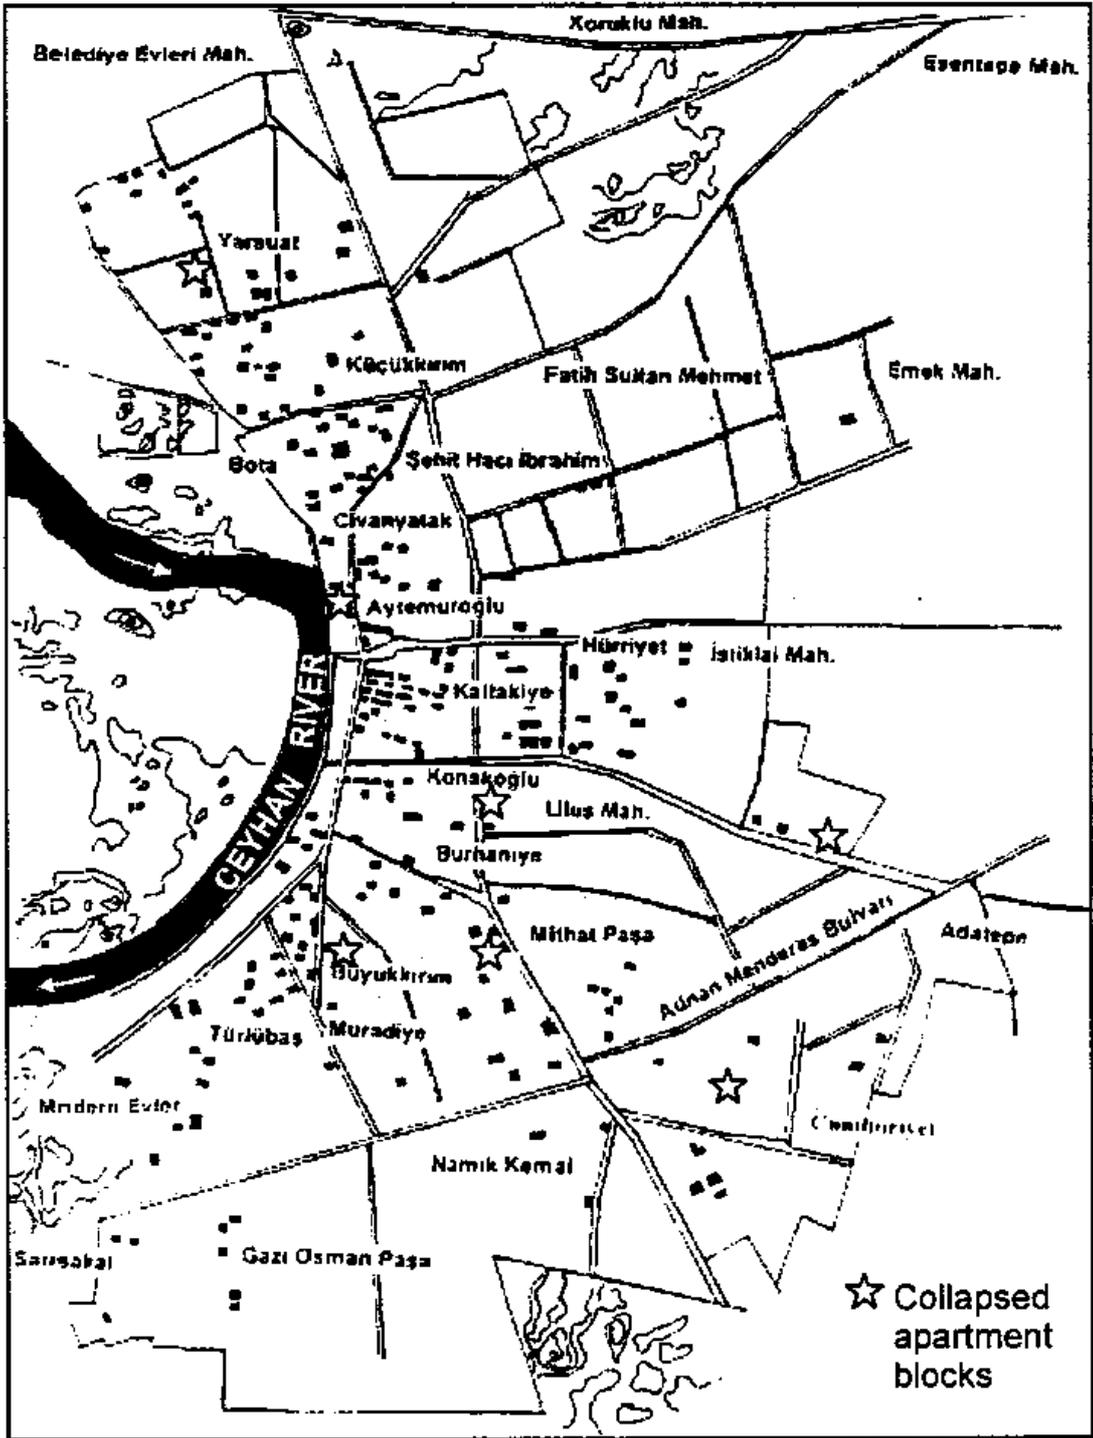
Figure 7.51, provided by the Municipality of Ceyhan town, illustrates locations of collapsed buildings and totally collapsed apartment blocks in Ceyhan town. It was striking that the damage was concentrated on structures built on alluvial deposits and parallel to the meandering of the Ceyhan River. The sediments deposited in the fluvial environment and it consists of fine grained and poorly graded sands and silts which are highly prone to liquefaction.

Figure 7.51 Damage distribution in Ceyhan town

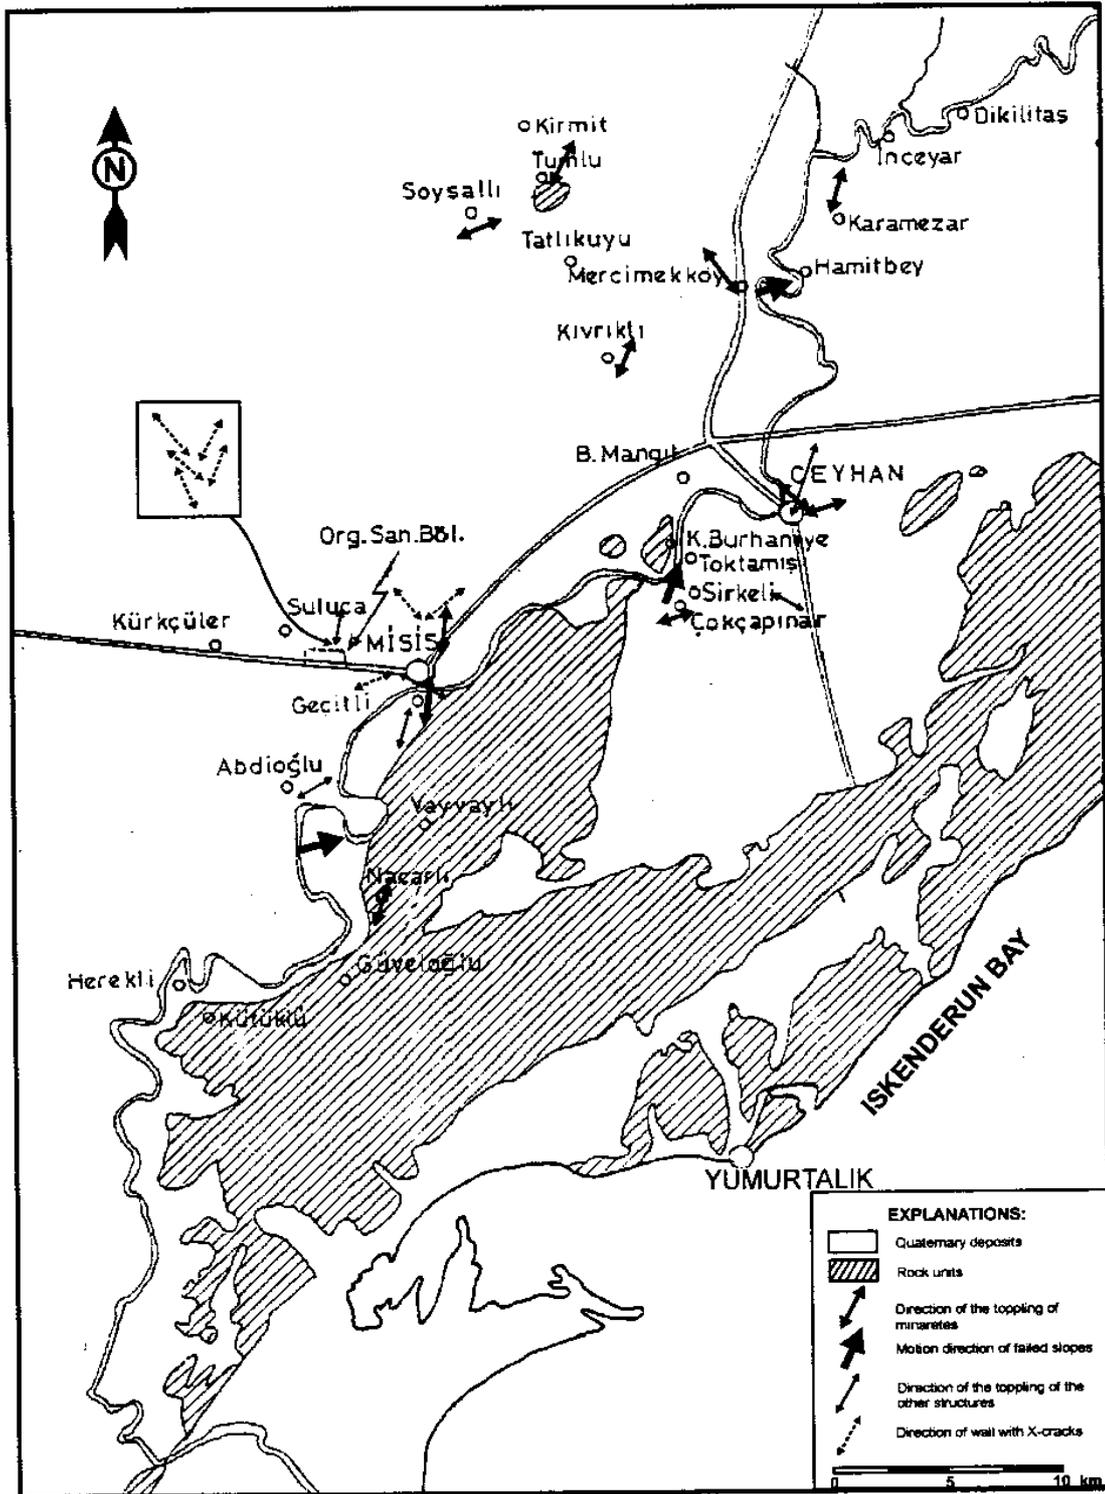
The authors measured collapse directions of minarets, walls and the strike of walls with X-cracks and the motion directions of failed banks of Ceyhan River and plotted in Figure 7.52. Minarets are mostly toppled in the direction of NE-SW. This is consisted with the direction of the first largest impact as observed from the traces of acceleration waves shown in Figure 6.8 for Ceyhan. Few minarets are toppled in the direction of NW-SE direction which is consisted with the second largest impact as also seen from Figure 6.8. Similar tendencies are also observed in toppled walls, walls with X-cracks and the motion directions of the failed banks.

Figure 7.52 Spatial distribution of collapse directions of some structures
