3. GEOTECHNICAL HAZARDS

3.1 LIQUEFACTION

3.2 EXPANSIVE SOILS

3.4 DAMAGE TO PAN AMERICAN HIGHWAY

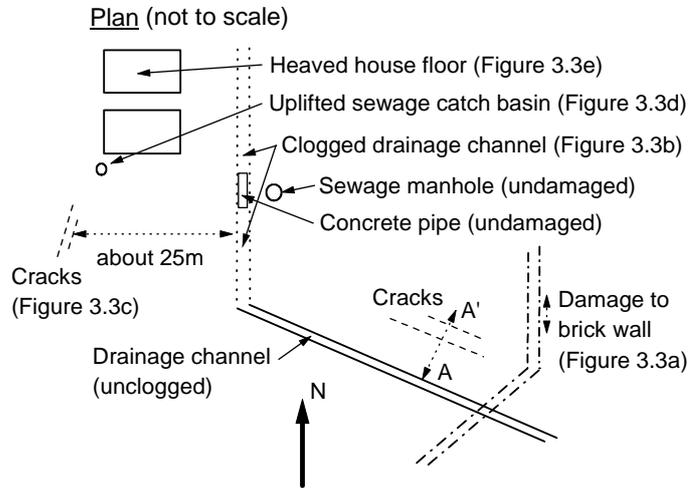
Figure 3.2 Plan of affected area (Lara, Socabaya District, Arequipa)

Liquefaction occurred in a lowland of Arequipa (at Lara, Socabaya district; latitude of $S16^{\circ}27.271'$, longitude of $W71^{\circ}32.148'$, and elevation of 2288 m). It induced lateral spreading of ground as typically shown in **Figure 3.1**. The plan of the affected area is shown in **Figure 3.2**. The lateral spreading caused collapse of brick walls (**Figure 3.3a**) and clogging of drainage channels that had an original opening width of about 50 cm (**Figure 3.3b**). Several cracks were also formed in almost level ground at a horizontal distance of about 25 m from the closed drainage channel (**Figure 3.3c**). It should be noted that there was no damage to concrete pipes with a diameter of about 50 cm used for the drainage channel to under-pass an unpaved road (**Figure 3.2**).

It should be noted that a sewage manhole with a diameter of about 60 cm located near the undamaged concrete pipe (**Figure 3.2**) did not suffer any damage or uplift. In contrast to this, the uplifted sewage catch basin (**Figure 3.3d**) had a diameter of about 40 cm and an original depth of about 50 cm below the ground surface, suggesting that its bottom was located above the ground water table even before the earthquake. In addition, it is reported that extensive sand boiling took place around the uplifted catch basin. This uplift damage was, therefore, estimated to have been caused by the upward forces exerted by the boiling sands, not by the loss of stability against uplift due to generation of excess pore water pressures in the liquefied soils.

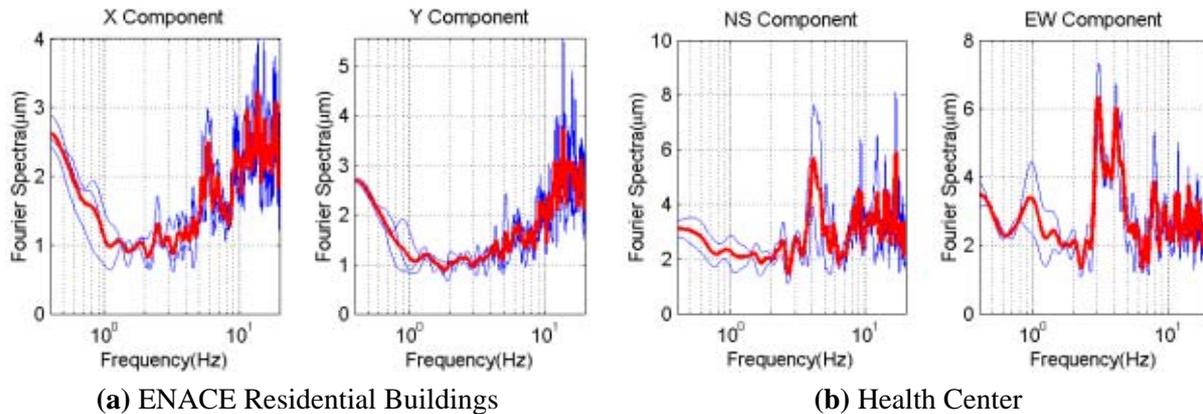
Figure 3.5 Microtremor Fourier Spectra at San Antonio, Moquegua

Microtremors were measured at San Antonio where expansive soils have been identified. The corresponding Fourier spectra are shown in **Figure 3.5**. Although both locations correspond to expansive soils, very different shapes are observed. When comparing the H/V ratio (Nakamura, 2000), differences are also observed (refer to **Figure 2.13, chapter 2.3**).

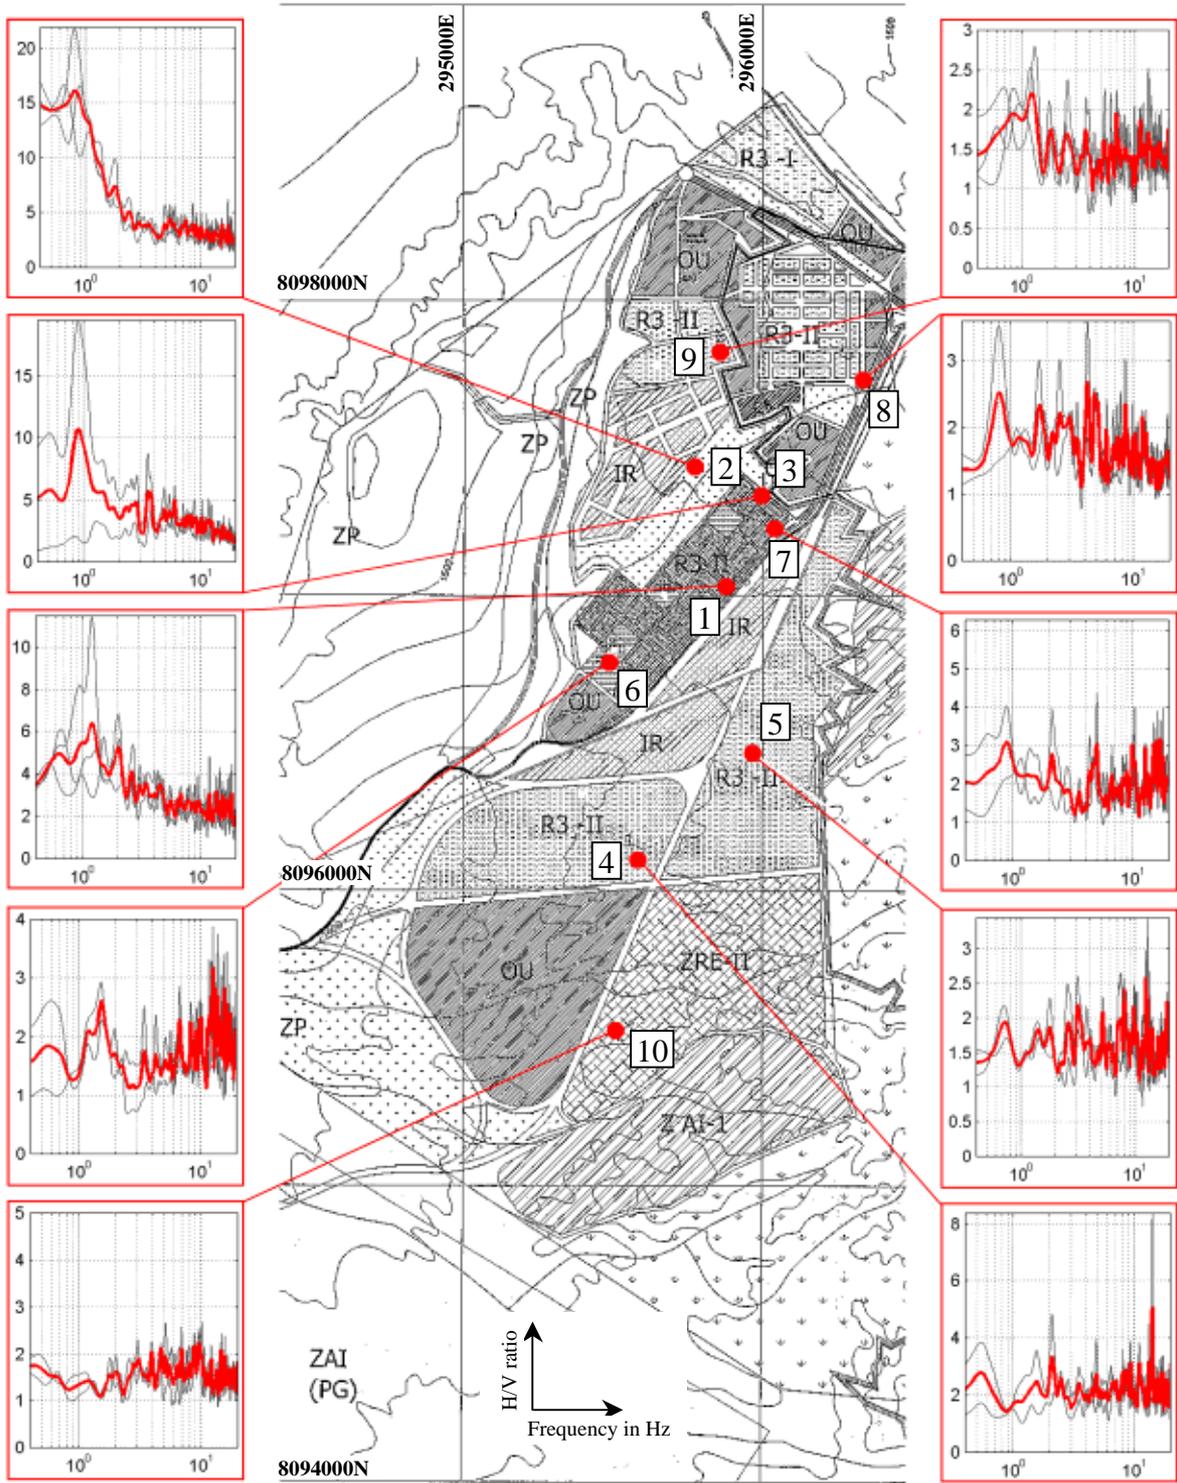
Figure 3.6 Microtremor measurements at Chechen – H/V ratio

Upon request of the Peruvian counterpart, microtremors were measured at Chechen, Moquegua. Although this area has been chosen to relocate the people affected by the earthquake, there are serious concerns that the soil at this location is expansive. Although microtremors cannot identify whether a soil deposit is expansive or not, it was expected that by finding some similarities between the frequency contents of microtremors at other locations where expansive soil presence is confirmed could give some indication of the presence of such type of soils at Chechen. A total of 10 sites were measured and the H/V ratio as well as the Fourier Spectra of the NS and EW components are shown in **Figures 3.6 to 3.8**.

Unfortunately, neither the Fourier Spectra nor the H/V ratio within the frequency range 0.4 to 20Hz showed a clear pattern. The only common feature observed at eight (8) of the observed sites, was the predominance of low frequency components in the Fourier Spectrum such as the one observed at the ENACE Residential Buildings. Both horizontal and vertical components showed this characteristic. Low frequency components involve thicker soil strata and therefore this common feature might evidence the presence of a deep common structure.

In general, ground microtremor observations are used to identify soil dynamic properties such as the site predominant period, which depends on the soil column thickness, shear wave velocity, and mass density. Therefore, by estimating the predominant period and knowing some of the previously mentioned properties, it could be possible to indirectly estimate soil stiffness or density and then compare it to the ranges expected for expansive soils. Another possibility is to perform measurements before and after moistening the soil to detect variations in the soil properties that resemble those expected for expansive soils. By using microtremor measurements only, it is impossible to detect conclusively the presence of expansive soils.
