THE M8.7 NIAS EARTHQUAKE OF MARCH 28, 2005
IN
NIAS ISLAND, INDONESIA

Ömer Aydan
Tokai University, Shizuka, Japan

April 30, 2005

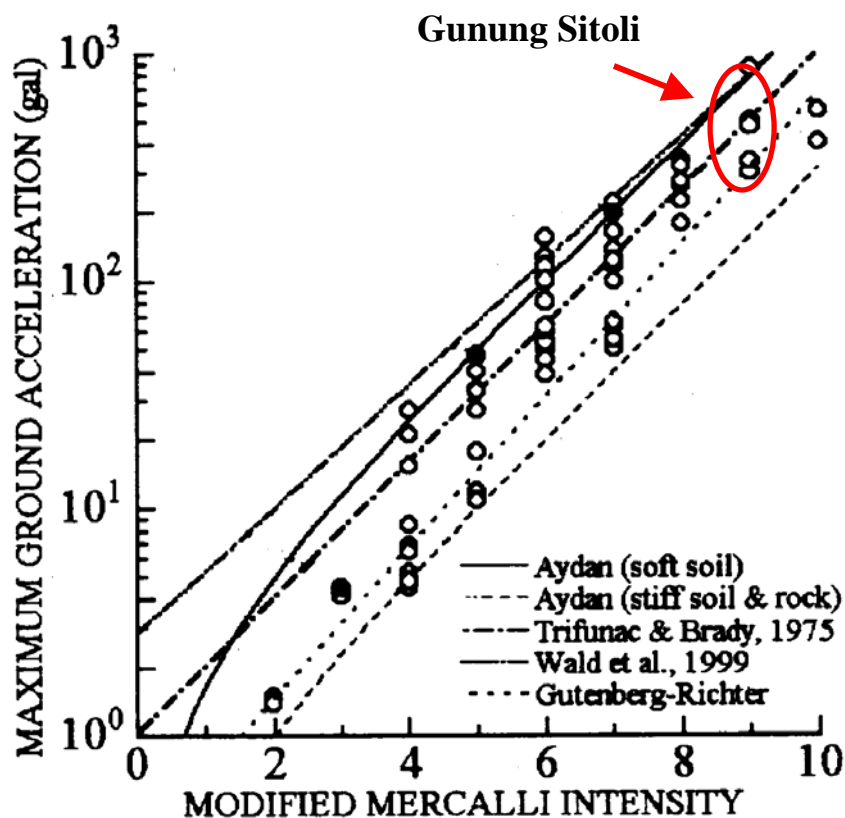
Figure 7.1 Inferred maximum ground acceleration (A_{max})

There is no acceleration record in any of Simeulue, Nias and Banyak Islands and the west coast of Sumatra Island. Therefore, it is almost impossible to know the exact ground motions during this earthquake. The only way is to infer the strong motions from the collapsed or heavily damaged structures such as reinforced concrete buildings, masonry or wooden houses and walls. The authors inferred the MKS intensity as IX from the observations of the collapsed buildings. Furthermore, the maximum ground accelerations should be ranging between 300 and 900 gals depending upon ground conditions using the approach proposed by Aydan (2002) (Figure 7.1).

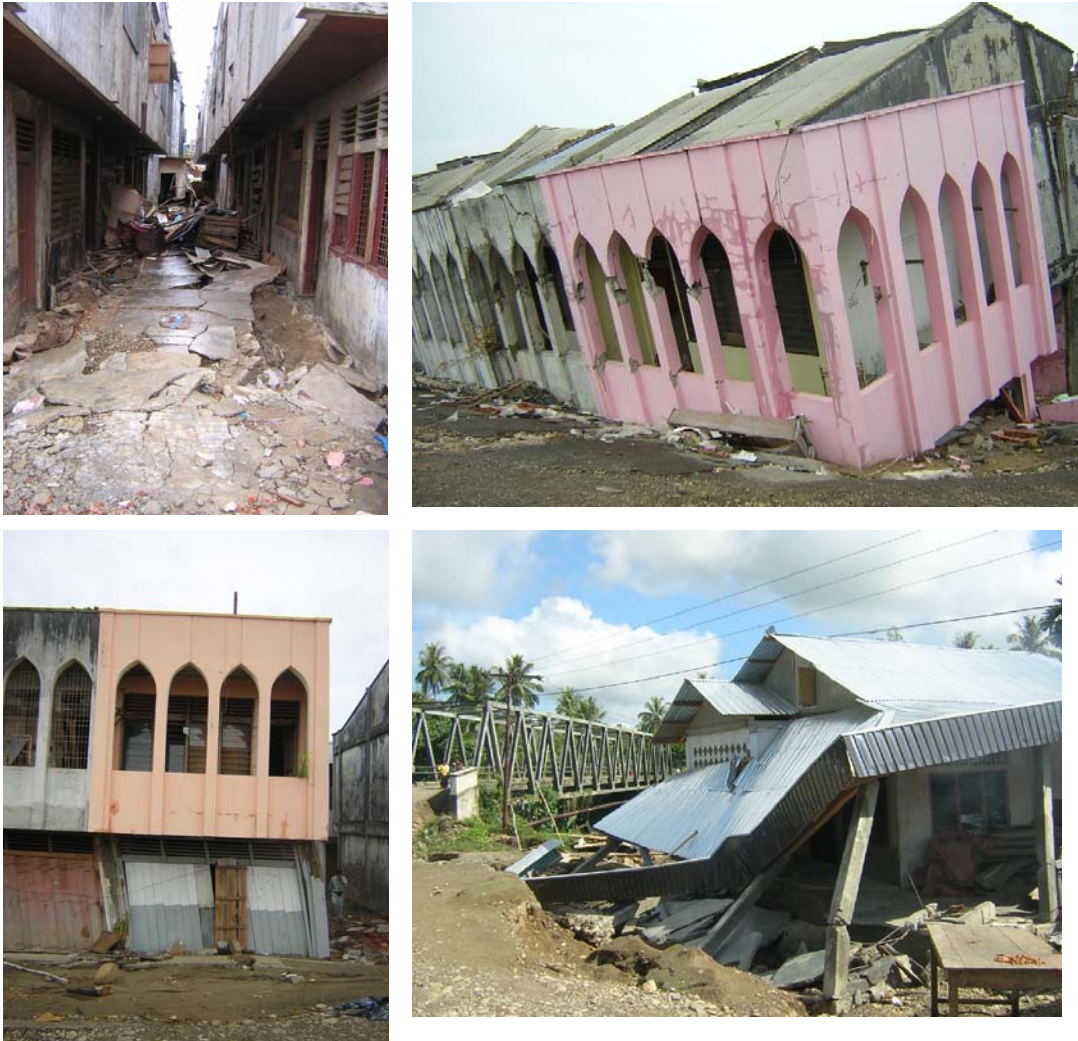
Figure 9.1 Liquefaction induced damage to buildings in Adapazari

The causes (a) and (b) should be generally regarded as site effects and local ground conditions which affected residential apartment buildings in the region. Although it is not known exactly, the 15-20 percent of damaged buildings in the Gunung Sitoli either settled up to 1m or tilted and toppled due to ground liquefaction and associated lateral spreading (Figure 9.1). Due to high level of underground water table and liquefiability of the ground without raft foundations and continuous tie-beams could not resist to ground failures unless they are built on piles extending into the non-liquefiable layer.

Compared to those of December 26 2004 earthquake, so many buildings are affected due to the liquefaction in this earthquake.

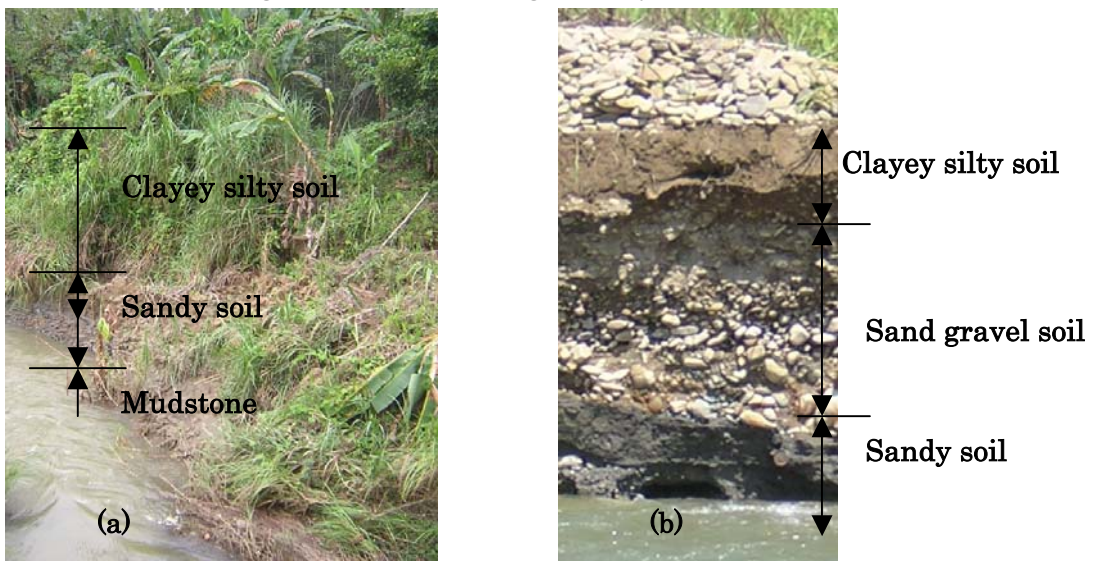
Figure 10.4 Typical Soil Conditions at abutments of bridges

about 1.3m. The piers were constructed without using pile foundations. The site investigation indicated that there is a mudstone-like layer and overlaying soil layers consist of sand, gravel and sandy-silt from bottom to top (Figure 10.4(a)). These layers are tilted towards upstream side with an inclination of 5-10 degrees. Furthermore, the river flow is directed towards the pier and box-culvert. Although the construction details of the pier and box culvert are not known, it seems that the toe erosion (scouring) of the pier and box culvert together with liquefaction of inclined sandy layer and horizontal shaking may be the major causes of the damage to Gawo bridge.

Many truss bridges along Gunung-Sitoli and Telukdalam route were damaged by permanent movement of abutments as a result of lateral spreading of liquefied ground. The ground consists of mudstone-like layer, sand layer and clayey-silty soil and top organic soil (Figure 10.4(b)). Sandy layer is generally found at the water level of river and it is expected to be full saturated. During earthquake shaking, it seems that this sandy layer is liquefied and caused the lateral spreading of ground. The lateral spreading of ground was particularly amplified on the convex side of the river bank as the ground can freely move towards the river. These movements caused high lateral forces on the abutments, which caused the sliding and tilting of piers or fractured the piles of the abutments of truss bridges. Similar situations are also observed on RC bridges.

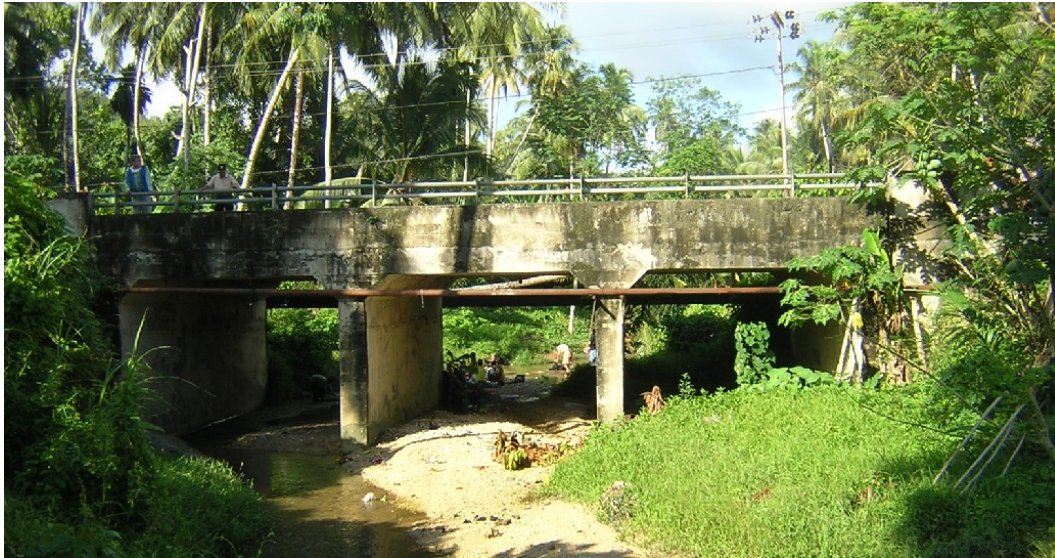
Figure 10.6 Non-damaged RC box culvert

Box culvert bridges generally performed well during the earthquake except locations where scouring or ground settlement occurred (Figure 10.6).

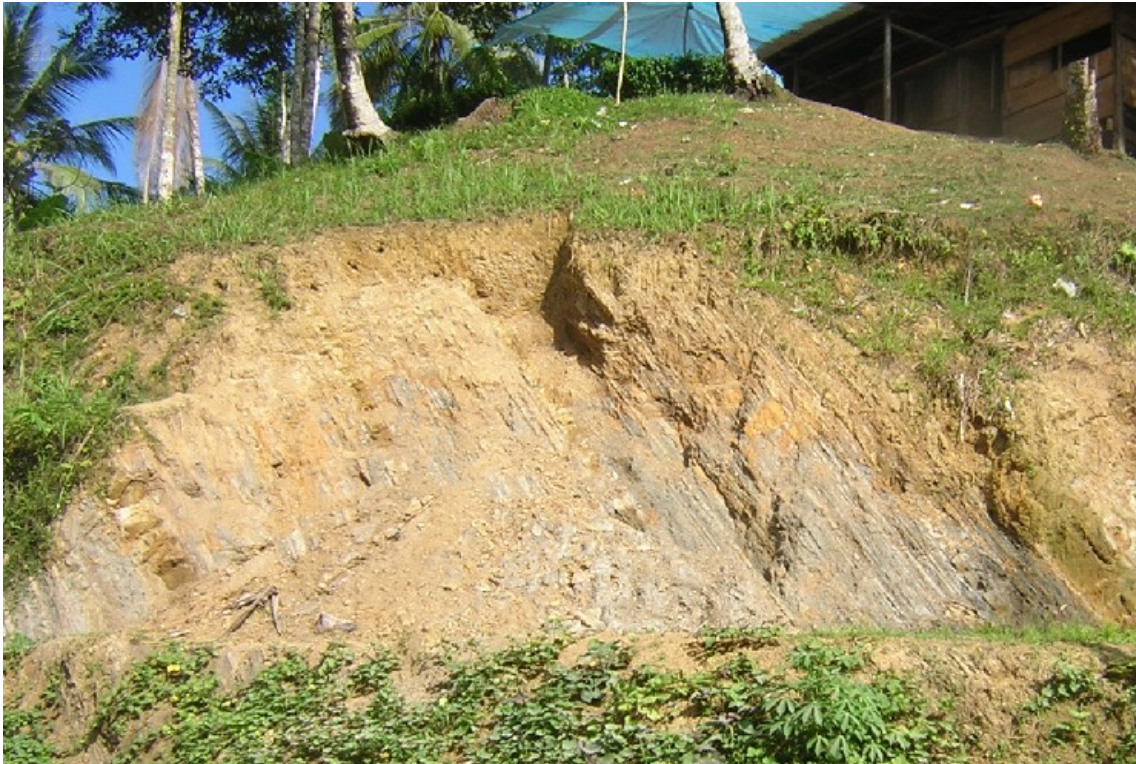
Figure 12.2 Intercalated sandstone, siltstone and mudstone (brown part is weathered)

The permanent movements of slopes consisted of weathered rock is also likely during this earthquake. The inspections of villages with traditional houses such as Ohalili nearby Telukdalam and the routes of Lahusa - Telukdalam and Gunung Sitoli – Lawa village indicated that there were permanent movement of slopes. The slope for example between Gunung Sitoli and Lawa village consists of soft sandstone and siltstone. As seen in Figure 12.2, the top part of the slope consists of weathered soft rocks having their bedding plane inclinations largely varied. Figure 12.3 shows some example of slope movements in this type of materials.
