A RECONNAISANCE REPORT ON THE 2007 SINGKARAK LAKE (SOLOK) EARTHQUAKE WITH AN EMPHASIS ON THE SEISMIC ACTIVITY OF SUMATRA FAULT FOLLOWING 2004 and 2005 GREAT OFF-SUMATRA EARTHQUAKES

Ömer AYDAN

Tokai University, Department of Marine Civil Engineering Shizuoka, Japan

August 2007

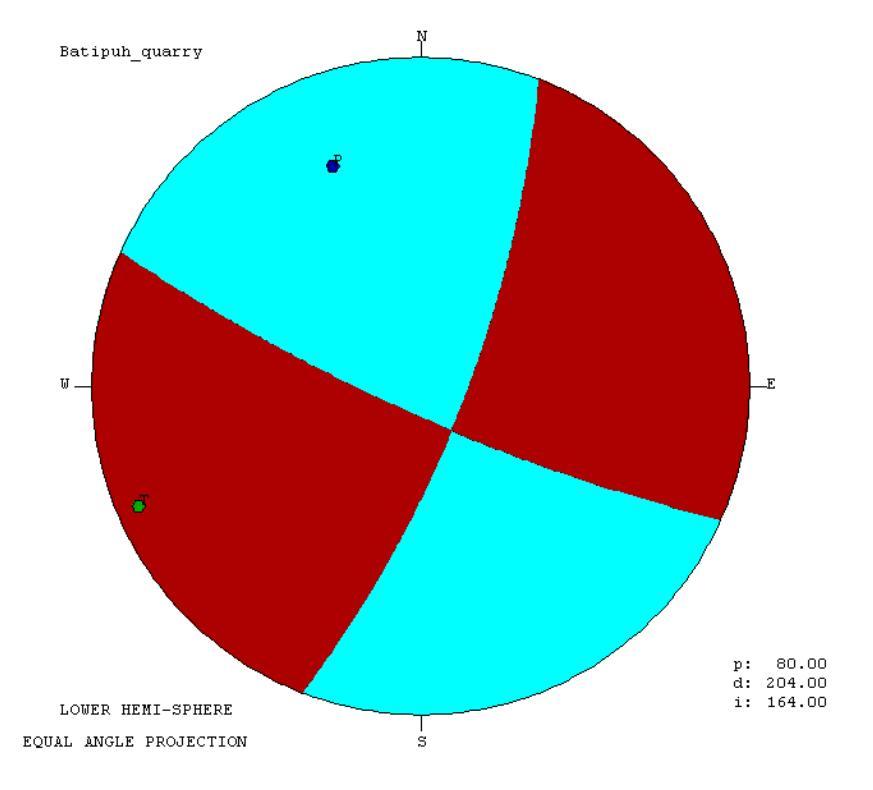
The author did some observation in a quarry just north of Singkarak Lake. Figure 3.3 shows views of the fractures in the quarry and a fault surface with striations. The fractures are almost steeply inclined. However, their dipping direction is about 85°SW. The striations are almost horizontal. Nevertheless, they have slight normal component. In other words, the sense of deformation implies slight trans-tension type movements. Figure 3.4 shows the inferred focal mechanism solution for the striations in the quarry proposed by Aydan (Aydan and Kim, 2002, Aydan 2007b). The strike of the fractures is slightly different from the general trend of the SFZ.

Figure 3.4. Inferred focal mechanism solution for the striations in Batipuh quarry.

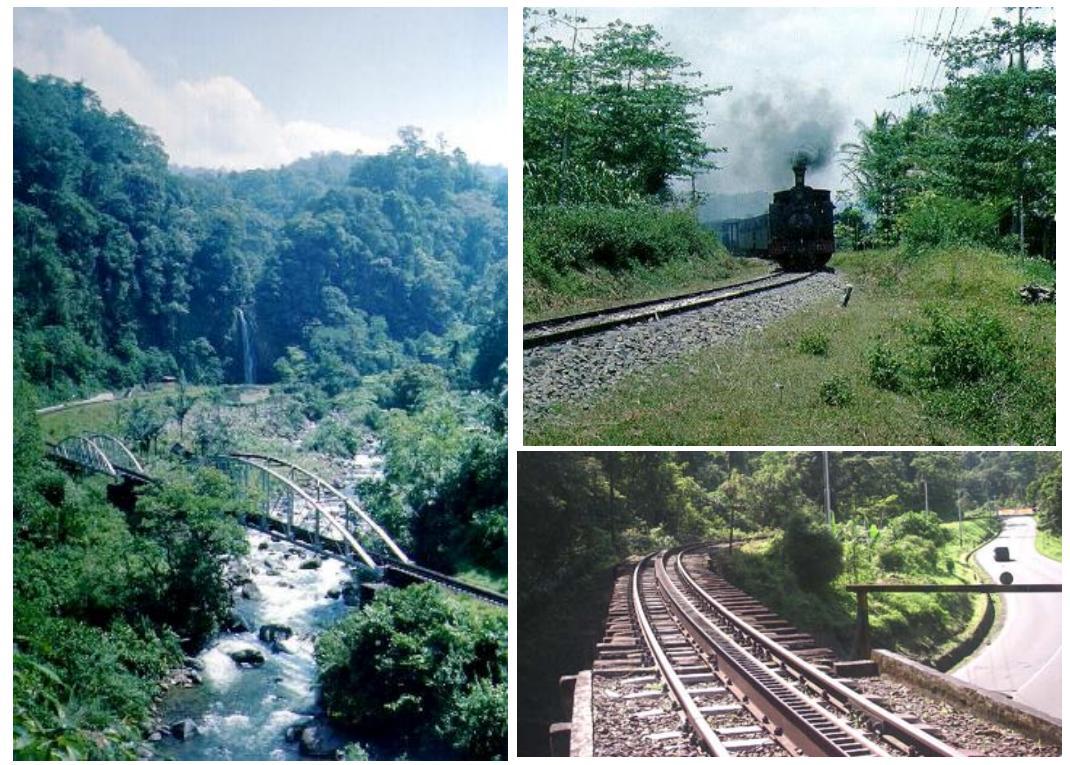
There is a railway line which starts from Teluk Bayar port of Padang pass through Anai Valley to Padang Panjang where it joins the line from Lima through Bukit Tinggi and the line from the east coast of Sumatra Island via mining town Sawahlunto and Solok. The construction of the line was associated with the colonial Dutch period, during which Ombilin underground coal field was started to be exploited in 1891. The gradient of a 43km long section of the line between Kayutanam and Batu Tabal is quite steep and it was constructed as rack line. The visual inspection of the railway line near the famous Anai water-fall and Padanglawas near the epicenter revealed that there was no damage to the railway line (Figure 6.1). Furthermore, there is no report about the ob

Figure 6.1. Views of railway lines in the epicentral area

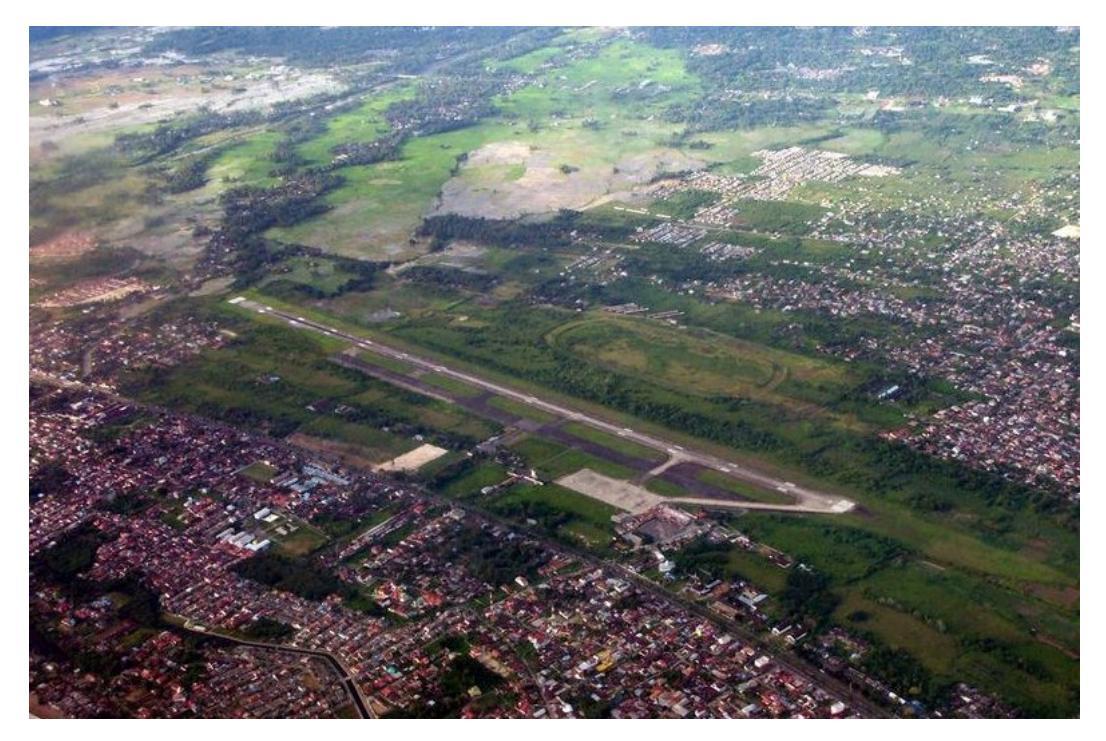
The airports in the earthquake affected area are Tabing air-force airport and Minangkabau civil airport (Figure 6.4). Minangkabau airport is newly re-built in 2001 by Shimizu Corporation and PT Adhi Karya through a softloan from Japan International Corporation Bank (JICB) (90%) and APBN (10%). The runway is 2750m long and its elevation is about 5m. The ground condition in the vicinity area is sandy soil. The earthquake did not cause any damage to its runway and terminal building. Furthermore, the airport traffic was not suspended following the earthquake.

(a) Tabing air-force airport

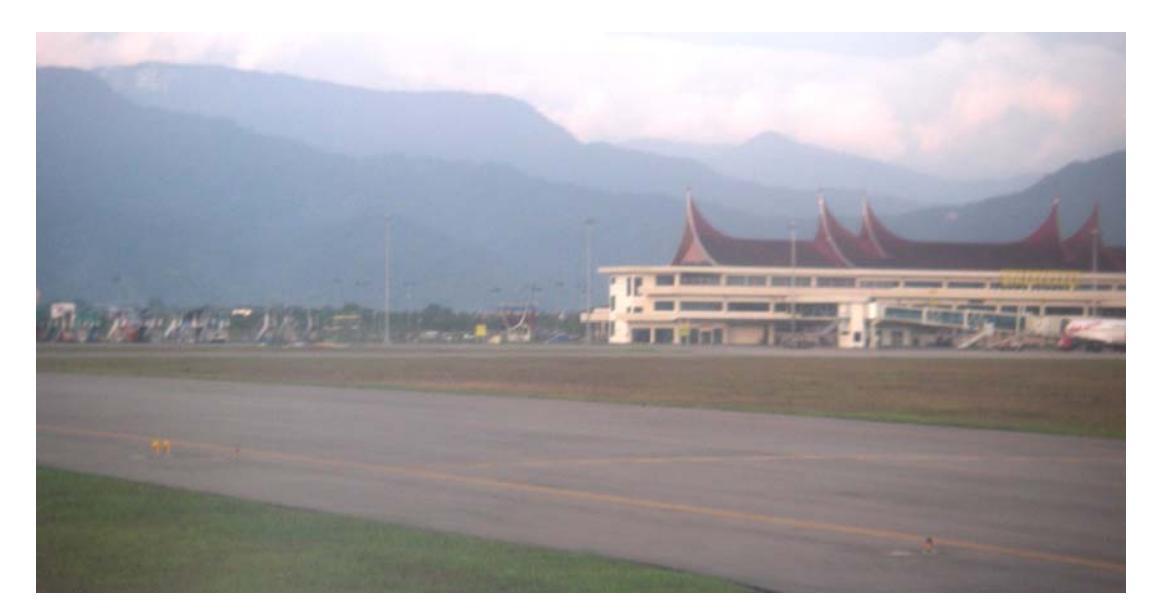
(b) Minangkabau airport

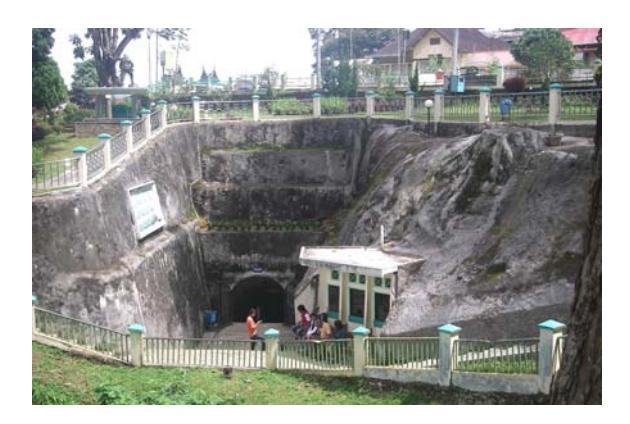
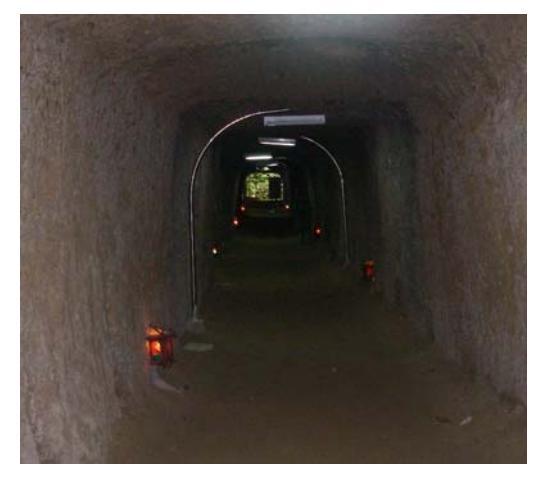
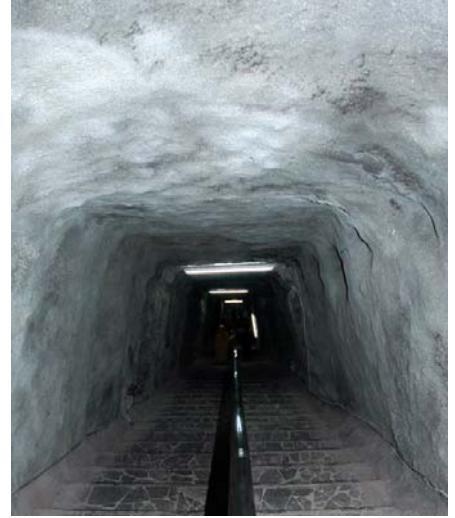
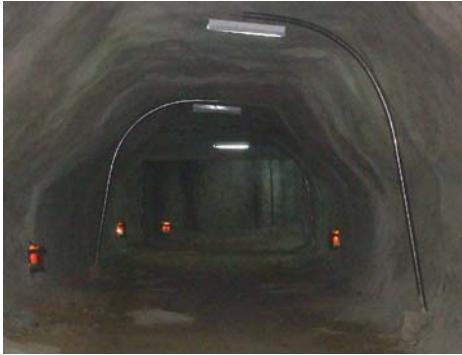
The configuration of adits changes from location to location and their functions. The inclined shaft has arched roof and it is 2.4m high and 3.0m wide (Figure 7.4). The main adits has a trapez shape with a height ranging between 1.8 to 2.1m and its base width ranges 2.4 to 2.6m. The rooms between adits are larger and their width is about 4m with a height of 2m.

The adits were probably supported by wooden supports at the time of the construction. However, the wooden supports got rotten in time and they were taken away at the time of opening of the shelter to touristic visits. Although the inclines shaft and some parts were supported by a thin shotcrete layer, the underground shelter is almost non-supported. In other words, it is self-standing for about 65 years since its construction.

Figure 7.4. Some views of the inclined shaft and adits and rooms in the shelter

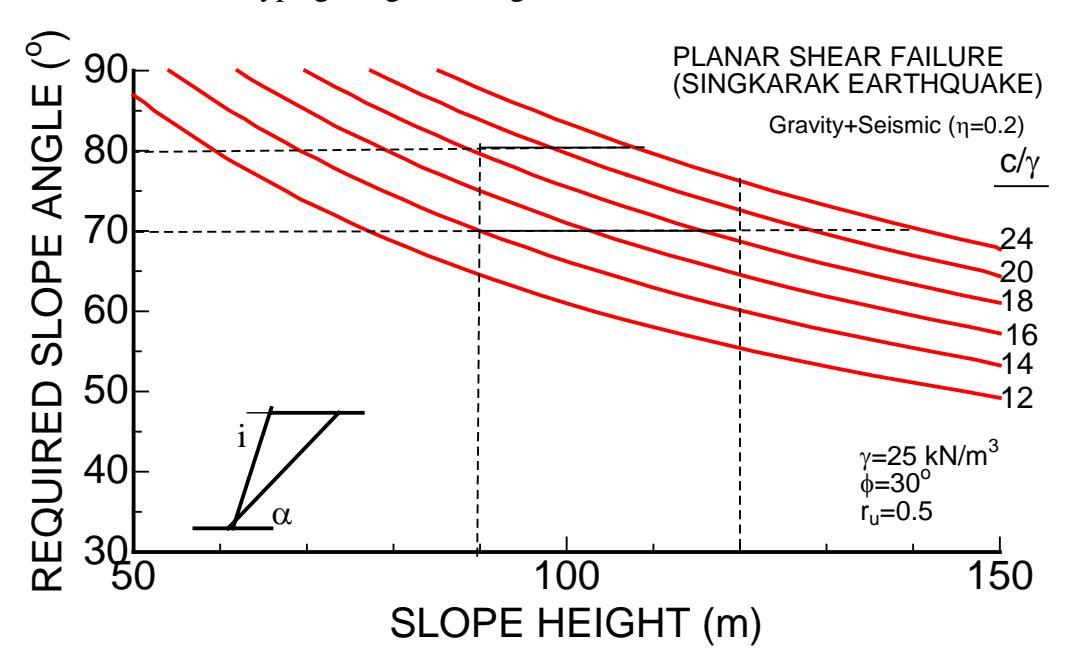
Using the seismic coefficient method and assuming that the failure is planar, and the friction angle of the ground is 30° and pore water coefficient of 0.5, the relation between slope angle and slope height can be obtained as a function of normalised cohesion to the unit weight of rock for a seismic coefficient of 0.2 as shown in Figure 8.5. In view of the self-standing underground shelter discussed in the previous section and the observed slope heights (80-120m), the most likely normalized cohesion by the unit weight is likely to be about 20. For this value of the normalized cohesion, the value of seismic coefficient varied between 0.2 to 0.3 by an increment of 0.5 (Figure 8.6). From these parametric computations, the expected

maximum ground acceleration is likely to be around 0.25g. There is no doubt that it will be desirable to carry out detailed geotechnical investigations for determining the properties of ground around Sianok Valley. Nevertheless, the results from these parametric studies would be quite close to the actual values in view of ground conditions in similar type geological and geotechnical environments.

Figure 8.5. The relation between slope angle and slope height as a function of normalized cohesion by unit weight

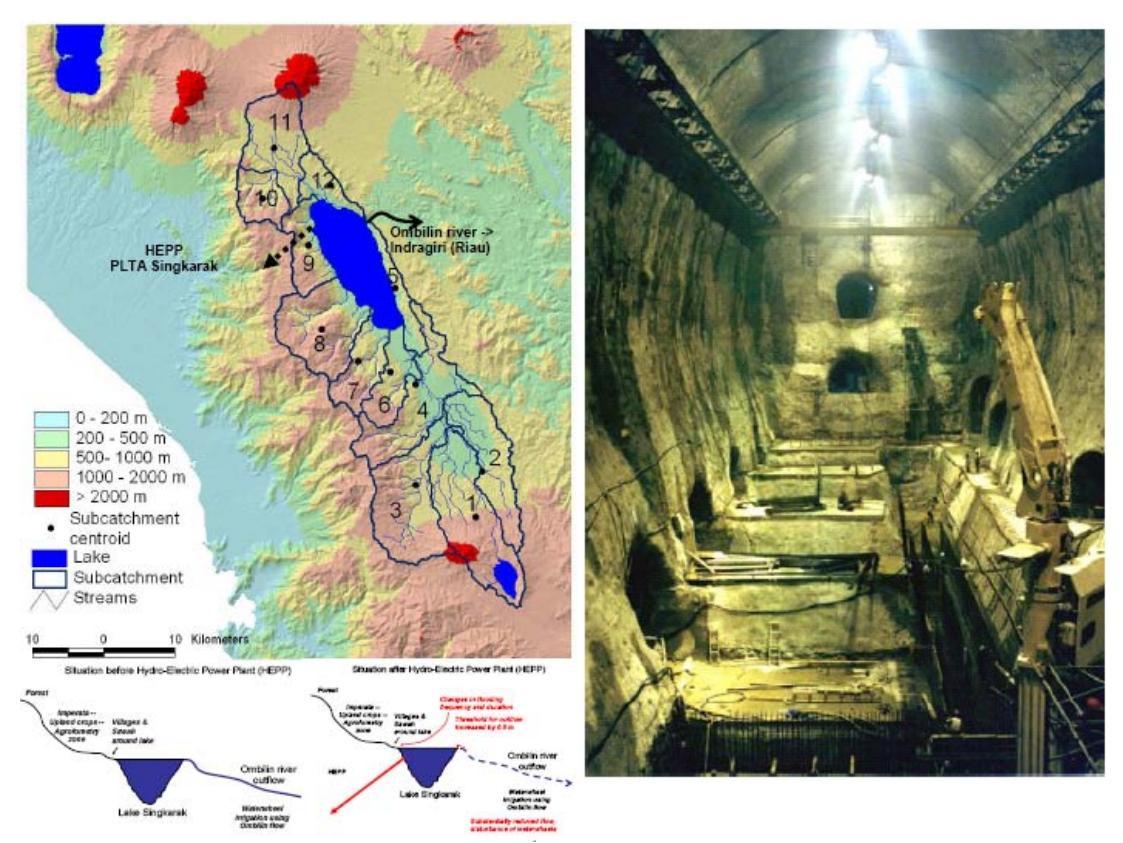
(a) Layout and location of HEPP (b) Underground power house Figure 8.1. Singkarak hydro-electric power plant

There was no damage to the Singkarak hydro-electric power plant by the earthquake. The electricity production was back after an automatic shut-down of the plant due to ground shaking.

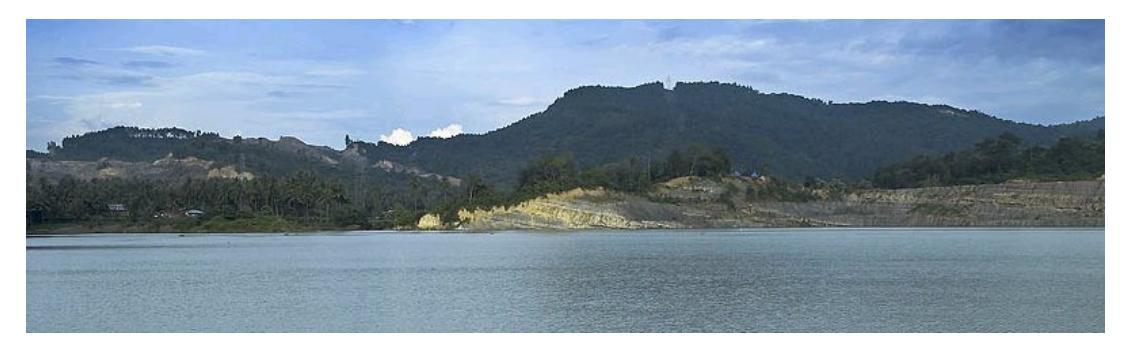
Figure 10.3 Kandi lake created by the flooding of the abandoned coal open-pit

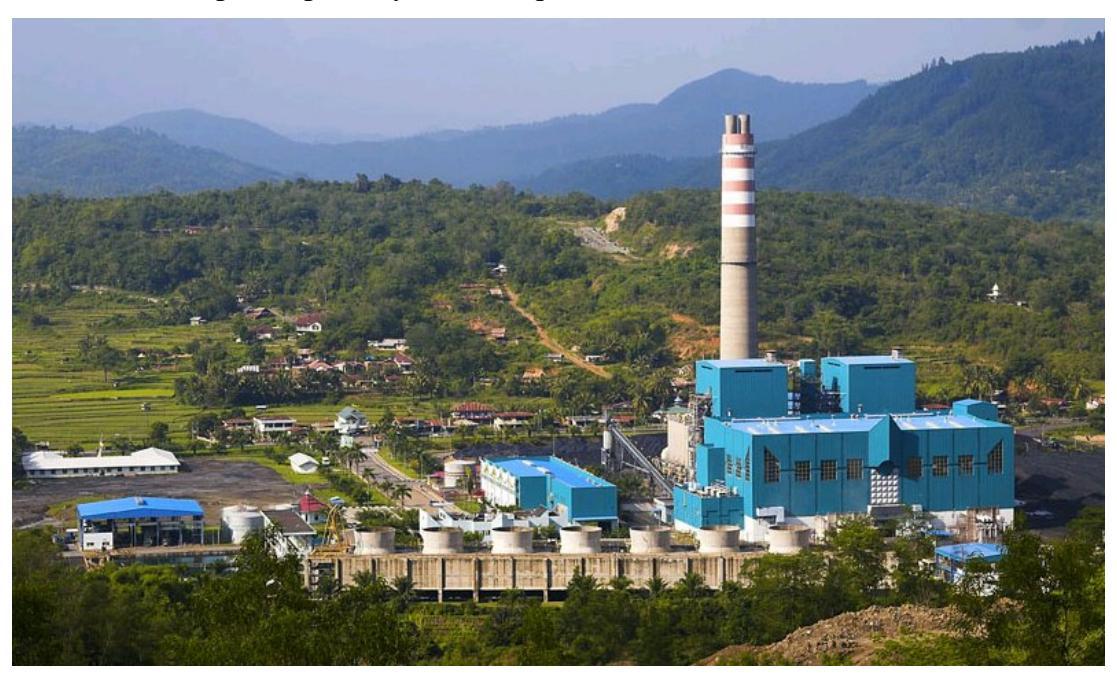
Figure 10.4. A view of Kandi Thermo-electric Power Plant

Another major power plant in the epicentral area is Kandi Thermo-electric Power Plant near Sawahluhung (Figure 10.4). The coal to this plant is supplied from underground mine at Sawahluhung. There was no report of damage to this thermo-electric power plant by the earthquake.
