Damage of Bridges in 2008 Wenchuan, China, Earthquake

This is a reconnaissance report on the damage to bridges during the 2008 Wenchuan, China, earthquake. Site investigation was conducted by the authors on August 10-14, 2008. Presented is a detailed discussion of the damage to twelve bridges as well as possible damage mechanisms. Characteristics of two near-field ground accelerations and Chinese seismic bridge design practices are also presented. An investigation of the damage finds insufficient intensity of seismic design force, inadequate structural detailing for enhancing the ductility capacity and an absence of unseating prevention devices.

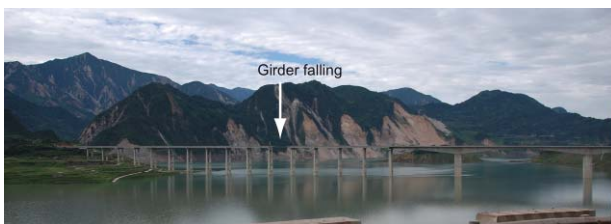
Photo 1 Miaoziping Bridge and the location of falling girder

Miaoziping Bridge is located where Duwen Highway (connecting Chengdu and Wenchuan) crosses the Zipingpu dam reservoir and Min River. In total, the structure is 1,440 m long and consists of a three-span continuous prestressed box girder bridge with prestressed concrete girder approach bridges of two, four, and five spans as shown in Photo 1. The main structure is a 450 m long three-span continuous pre-stressed concrete frame bridge with a main span of 220 m. A pre-stressed concrete girder bridge was constructed by connecting 50 m long, simply supported, PC T-girder bridges with concrete slabs. PC girder bridges were supported by elastomeric bearings. All spans were supported by nearly 100 m tall reinforced concrete piers resting on pile foundations in the dam reservoir. Upper and lower bound bridges were separated.

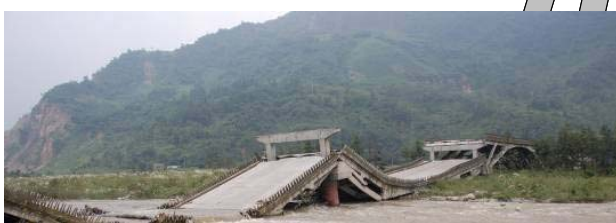
Photo 20 Collapse of Xiaoyudong Bridge (Deck 4, Deck 3 and Deck 2 from the left)

Photo 22 shows the connection of a pile cap, two piles and slant-legs at P2 which supported Deck 2. Flexural and shear failure developed at the slant-legs. These were a typical failure with limited plastic deformation capacity due to insufficient reinforcement. Local buckling of main bars was observed in the slant-legs. If this failure progressed further, the failure shown in Photo 21 would develop.

Photo 23 shows Deck 2, which was about to fall off from the cap beam of Pier 1. This obviously shows that response displacement of Deck 2 was quite large. Deck 2 was displaced not only in the longitudinal direction but also in the transverse direction.

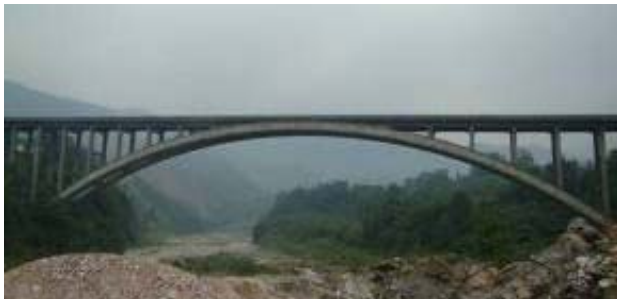
Photo 37 Jinhua Bridge

Jinhua Bridge is a 228 m long reinforced concrete arch bridge with the main span of 150m as shown in Photo 37. It was completed in 1997. The main arch consisted of two box section ribs and the rise vs. span ratio was 1/6. Main girders were supported by vertical members with rubber bearings. Photo 38 shows cracks of a lateral beam near a beam-vertical member joint. The cracks showed typical damage for low reinforced concrete structural members with insufficient ductility capacity. Similar damage occurred at many other lateral beams. Extensive cracks occurred on the side walls of the abutments as shown in Photo 39, which were induced by collision between girders and the abutment in the longitudinal direction. Shear cracks occurred at the support of the deck at the arch crown as shown in Photo 40. This was also induced by collision between the girders and the support.

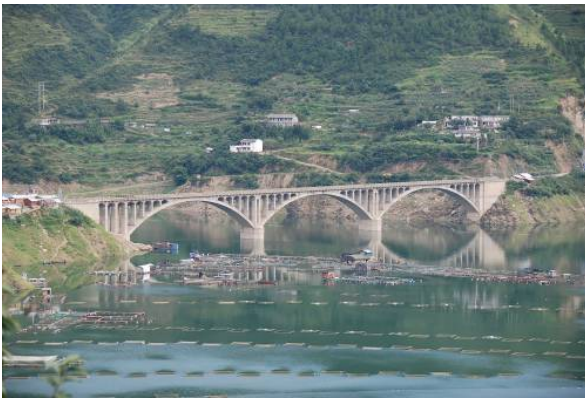
Photo 41 Baishui Bridge

Baishui Bridge is located on national road 212 connecting Qinchuan and Guangyuan City. As shown in Photo 41, it is a three span reinforced concrete arch bridge completed in 1988. It did not suffer serious damage but moderate failure occurred at various locations. For example, Photo 42 shows an emergency repair by steel truss for cracks of arch girders in the transverse direction. Also, a large number of cracks occurred at the abutments. Temporary steel trusses (bailey truss) were set on the damaged decks to ensure traffic safety.

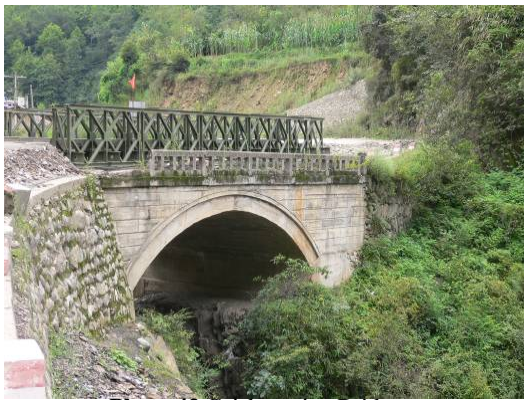
Photo 43 Caishenmiao Bridge

There were a number of short span reinforced concrete arch bridges which suffered damage in the fault regions. They were important for daily life inside regional communities. As an example, shown in Photo 43 is Caishenmiao Bridge in Qingchuan. It is a 10 m long reinforced concrete arch bridge. The construction era is unknown but it is perhaps a considerably old bridge. Because cracks ran along the body of the arch, an emergency temporary steel truss (bailey truss) was set up for traffic safety.

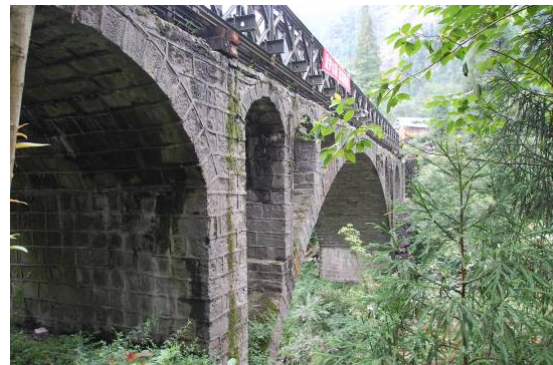
Photo 44 Guantong Bridge

There were also a large number of stone masonry arch bridges. For example, Guantong Bridge is a 30 m long unreinforced sandstone masonry arch bridge between skewbacks as shown in Photo 44. It was built nearly 10 years ago. Because it was built on stable bedrock, damage was not extensive. Only top stones suffered compression failure near the arch crown and the 1/4 point as shown in Photo 45 are due probably to large response displacement of the bridge in the longitudinal direction.

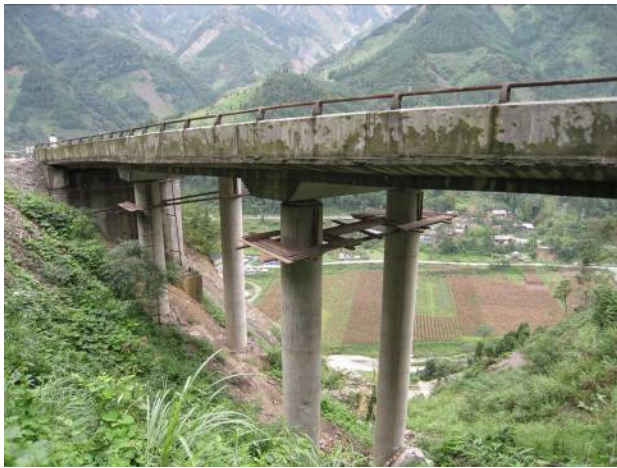
Photo 47 Longchi Bridge

There were many bridges which suffered damage due to slope failure. For example, Longchi Bridge on Duwen Highway between Dujiangyan and Yinxiu is a four-span, simply supported, slab bridge near Longxi Tunnel, as shown in Photo 47. It suffered damage due to slope failure as shown in Photo 48. Lateral drift as well as tilting occurred in the foundations, and this resulted in a large offset of the deck relative to the abutment in the transverse direction.

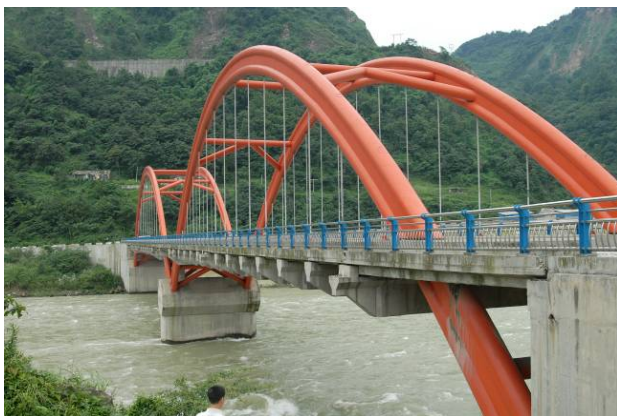
Photo 49 Zixia Bridge

It should be noted that a number of bridges located in the fault regions remained undamaged. For example, Zixia Bridge located 1 km downstream of Zipinpu dam and 10 km away from Miaozipin Bridge and Baihua Bridge suffered almost no damage. As shown in Photo 49, it is a two-span, simply supported pipe arch bridge with about 80 m spans. The arch is composed of two steel pipes. Transverse girders are hung by the arch through vertical members and deck panels are set on the transverse girders. Damage was very minor because of light steel pipe arches, light weight girders and the steady bedrock ground condition at both shores. Photo 50 shows minor damage, such as partial flaking to the cover concrete of curbs around a pipe arch due to its oscillation.
