Damage of 2009 L'Aquila, Central Italy Earthquake

This is a reconnaissance report on the damage to buildings, bridges and other structures caused by the 2009 L'Aquila, Italy earthquake. The authors conducted site investigation during the period of April 18-21, 2009. A detailed discussion on the damage of buildings, bridges and other facilities as well as possible damage mechanisms is presented. Geotechnical damage and ground motions are also presented.

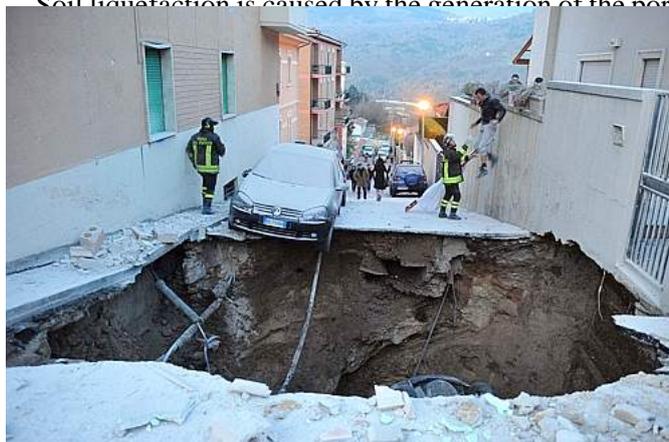
In the old city of L'Aquila, at least two sinkholes nearly 60 m apart developed on roads due to the earthquake and a vehicle was about to fall into one of the sinkholes as shown in Photo 6. This sinkhole was already back-filled with soils for stabilizing the surrounding ground. However the other sinkhole was only partially back-filled as shown in Photo 7 and it was possible to investigate it. The deepest point was 12.9 m from the road surface near the east edge of the sinkhole (refer to Fig. 4). However the cave tended to become deeper towards west. The roof of the cave consists of four horizontal layers. From the bottom to top, they are (1) well cemented calcareous conglomerate, (2) clayey conglomerate, (3) clay, and (4) backfill. It was observed that a sewage conduit was constructed after excavating a 3.7 m deep vertical trench reaching to the level of the calcareous conglomerate. This trench excavation has eventually notched the upper surface of the conglomerate roof of the cave, which could further reduce its effective thickness. The scenario mentioned above may have been responsible for the formation of the sinkhole during the earthquake shaking.

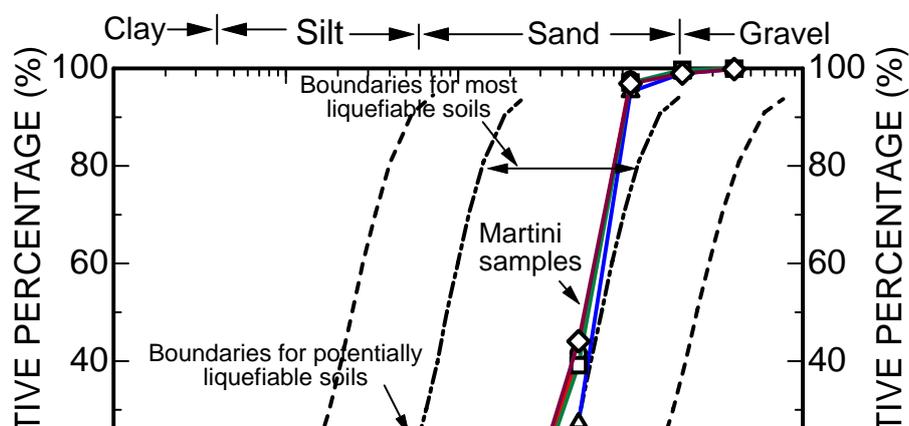
Fig. 5 Grain size distribution and comparison of liquefaction bounds liquefaction bounds

shown in Photo 8. Sand boiling as thick as 150 mm was observed in various locations. The movement of ground was towards SE direction. Table 3 and Fig. 5 show some physical properties and grain size distribution of sand boils, respectively, based on laboratory tests at Tokai University, Japan and Pamukkale University, Turkey. Boiled sand is almost homogenous and its grain size distribution falls within the “easily-liquefiable bounds” according to Japan Port and Harbour Research Institute classification (1997).
