# THE SURUGA BAY EARTHQUAKE OF AUGUST 11, 2009

Ömer AYDAN

This reconnaissance was carried out  
on the behalf of  
Earthquake Disaster Investigation Committee of  
Japan Society of Civil Engineers

June 2010

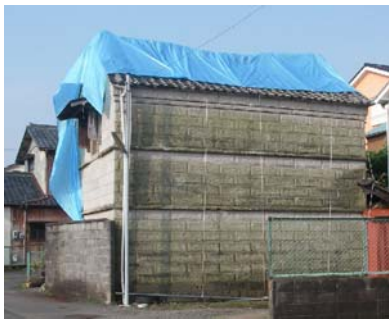
(a) Yaizu masonry building

There was no collapse of buildings caused by this earthquake. The damage to buildings was mainly limited to the roofs of the common two story buildings. High-rise buildings are fundamentally steel structure with extra reinforced concrete columns and shear walls. Low-rise buildings are generally reinforced concrete buildings. The damage was particularly widespread in the vicinity of Haibara and areas with soft-ground conditions. The tiles of roofs were displaced due to ground shaking and fallen subsequently as seen in Figure 22:

Figure 22: Damage to two-story buildings in the earthquake affected area

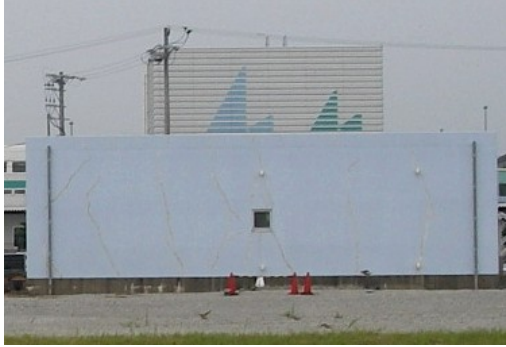
(a) Yaizu Deep-sea water facility

There is no report of damage to high-rise buildings including one of the compounds of Shizuoka Prefectural government buildings. Reinforced concrete buildings performed well during the earthquake. Some reinforced concrete buildings in liquefied areas were also cracked (Figure 23(a,b,d)). Retrofitted RC buildings also performed well. However, there were some cracking in unretrofitted floors of such buildings (Figure 23(c)).

Figure 23: Slight damage in reinforced concrete buildings

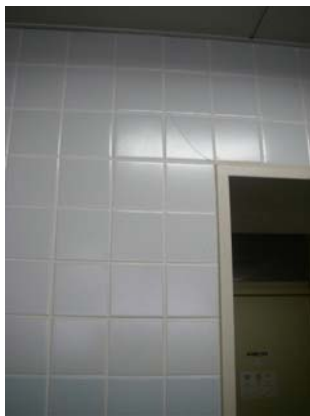
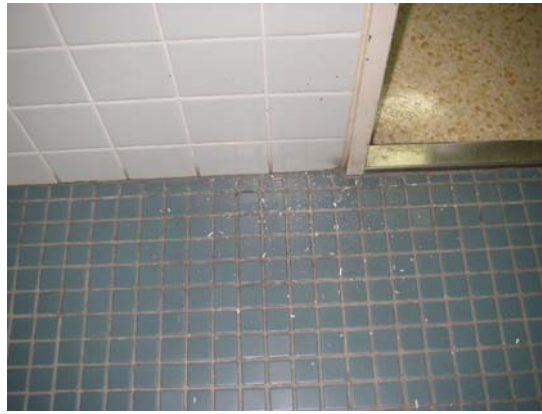
(c) Cracking in the unretrofitted floor of a retrofitted building

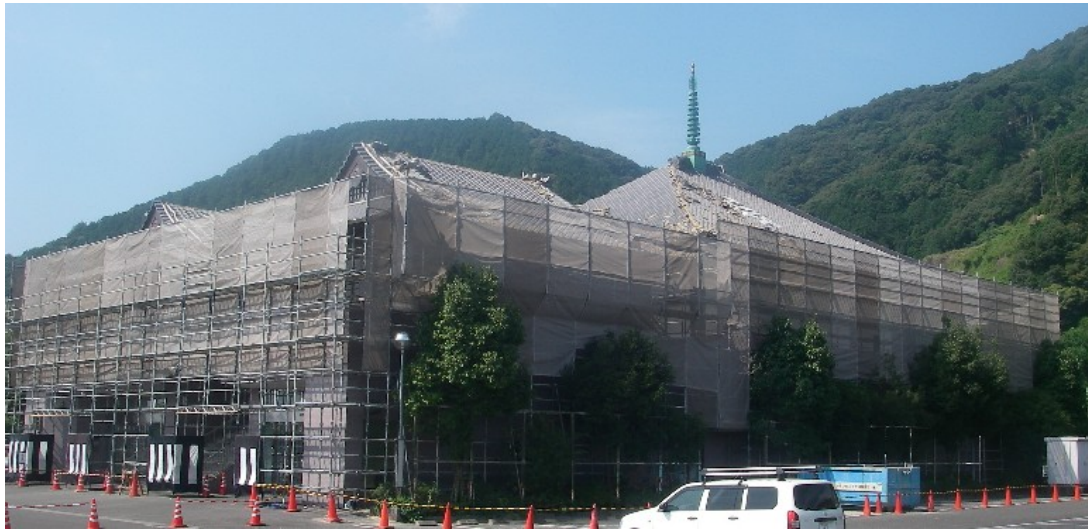
(a) Aishoden – West Shizuoka

Damage to temples and shrines generally occur at gates and buildings. The gates of temples are either made of granitic stone or wood. Furthermore, damage to monuments and stone lanterns occur along the alleys leading to the main compound. The damage to such structures occurred in temples and shrines situated over soft ground or hilly ground with ridges (Figure 24). The damage to main buildings and auxiliary structures were mainly due to the displacement of roof tiles and/or the relative sliding of the wooden columns over the foundation stones. In some of temples and shrines, uneven settlement of ground due to liquefaction caused some distressing in the main buildings.

Figure 24: Damage to temples and shrines

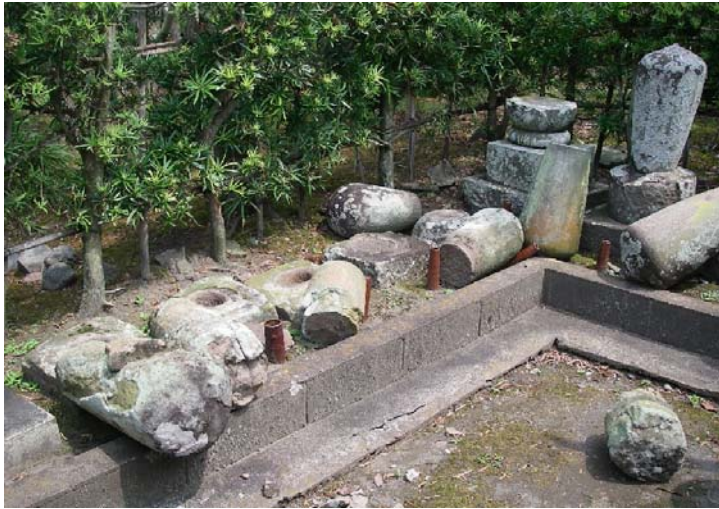
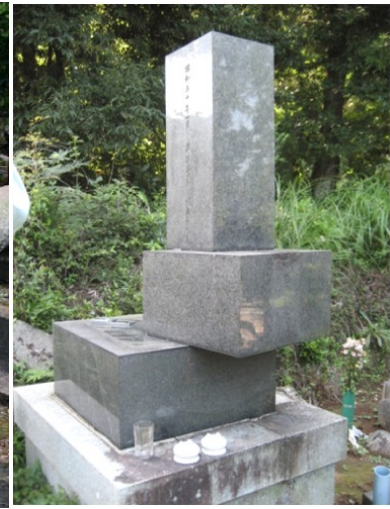
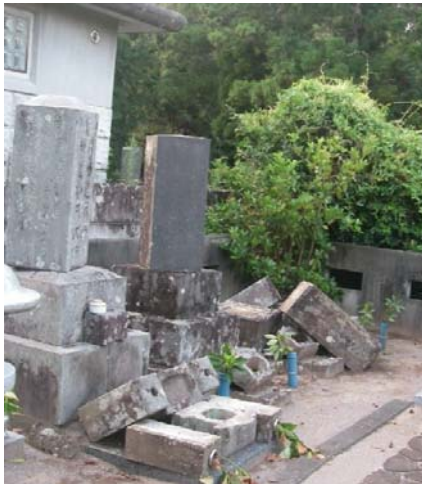
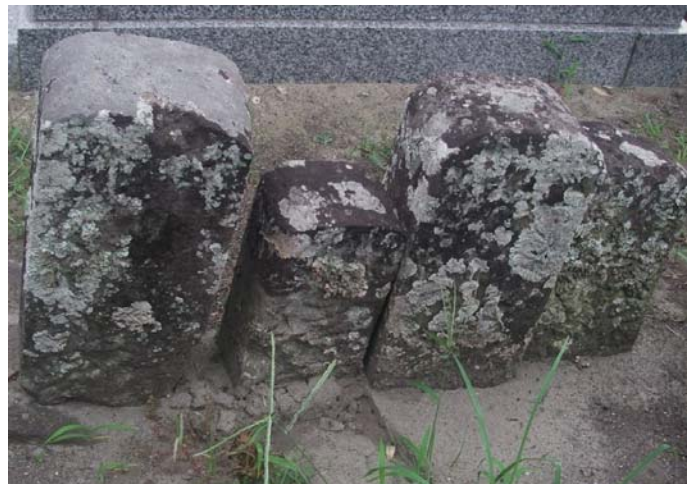
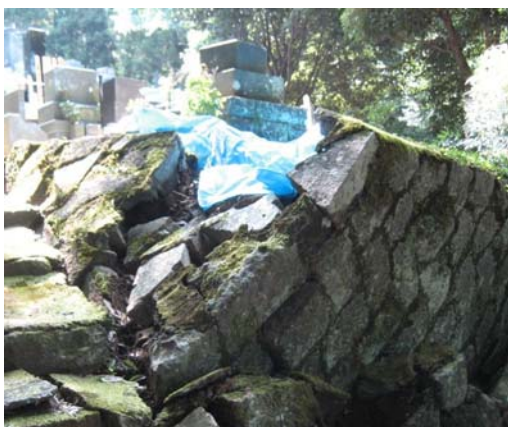
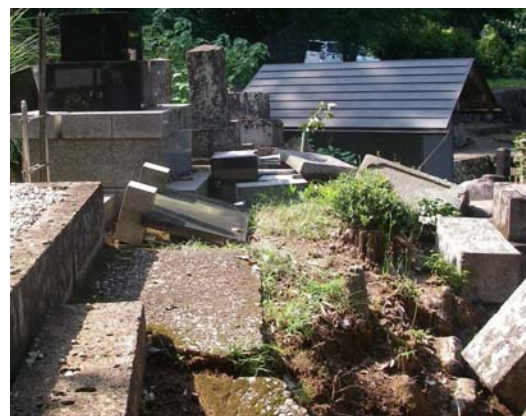
Figure 25: Damage to tombs of cemeteries

The damage to cemeteries were very extensive particularly in areas with thick soft sedimentary ground. Tombs in cemeteries consist of well-shaped stone blocks, which mostly have rectangular prism shapes.

The collapse direction and collapse ratios of the stones of tombs served as a measure of intensity of shaking since early times in Japan. In earlier tombs, no bonding agent has been used. However, the use of stone dowels is generally common. In recent tombs, some bonding agents and/or steel dowels are used. When all resistance is due to frictional forces, they are well indicators of the ground motions. When the resistance depends on either frictional and/or geometrical shape, the failure modes are sliding, toppling or combined sliding and toppling with or without rotation (Figure 25). In some cases, there were failure of ground or retaining walls in cemeteries on hilly ground.

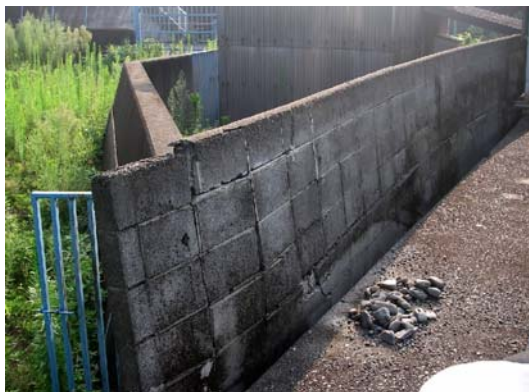
(a) Yaizu

Walls are generally vulnerable to topple due to high aspect ratio of their height to width. Although it is an obligation to put reinforcing bars in brick walls, they may fail under strong shaking. When they fail by toppling, they behave like a monolithic body. Such failures may be more dangerous compared to those without reinforcing bars. Figure 29 shows several examples of wall failure in the epicentral area.

Figure 28: Toppling of walls

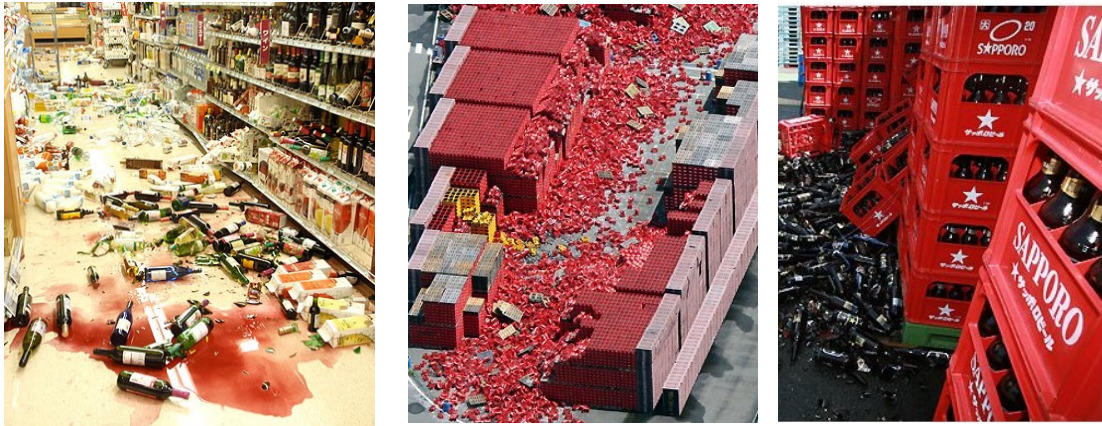
Many shops, particularly convenience shops, have shelves with goods. It is now a common phenomenon to see many goods fallen or displaced from the shelves in such shops due to earthquakes. Figure 30 shows several examples of damage in some convenience shops.

Figure 30: Views of fallen or toppled goods (pictures collected from newspapers)

damage was caused by the breakage of bottles of beer due to toppling of beer bottle containers as seen in Figure 30.

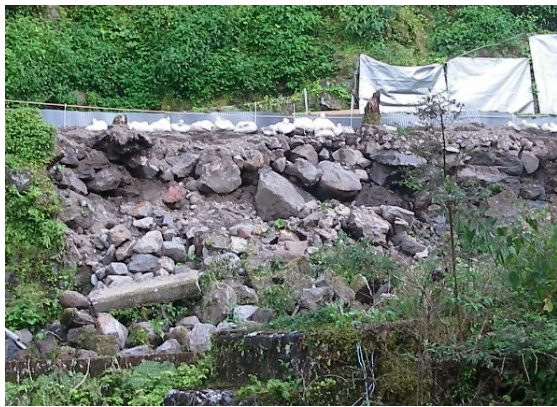
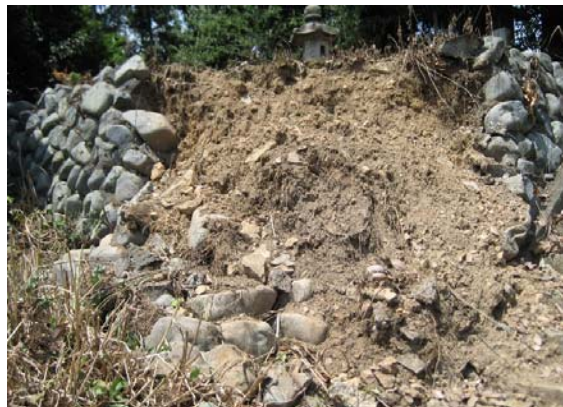
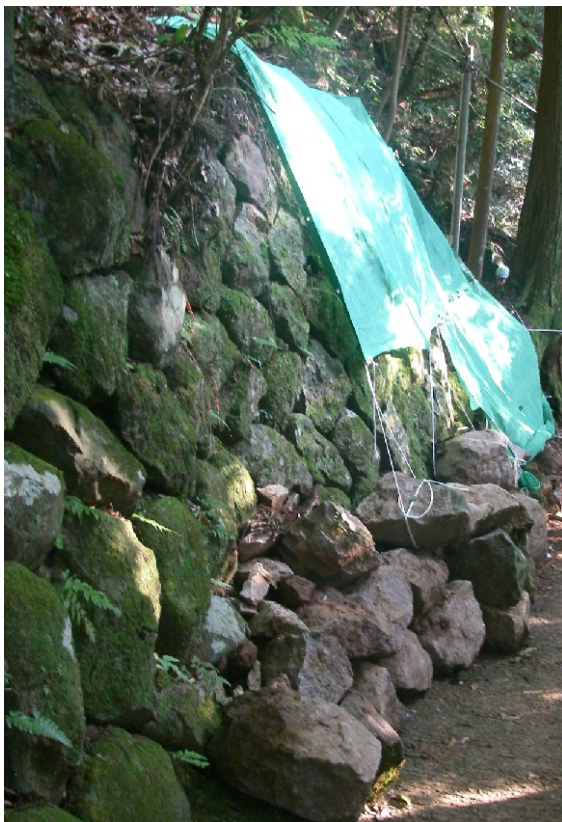
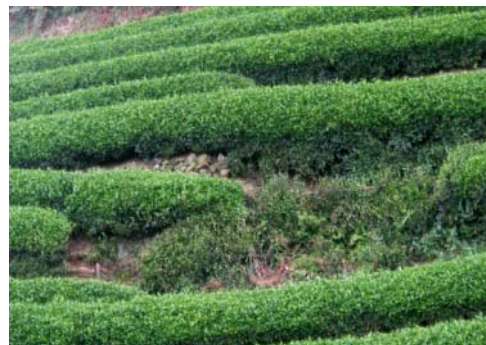
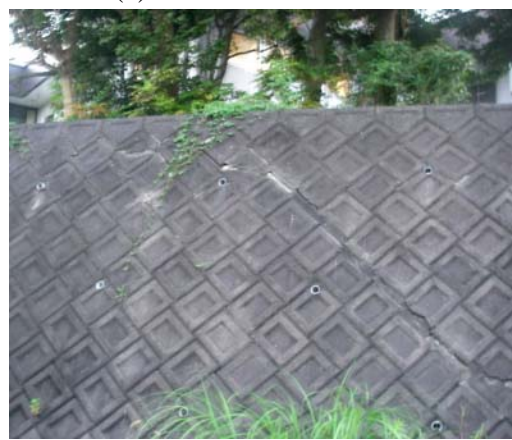
Figure 35: Some examples of retaining wall failure

There are different types of retaining walls. Old retaining walls are generally of dry masonry type. Stones used are either rounded or cut to rectangular prism shape and the size changes depending upon their height, location and purpose. Some of recent retaining walls were constructed using the pre-cast concrete blocks. The inclination of the retaining walls generally ranges between  $70^\circ$  and  $80^\circ$ . The failures were generally induced by the displacement of a stone or several stones in the wall, which serves a point of singularity to induce the failure of subsequent fall of stones (Figure 35). The dry masonry retaining walls having rounded stones are more vulnerable to failure during the earthquake. Although the retaining wall on the northern side of the Makinohara service are did not collapse, there was a trough-going crack in the retaining wall, which may be caused by a mass-movement or ground rupture.

The inspection of the failed retaining walls indicated rounded sandstone and shale gravels used as backfill material except the soil for growing plants on the top of the retaining wall. The first author also noticed some bulging in retaining walls during 2008. As the average inclination of retaining walls was about  $70^\circ$ , it was unlikely for the walls to fail in rotational mode on the basis of previous case histories and analyses (Aydan et al. 2008). The fundamental mode of failure is likely to be the inter-sliding of blocks, which has a pyramid shape under strong shaking in N-S direction. The bulging of the wall probably rotates castle wall blocks and loosen the contact between the load carrying blocks and small filling stones or gravels. Round large river gravels seem to be used as the back-fill material, which probably reduces the apparent friction of the back-fill material. This, in turn, results in the increase of the pressure from the back-fill material on the retaining walls.

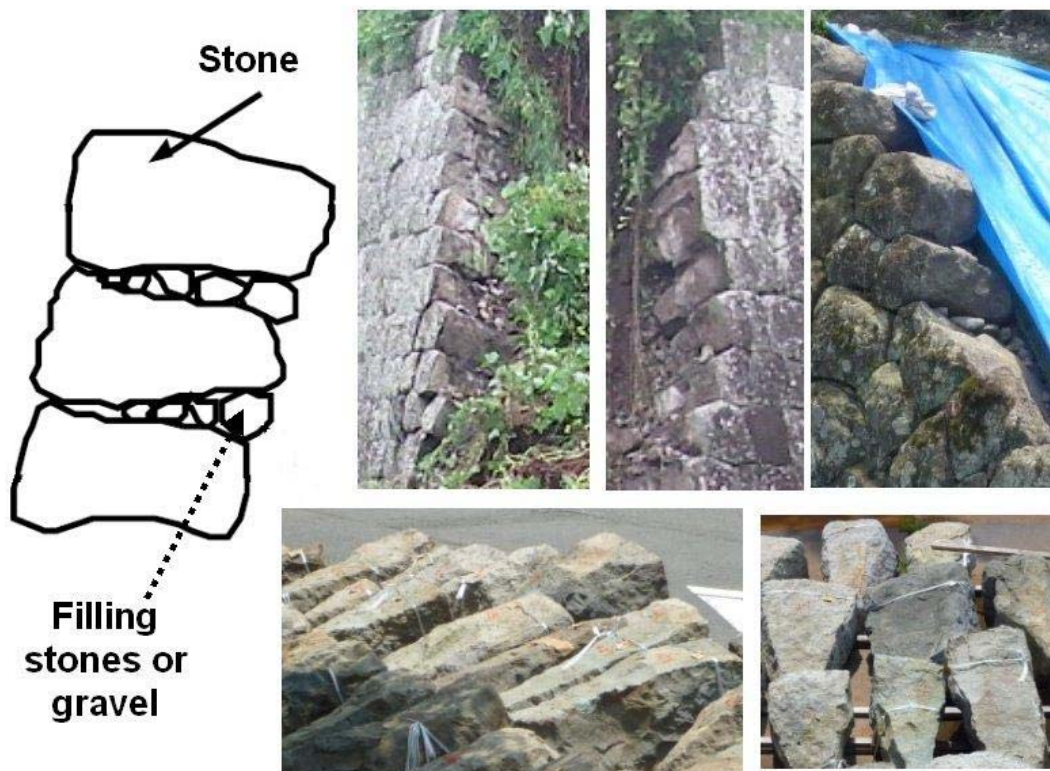
The most publicized retaining wall failure was observed at the remains of the Sunpu Castle (Figure 36). The retaining walls of about 8-9 m high failed at three locations in N-S direction, indicating the directivity effect of the strong ground motions. Two failures occurred at the south and north side of the outer moat (soto-bori) and one failure occurred in the south side of the inner moat (uchi-bori). The size of corner stones is generally large (longest side length is about 200 cm) and placed in an intermittent pattern with an average inclination of  $70^\circ$ . The sizes of blocks at other parts are very variable. Nevertheless the longest side of the stones cut into pyramid shape is generally more than 80 cm and it is placed into the inside of the wall (Figure 37). Old stones are

generally made of andesite and porphrite while the newly restored parts consist of basalt blocks. It is well known that the retaining walls suffered heavy damage in the past. It is reported that all retaining walls were collapsed during the 1854 Ansei earthquake. Some part of the restored retaining wall failed again in the 1935 Shizuoka earthquake. Although the configuration of the retaining walls of Japanese castles is earthquake-resistant, the ground motions are generally expected to be large to fail these retaining walls.

Figure 37: Masonry technique for building retaining and castle walls of Japan and views of stones used in Sunpu castle retaining walls.

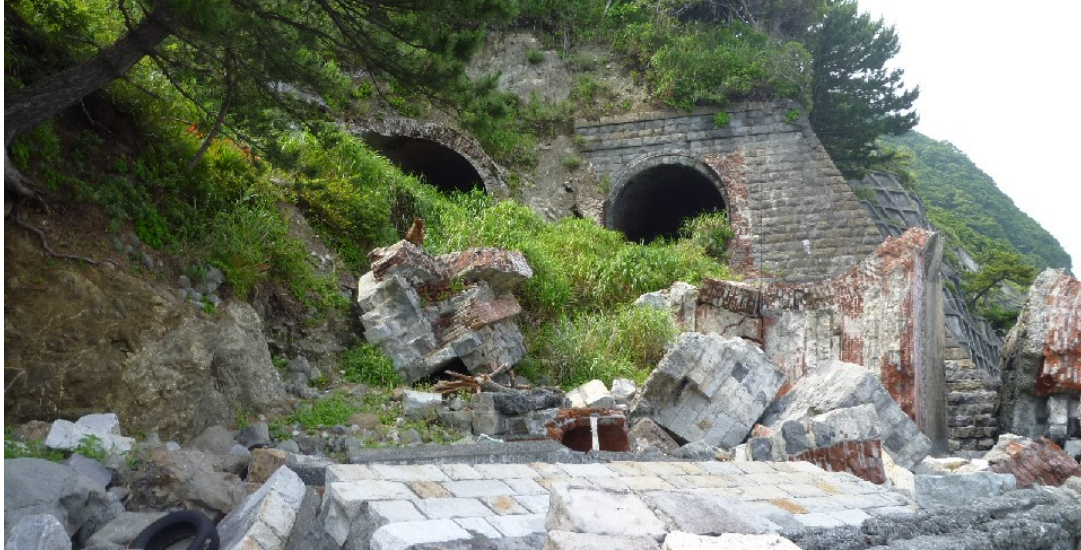
Shizuoka is one of the mountainous prefectures in Japan and there are very large-scale rock slope failures. For example, the 1707 Hoei earthquake caused the Oya-kuzure failure. Another area is called Yui, where slope failures occurred and resulted in the disruption of railway and roadway between Tokyo and Osaka in 1970s. The Okuzure shore is another area of the huge slope failures and it was the main route between Tokyo and Osaka before the construction of Nihonzaka tunnels. One can find the remains of the collapsed tunnels of the old Tokaido railway tunnel (Figure 38).

Figure 38: The remains of the tunnel of the old Tokaido railway line

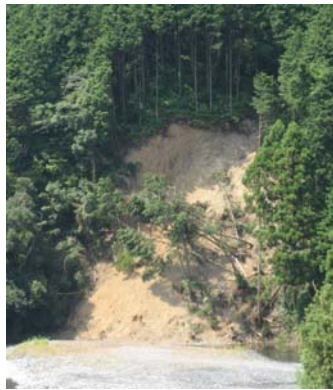
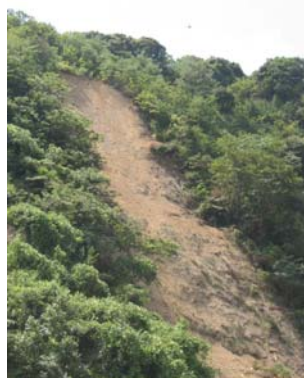
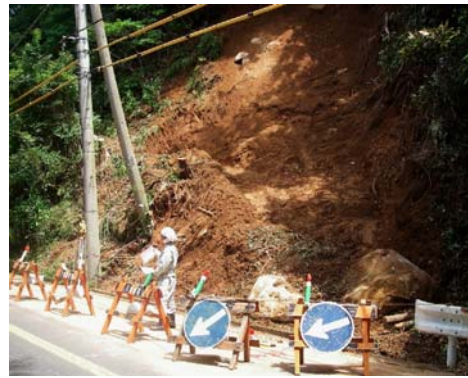
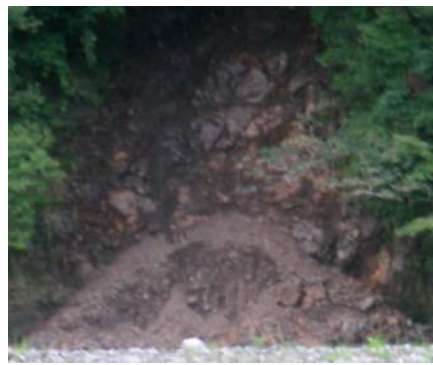
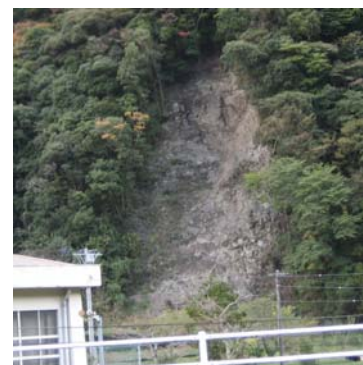
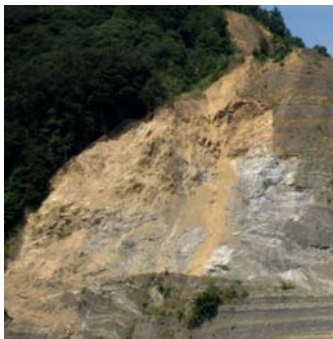
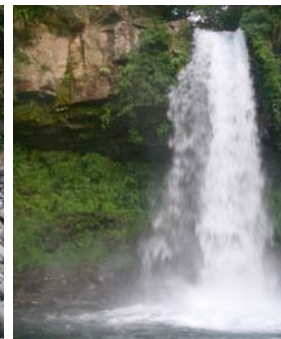
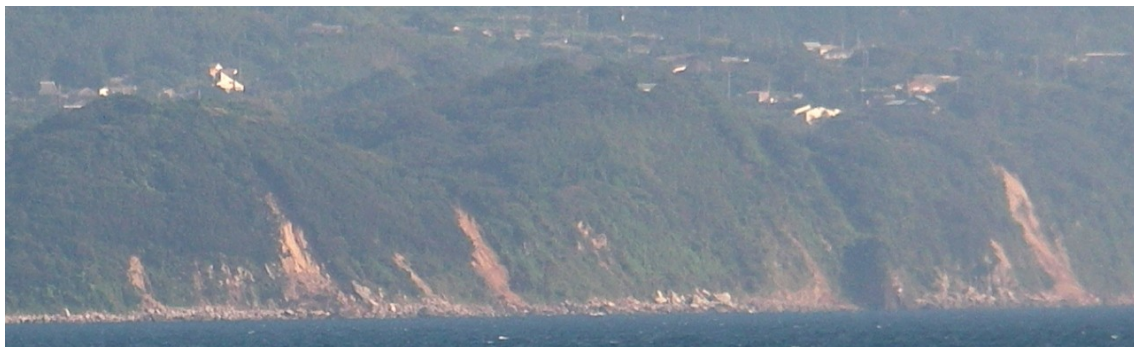
Figure 39: Example of some of slopes failures caused by the Suruga earthquake

The earthquake caused numerous slope failures and rockfalls of various scale along the banks of Abe River as far as Umegashima area, Yui, Okuzure and the west shore of Izu Peninsula (Figure 39). As most of slope failures far from the populated areas and involved natural slopes, their effect was minimal. However, it was interesting to note that the slope failures occurred in previously known locations of slope failures. This may further imply that larger earthquakes may cause significant slope failures, which may have significant effects in the prefecture. Slope failures may be classified as surfacial sliding, planar or wedge sliding and toppling depending upon the slope configuration and discontinuities in rock masses.

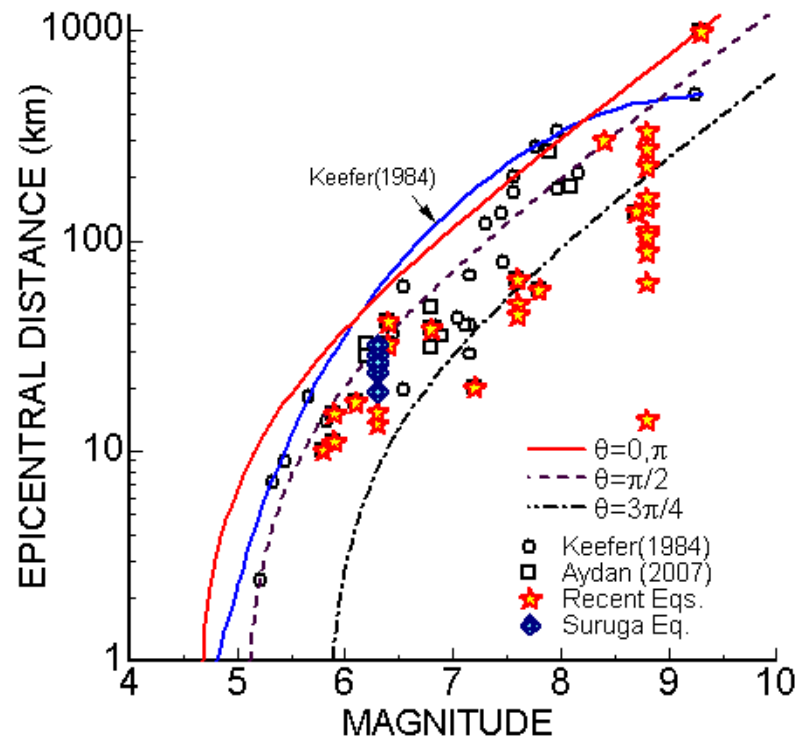
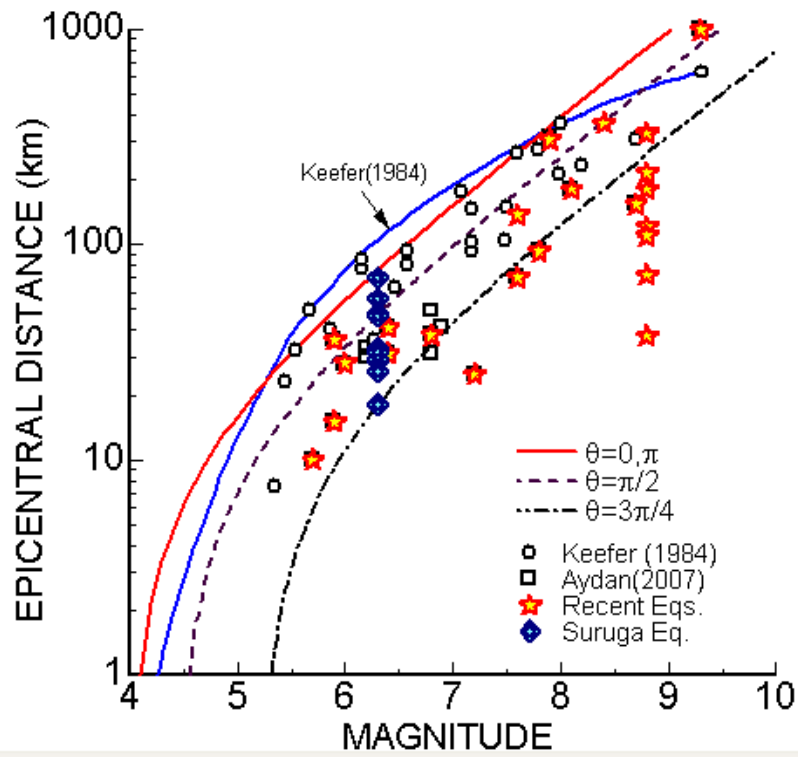
The author compiled slope failures caused by the 2009 earthquakes according to Keefer's classifications and plotted in Figure 40. Besides the empirical bounds of Keefer, the empirical equations proposed by Aydan (Aydan 2007, Aydan et al. 2009) are also plotted in Figure 40. The observations on the slope failures caused by the 2009 Suruga Bay earthquake fall within the empirical bounds of Aydan's relations.

Figure 40: Comparison of empirical relations with observations on slope failures

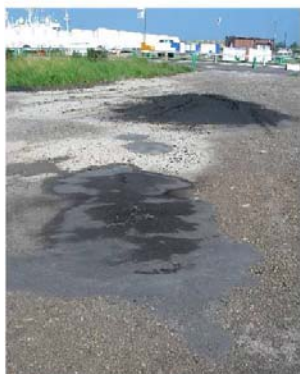
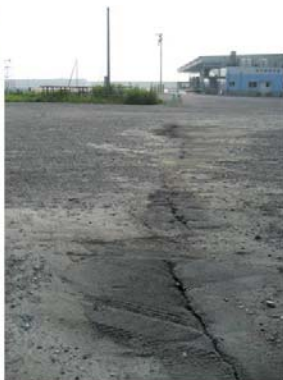
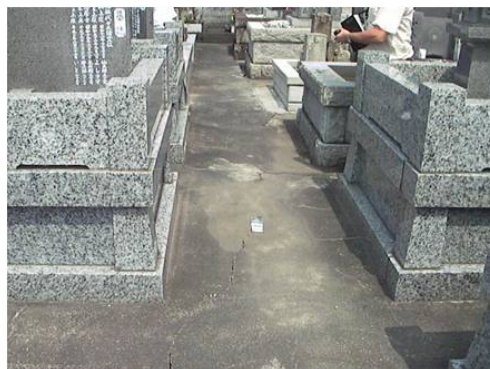
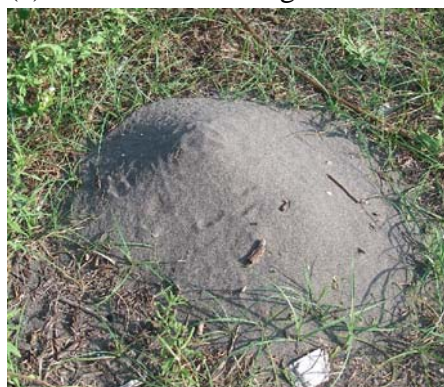
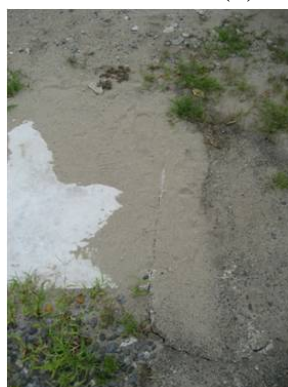
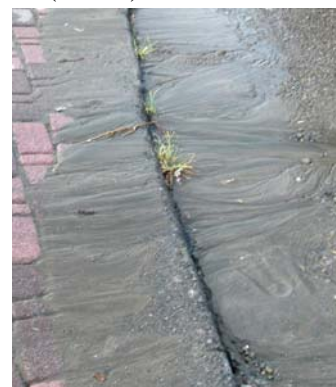
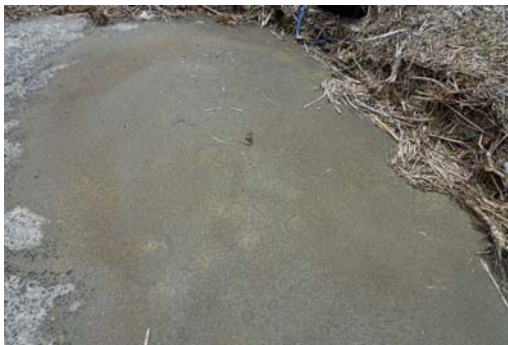
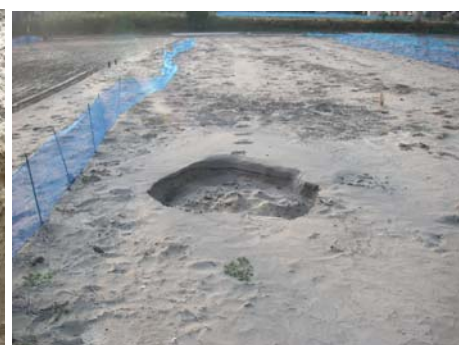
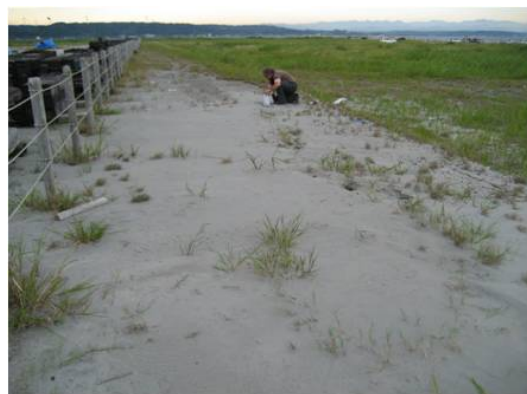
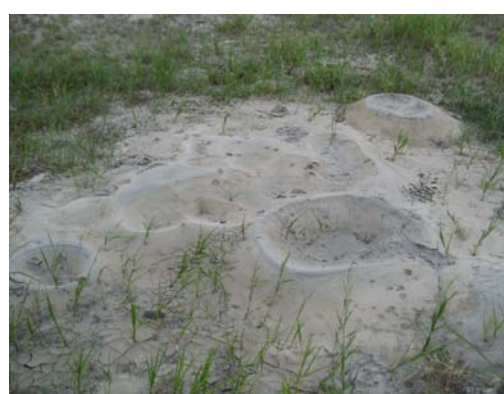
Figure 41: Views of ground liquefaction at several locations

It is well known that there are many case histories of ground liquefaction in Shizuoka prefecture in past earthquakes such as 1854 Ansei, 1891 Nobi-beya, 1935 Shizuoka and 1944 Tonankai earthquake (i.e. Wakamatsu 1991). As the magnitude of the earthquake is intermediate and duration is about 10 seconds, it is expected that the ground liquefaction would be limited. Nevertheless, the authors observed ground liquefaction in many locations as shown in Figures 41 and 42. Although no sand-boiling was observed in some of cases, the ground settlement in many locations (i.e. Shizuoka, Haibara, Sagara, Yoshida and Yaizu) was a clear indication of ground liquefaction. It was also interesting to observe the settlement of cemetery stones into the ground in liquefied areas.

The effects of ground liquefaction on structures are observed as settlement, uplift or lateral movement. The authors observed such effects on structures in areas of alluvial deposits, which are potentially liquefiable (Figure 43). The most severe effects of ground location was observed in Sagara fishing port, where quaywalls moved towards the sea, causing the separation cracks and settlement in the pavements. The maximum settlement and lateral movement of quaywalls were about 400 mm and 600 mm, respectively. The most severe movement was perpendicular to the fault strike. The top soil was sand (Figure 41(f)), which was observed by the authors when they visited the port on July 1, 2010 to see how the restoration was carried out. The most spectacular ground liquefactions were observed in Omaezaki West Wharf, Sagara-Sakai fishing port and Susuki area of Sagara. Although the filling material of the West Wharf contains mudstone and sandstone of Sagara formation, the ground liquefaction was wide spread and the diameter of sand volcanoes was about 5 m in some locations. The movement of water breaks and quay walls ranged between 25-40 cm in the West and Jitogata wharfs of Omaezaki port. The maximum ground velocity obtained from the acceleration record taken at the Omaezaki port by The Port Authority of Japan was about 40 cm/s.

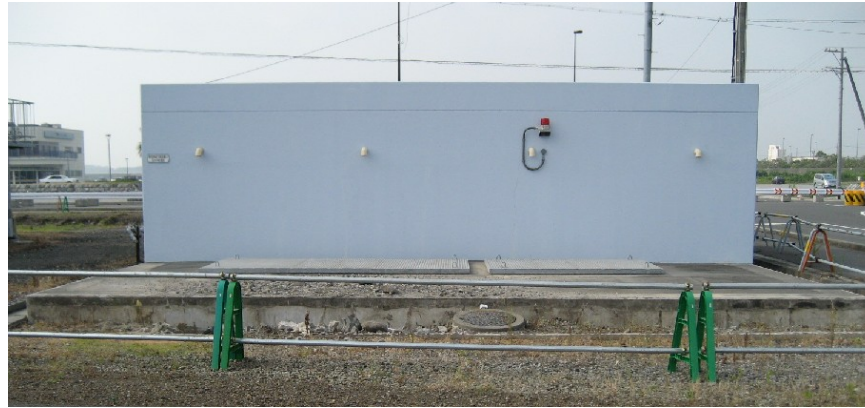
The ground liquefaction caused the uplift of deep-sea water tank and rupturing connections pipes. The relative settlement between the non-treated ground and Aquas building caused stretching of pipes of the facilities as well as the rupturing of concrete foundation of the stairs.

(a) Yaizu Deep-sea water plant storage tank

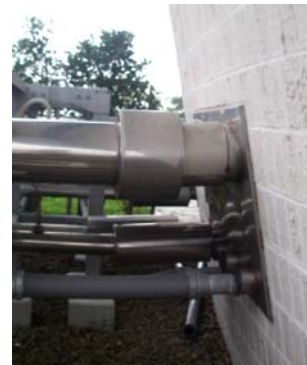
(c) Aquas building

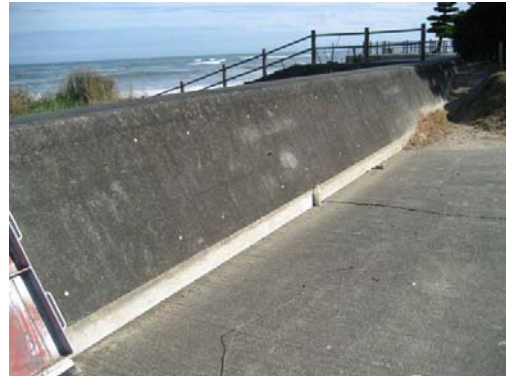
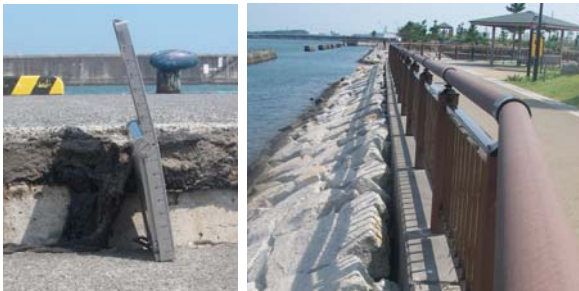
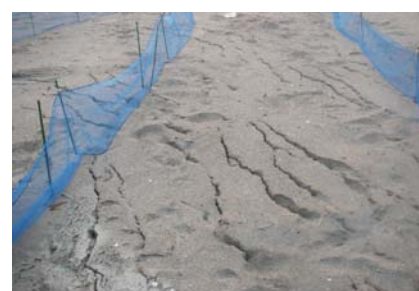
Figure 42: Ground-liquefaction induced damage at several locations

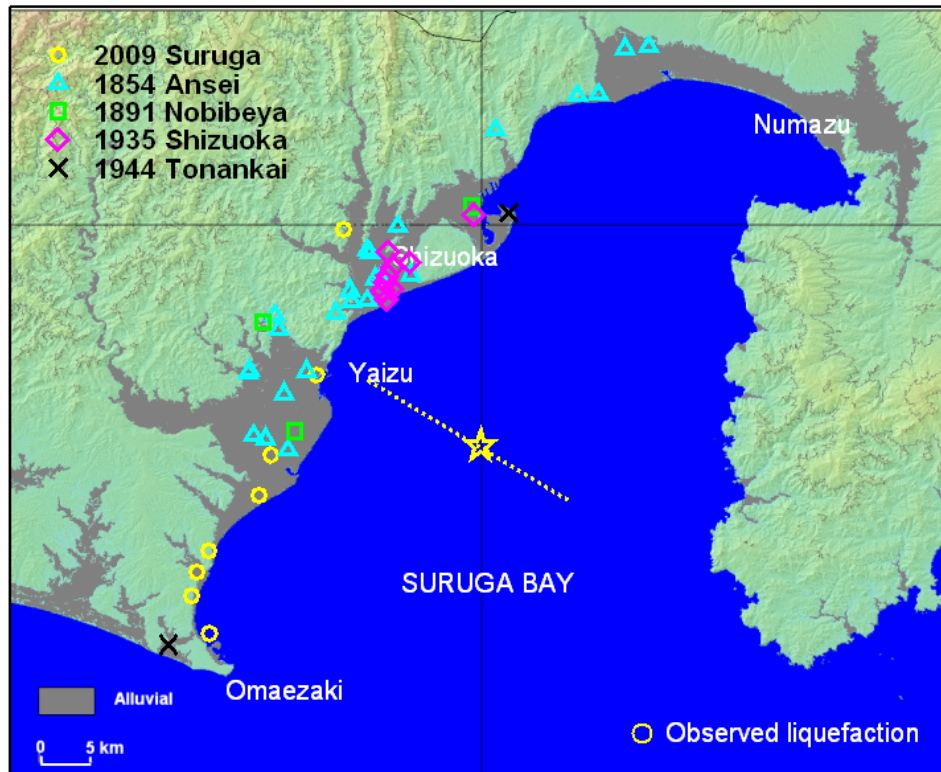
Figure 43: Comparison of observed liquefaction with those observed in past earthquakes

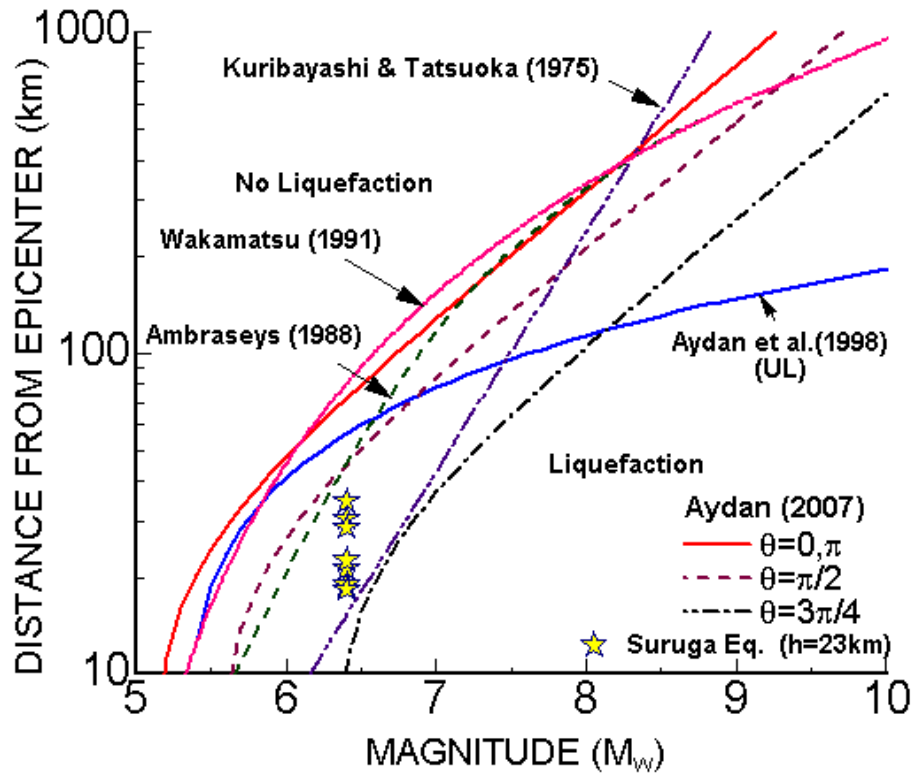
The grain-size distribution of soil samples, the estimation of lateral spreading and the limiting distances as a function of earthquake magnitude for ground liquefactions are shown in Figure 44, 45 and 46. As noted from these figures, the observations are in accordance with empirical relations.

Figure 44: Comparison of various empirical relations between earthquake magnitude and distance of ground liquefaction with observations

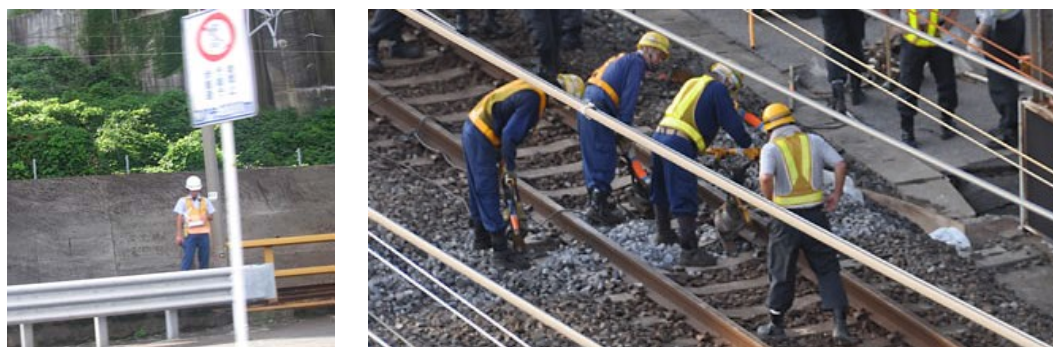
The effect of the earthquake on railway lines was almost none. The railway lines are the JR Shinkansen line, JR Tokaido Local Railway line and the local Shizutetsu railway line between Shimizu and Shizuoka. Railways companies carried out necessary inspections on railways (Figure 46). The train services were temporarily halted.

Figure 46: Inspection of railways and the restoration of disrupted parts

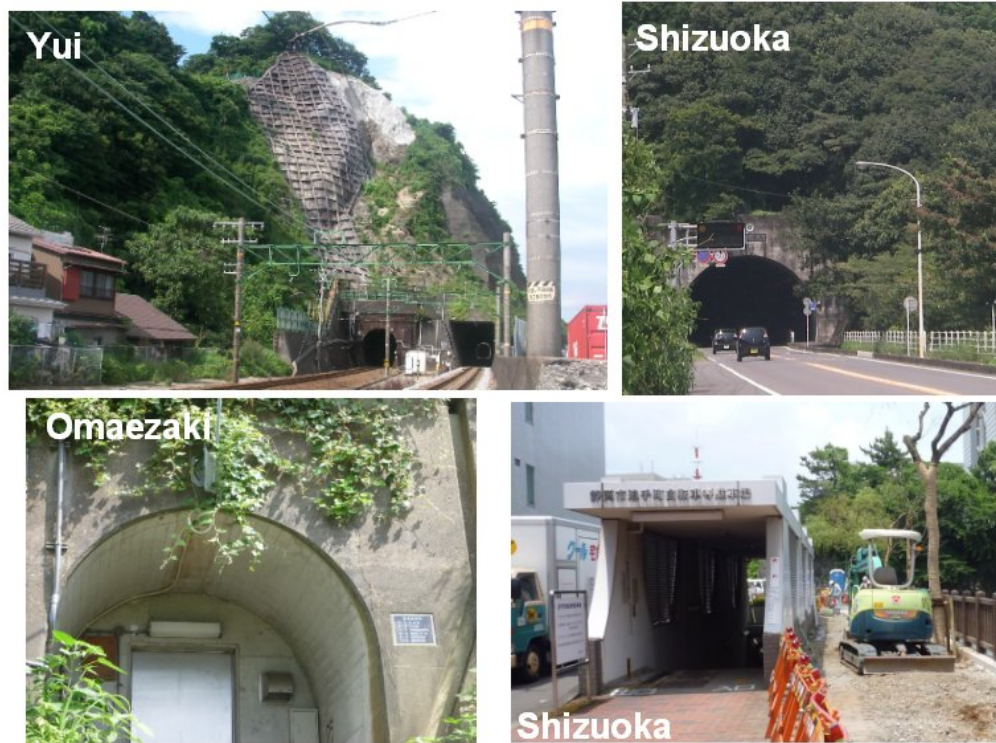
There are many roadway and railway tunnels in the earthquake-affected area. No major damage was reported for these underground structures even at portals, which are quite vulnerable to earthquakes. Figure 52 shows some examples of tunnels in Yui and Shizuoka, an underground passage next to the failed masonry retaining wall in near Sunpu Castle and underground observation gallery in Omaezaki. As noted from pictures of these structures, the earthquake caused no visible damage.

Figure 52: Non-damaged underground structures in the earthquake affected area

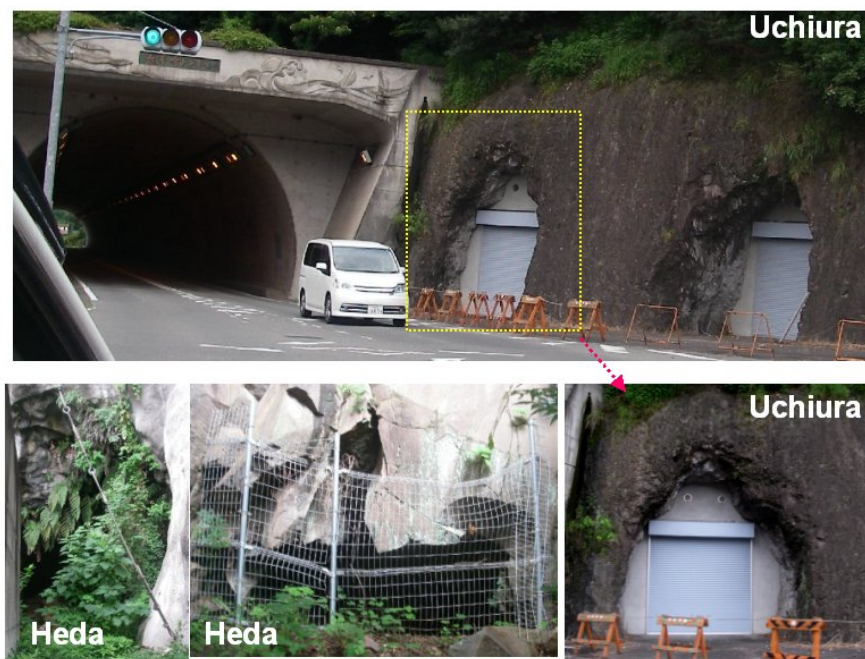
Figure 53 shows pictures of unsupported caverns excavated in andesite in Uchiura and Heda in Izu Peninsula. The caverns were probably excavated before the Second World War as rock shelters. These caverns are still used for storage of goods. Although almost all these caverns were structurally stable, there were some small fallen rock fragments due to ground shaking.

Figure 53: Views of underground caverns in Izu Peninsula

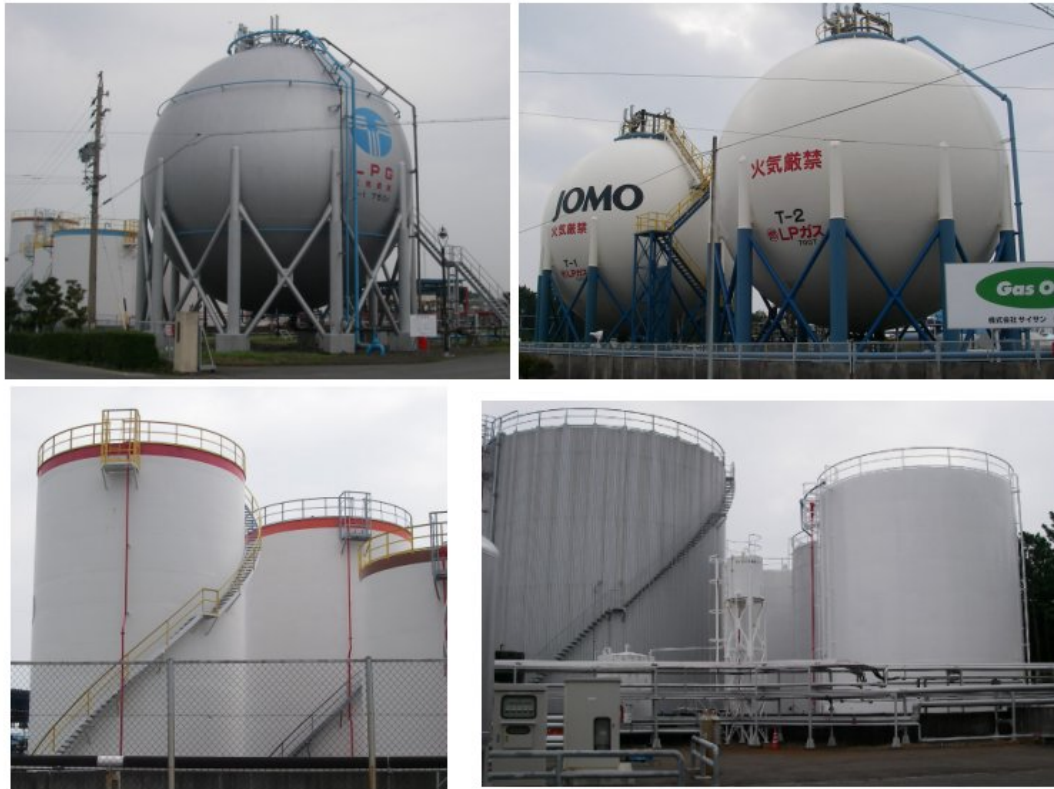
There are many industrial facilities around Suruga Bay. Although small-scale damage due to rotation and dislocation due to ground shaking was observed, there was no major damage in any industrial facility. The silos at Shimizu port and Ohkawa port were all intact. There are also many oil and gas surface and semi-underground storage tank yards around Suruga Bay. No damage was reported in any such facilities. The authors investigated some of cylindrical and spherical storage tanks in the vicinity of Yaizu-Ohkawa port area (Figure 55). There was no visible damage to any of tanks in the area, although it is very close to the earthquake epicenter. A small oil-tank in Sagara fishing port was only tilted due to lateral movement of the ground.

Figure 55: Non-damaged cylindrical and spherical oil and gas storage facilities

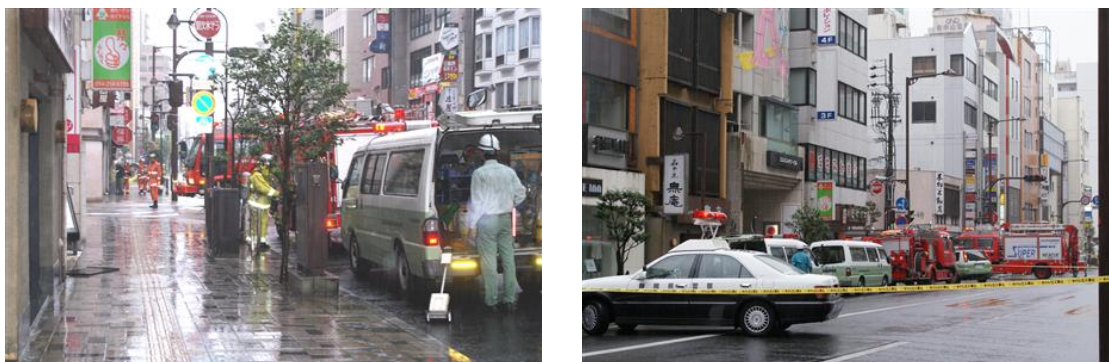
Tokai Gas reported that gas leakage occurred at 12 sites due to ruptured gas pipes. Figure 63 shows two examples of gas leakage in Shizuoka City.

Figure 63: Views of gas-leakage sites in Shizuoka City (from newspapers)
