A RECONNAISSANCE REPORT
ON
THE PARIAMAN-PADANG EARTHQUAKE OF SEPTEMBER 30, 2009*

2009 Pariaman-Padang Earthquake Reconnaissance Team

Japan Society of Civil Engineers,

October 2009

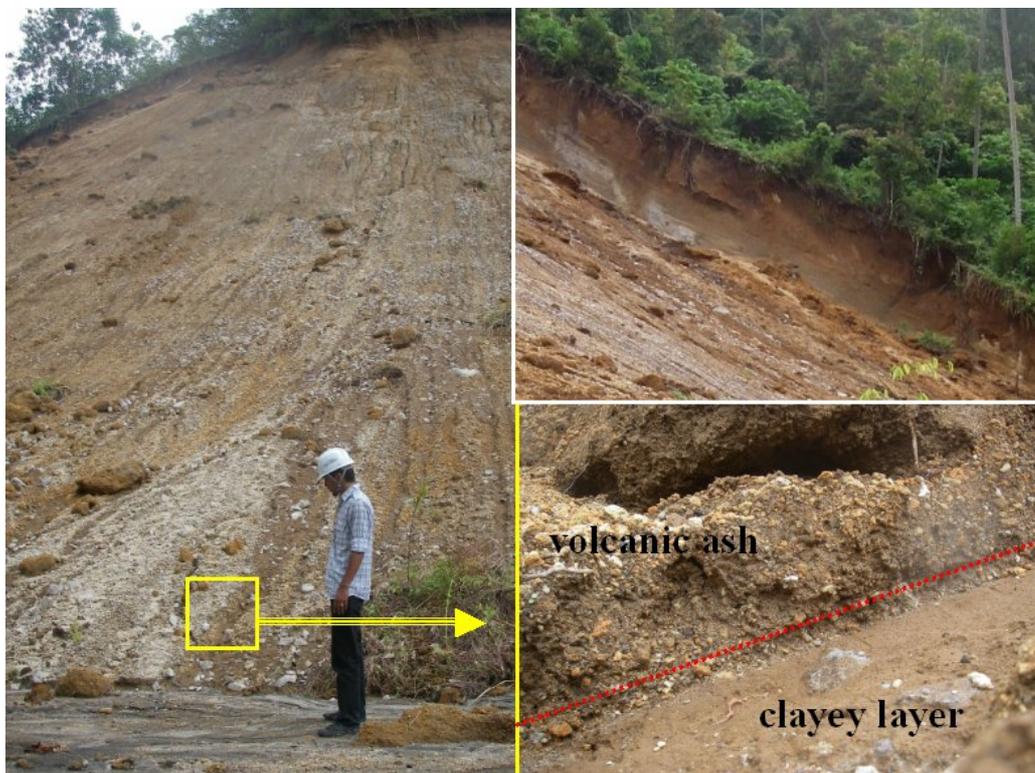
Mountainous areas where surficial landslides occurred are generally covered with intercalated sandy to gravelly and clayey layers of volcanic origin (Figure 3.3). The sandy to gravelly layers are very porous and abundant with ground water.

Figure 3.3: Intercalated layering at surfacial landslides area (Padang Alai)

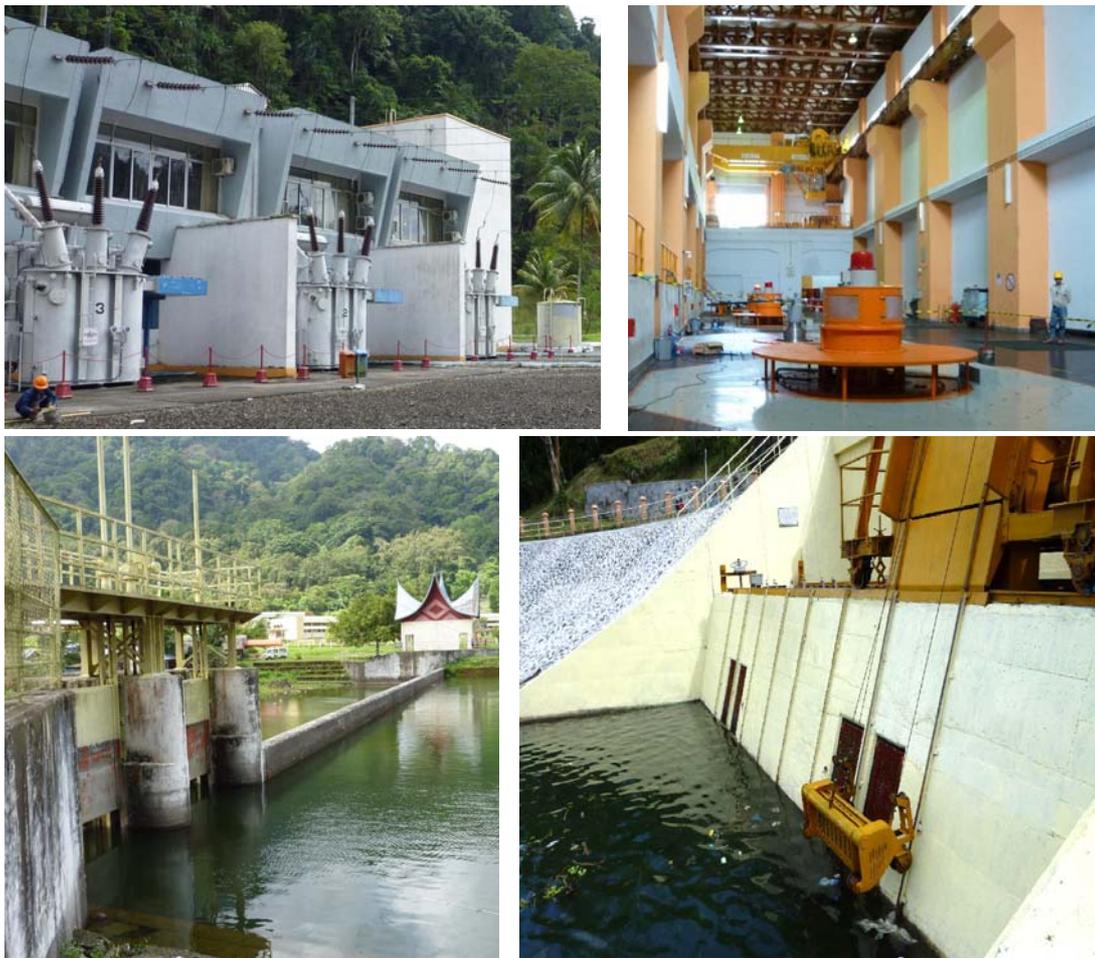
The second power plant is located near the Maninjau Crater Lake. The power plant is a hydroelectric power plant. The power plant has four turbines. The earthquake did not cause any damage to the power plant (Figure 5.11). However, some ceramic isolators were broken due to ground shaking at the sub-station of the Maninjau power plant. As the isolators had to be brought from Sweden, it took several days to repair the isolators (Figure 5.12). The sub-station near Pariaman did not suffer any damage due to the earthquake. In the downtown of Padang and Pariaman some transformers mounted on poles were fallen down so that the electricity had to be cut-off in such areas. Although some reinforced concrete poles broken due to either ground shaking or collapsed buildings, nor damage occurred to the pylons of the major transmission lines.

Figure 5.11: Views of Maninjau hydroelectric power plant

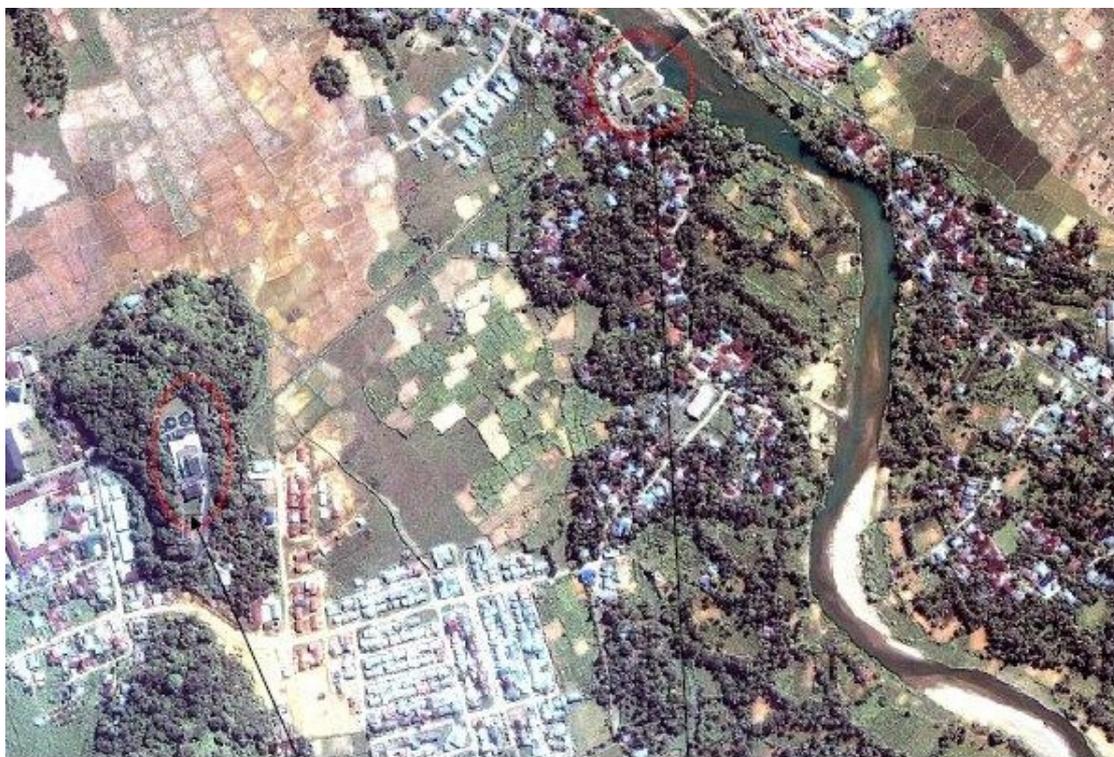
The water supply plant was investigated by Prof. Kawamura of Toyohashi Technical University and the information given here is based on his report in Padang. The water is basically pumped from the river to the purification plant on a hill and it was distributed through the gravitational flow after the purification (Figure 5.13). The major damage occurred at the purification plant due to relative settlement and movement of foundation ground, which caused some structural damage to the plant (Figure 5.14). The water was supplied to the network 4 days after the earthquake. However, it took more than 10 days in heavily damage areas.

Figure 5.13: Water supply system of Padang City

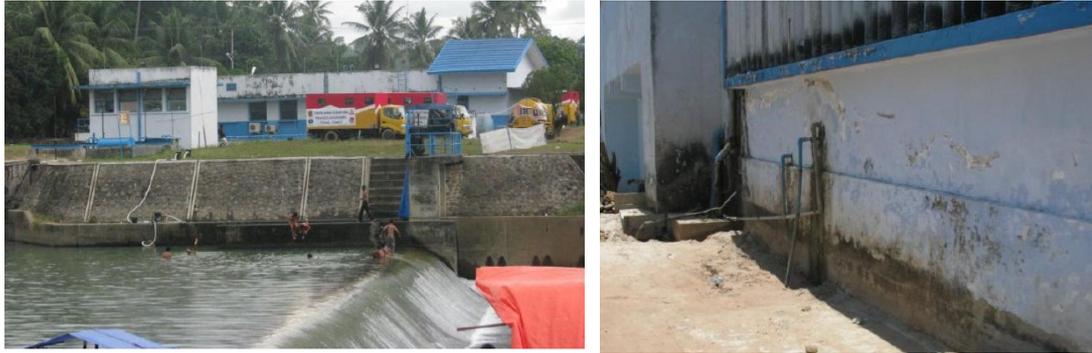
(a) Water intake facility

(b) Purification and supply facility

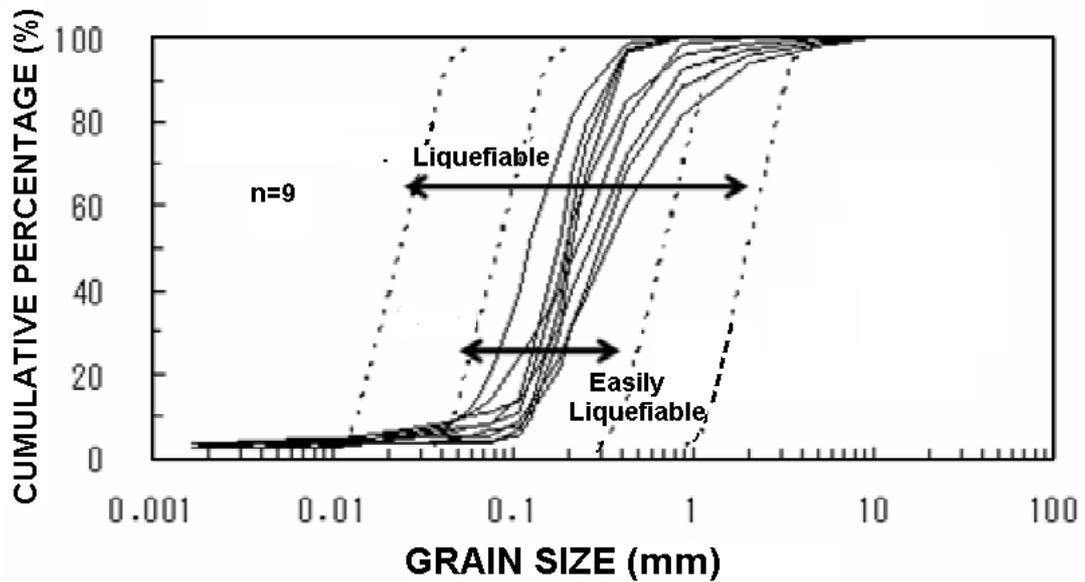
layer is potentially prone to liquefaction. The loose sandy layers at the depth of less than 5 meters below the ground are considered as the controlling factor for the susceptibility. Ground liquefaction was observed in various parts of Padang City in the areas such as Pecinan, Purus, Air Tawar, Alay, Ampang, Tabing, Linggarjati, Lubuk Buaya, Pariaman City and Bungus port (Figure 6.7-6.9). The settlement of the ground ranged between 5-40 cm. Lateral spreading of ground were greater than 200 cm in some areas. The ground liquefaction caused some structural damage to buildings and port facilities. Figure 6.10 shows the grain size distribution curves curves of samples collected at several sand boiling sites. As it is noted from the figure, the liquefied soil is within the bounds of easily liquefiable ground.

Figure 6.10: Grain size distribution of samples of sand boils.
