**A RECONNAISSANCE REPORT**

**THE DARFIELD (NEW ZEALAND) EARTHQUAKE OF SEPTEMBER 4, 2010**

**On the behalf of JSCE**

**Earthquake Disaster Investigation Committee**

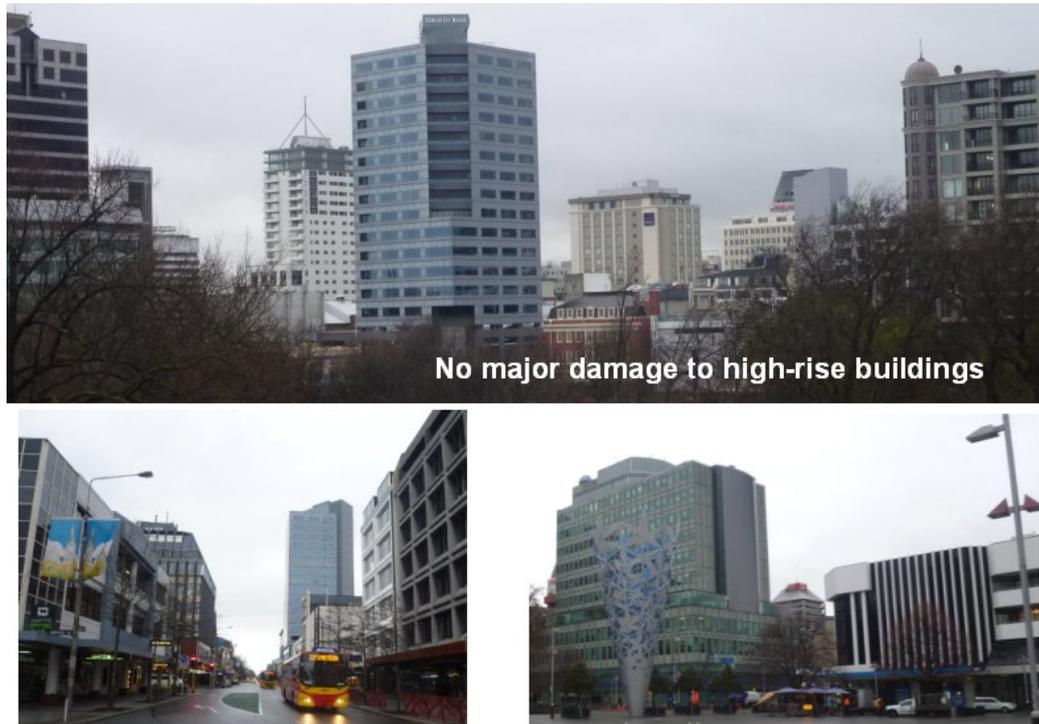
Many of the worst-affected buildings in both Christchurch and the surrounding districts were older unreinforced masonry buildings (Figures 18 and 19). The low story timber framed residential houses except those on liquefied ground and new reinforced concrete or steel framed buildings were almost intact (Figure 20). These buildings are characterized as typically 2 or 3 stories. However, 2 story buildings are most common. The causes of damage to unreinforced masonry buildings may be classified as:

Figure 20: Views of high-rise buildings in the downtown of Christchurch

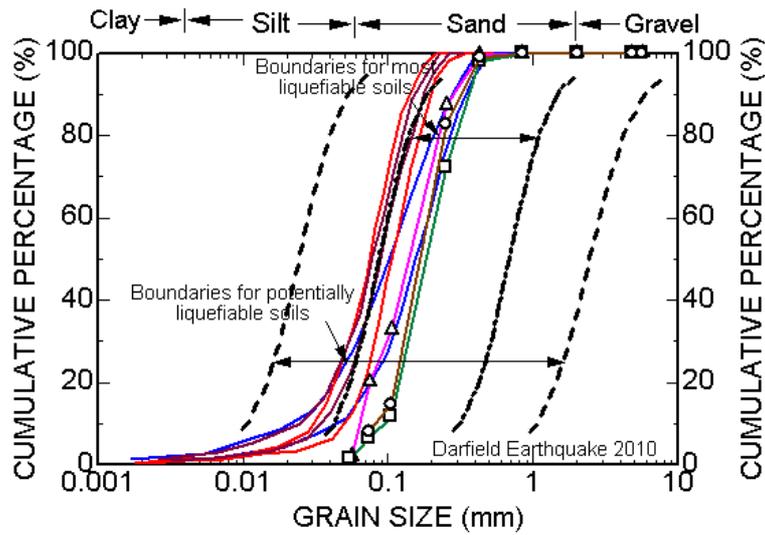
Figure 31 compares the grain-size distribution of samples obtained from sand volcanoes in Kaiapoi, Porrit Park and New Brighton with empirical bounds of liquefiable soils. As noted from the figure, grain-size distributions fall within the easily liquefiable limits. Figure 32 compares the observations with the relation between the earthquake magnitude and liquefaction limit distance proposed Aydan (2007). Once again, good correlations are observed between observations and estimations from the empirical relations.

Figure 31: Comparison of grain-size distribution of samples with empirical bounds

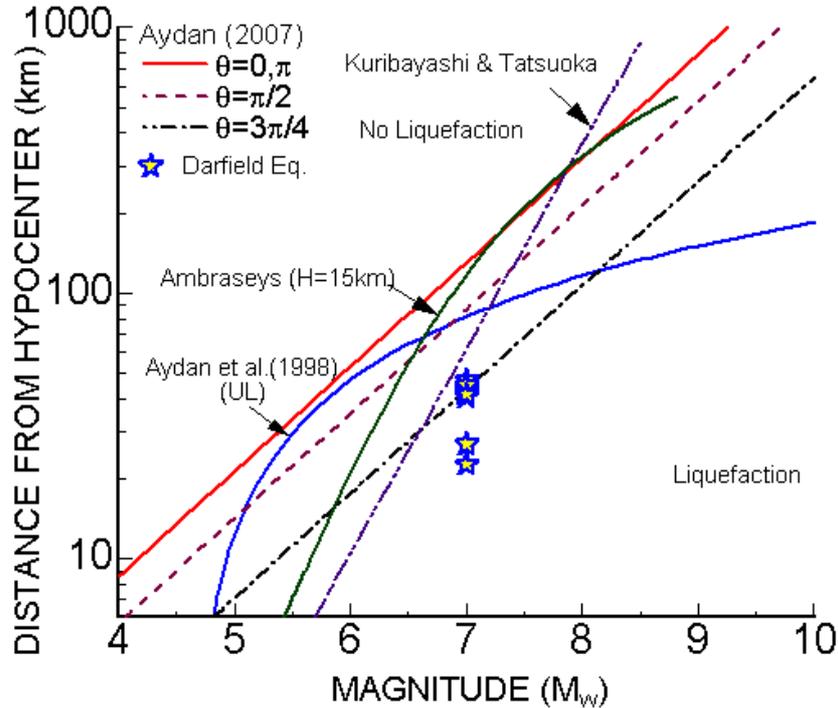
Figure 32: Comparison of observations with empirical relations

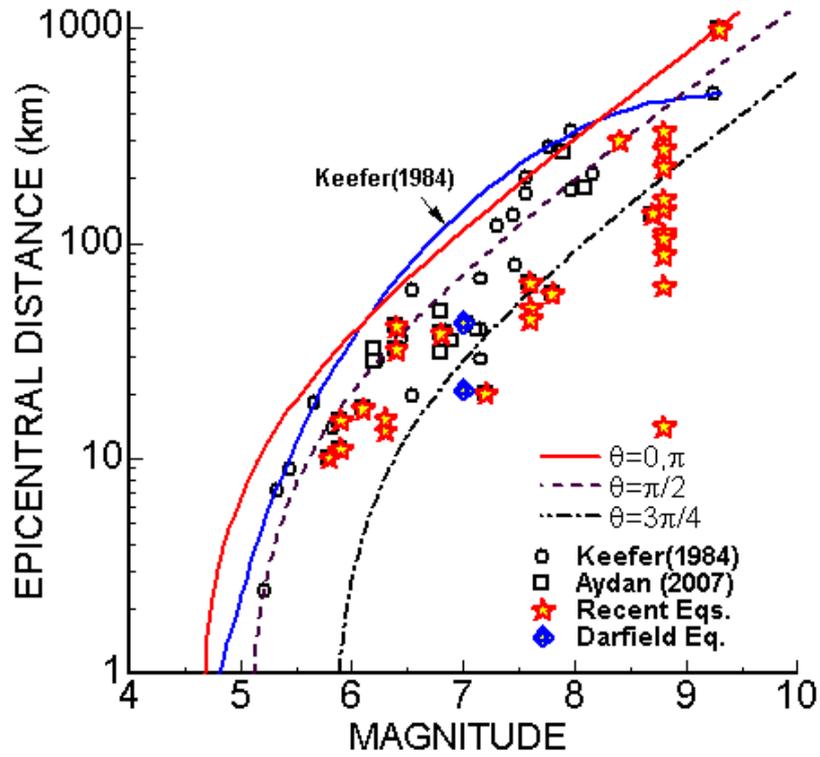
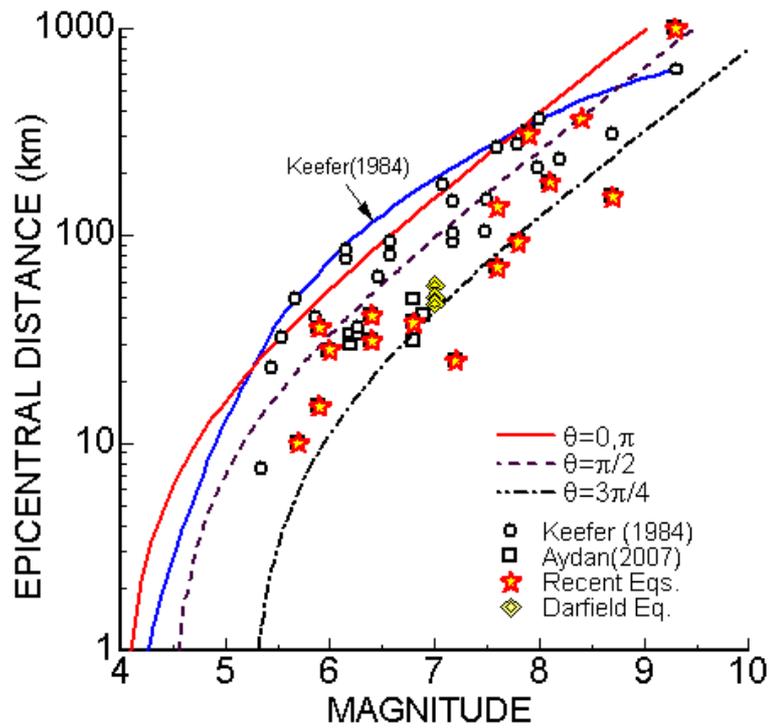
In addition to extensive ground liquefaction, retaining-wall failures, slope failures were also observed as seen in Figures 33 and 34. A slope failures was reported in the Rakaia Gorge, blocking State Highway 77. Some rockfalls reported at Castlerock, Lyttelton and Summit Road. Figure 35 compares the observations with empirical magnitude and epicentral limit distance relations for coherent and disrupted slopes. Once again, we note good correlations between observations and empirical relations.

Figure 35: Comparison of observations with empirical relations

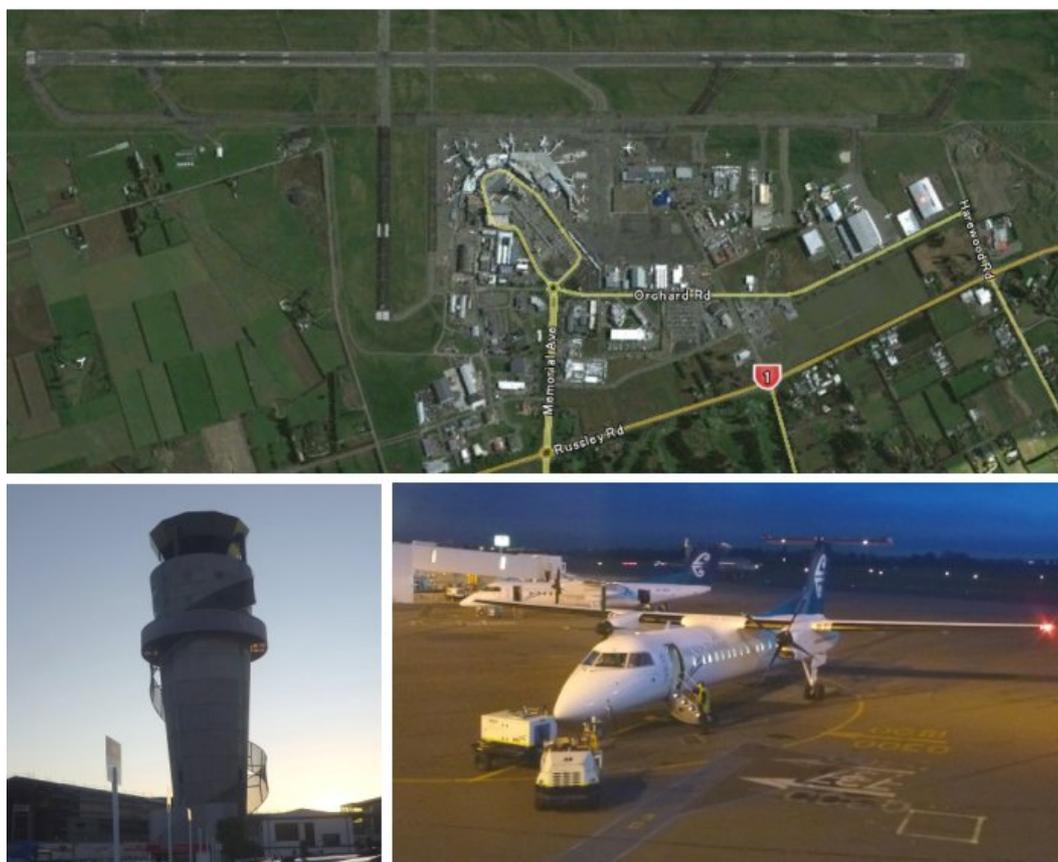
Christchurch International Airport was closed following the earthquake and flights in and out of it cancelled. It reopened at 1:30 pm, following inspection of the terminals and main runway. No damage to terminal buildings, control tower and runways were found although the fall of roof panels were observed in some of office buildings. It was closed to traffic until September 6, although the Airport was functional.

Figure 43: Views of the Christchurch Airport (satellite image from Google)

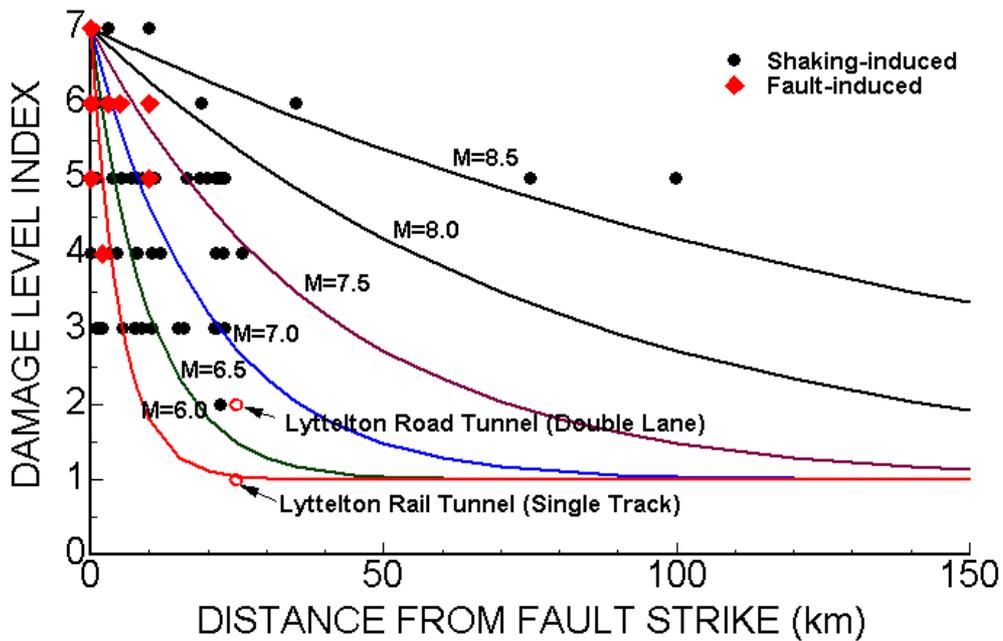
inspected by the New Zealand Transport Agency, and some cracks in the lining and sulphur smells were found. However, the tunnel was structurally sound in spite of earthquake induced cracks. Recently Aydan et al. (2010) proposed some empirical relations to estimate the degree of damage level in tunnels. This empirical relations applied to assess the damage level in the Lyttelton tunnels. The observations were found to be consistent with empirical estimations as seen in Figure 45.

Figure 45: Comparison of empirical damage level index with observations

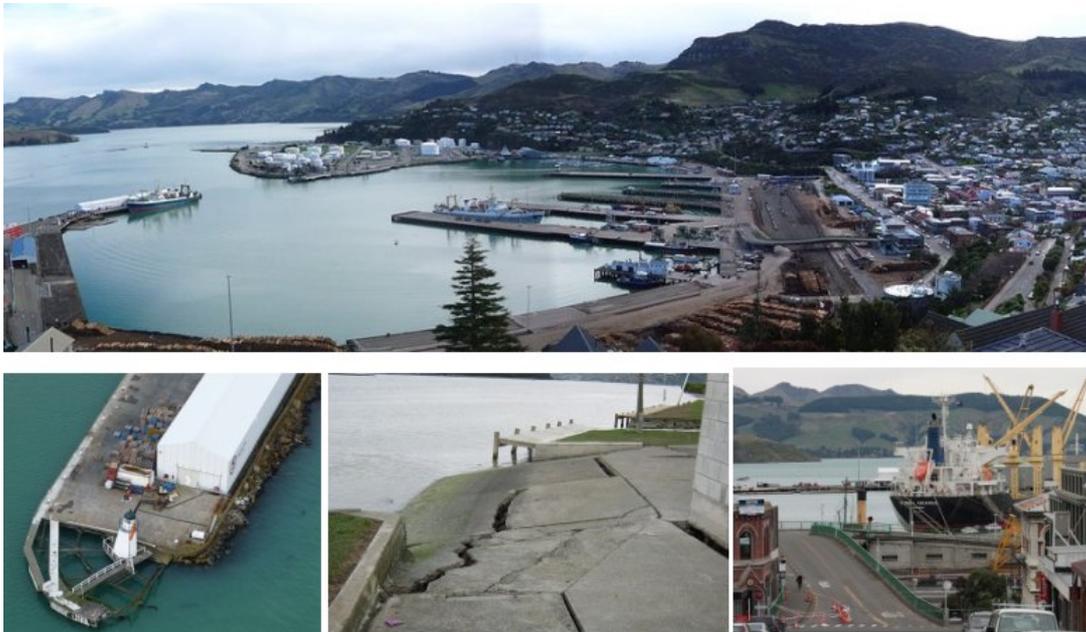
The main port facilities in Christchurch is located in Lyttelton in Banks Peninsula. Port of Lyttelton is the largest port in South Island, it is the port of export of coal and lumber, and import and export of goods through containers. The port was first constructed in 1970. The strong motion records at the port recorded maximum ground acceleration of 0.3g and maximum ground velocity of 19cm/s at a rock site during the main shock. Although the ground conditions were relatively good in this port, There has been some damage to the wharves and coal conveyors at Port of Lyttelton. No crain damage was observed.

Figure 46: Views of the Lyttelton port (arranged from various web-sources)
