Berlin

3.5 CONCLUSIONS AND RECOMMENDATIONS

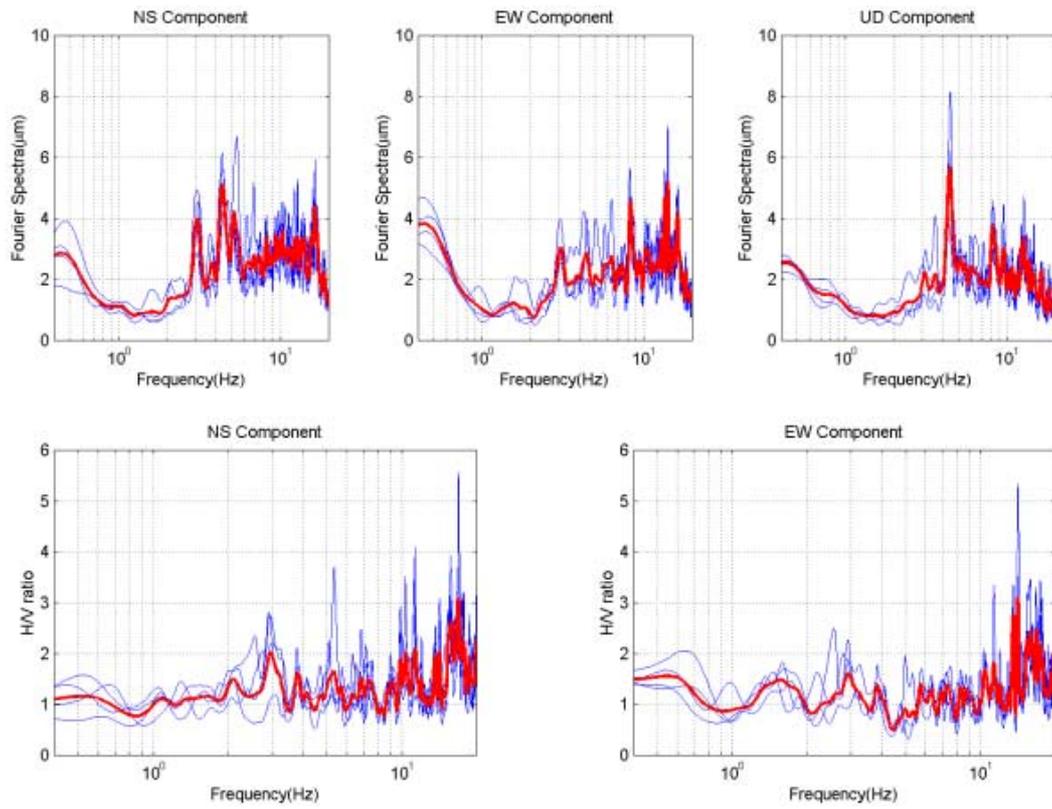
Figure 3.32. Microtremor measurements at Explotacion Station

Microtremors were measured at the Explotation Station (88°30.69W, 13°30.75N) and at Berlin (88°31.70W, 13°29.40N) where the PGA of the January 13th event was around 200gals as mentioned in **Chapter 1**. **Figure 3.32** and **3.33** show the Fourier Spectra for each of the recorded components. The Fourier Spectra was calculated by averaging the spectra of four windows (blue lines). The averaged spectra are shown in a thick red line. The ratio of the horizontal component spectra to the vertical component spectra (H/V ratio) was calculated in order to get the predominant period of the site [Nakamura, Y., 1989]. The H/V ratio is fairly flat which might indicate the rocky nature of the site. On the other hand, at Explotation Station, a peak can be identified at 15-18Hz, which corresponds to a very stiff soil.

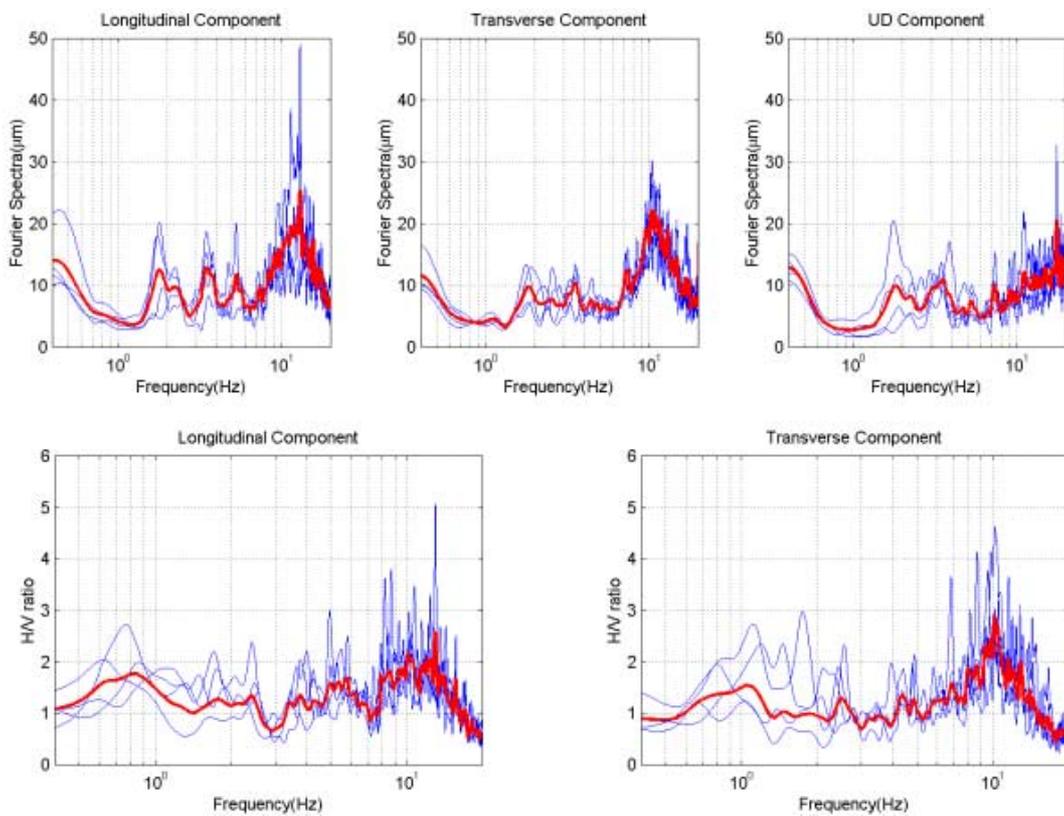
The Fourier Spectra of these three components recorded as well as the H/V ratio are shown in **Figure 3.41**. The H/V ratio graph does not show any clear peak, which might indicate a rocky type of site.

Figure 3.41. Microtremor Fourier Spectra at the ground level in San Julian

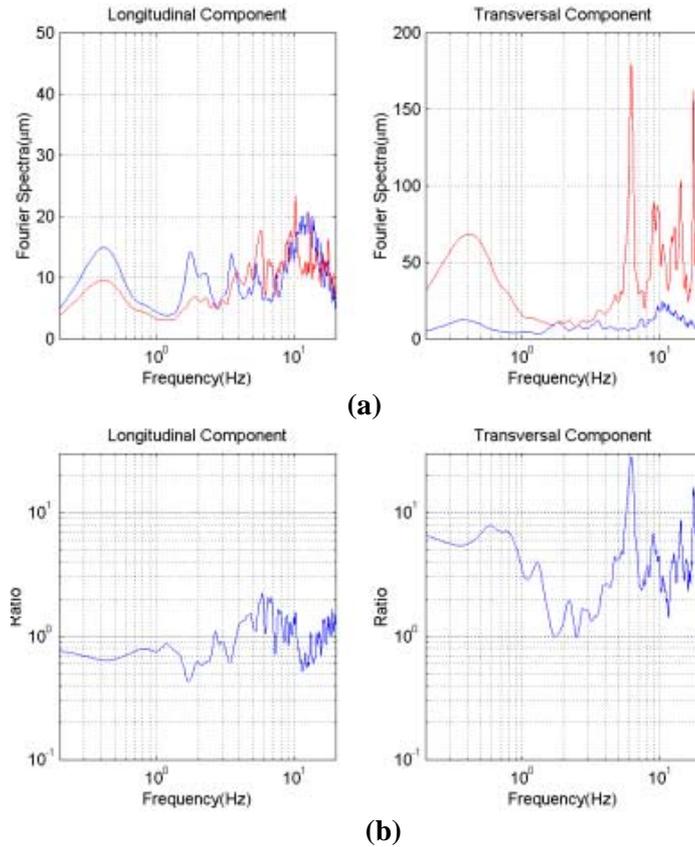
Figure 3.42. (a) Fourier spectra of the microtremors recorded on top of the bahareque wall (red) and at the ground level (blue); (b) Ratio of the microtremor Fourier spectra

For the analysis of the dynamic characteristics of the bahareque house, the Fourier Spectra of the microtremors recorded on top of the wall were divided by the corresponding microtremors at the ground surface. The results are shown in **Figure 3.42**.

In the longitudinal direction, a slight amplification of the components in the frequency range 4-10Hz can be observed. On the other hand, all frequency components are amplified in the transverse direction, especially at 6Hz. This might indicate that the predominant period is between 0.1 and 0.25sec in the longitudinal direction and 0.16sec in the transverse direction. The amplification of the motion in the transverse direction is higher than in the longitudinal, especially at 6Hz.
