## 2.5 LAS COLINAS LANDSLIDE

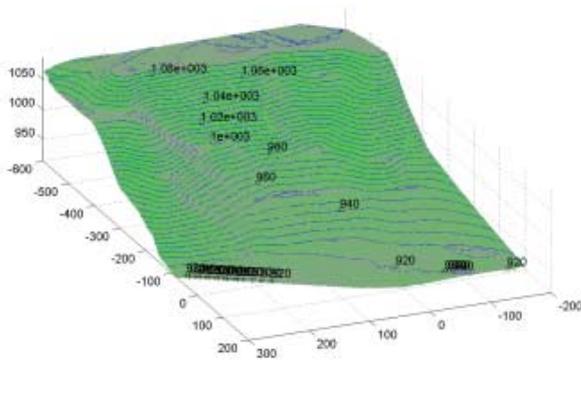
**Figure 2.14** Original Slope plotted with Matlab, as seen from the North East.

To estimate the total volume the original slope data is needed. A 1:5000 scale topographic map (Ministerio de Obras Públicas, 1970) was scanned and the original elevation contours were digitized with AutoCAD. The elevation data was plotted in **Figure 2.14** and compared with the survey slope data (**Figure 2.15**).

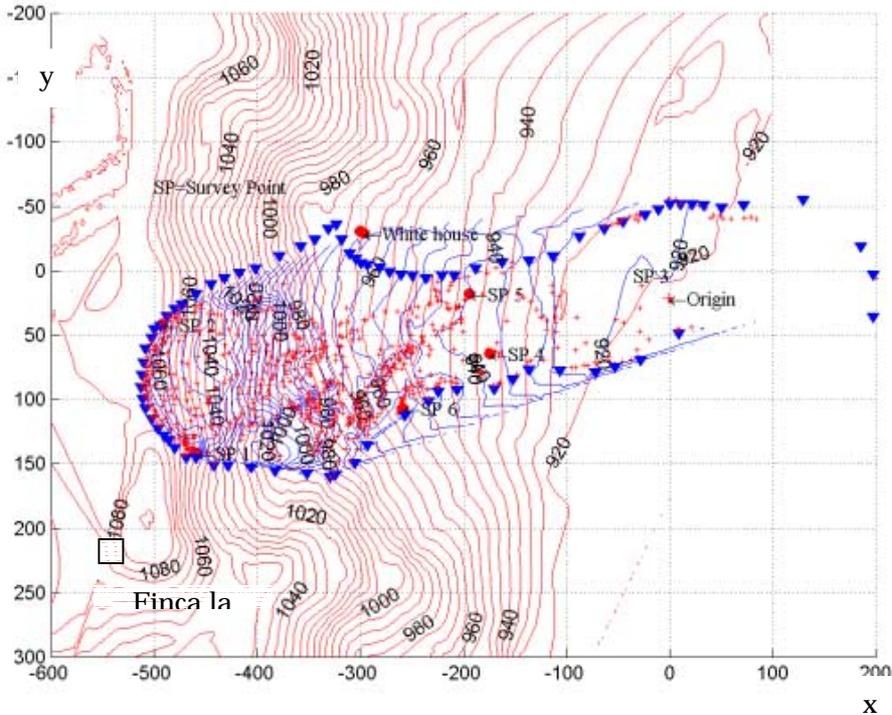
**Figure 2.17** Original Slope with Surveyed slope slide perimeter (blue triangles), Red dots are Survey Points, red crosses are surveyed points.

**Figure 2.17** shows contour plots of the original and surveyed slopes. In the figure the locations of the survey points (SP1-6: red solid circles), surveyed points (red crosses) and the slope perimeter (blue upside-down triangles) can also be seen.

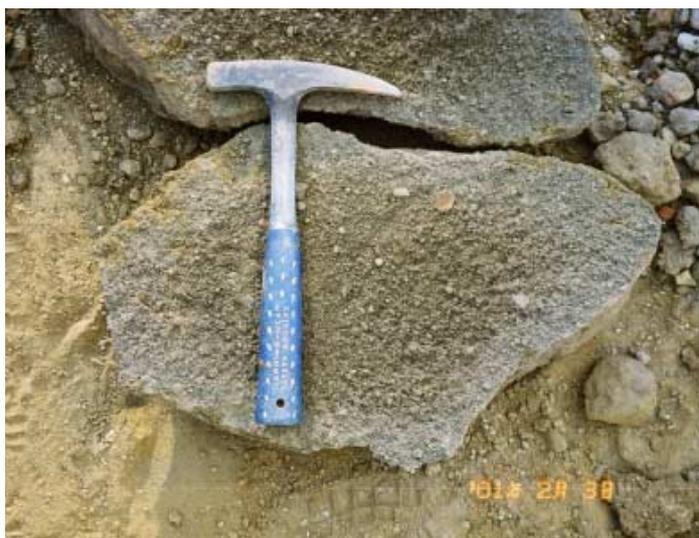
**Figure 2.20** A piece of lapilli tuff

Two photos (**Figure 2.19**) of the same soil layers appearing on the west half of the uppermost scarp were taken on January 14 and February 4, respectively. Dark and blight colored stripes appearing on the scarp shows a stratified soil profile with the top lapilli tuff layer of about 2.0 m thickness overlying a pair of two differently colored (ocher and white) pumice layers of about 11.9m thickness. Some bedding planes separate the lapilli tuff into some sub-layers of varying thickness (10cm to 25cm). Dark brown color of soil indicates that the soil is moistened, and this pair of photos shows that the dark colored stripes were steadily thinning, in other words, exposed soils were drying. This fact may evidence that the intact soils along the slip surface were wet before the event. Beneath the dark and wet soils, there appear white and/or ocher colored pumice soils. They were also moistened and weakly cemented. The pumice is easily broken into small pieces or into powder just by rubbing together with fingers. Broken fragments of this pumice have sub-angular or angular shapes. Some pieces were medium-sized (1 mm × 4 mm × 7 mm for example) and some were fairly large reaching 12 mm × 25 mm × 35 mm (**Figure 2.20**). As shown in **Figure 2.21**, cracks and joints were observed even on an intact part of pumice.
