Japan Society of Civil Engineers
Yotsuya 1, Shinjuku-ku, Tokyo 160-0004
<http://www.jsce.or.jp/>

Provisional Report on the January 13, 2001 Earthquake Occurred Off The Coast of El Salvador (updated 15, February, 2001)

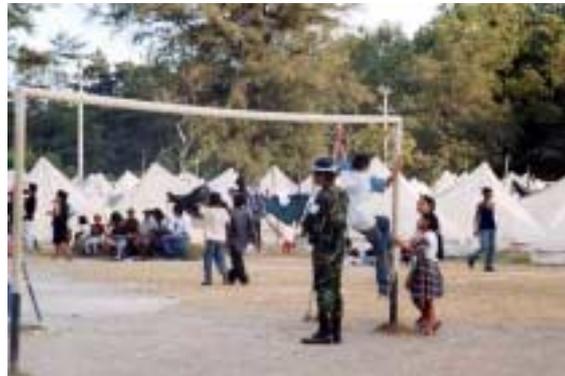
Fig. 1.11. Refugees' camp

Extensive cracks running along the ridge crest are the serious threat of further slides. The city of Santa Tecla is controlling the potential hazard zones, the red zone with the highest risk and the yellow zone of slightly less danger (**Fig. 1.10**). A week after the earthquake, the number of residents evacuated from the zones exposed to the menace of possible landslides reached 14,000, and as of Feb. 3, about 4,000 refugees were still being forced to live in tents (**Fig. 1.11**).
