6 DAMS

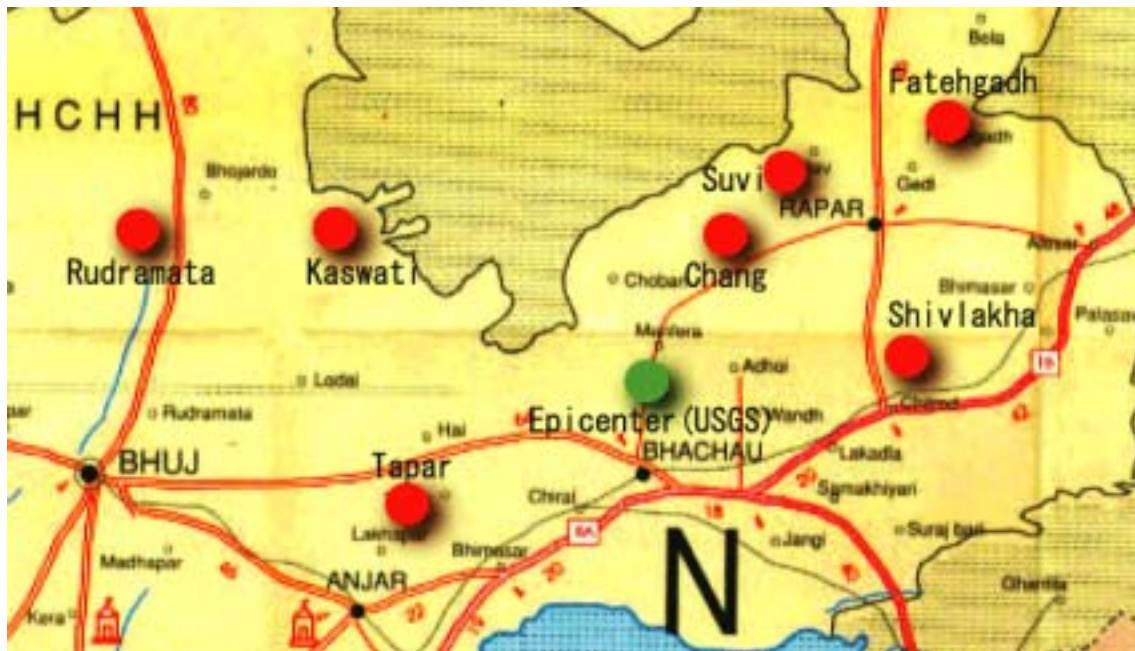
Most of the dams are earth dams except a few which are stone masonry built. The dams are built for irrigational purposes. The list of major medium size dams is given in Table 6.1 There are more than 174 earth dams in the region. Figure 6.1 shows the location of dams. Seven medium sized dams and 14 small sized dams in Kutch were damaged. The major damaged dams are shown in the figure.

Figure 6.1 Locations of dams and major damaged dams
