Provisional Report on the June 23, 2001 Atico Earthquake, Peru (Updated 04, September, 2001)

PREFACE

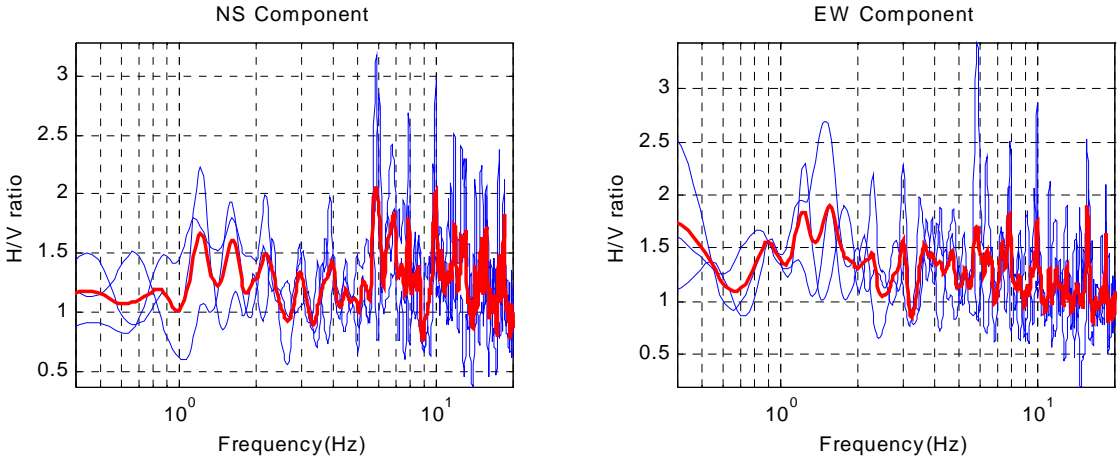
Figure 8. H/V ratio at the toe

In order to evaluate the topographical effect in a different way, microtremors at the top and toe of the ridge were measured, and at each site, the ratio of the horizontal component spectra to the vertical one (H/V ratio) was calculated in order to get the predominant period of the site [Nakamura, Y., 1989]. The H/V ratio is fairly flat at the toe, which might indicate the stiff soil nature of the site (**Figure 8**). On the other hand, at the top of the ridge, a peak can be identified at around 4-5Hz, the fact indicating the topographical effect. EW component at around this peak is about twice as large as the NS component in **Figure 9**. Since EW direction is about normal to the ridge, this fact is consistent with the finding from the investigation of cracked utility poles.

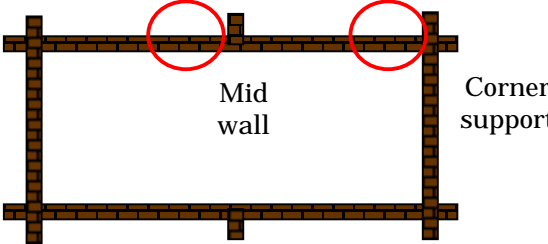
Figure 13: Plan view of overlapping adobe walls with mid wall side support.

In **Figure 11** and **12** an adobe wall with side support still stands after the shake while the brick wall next to it fell over. This type of side support could be a simple but effective strengthening technique for adobe houses (**Figure 13**).

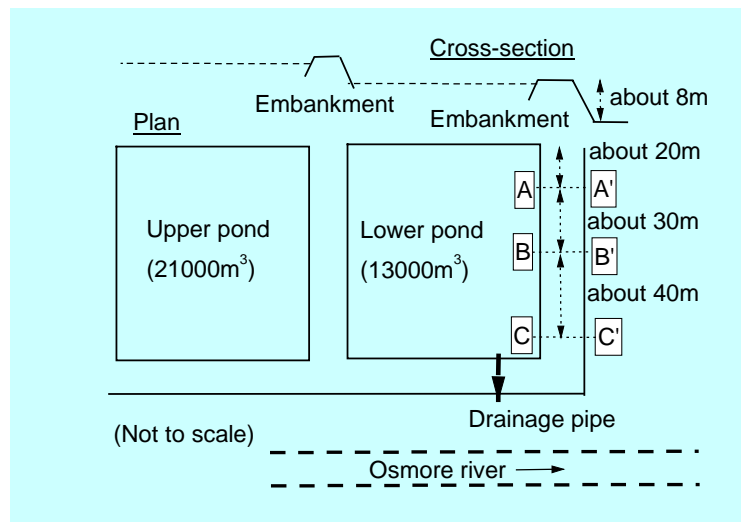
Figure 15. Plan of two oxidation ponds for sewage treatment

Figure 15 shows a plan of two oxidation ponds for sewage treatment in Moquegua. The upper and lower ponds have a capacity of 21000 and 13000 m³, respectively, and have been cleaned every ten years. Their bottom is sealed with clay layer.

By the earthquake, the embankment on the downstream side of the lower pond suffered cracking in its crest (**Figure 16, left**). The total opening width of the cracks amounted up to 46 cm at maximum (**Figure 16, right**), and the residual settlement at the embankment shoulder was about 10 to 20 cm. In addition, the embankment between the upper and lower ponds became partly wet (**Figure 17**), suggesting a sign of piping. This location corresponds to a boundary between the original embankment constructed 40 years ago and the newer embankment re-constructed 6 years ago.

After the earthquake, in order to avoid instability of these embankments, the water level in both ponds were lowered by about 1 m. In order to cope with the current influent flow rate of 120 liters per second, which exceeds the design flow rate of 38 liters per second, the oxidation period had to be reduced down to 5 hours from the design value of 10 hours. These operations resulted into poor quality of treated water, which was used for irrigation purposes. Because the pipes to distribute the treated water were also damaged by the earthquake, it leaked into the adjacent Osmore River, affecting the quality of the river water.

It is reported that this sewage treatment facility will be closed after constructing a new facility on the downstream side, which would cover all the demand from the residential areas.

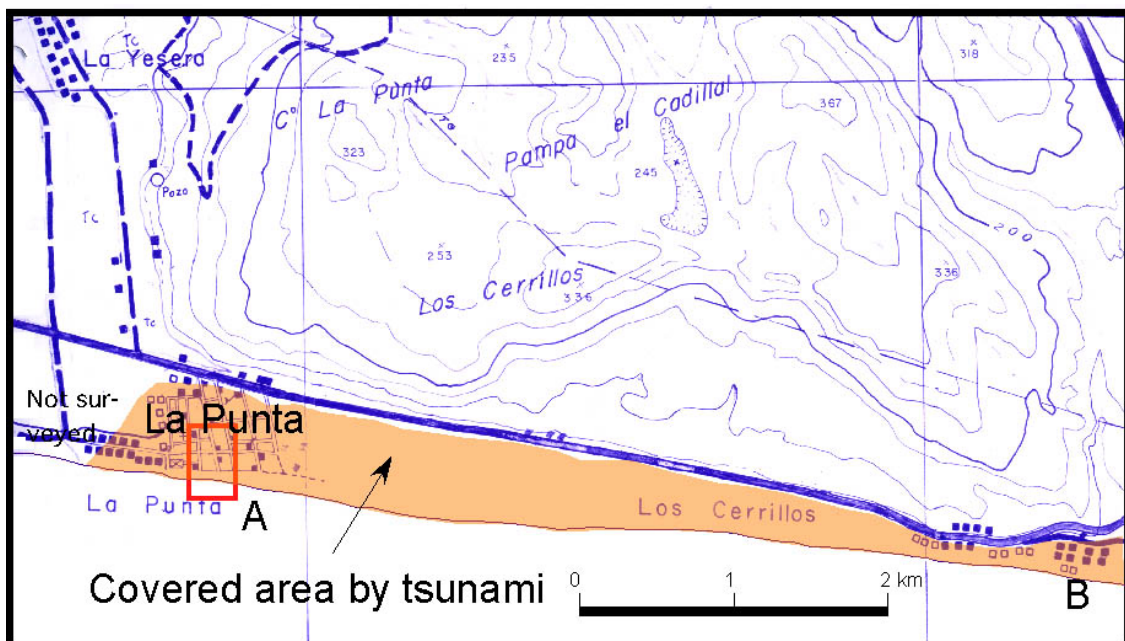
Figure 19. Inundated zone, La Punta:

The orange colored zone in **Figure 19** is considered to have been inundated with water. The surges destroyed a great number of dwellings, hotels and restaurants there (**Figures 20** and **21**). The inundated zone was covered thin with wet fine silty soils suggesting that the water surged over the zone was stopped there for a while as is shown in **Figure 22(c)**. From a number of RC columns pushed down (**Figure 22(a)**), possible directions of tsunami surges were estimated (**Figure 22 (b)**).

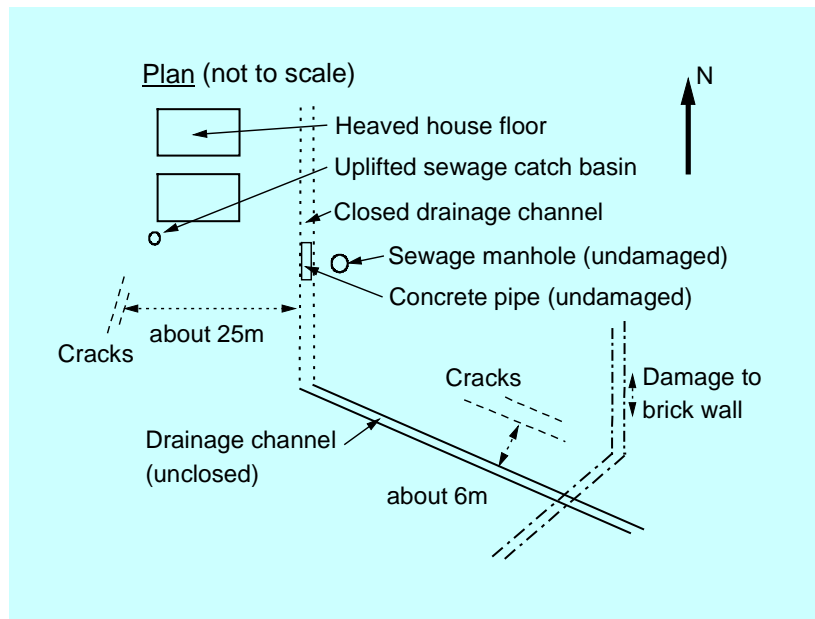
Figure 25. Plan of affected area (Lara, Socabaya District, Arequipa)

Liquefaction occurred in a lowland of Arequipa (at Lara, Socabaya district; latitude of $S16^{\circ}27.271'$, longitude of $W71^{\circ}32.148'$, and elevation of 2288 m). It induced lateral spreading of ground as typically shown in **Figures 24a** and **24b**. The plan of the affected area is shown in **Figure 25**. The lateral spreading caused collapse of brick walls (**Figure 26a**) and closing of drainage channels that had an original opening width of about 50 cm (**Figure 26b**). Several cracks were also formed in almost level ground at a horizontal distance of about 25 m from the closed drainage channel (**Figure 26c**). It should be noted that there was no damage to concrete pipes with a diameter of about 50 cm used for the drainage channel to under-pass an unpaved road (**Figure 25**).

It should be noted that a sewage manhole with a diameter of about 60 cm and a depth of *** cm below the ground surface (Mr. Carlos Huaman Egoavil at CISMID is going to get this information) located near the undamaged concrete pipe (**Figure 26**) did not suffer any damage or uplift. In contrast to this, the uplifted sewage catch basin had a diameter of about 40 cm and an original depth of about 50 cm below the ground surface, suggesting that its bottom was located above the ground water table even before the earthquake. In addition, it is reported that extensive sand boiling took place around the uplifted catch basin. This uplift damage was, therefore, estimated to have been caused by the upward forces exerted by the boiling sands, not by the loss of stability against uplift due to generation of excess pore water pressures in the liquefied soils.

Detailed investigation is required on the soil conditions at this site, which will provide useful information on liquefaction susceptibility in lowland areas in Arequipa.
