Provisional Report on the June 23, 2001 Atico Earthquake, Peru (Updated 04, September, 2001)

SOURCE CHARACTERISTICS AND STRONG GROUND MOTION

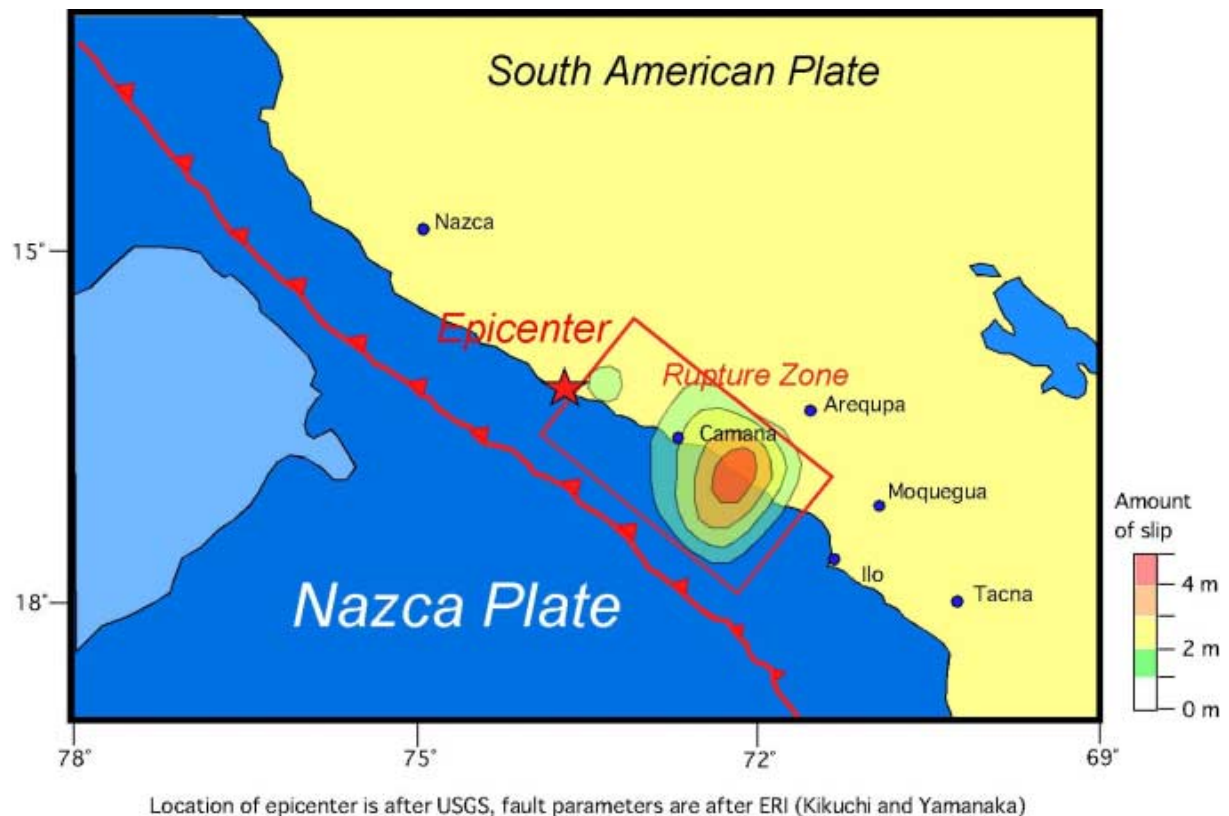
Figure 1. Source Inversion of the teleseismic body-waves (IRIS-DMC) of the June 23, 2001 Atico Earthquake (Kikuchi and Yamanaka).

Atico Earthquake occurred off the coast of southern Peru, about 175 km west of Arequipa or about 595 km southeast of Lima at 4:33 PM EDT on Jun 23, 2001 (3:33 PM local time in Peru). A revised moment magnitude of 8.4 (Harvard) was computed for this earthquake, making this the largest earthquake to occur anywhere in the world in the past 25 years. The focal depth was shallow, with estimates from 9 km (Sipkin, USGS), 26 km (Harvard) to 40 km (Univ of Tokyo). This earthquake was produced by the subduction of the Nazca plate beneath the South American plate. The final slip distribution of the main event, from the inversion of teleseismic body-waves (Kikuchi and Yamanaka) shows a 300-km zone striking northwest extending from Chala to south of Motegua with two asperities: a large asperity is located at the southeast side of the zone and a smaller asperity located in the northwest end of the zone.

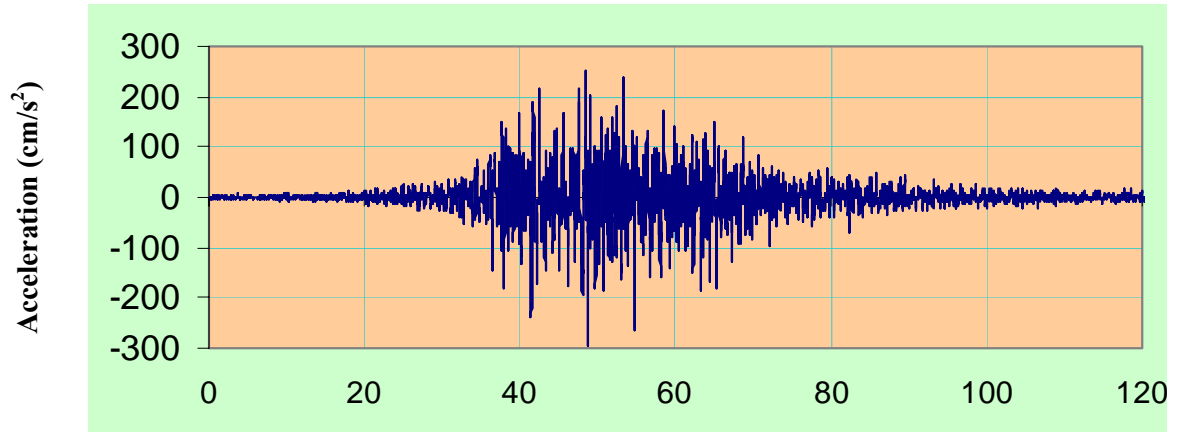
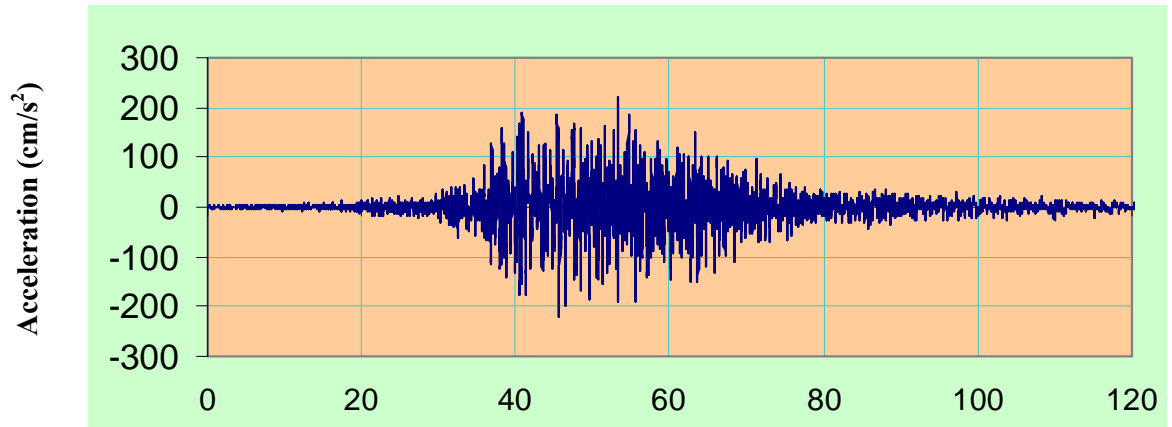
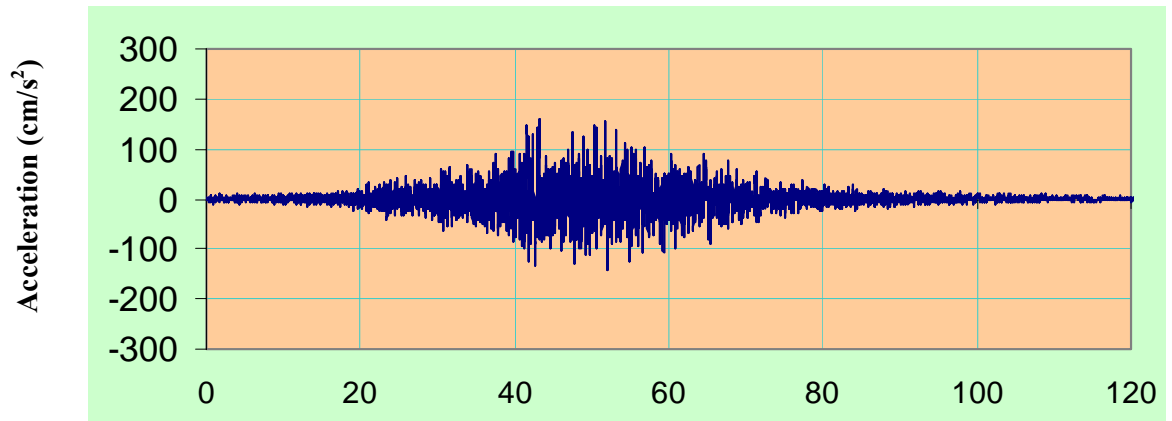
Figure 2. Acceleration time histories at Moquegua

CISMID (Japan-Peru Center for Earthquake Engineering and Disaster Mitigation) has recovered and processed the information from only one instrument that triggered in Peru, the one in the city of Moquegua. Two other instruments in the epicentral area apparently malfunctioned. **Figures 2 and 3** show the corrected ground acceleration time histories and the corresponding acceleration response spectra obtained from that instrument recording in East-West, North-South, and Vertical directions.

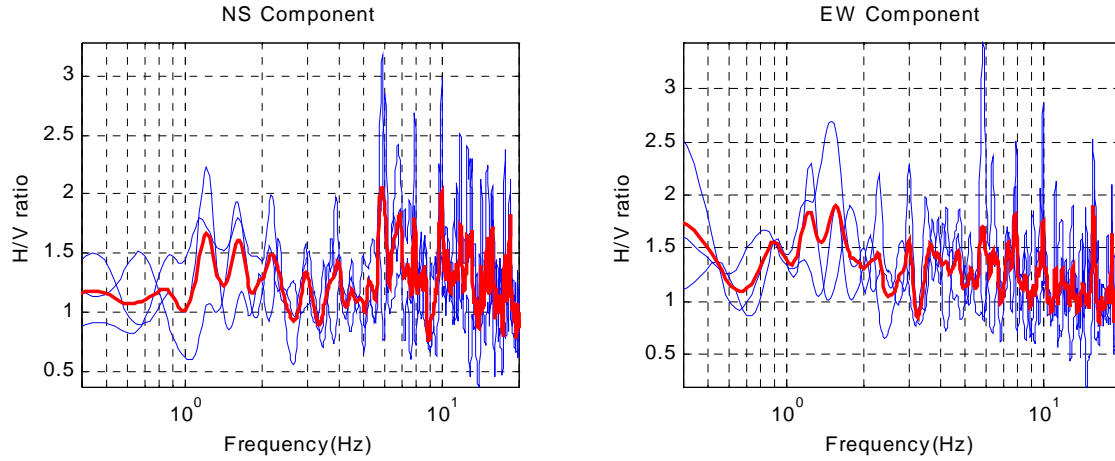
Figure 8. H/V ratio at the toe

In order to evaluate the topographical effect in a different way, microtremors at the top and toe of the ridge were measured, and at each site, the ratio of the horizontal component spectra to the vertical one (H/V ratio) was calculated in order to get the predominant period of the site [Nakamura, Y., 1989]. The H/V ratio is fairly flat at the toe, which might indicate the stiff soil nature of the site (**Figure 8**). On the other hand, at the top of the ridge, a peak can be identified at around 4-5Hz, the fact indicating the topographical effect. EW component at around this peak is about twice as large as the NS component in **Figure 9**. Since EW direction is about normal to the ridge, this fact is consistent with the finding from the investigation of cracked utility poles.

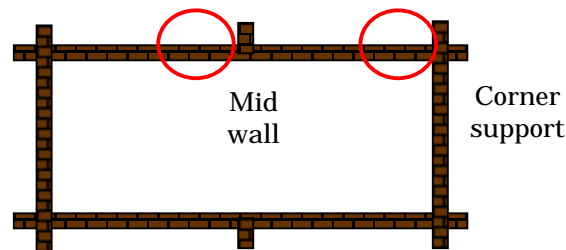
Figure 13: Plan view of overlapping adobe walls with mid wall side support.

In **Figure 11** and **12** an adobe wall with side support still stands after the shake while the brick wall next to it fell over. This type of side support could be a simple but effective strengthening technique for adobe houses (**Figure 13**).

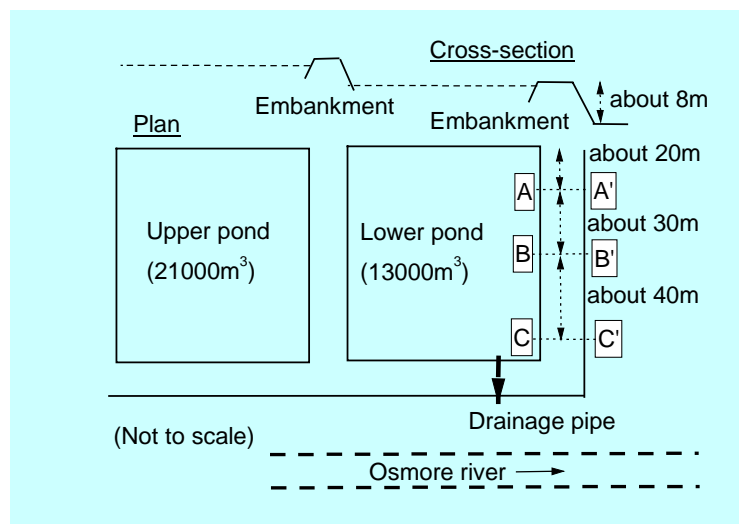
Figure 15. Plan of two oxidation ponds for sewage treatment

Figure 15 shows a plan of two oxidation ponds for sewage treatment in Moquegua. The upper and lower ponds have a capacity of 21000 and 13000 m³, respectively, and have been cleaned every ten years. Their bottom is sealed with clay layer.

By the earthquake, the embankment on the downstream side of the lower pond suffered cracking in its crest (**Figure 16, left**). The total opening width of the cracks amounted up to 46 cm at maximum (**Figure 16, right**), and the residual settlement at the embankment shoulder was about 10 to 20 cm. In addition, the embankment between the upper and lower ponds became partly wet (**Figure 17**), suggesting a sign of piping. This location corresponds to a boundary between the original embankment constructed 40 years ago and the newer embankment re-constructed 6 years ago.

After the earthquake, in order to avoid instability of these embankments, the water level in both ponds were lowered by about 1 m. In order to cope with the current influent flow rate of 120 liters per second, which exceeds the design flow rate of 38 liters per second, the oxidation period had to be reduced down to 5 hours from the design value of 10 hours. These operations resulted into poor quality of treated water, which was used for irrigation purposes. Because the pipes to distribute the treated water were also damaged by the earthquake, it leaked into the adjacent Osmore River, affecting the quality of the river water.

It is reported that this sewage treatment facility will be closed after constructing a new facility on the downstream side, which would cover all the demand from the residential areas.

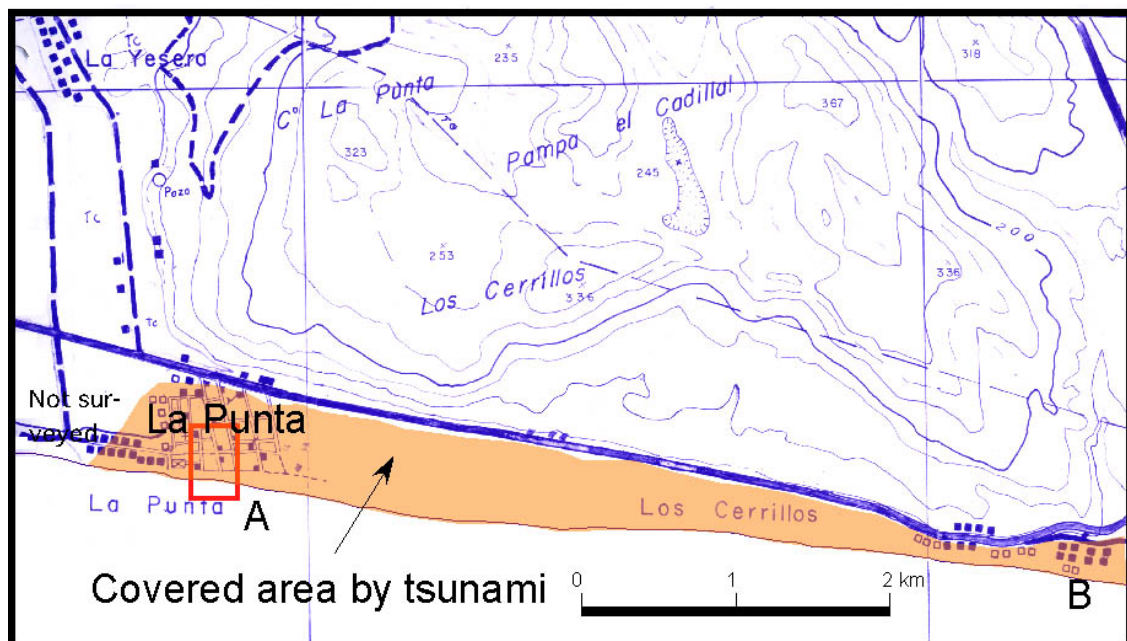
Figure 19. Inundated zone, La Punta:

The orange colored zone in **Figure 19** is considered to have been inundated with water. The surges destroyed a great number of dwellings, hotels and restaurants there (**Figures 20** and **21**). The inundated zone was covered thin with wet fine silty soils suggesting that the water surged over the zone was stopped there for a while as is shown in **Figure 22(c)**. From a number of RC columns pushed down (**Figure 22(a)**), possible directions of tsunami surges were estimated (**Figure 22 (b)**).

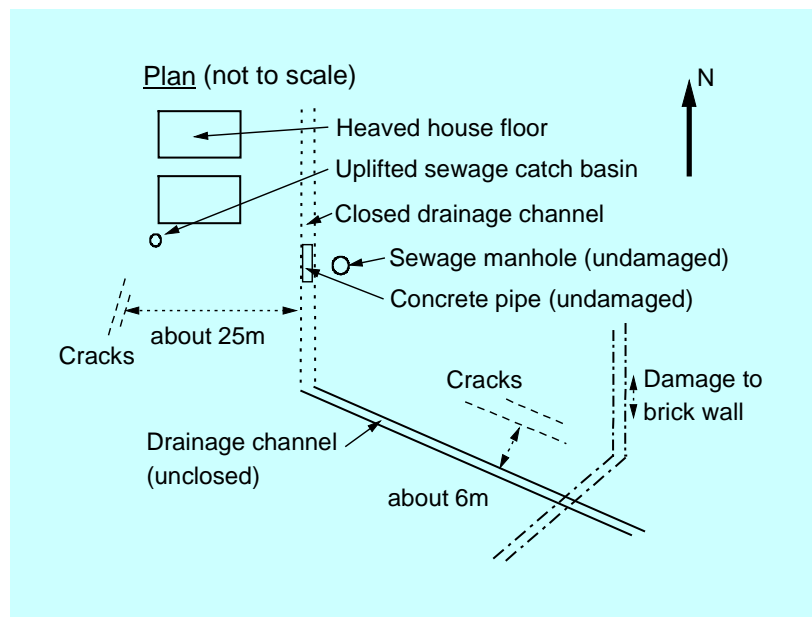
Figure 25. Plan of affected area (Lara, Socabaya District, Arequipa)

Liquefaction occurred in a lowland of Arequipa (at Lara, Socabaya district; latitude of S16°27.271', longitude of W71°32.148', and elevation of 2288 m). It induced lateral spreading of ground as typically shown in **Figures 24a** and **24b**. The plan of the affected area is shown in **Figure 25**. The lateral spreading caused collapse of brick walls (**Figure 26a**) and closing of drainage channels that had an original opening width of about 50 cm (**Figure 26b**). Several cracks were also formed in almost level ground at a horizontal distance of about 25 m from the closed drainage channel (**Figure 26c**). It should be noted that there was no damage to concrete pipes with a diameter of about 50 cm used for the drainage channel to under-pass an unpaved road (**Figure 25**).

It should be noted that a sewage manhole with a diameter of about 60 cm and a depth of *** cm below the ground surface (Mr. Carlos Huaman Egoavil at CISMID is going to get this information) located near the undamaged concrete pipe (**Figure 26**) did not suffer any damage or uplift. In contrast to this, the uplifted sewage catch basin had a diameter of about 40 cm and an original depth of about 50 cm below the ground surface, suggesting that its bottom was located above the ground water table even before the earthquake. In addition, it is reported that extensive sand boiling took place around the uplifted catch basin. This uplift damage was, therefore, estimated to have been caused by the upward forces exerted by the boiling sands, not by the loss of stability against uplift due to generation of excess pore water pressures in the liquefied soils.

Detailed investigation is required on the soil conditions at this site, which will provide useful information on liquefaction susceptibility in lowland areas in Arequipa.
