5. DAMAGE TO BUILDINGS AND DWELLINGS

5.2 STRUCTURAL DAMAGE SURVEY

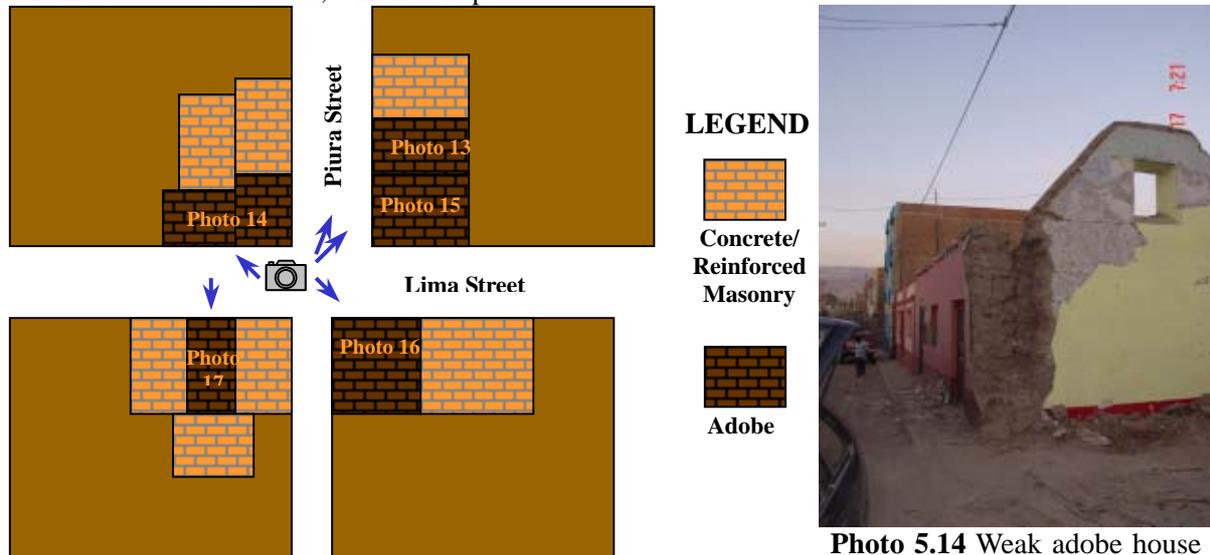
Figure 5.1 Location of the photos 5.14 to 18

In general, adobe structures performed badly as observed in many other earthquakes. **Figure 5.1** and **Photos 5.14 to 5.18** present collapsed adobe structures neighboring reinforced masonry structures, which suffered only minor damage.

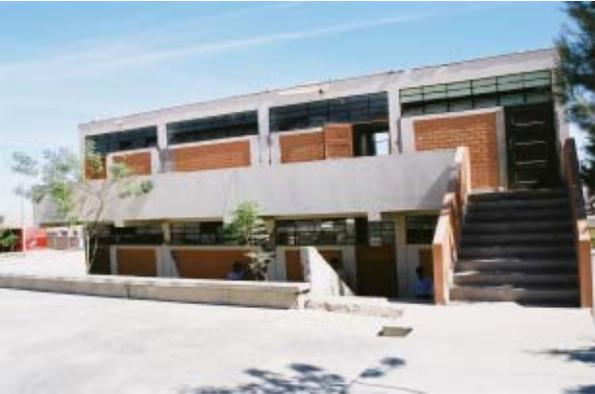
Microtremors were used to identify predominant periods of damage and undamaged structures. At Moquegua, measurements were done at San Antonio School. Three buildings (**Photos 5.19** and **5.20**) whose characteristics are presented in **Table 5.1** were surveyed.

Photo 5.19. Typical 2-story building

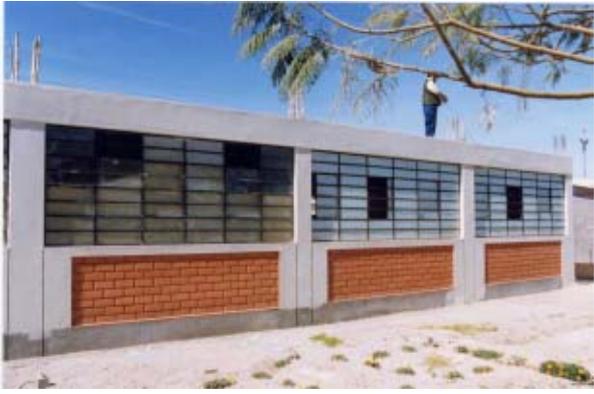
Photo 5.20. 1-story building

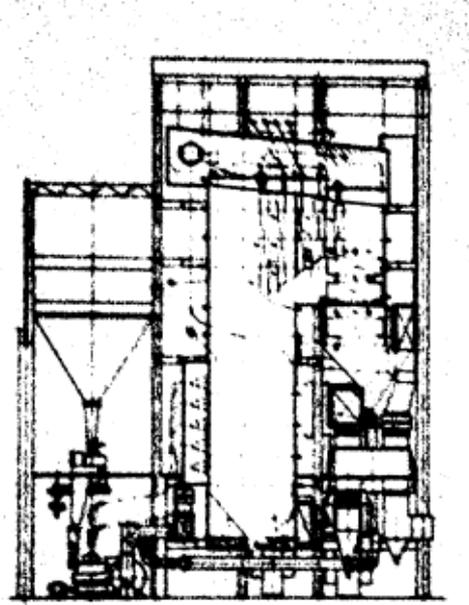
Photo 5.2.3 shows the boiler plant built in a multi-story steel braced frame. Since the detail dimensions of the frame were not available to the author, the elevation of a similar boiler plant (Radiant Boiler Type C , 125MW Shin-Ebetsu Power Station, Hokkaido Electric Power Ltd.) is shown in **Figure 5.2.3** for the readers information. **Photos 5.2.4** through **5.2.7** show the damage to column anchorages in the boiler plant frame. Some of the column anchorages connected to the steel brace members were damaged.

Figure 5.2.3 A framing elevation of similar boiler plant in Japan (Shin-Ebetsu Power Station)
