4. LIFELINES

4.1 SEWAGE TREATMENT FACILITY

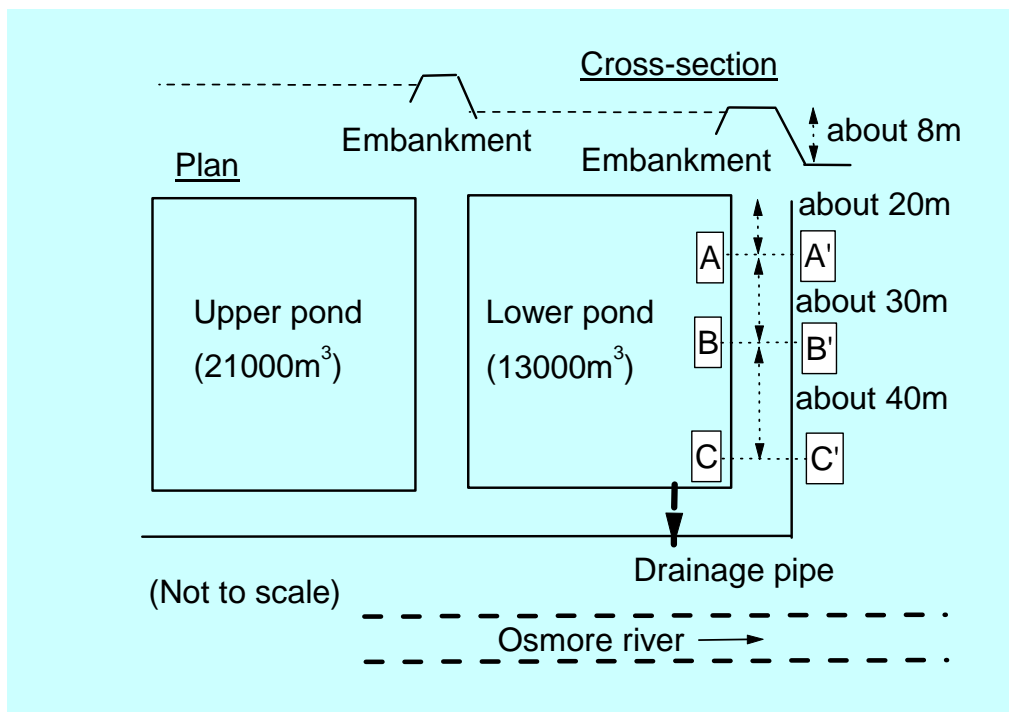
Figure 4.1 shows a plan of two oxidation ponds for sewage treatment in Moquegua. The upper and lower ponds have a capacity of 21000 and 13000 m³, respectively, and have been cleaned every ten years. Their bottom is sealed with clay layer.

Figure 4.1. Plan of two oxidation ponds for sewage treatment
