## 1. TECTONIC SETTING, GEOLOGICAL STRUCTURE AND SURFACE FAULT

### 1.3 ACTIVATED FAULT

## 1.4 FAULT AND DAMAGE TO ABDARREH

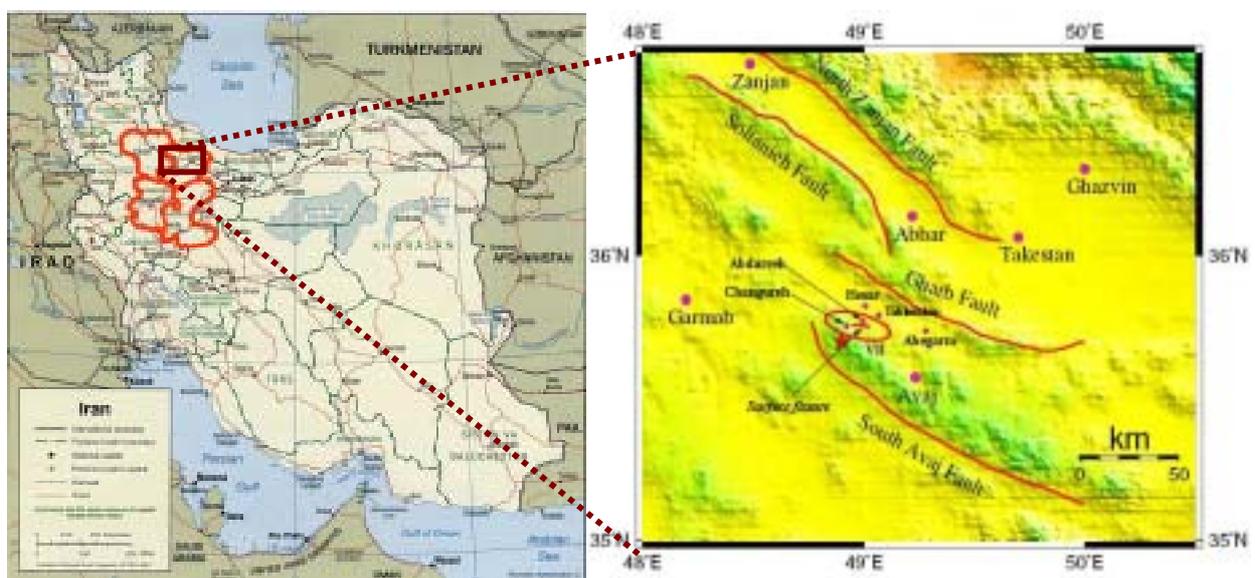
Fig. 1.1 Faults and seismicity of the zone:

The epicenter and the damaged area are located in a fold and thrust (low-angle reverse fault) belt in the north of Zagros tectonic boundary (Fig. 1.1). This belt trends NW-SE direction. Mountain ranges and valleys of about 30 km wide run along the belt. Reverse fault movements have been responsible for large earthquakes including 1962 Ipak (Buin-Zahra) earthquake.

Magnitude (M<sub>W</sub>): 6.5  
 Time: 07:28:21.61 (local)  
 Location: 35.63N 48.95E  
 Focal Depth: 10 km  
 Fault Mechanism: reverse  
 (Source: USGS, NEIC)

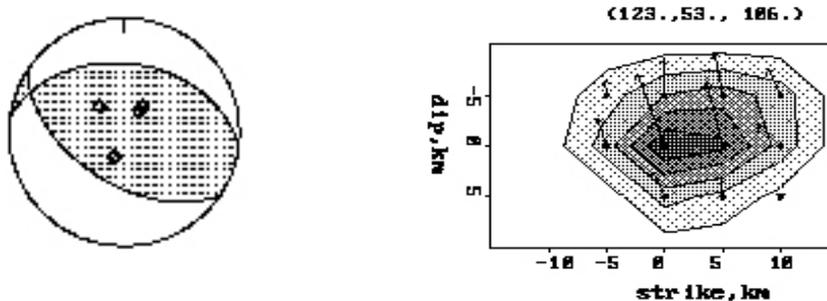
Fig. 1.2 Focal mechanism and slip distribution (Kikuchi and Yamanaka, 2002, ERI)

Kikuchi and Yamanaka, Earthquake Research Institute, University of Tokyo, put up their fault plane solution (**Fig. 1.2**, [http://www.eic.eri.u-tokyo.ac.jp/EIC/EIC\\_News/020622.html](http://www.eic.eri.u-tokyo.ac.jp/EIC/EIC_News/020622.html)) that indicates that the main shock occurred on a reverse fault of about NW-SE trend. That mechanism is consistent with the tectonic setting of this area. The Moment Magnitude  $M_w$  of 6.4 was calculated for the main shock, while 6.5 was calculated by USGS. The focal depth was about 7 km (ERI, 2002).
