**JSCE- AIJ Joint Investigation/ Technical Support Team  
for Restoration and Reconstruction  
of the Affected Areas by the Pakistan Earthquake on  
Oct. 8, 2005**

Nov. 2005

# A QUICK REPORT ON 2005 KASHMIR EARTHQUAKE

Investigation and Support Team  
For Disaster Mitigation of  
Oct. 8, 2005 Kashmir Earthquake

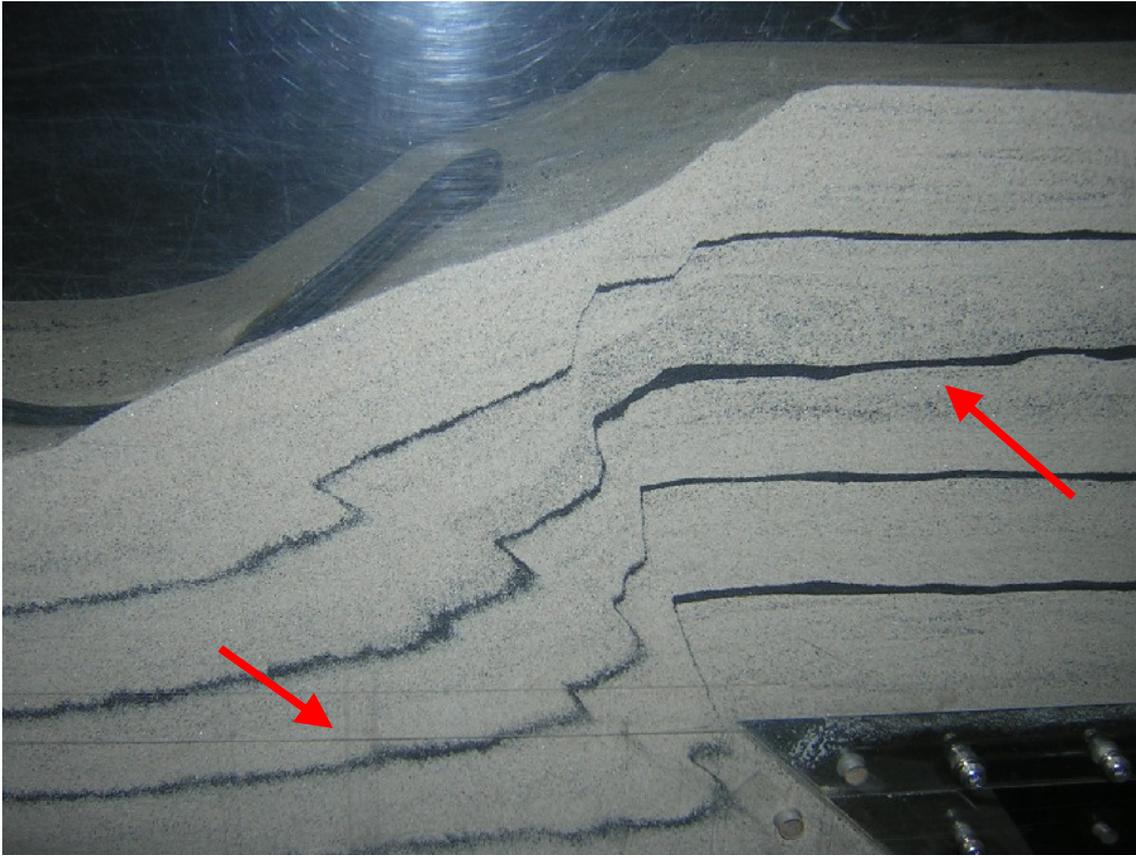
which is a highly deformed and fractured rock unit (Figure 7.4). Figure 7.5 shows a laboratory test on ground deformation in loose non-cohesive ground during thrust faulting. As noted from the figure, in spite of upward motion of the base-rock, some surficial slope failure (similar to small scale seemingly normal faulting) occur within the non-cohesive deposits. Furthermore, the thickness of deposits increases above the tip of the moving hanging wall as a rigid-body. Therefore the slope failures observed particularly on the hanging-wall side of the fault can be interpreted as the surface expressions of the earthquake faulting.

Figure 7.5 A view of non-cohesive deposits over the thrust movement of the basement

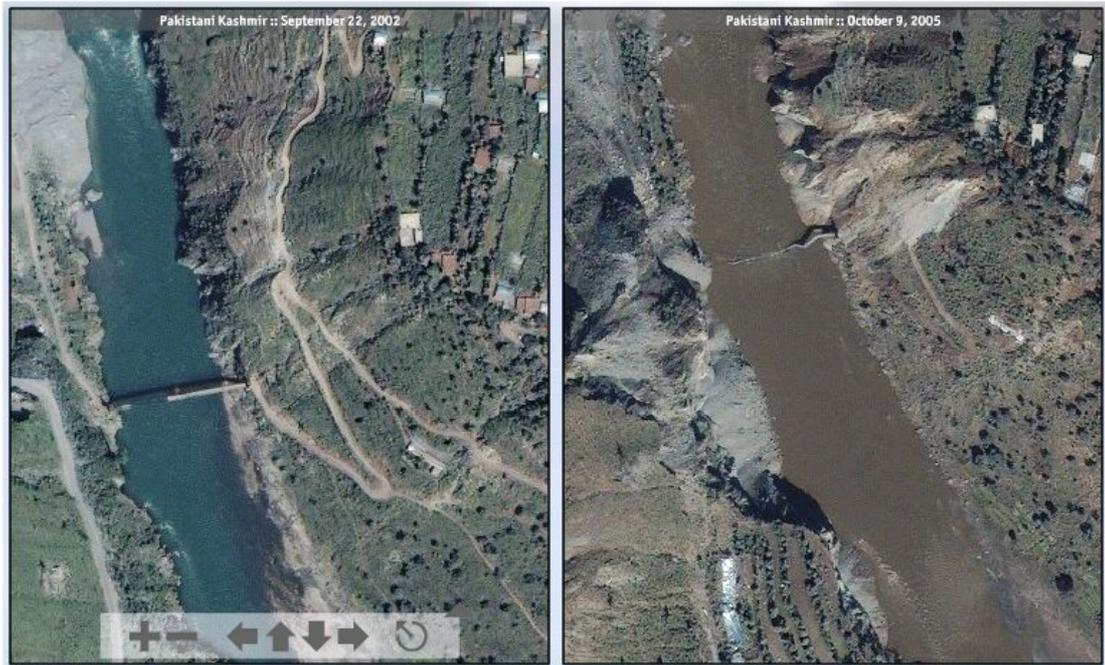
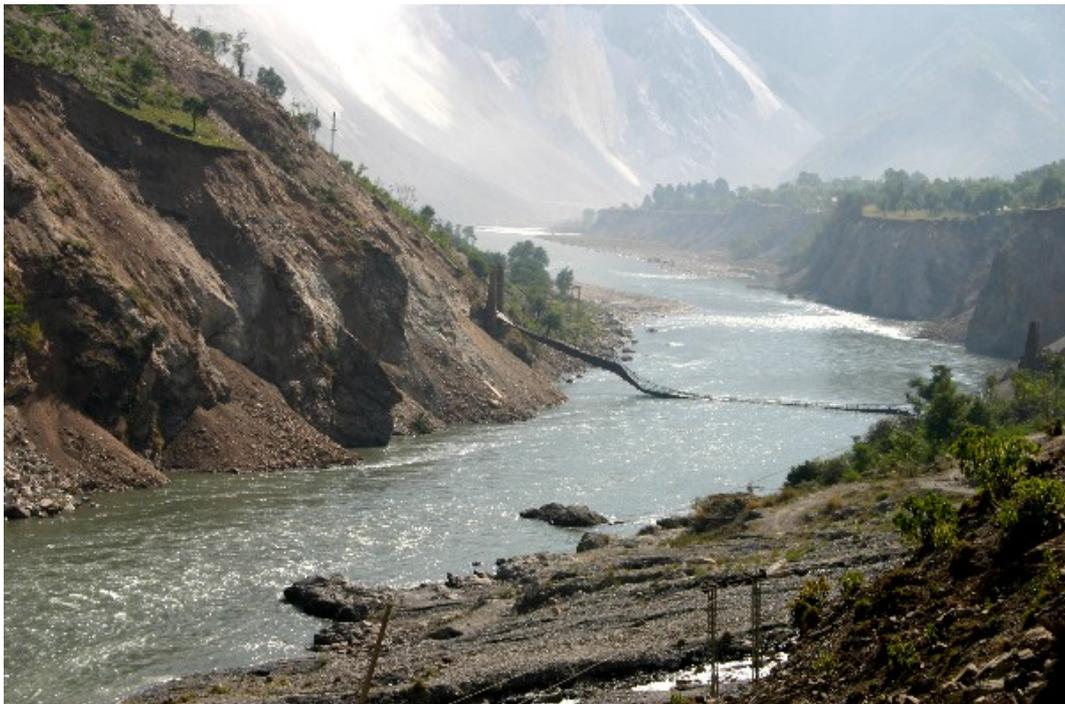
The bridges in Muzaffarabad city were non-damaged. The bridges about 2-3km away from the causative fault and they are on the foot-wall side of the fault. The Domel bridge is quite old with masonry abutments and single lane truss deck. There is a new RC bridge founded on group pile foundations next to the Domel bridge and they were all non-damaged in spite of high ground motions. However, a pedestrian suspension bridge to the north of Muzaffarabad city, where whitish rock slope failures observed, was collapsed (Figure 9.3). The causes of the collapse are thought to be similar to those of the Balakot bridge.

(a) Satellite images of the collapsed pedestrian bridge before and after the earthquake

(b) Collapsed pedestrian bridge

Figure 9.3 Satellite and land views of the collapsed pedestrian bridge.

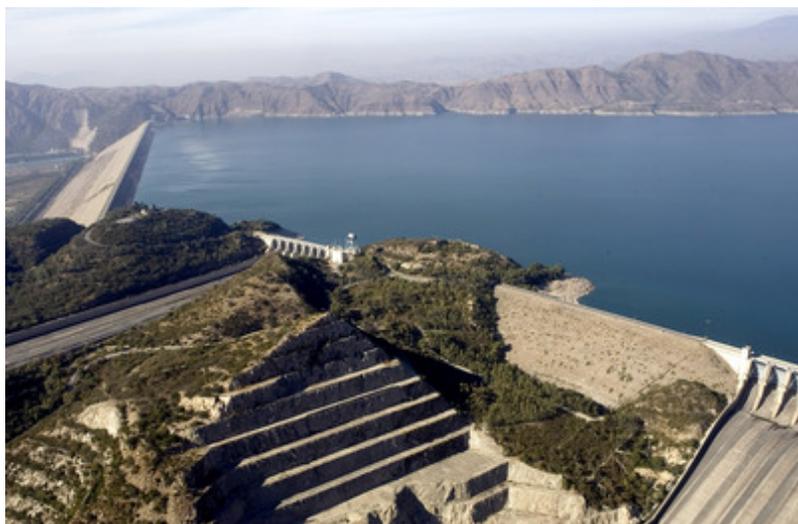
The nearest dam to the epicenter is Terbel Dam built for hydroelectric power and also for irrigation. There was no report of damage to this dam (Figure 9.7).

Figure 9.7 Terbela dam

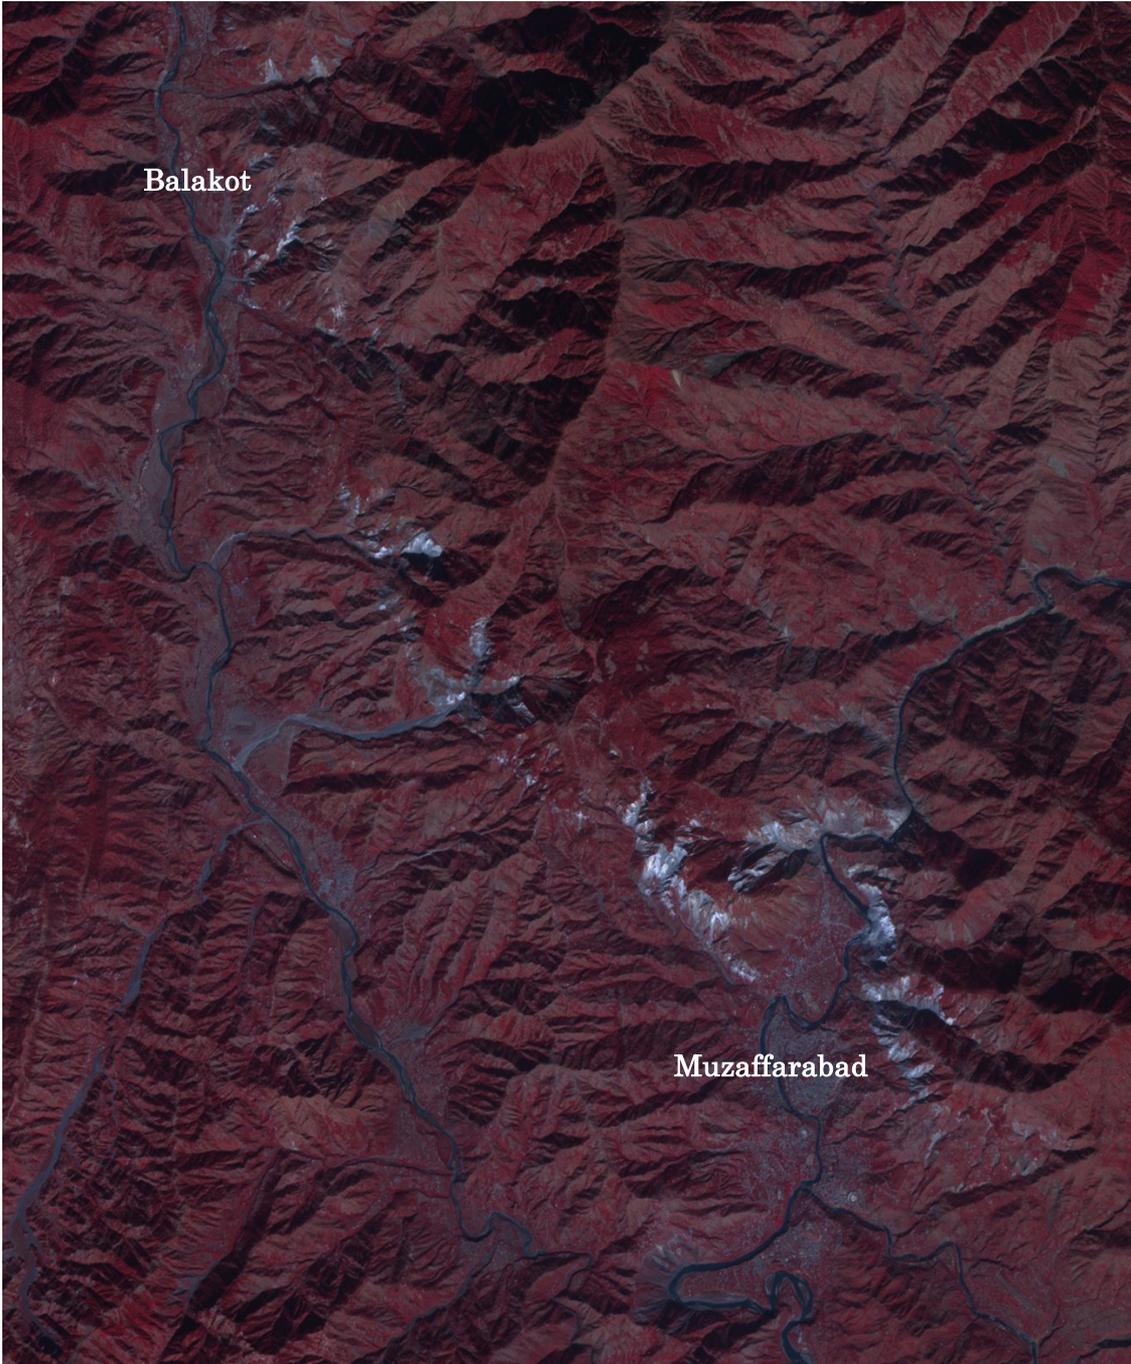
Rock units in the epicentral area are schists (phyllite-like), sandstone, shale, limestone and dolomite. Particularly red shale of Balakot formation is prone to weathering and the thickness of the weathered rock seems to be about 2-5m. Dolomitic rock unit is intensively sheared and this unit is thought to be constituting the fault fracture zone. Figure 10.4 shows a surficial slope failure in weathered red shale nearby Balakot. The surficial slope failures in dolomitic rock unit was spectacular and continued for several kilometers as they are clearly noticed in satellite images (Figure 10.5 and Figure 10.6)

(Whitish areas are surficial slope failures in intensively sheared dolomitic rock unit)  
Figure 10.5 Satellite image of surficial slope failure in intensively sheared dolomitic rock unit

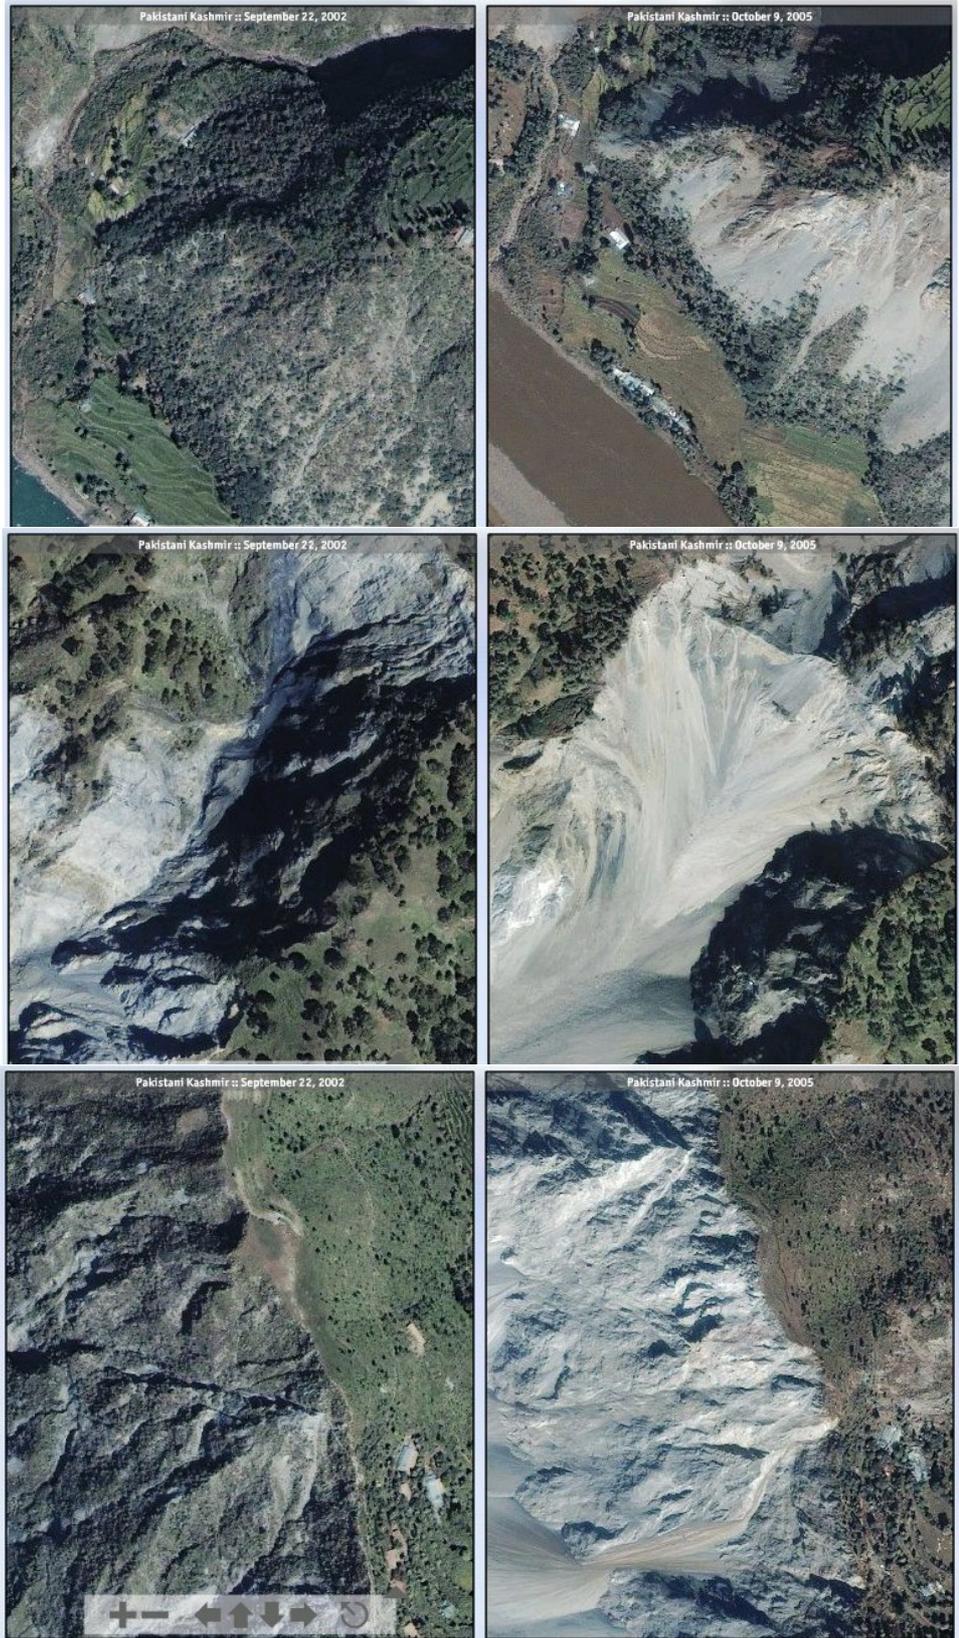
Figure 10.6 Satellite images of slope failures nearby Muzaffarabad

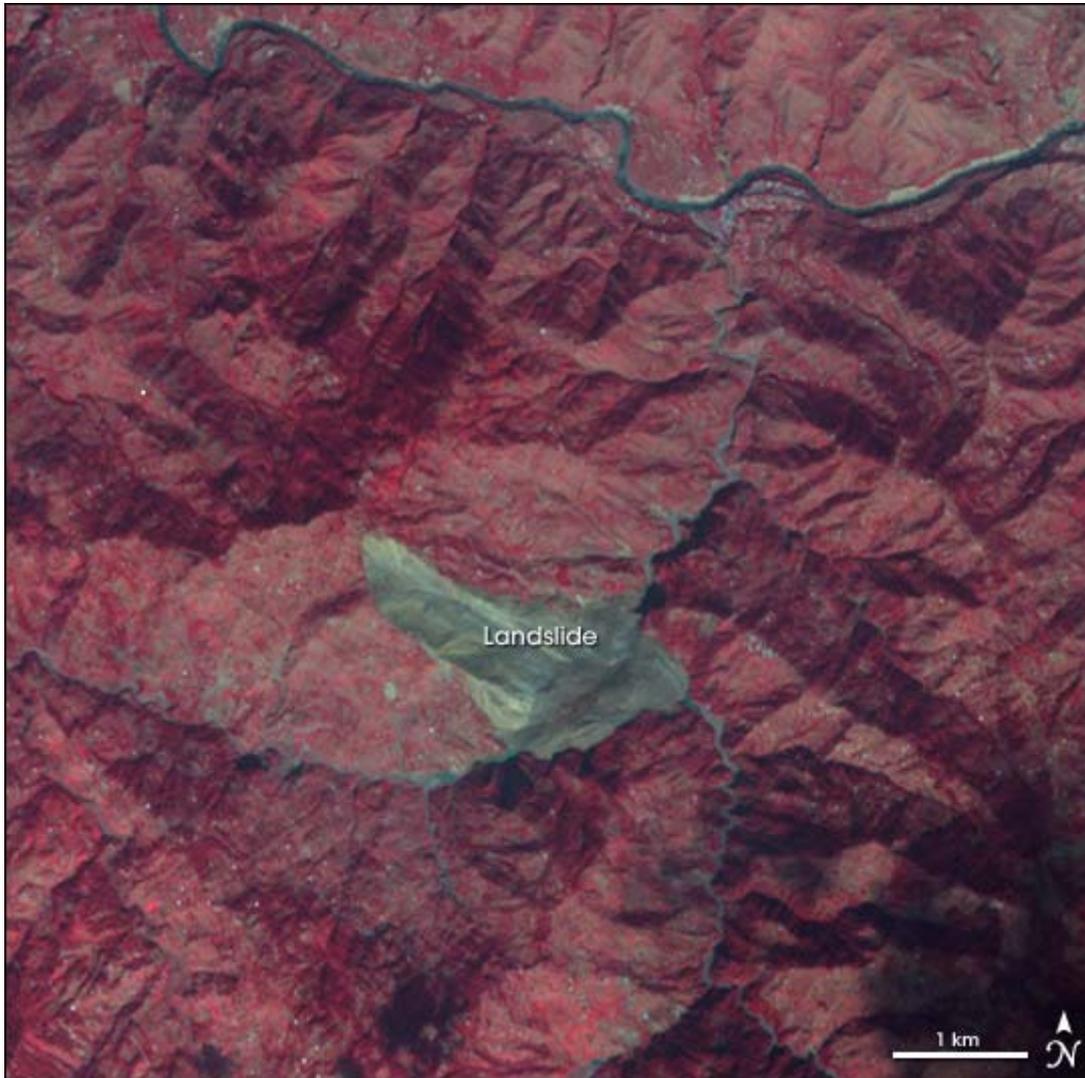
The satellite images indicated that there was a large scale slope failure in the vicinity of the SE tip of the causative fault (Figure 10.9). Although the area could not be visited by the JSCE team, the slope failure may be of planar sliding or asymmetric wedge sliding

type. This type sliding generally observed on rock slopes having layers dipping towards to free slope surface.

Figure 10.9 A large scale slope failure detected from a satellite image

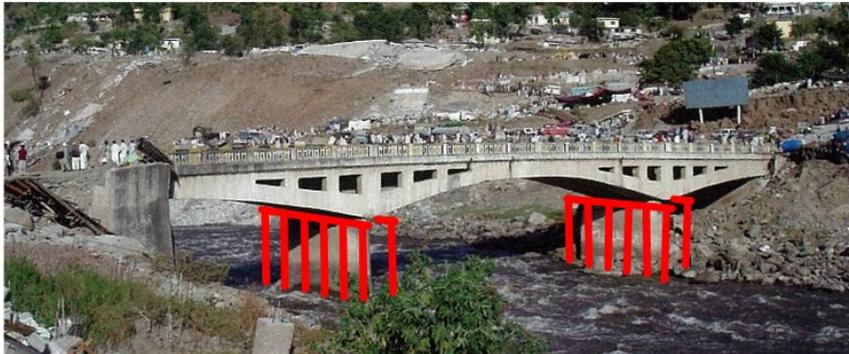
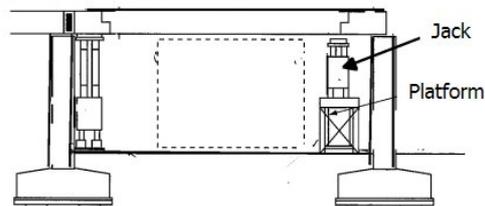
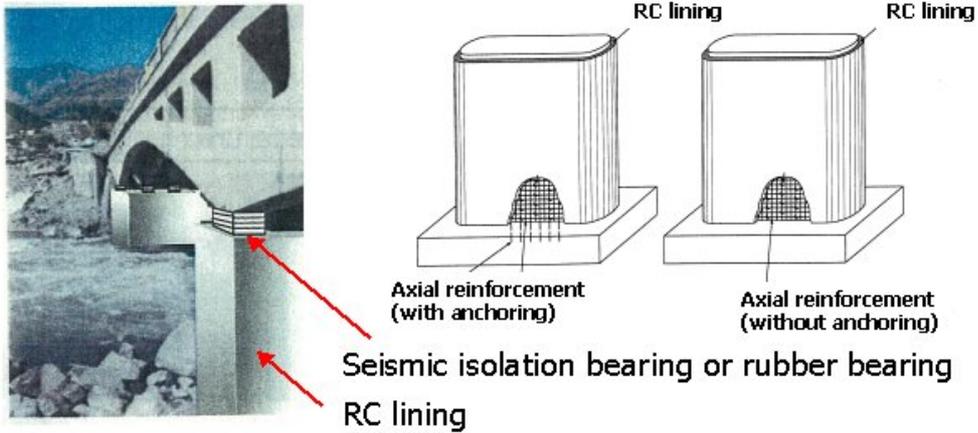
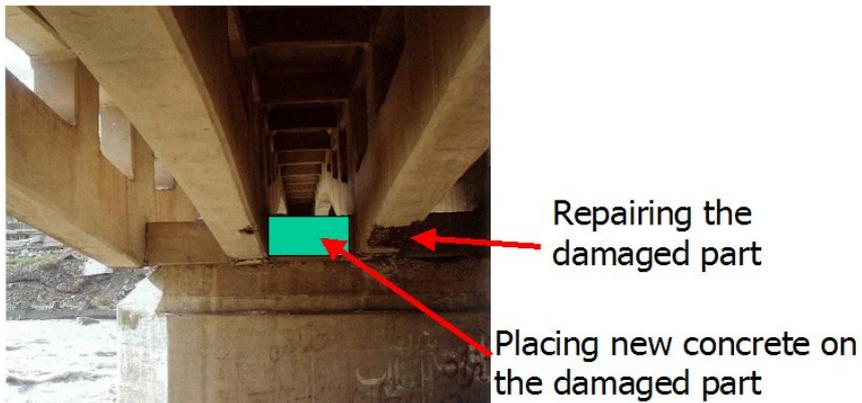
Figure 11.1 Recommendations of possible options for restoration of Balakot bridge

There are several severely damaged bridges in the epicentral area. The most severely damaged largest bridges were in Balakot town. Balakot Bridge is a 3 span girder bridge. The girder of the bridge is displaced laterally for about 1m downstream side and the NE side of the bearings are offset from the pier. Furthermore, the concrete of the girder is damaged at several locations. Damage to the cross beam of the superstructure is found to be relatively severe while the damage to main girders is negligible. The damage to foundation could not be observed visually during the inspection. Figure 11.1 illustrates the possible options for the restoration and rehabilitation of the bridge. The first option is to jack up the superstructure and to translate to its original position as illustrated in Figure 11.1(a).

The second option is to widen the piers and to support the abutment with a RC liner. Furthermore, new shoes (bearings) must be installed at appropriate positions. Furthermore, damaged cross girders and damaged main girders must be repaired. The residual strength of the bridge must be computed in order to check its capacity before the restoration works start. In addition, it is highly recommended to execute regular inspections to prevent the failure of the bridges and consequent accidents. Nevertheless, a new bridge might be necessary if we consider that operation period of bridge and the extent of the damage by the earthquake.

### (1) Translation of girder by jacking

### (2) Widening of piers by addition of RC lining

### (3) Repairing the damaged girder

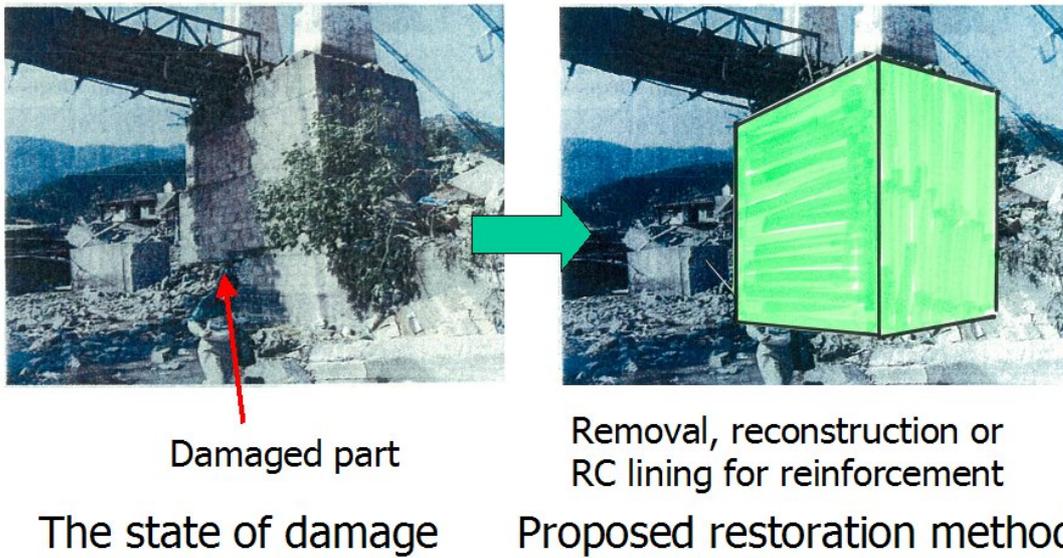
Balakot suspension bridge is a pedestrian suspension bridge. The bridge is severely damaged and upper parts of both abutments are displaced by about 20cm to SE direction. And superstructure is heavily deformed like an S-shape. It would be advisable to construct a new bridge in view of the damaged state of the bridge. Nevertheless, the abutments of the suspension bridge can be repaired as illustrated in Figure 11.2. Furthermore, it is highly recommended that precise measurements of the damaged bridges must be performed.

Figure 11.2 Recommendation for the restoration of Balakot pedestrian bridge

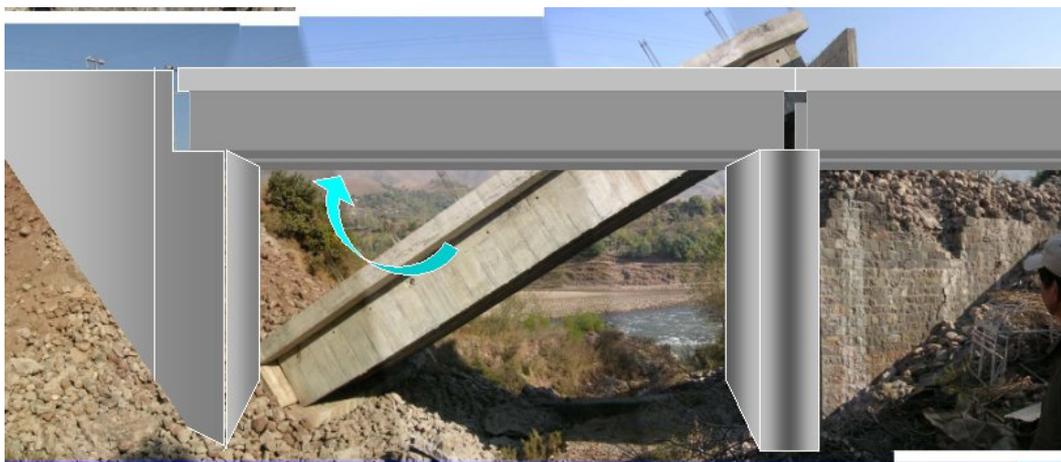
Next we describe our recommendations for the three damaged bridges along the roadway in Jhelum Valley between Muzaffarabad and Chakoti. The first damaged bridge is located 5 km south east of Muzaffarabad city. This bridge is a single girder bridge, which is under construction. Its north-west side of the girder was fell down to ground. The abutment was of stone masonry and it failed during the shaking of the earthquake. It is recommended to construct a new bridge along the present bridge as a permanent measure. However, if the existing girder is to be restored, then it is recommended to construct reinforced concrete abutments instead of stone masonry abutments.

Figure 11.3 New bridge recommendation for the damaged bridge with the use of existing girder

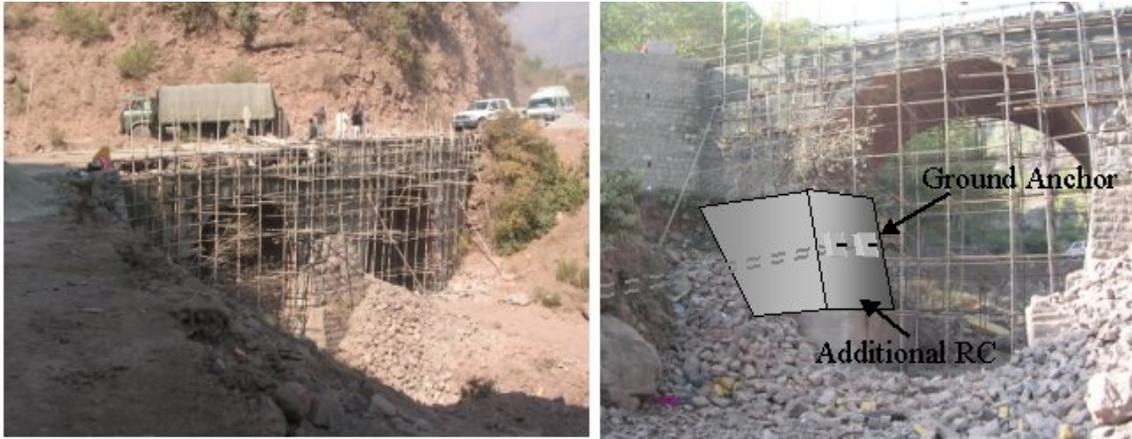
The top side part of arch masonry superstructure collapsed partially as a result of earthquake shaking. The collapsed section may be repaired by casting a new concrete liner. The east masonry abutment of the bridge damaged by the earthquake and it is recommended to cast a peripheral concrete and install ground anchors as illustrated in Figure 11.4.

Figure 11.4 Recommendation for the restoration of the damaged arch bridge

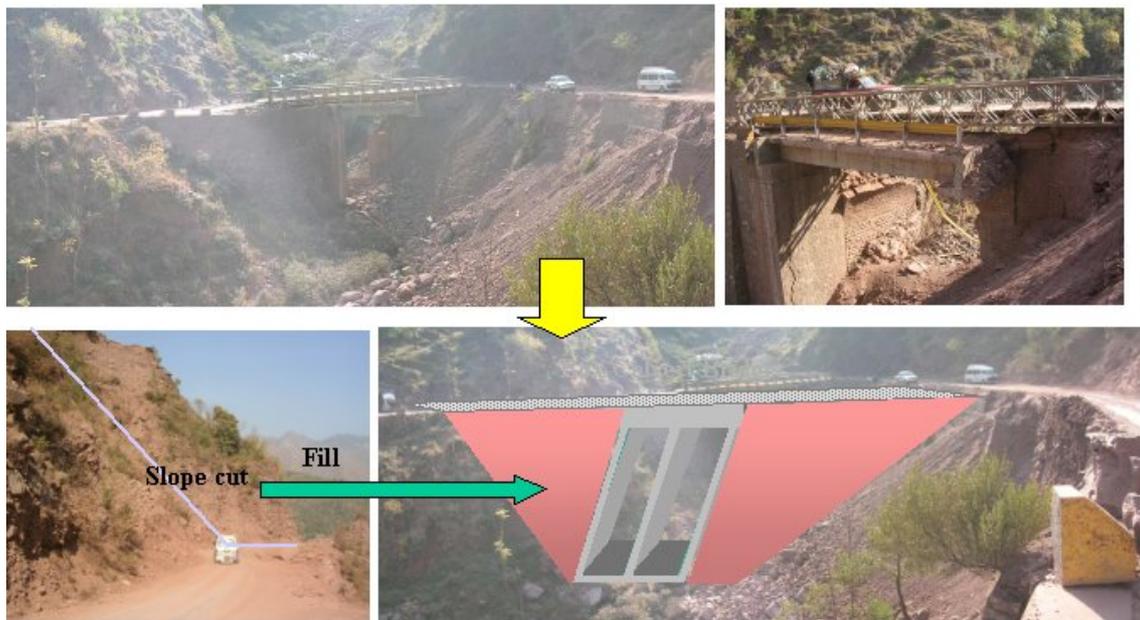
The west abutment of third bridge along the Jhelum Valley was partially damaged by the earthquake. As a temporary measure, an emergency bridge was installed. As for permanent measure, the box culvert is suitable for this bridge in view of its span (Figure 11.5).

Figure 11.5 Recommendation for the construction of a box-culvert for the damaged bridge

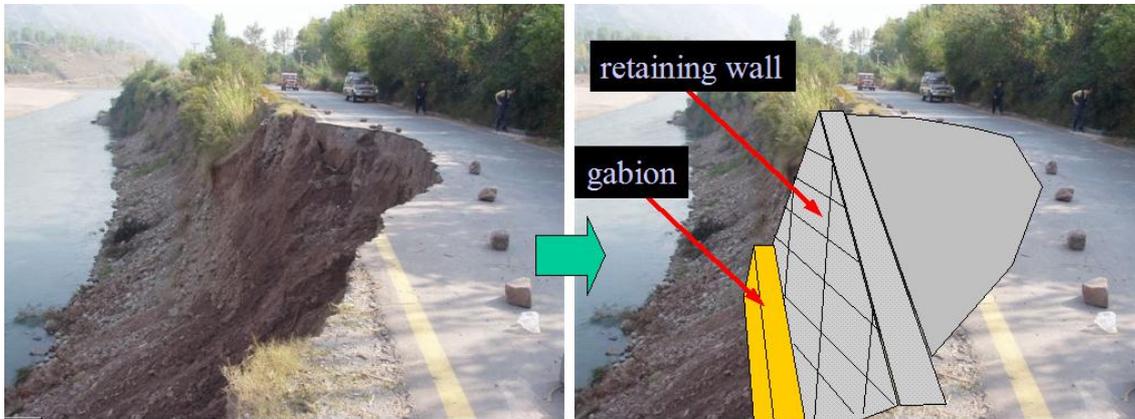
The embankments of roadways failed along the rivers. Stone masonry or gabions are commonly used for supporting the embankments of roadways in steep terrain as well as along rivers. However, the embankments of roadways are not generally protected by retaining walls or gabions for a great length, which may make them prone to slopes as a result of toe erosion due to fast river currents. They may also suffer from heavy rainfalls in long-term. Therefore some measures should be undertaken either by reducing the slope of natural embankments or constructing gabions and retaining walls. Figure 11.6 illustrates a protection procedure for the collapsed section of the embankment.

Figure 11.6 A recommended protection procedure for the collapsed section of the embankment.

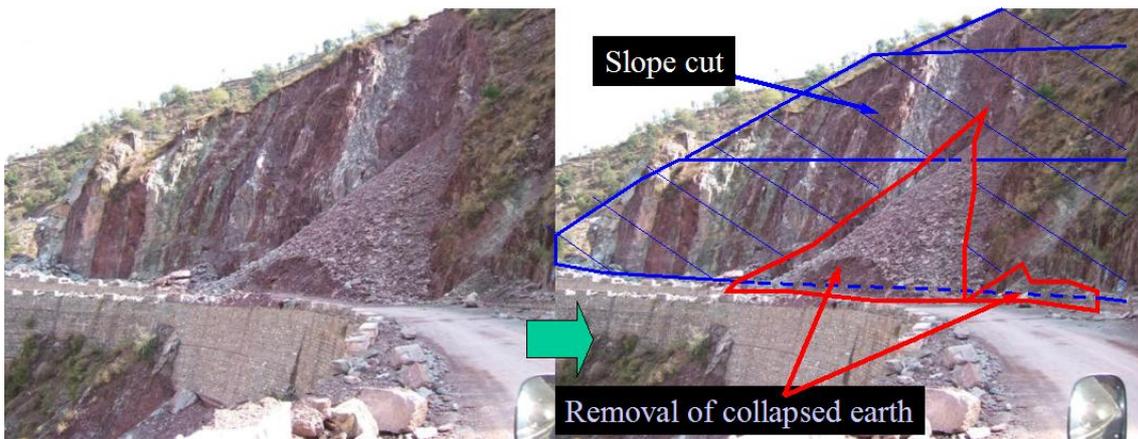
No support or protection measures for most of slope cuts along roadways is undertaken. Furthermore, the slope cuts are generally very steep and there are no catchment pockets in case of rockfalls and small scale slope failures. Figures 11.7 and 11.8 show examples of slope-cut in rock with fallen debris caused by the earthquake and recommended procedures how to rehabilitate the slope-cuts.

Figure 11.7 Recommendation for the restoration of slope-cut with fallen debris

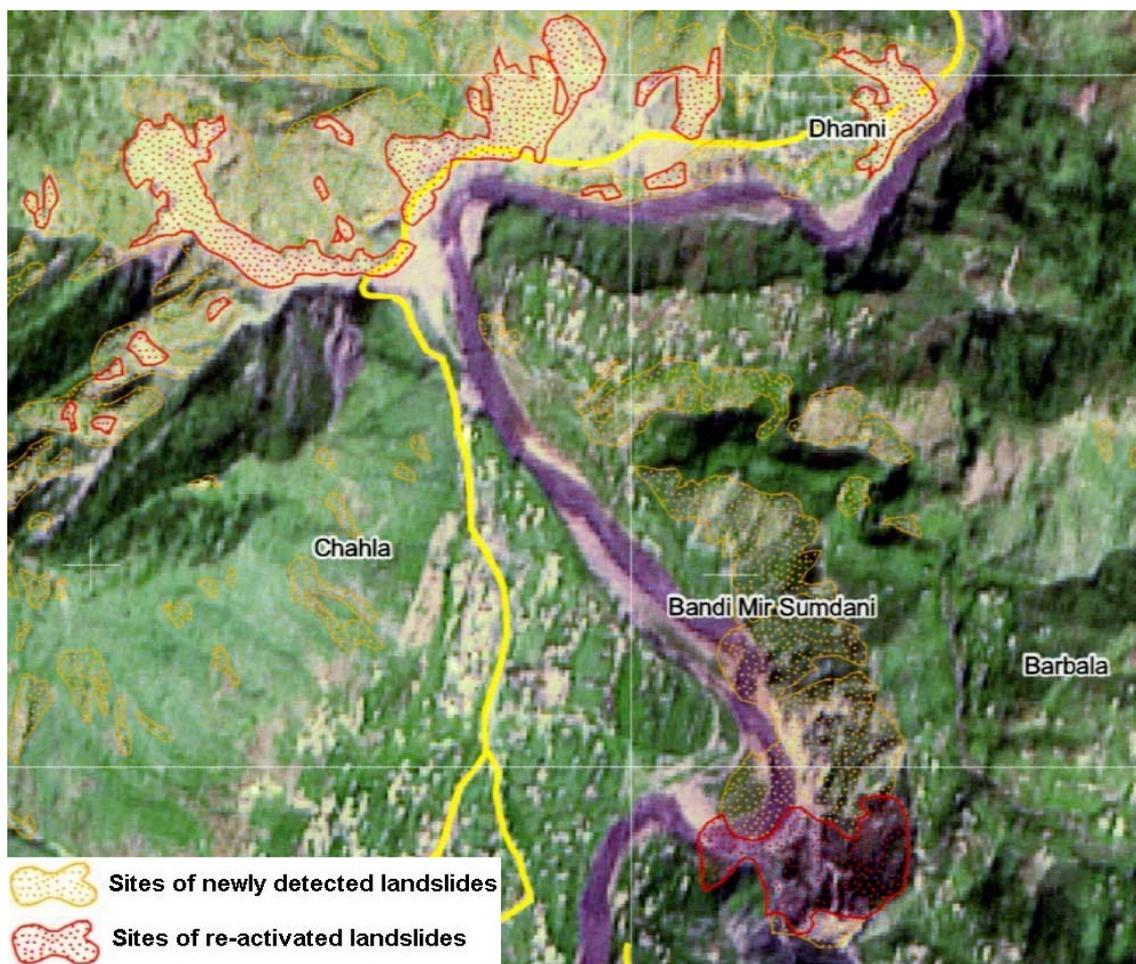
Rapid geotechnical investigations and assessments are based on satellite or aerial photography of the area of interest and outcrop surveys. Satellite or aerial photographs would be quite useful to know the extent of damage to civil infra structures and to identify most critical locations for drawing emergency restoration and recovery plans. Figure 11.26 shows a rapid assessment of slope failures and their extent nearby Muzaffarabad city.

Figure 11.26 Rapid assessment of slope failures and their extent nearby Muzaffarabad city from satellite images
