Provisional Report of the May 27, 2006, Mid Java Earthquake, Indonesia

June 15, 2006

**Advanced Body of the
“JSCE/AIJ mission for reconstruction
recommendations for areas devastated by the
May. 27, 2006, Java earthquake, Indonesia”**

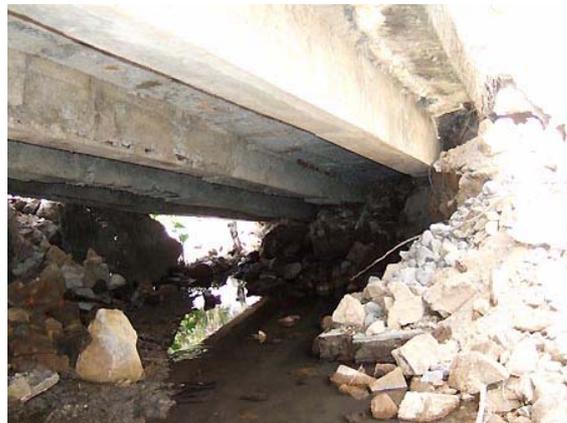
Fig. 5. Bridge (S7deg 47.102 min, E 110 deg 34.680 min)

(c) Four simple beams support the deck.

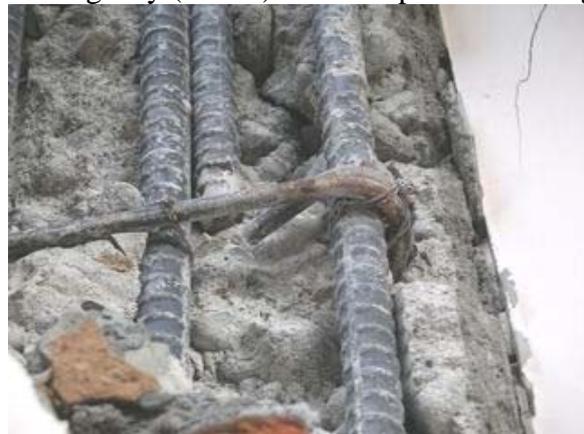
135-degree hooks in a column

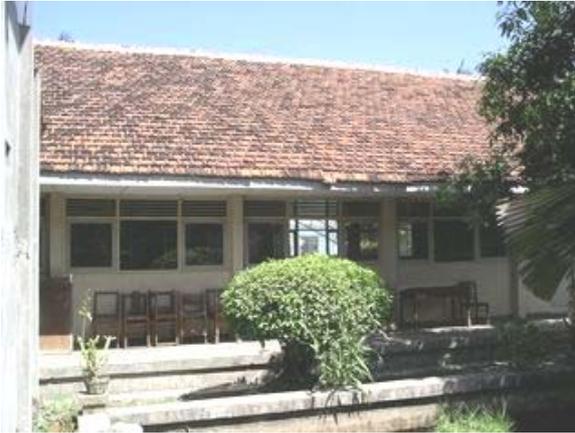
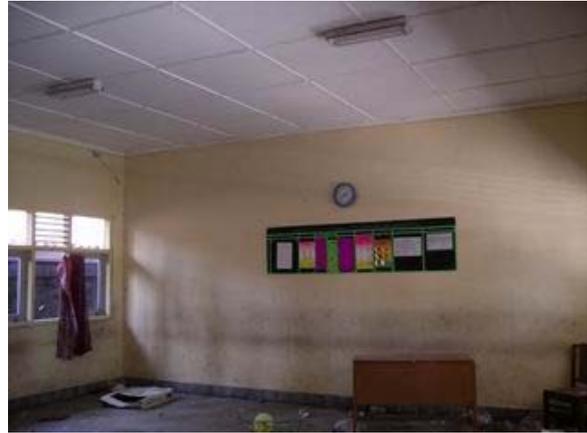
Bambanglipuro 2nd Middle School (SMP 2 at Bambanglipuro, Kecamatan Baglipuro / URM+RC column / 1F)

Each class had 3 bays in the longitudinal direction. No major damage was found in the structure.

SMP 2 at Bambanglipuro, Kecamatan Baglipuro / No major damage found in the building

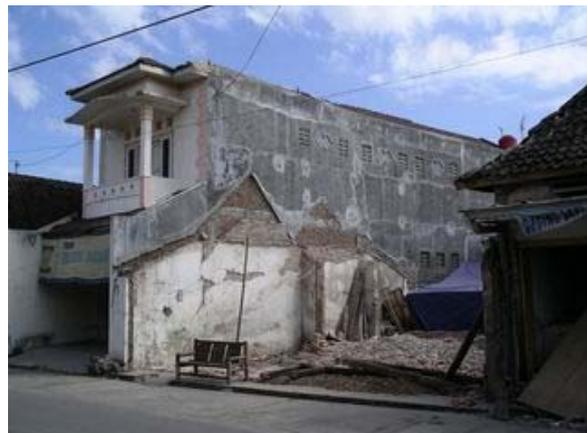
Houses in Imogiri were extensively devastated. They were URM structures with timber truss system and roofing tiles on it. URM walls were typically 20cm to 25cm thick with 2 or 1.5 brick units, having a geometry of 26cm x 12cm x 6cm. Since demolitions to reconstruct damaged houses had started in Imogiri, it was not easy to identify which debris were due to shaking and which were not. Those with RC frames to confine URM walls often survived the shaking although they had some damage.

Survived house with URM and RC frame

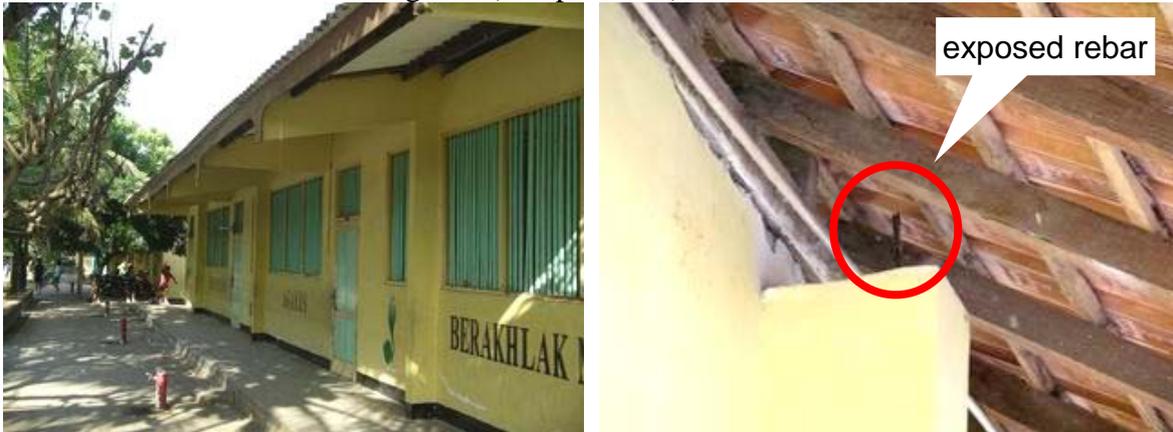
Parangtritis 2nd Elementary School (SD 2 Parangtritis at Parangtritis, Kecamatan Kretek / URM+RC column / 1F)

The school had 2 single story buildings. Each class had 2 bays in the longitudinal direction. Each bay was 3.5m long and the column in the center of each two-bayed frame was 175mm thick and 350mm wide. The eaves of one building were supported by Γ -shaped RC columns with cantilever beam while those of the other were supported by columns provided at the tip of eaves. No major damage was found in the structures. Note that less damage was found in the coastal areas around Parangtritis (to Opak river) than inland areas.

SD 2 Parangtritis / No major damage found in the building

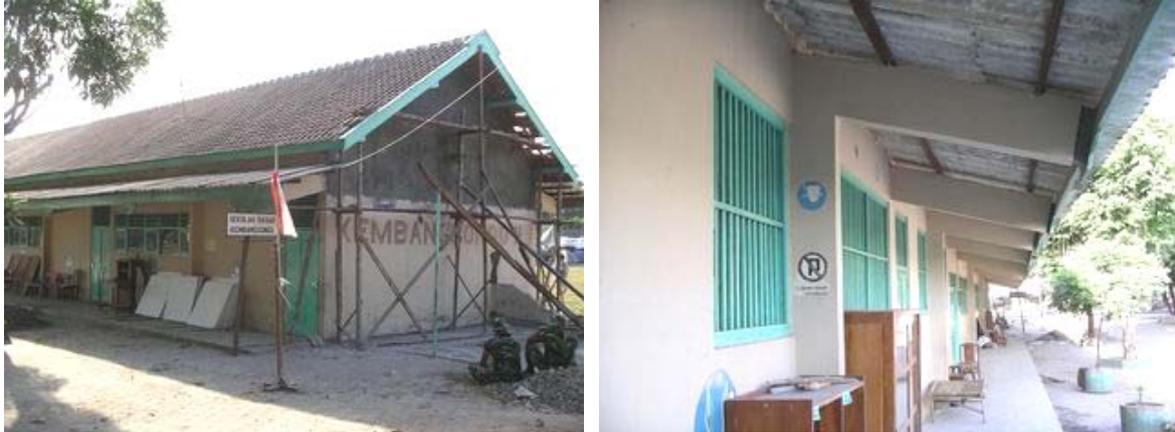
The school was located just north of the school at Trimulyo. The eaves were supported by

Γ-shaped RC columns with cantilever beam, which was similar to SD 2 Parangtritis. The exterior URM wall was damaged and repaired, but no other major structural damage was found in the structure.

SD 2 at Kembangsongo / No major structural damage found in the building

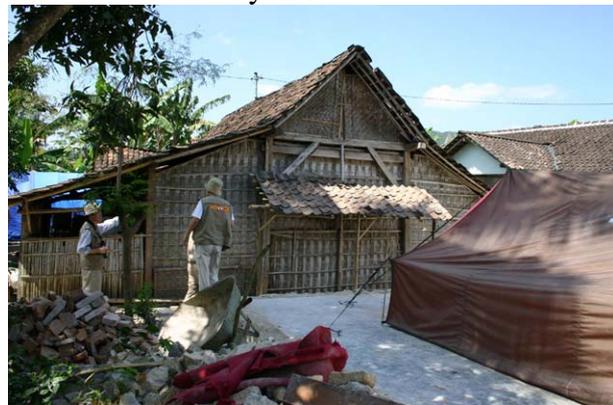
Traditional stone masonry houses in Gantiwarno Sub-Regency had some damage in masonry walls. They had some RC beams on the wall but no RC columns were provided in the houses. Although they were heavy, the stone masonry walls were thick and long enough to resist and survive the shaking. Another traditional house older than the stone masonry construction had minor damage since they had light bamboo-net walls. The bamboo-net house investigated by the reconnaissance team was older than 70 years.

Bamboo-net wall house

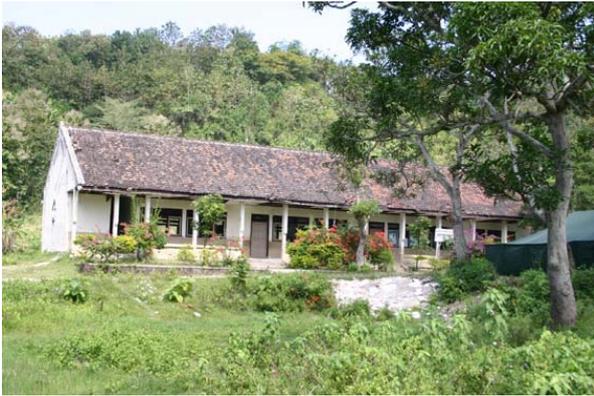
The school had 3 buildings, one of them (building #2) was stone masonry structure constructed in the 1970s while the other two buildings (#1 and #3) were URM structure with RC columns. Each classroom of the building #1 had 3 bays, each of which was 3m long. Damage to the roof system and ceiling boards was found in buildings #1 and #3 while cracks in URM stone walls were found in building #2.

Building #1 : URM with RC columns

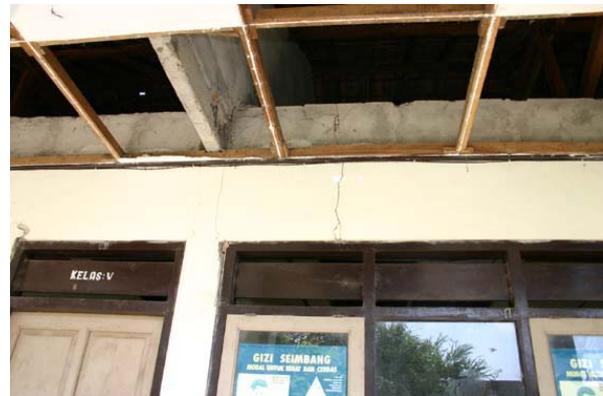
Building #1 : RC column and beam

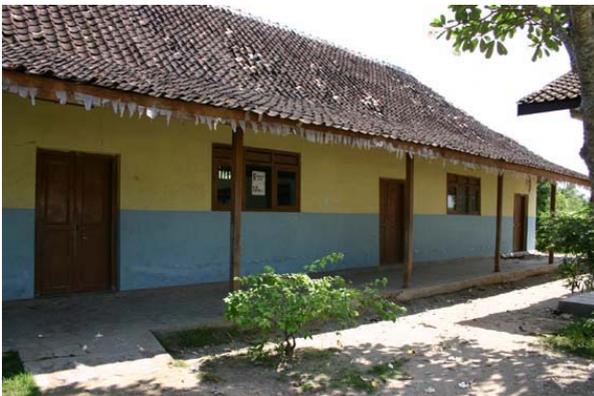
Building #2: Stone masonry structure

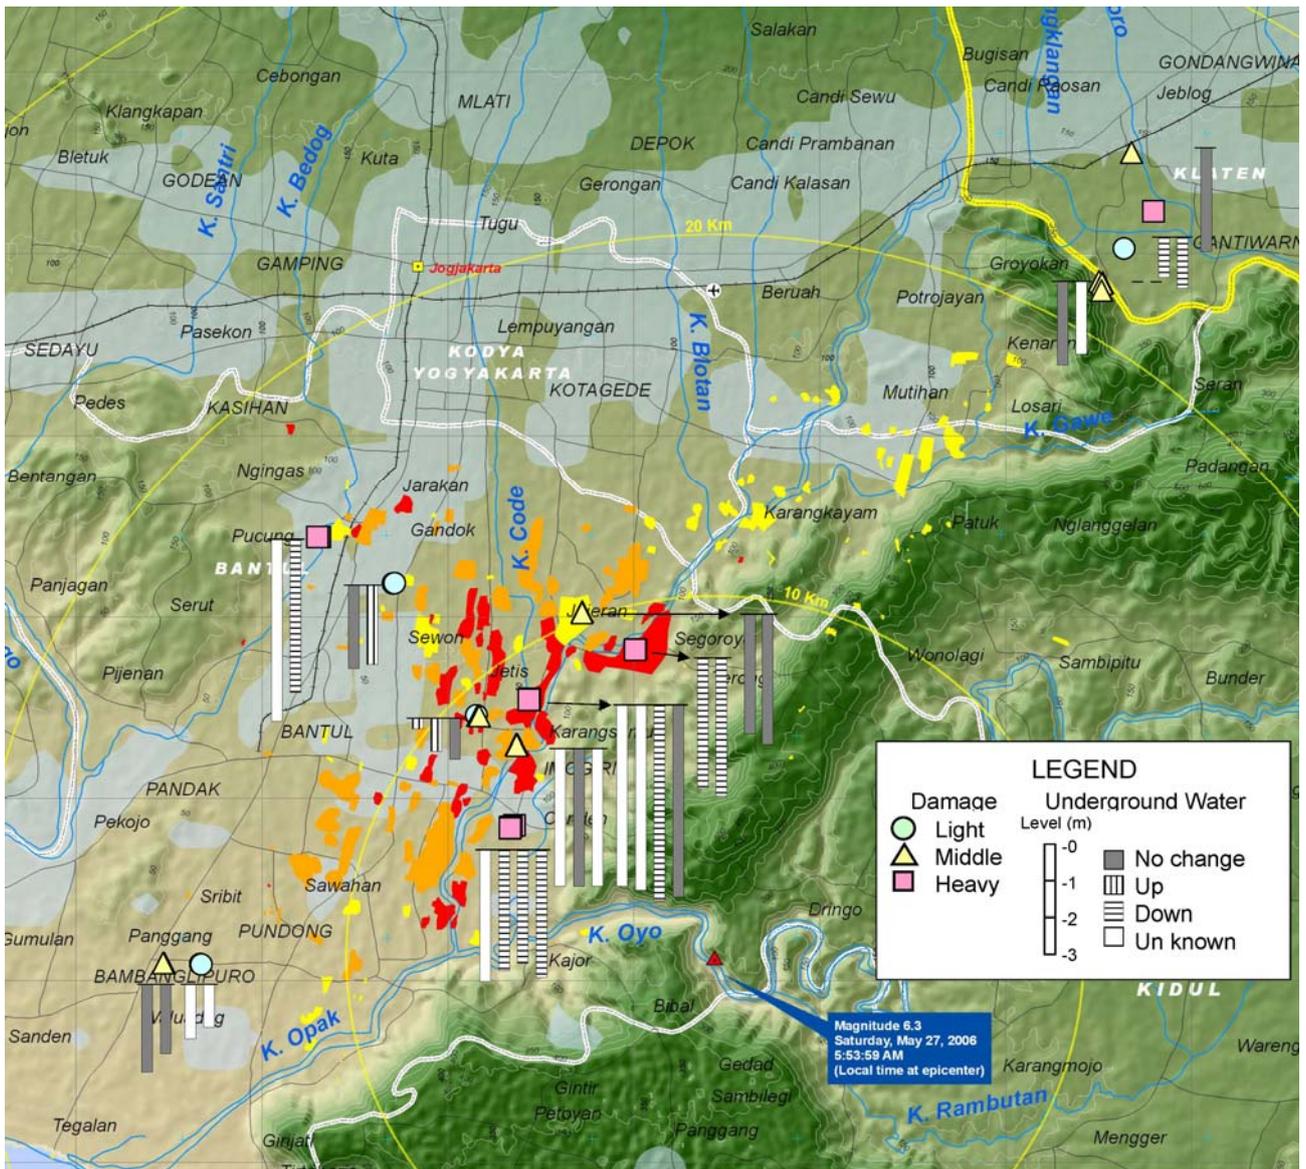
Figure A-3 Locations of investigated wells

The team members took total 40 wells randomly in the most seriously affected areas along and west of Opak fault to check if underground water levels have changed due to the strong ground motions. Some eyewitnesses said that they saw muddy water spouted out of their wells, and plastic pipes for pumping of these wells were found bent, broken and pushed up. They clearly say that soils beneath the wells have liquefied, while no clear sand volcanoes were found in their vicinities. This is firstly because the ground was covered thick with cohesive clay loam, and secondly the shake was not intense for the built-up pore-water pressure to force its way up through the surface clay-loamy soils. However the liquefaction was certainly responsible for destroying and/or clogging wells. For spreading water supply systems and sewage systems, these features of soils are to be studied.

- * Lengths of bars show depths of water levels as of June 12-13, 2006.
- * Changes of water levels are all from owners and/or eyewitnesses.
- * The background map illustrates a preliminary damage assessment of the affected areas (UNOSAT website: <http://unosat.web.cern.ch>). Red, orange and yellow colored spots show respectively extensive, middle and limited devastation areas.
