JSCE (Japan Society of Civil Engineers)
- NPO: EWB (Engineers Without Borders, Japan)
Joint Team
for
INSTRUCTIONS FOR GEOTECHNICAL INVESTIGATION
AND THE PRACTICAL UTILIZATION OF ITS RESULTS
FOR RECOVERY AND RECONSTRUCTION OF NIAS
ISLAND AND FOR DISASTER PREVENTION OF NORTH
SUMATRA AND WEST SUMATRA PROVINCE

Feb. 17 -25, 2007

SUPPORT ACTIVITIES FOR THE RECOVERY AND RECONSTRUCTION BY TRANSFERING THE TECHNIQUE ON GEOTECHNICAL INVESTIGATION IN NIAS ISLAND DAMAGED BY THE M8.7 OFF-SHORE SUMATRA EARTHQUAKE, MARCH 28, 2005

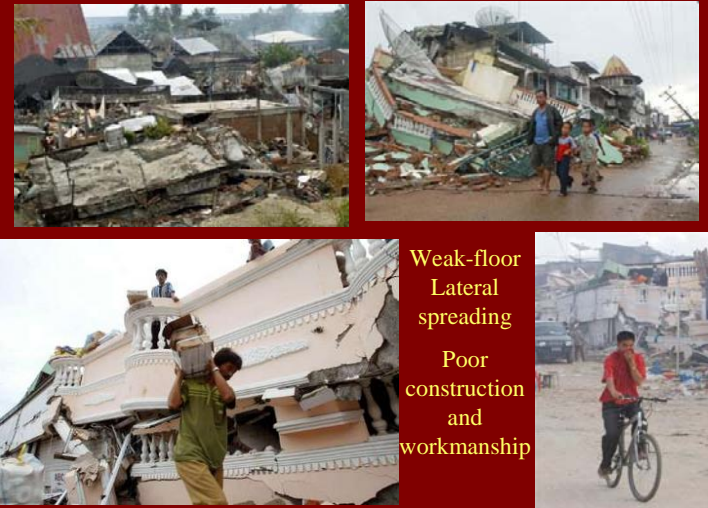
2004 Aceh Earthquake

Weak-floor
Lateral
spreading
Poor
construction
and
workmanship

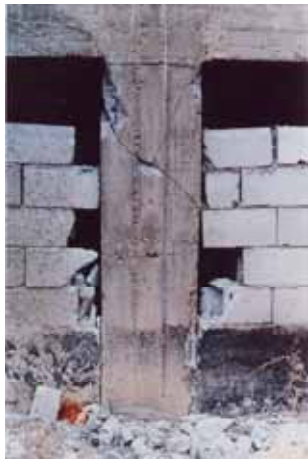
1992 Erzincan EQ (Turkey)

Nonstructural elements placed in RC frames, which are most typically masonry walls, are often neglected in the structural design. Past damaging earthquake, however, often revealed that they significantly affected structural responses due to column shortening, stiffer frames causing unexpected soft story in the adjacent story above and/or below, etc. as shown in Photos 3 and 4. Although the conservative strength may be obtained through neglecting effects of nonstructural elements, they may give adverse effects on structural performance and eventually cause brittle failures.

Photo 3 Contribution of nonstructural elements to column shortening and damage

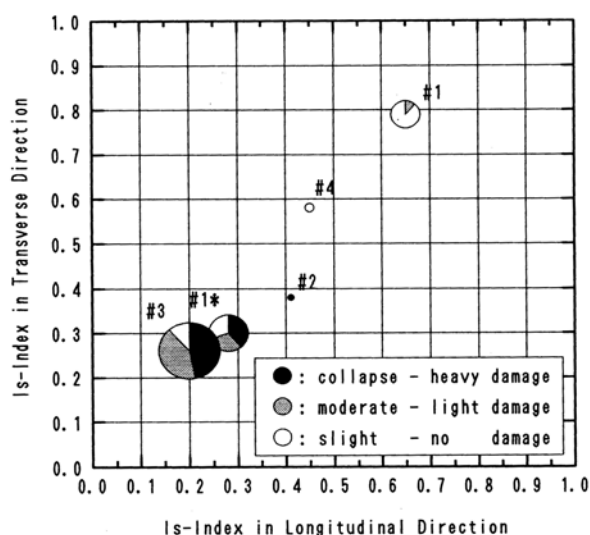
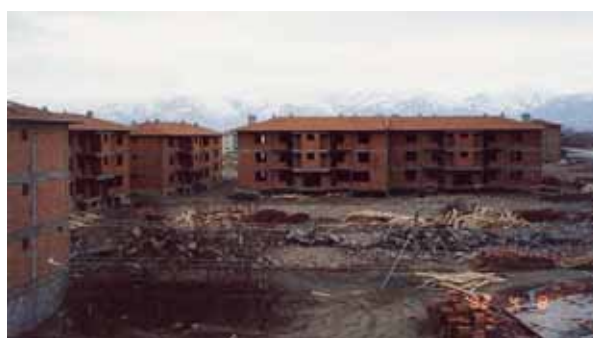
Fig. 3 Application example of Japanese Seismic Evaluation Standard after 1992 Erzincan Earthquake in Turkey (Nakano and Kato 1994)

The Japanese Standard also has been applied to buildings outside Japan such as Mexico (after 1985 Mexico EQ), Turkey (after 1992 Erzincan EQ and 1999 Kocaeli EQ), Taiwan (after 1999 Chi-Chi EQ), Pakistan (after 2005 Kashmir EQ), etc. to investigate their seismic capacities and to identify major reasons of damage (Okada et al. 1988, Nakano and Kato 1994). Fig. 3 shows an application example after 1992 Erzincan earthquake in eastern Turkey. In this study, the correlation of seismic performance and I_s -index of 5 standard structural designs (types #1, #1*, #2, #3, and #4) is investigated. In the affected area, approximately 100 buildings were designed and constructed according to either design type #1, #1*, or #3. The size of each circle in the figure corresponds to the number of buildings constructed according to an identical standard design type and the shaded portion shows the ratio of 3 structural damage categories shown in the legend. As can be found in the figure, the damage ratio increases according to decrease in I_s -index, and the index can be a good estimator to identify vulnerable buildings in the affected area in Turkey.

General view of type #1 and #1* buildings in the affected area

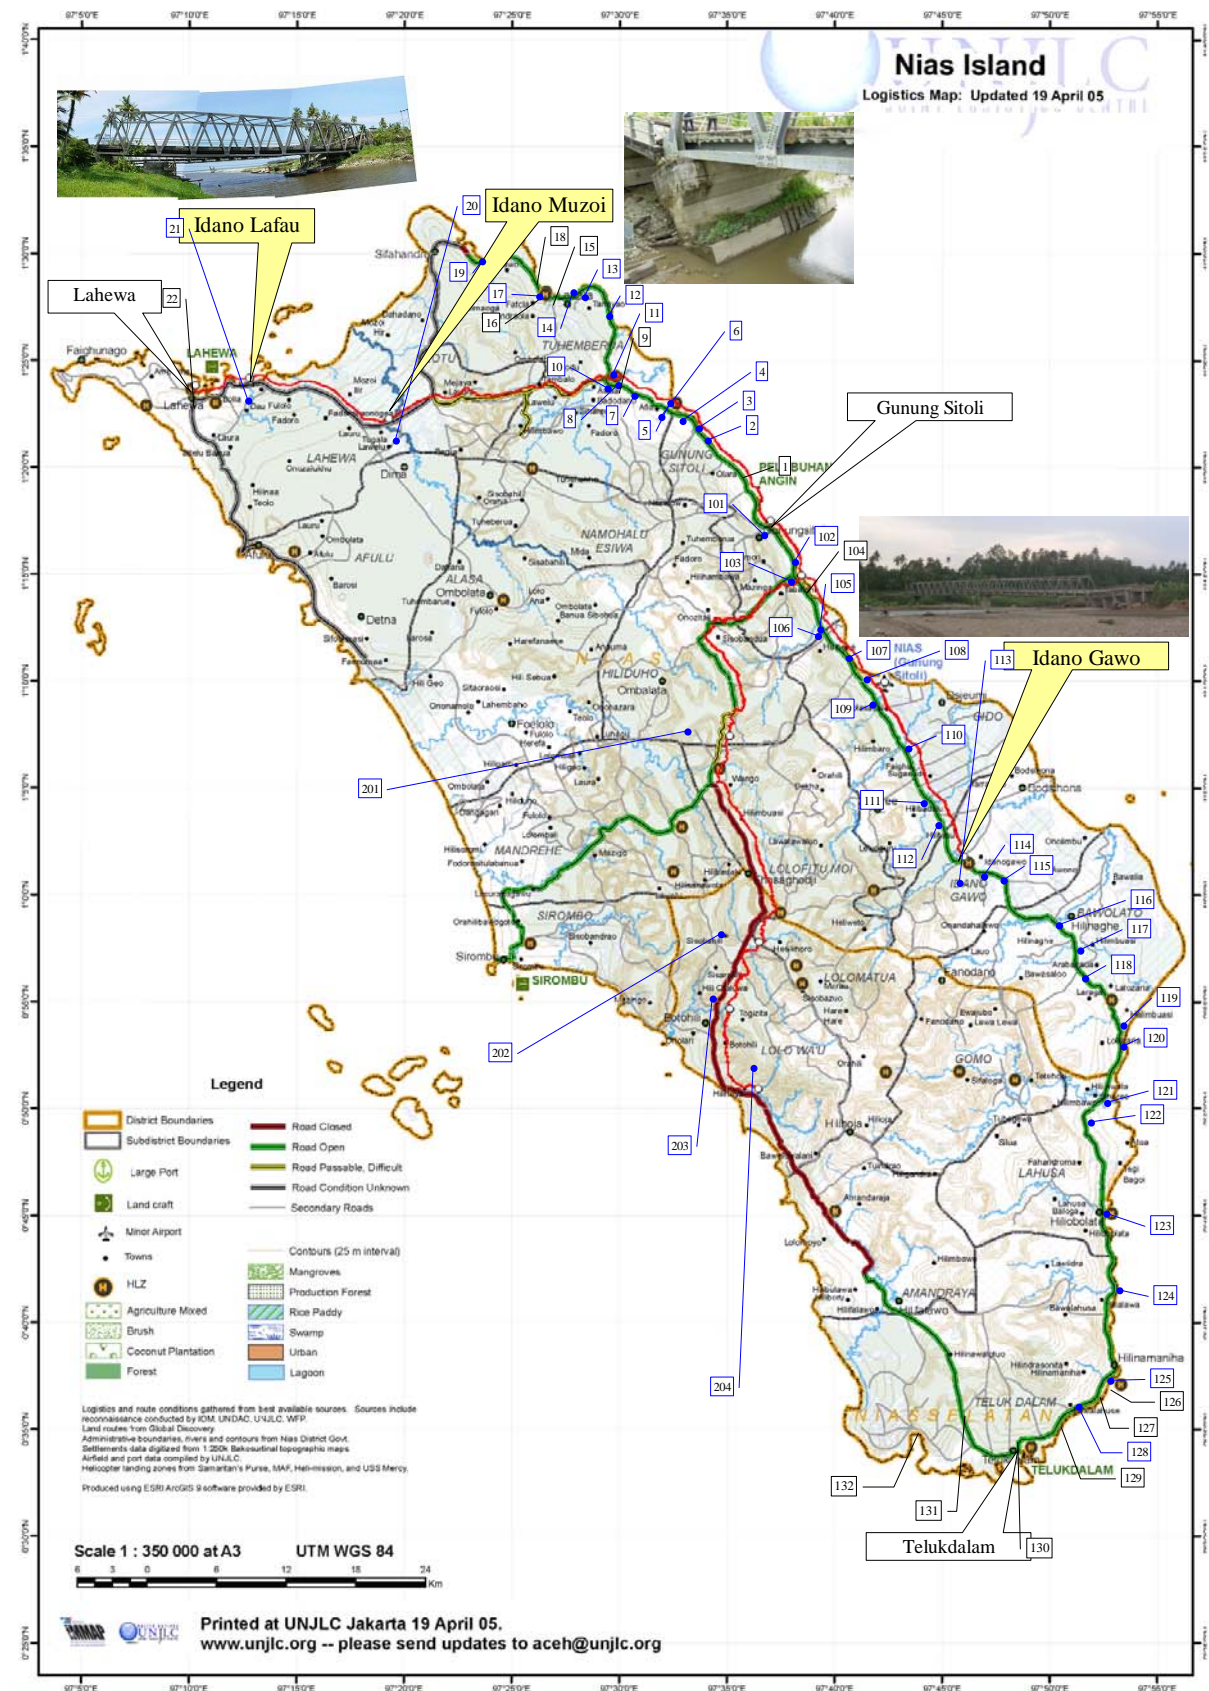
Figure 3: Investigated bridges and Major cites and towns

The roads connecting Lahewa in the northern part of island to Gunung Sitoli, Gunung Sitoli to Telukdalam in the southern part along eastern coast, and Gunung Sitoli to Telukdalam through the center of island are main roads. Bridges in Nias Island may be broadly classified as Truss bridges, RC bridges, RC Box Culvert bridges, Wooden paved steel framed bridges, and Wooden bridges. Long span bridges are either truss bridges or RC bridges with or without box culverts. Truss bridges were especially used for long span bridges along main roads. The list of bridges and dominant forms of their damage are listed in Table 3 and locations of these bridges are shown in Figure 3.

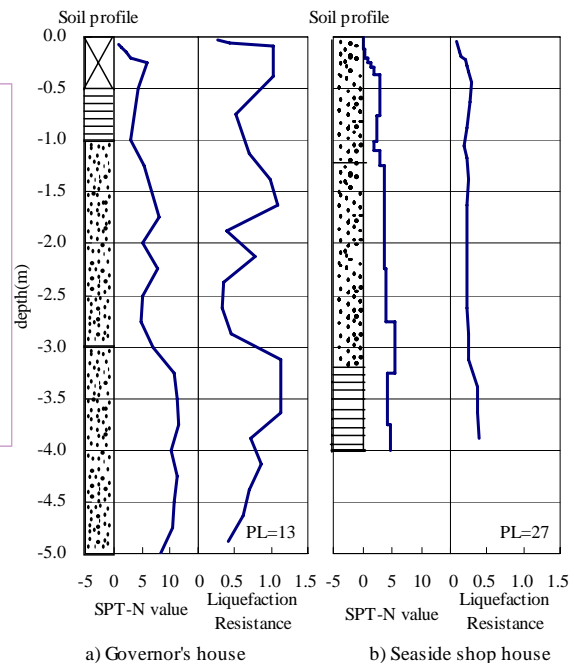
Figure 10: Soil profile, Converted SPT N-value from Swedish weight sounding test and liquefaction resistance at 2 sites in Gunung Sitoli

As expected from the magnitude of this earthquake, the liquefaction of sandy ground is very likely. The sandy ground is observed along seashore and riverbanks. Damage of ground like settlement, lateral flow and associated structural damage due to liquefaction were widely observed in various locations along the coastal area and reclaimed ground. The damage induced in Gunung Sitoli due to liquefaction is widespread along the coastal area, reclaimed ground and riverbanks. The all possible forms of ground movements and the effects of ground liquefaction were observed such as sand boils, lateral ground movements, settlement. The lateral spreading of ground nearby bridge abutments were almost entirely associated with liquefaction of sand soil layer. Figure 9 shows grain size distribution curves for soil samples in Gunung Sitoli. It can be seen that these soils have almost the same grain size and they are very liquefiable. Swedish weight sounding tests were conducted at 2 points in Gunung Sitoli. Soil profile, converted SPT N-value from Swedish weight sounding test and Liquefaction Potential based on the result of geotechnical investigation are shown in Figure 10. Method of liquefaction assessment is according to the Recommendation for Design of Building Foundations, Architectural Institute of Japan. In this study, maximum acceleration of strong ground motion is taken as 350cm/s^2 for ultimate limit, which is as large as observed in liquefied area during Hyogoken-Nambu earthquake. There is a 3m thick loose sandy layer at the subsurface of reclaimed ground (shop house), which is inferred to be easily liquefiable from the result of Swedish weight sounding. As mentioned above, many buildings in such areas were heavily damaged with partial settlement, inclination and uplift of ground floor. As a result, almost all building were demolished and removed. At the site of Governor's house, there exist sandy layer, but having relatively large N-value and partially liquefiable during strong ground motion obtained from the assessment based on the test result. The elevation of the site is slightly higher than that of the reclaimed area and only small damages such as cracking in floor concrete were observed after the earthquake. The results obtained from geotechnical investigation are in good accordance with the observed damages caused by the earthquake. However, the geotechnical investigations of ground are scarce in Nias Island and it would be desirable to carry out such investigations in areas particularly affected by ground liquefaction in relation to recovery and reconstruction of Nias Island.
